BATA OVERSIGHT COMMITTEE

Wednesday, April 10, 2013, 9:30 a.m.

THE SAN FRANCISCO-OAKLAND
BAY BRIDGE
SEISMIC SAFETY PROJECT

BATA Oversight Committee – April 10, 2013

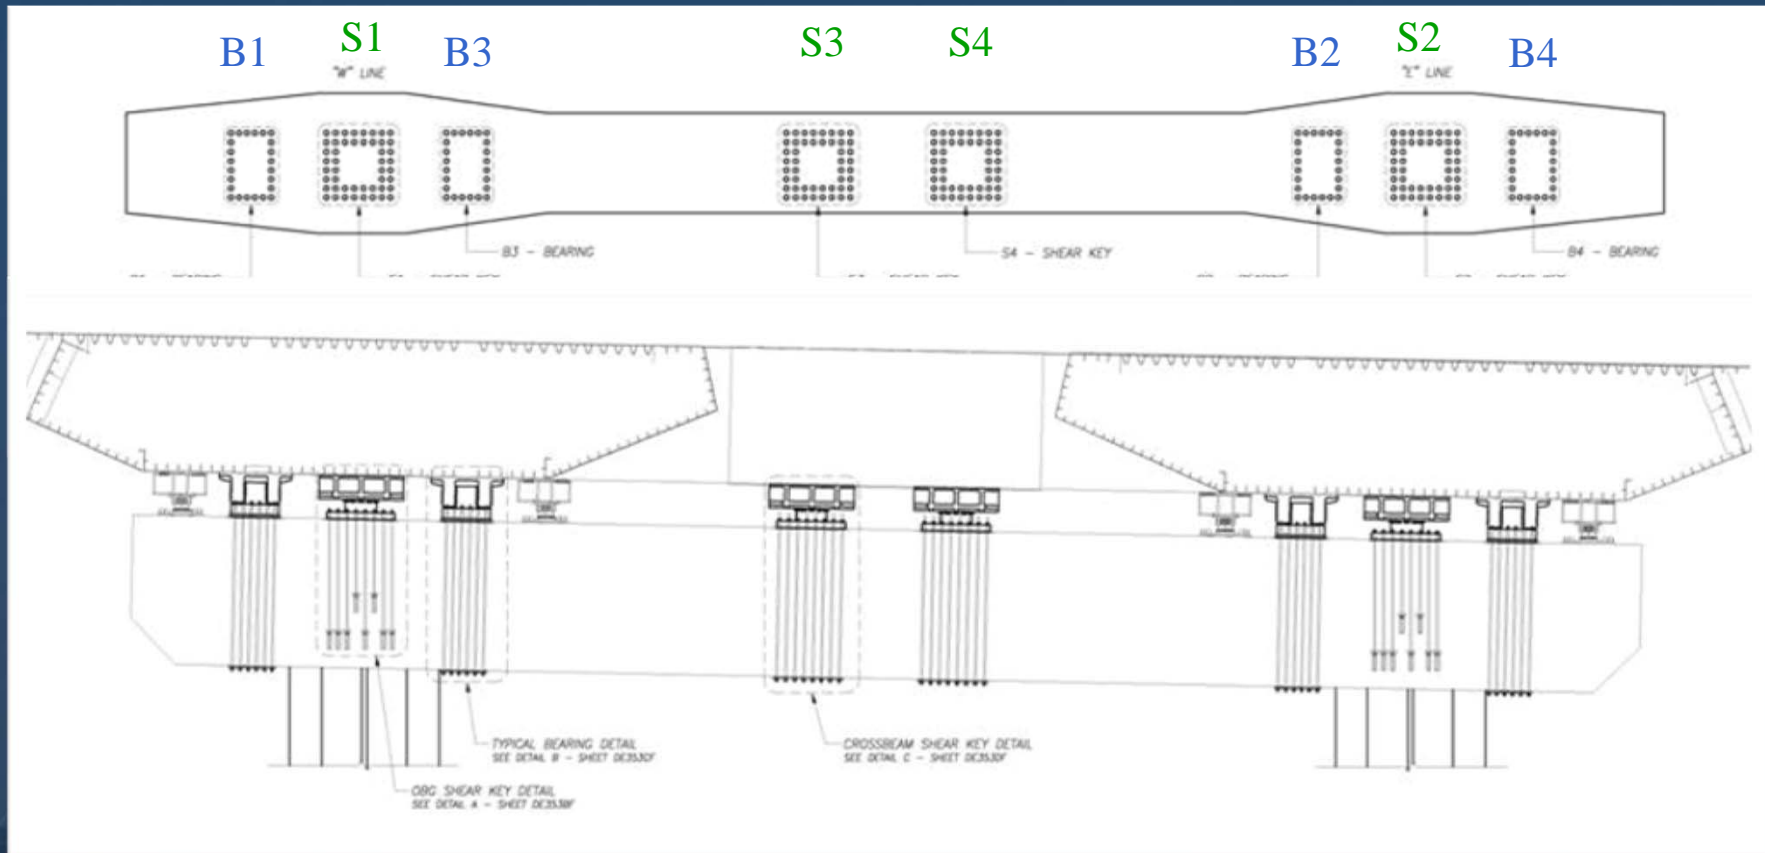
Bearings and shear keys are secured to Pier E2 by 3 inch diameter anchor rods, ranging from 9 feet to 24 feet in length

Each bearing has 24 anchor rods and each shear key has 48 anchor rods for a total of 288 anchor rods

This is, again, a little bit more detail about the location we're talking about. The top: you're basically looking down on the top of the pier without the bridge deck and crossbeams in place. And the bottom piece there is actually showing you the deck and the pier itself. Just a point of reference—you see the B1, S1, B3, etc., up on the top? The B's are bearings; the S's are the shear keys. And one other point just to note down on the bottom, you notice the long lines that extend down into what we call the cap beam. And one of the main issues we're dealing with is that those rods go through in some locations for all of the bearings and two of the shear keys, but there are two locations where those rods do not go all the way through the capping. They're actually sitting right on top of the column of the pier, which makes access at that location very, very difficult. There are 24 anchor rods installed for each of the bearings and 48 anchor rods for each of the shear keys for a total of 288 anchor rods at this location. Next.

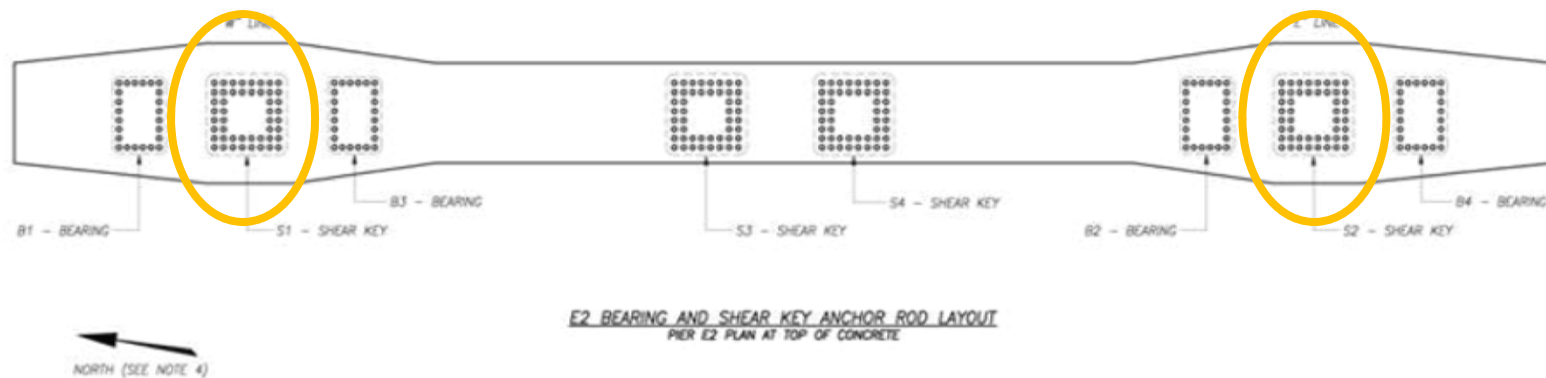
Shear key and bearing anchor rods could not be stressed until completion of load transfer.

Stressing began on March 1 of this year, starting with anchor rods fabricated in 2008 (total of 96 rods) for shear keys S1 and S2.

32 fractured rods were discovered between March 8 and March 15.

There are two distinct batches, if you will, of anchor rods, some were installed and fabricated in 2008, and it has to do with that access issue. They had to be installed prior to the pouring of the concrete at this location, whereas the rest of the anchor rods could be installed after the pour. So we had one batch that was fabricated and installed in 2008 and another batch that was fabricated and installed between 2010 and 2011. The yellow circles on here show the locations where the 2008 rods installed. Now, we couldn't actually start putting tension on those rods until after load transfer, because we had to get the final geometry of the bridge in place before you could actually secure these down. So once load transfer was complete, and that was right at the end of last year, very early part of this year, we started tensioning these rods. Stressing began on March 1st and it did start with the older batch of the anchor rods, the 2008 batch, which are at shear keys 1 and 2, the areas circled in yellow on this diagram. Within a very short period of time after tensioning, we started discovering fractured rods. We discovered, ultimately, a grand total of 32 fractured rods. Subsequent to the fracture, Director Dougherty issued me a 10-point Action Plan to review and assess the situation, and that plan is currently being used by the Oversight Committee to review progress on this issue. And one of the first things it outlined, basically, was a forensic analysis to be done to determine, you know, what happened here. And one of the first things that we do is we start going back and look at the documentation with respect to the fabrication of the rods in question. The documentation includes a pretty extensive set of documents relating to both quality control and quality assurance. Some of the key points are outlined on this slide. We review the quality control that's performed by the contractor and the supplier, which includes the mill certifications. It shows the chemical composition of the steel in question, various independent laboratory tests of material properties that are performed over the life of the fabrication of these items, and, ultimately, certificates of compliance that are provided by the supplier and the contractor for these particular items. In addition to the quality control process, there is a set of quality assurance documentation included in the record. Quality assurance is performed by the department. And we start very early on with quality assurance. We talked about this a little bit last time. We actually go out into the field to visit the facilities where these items are going to be made. We speak to the facilities management. We

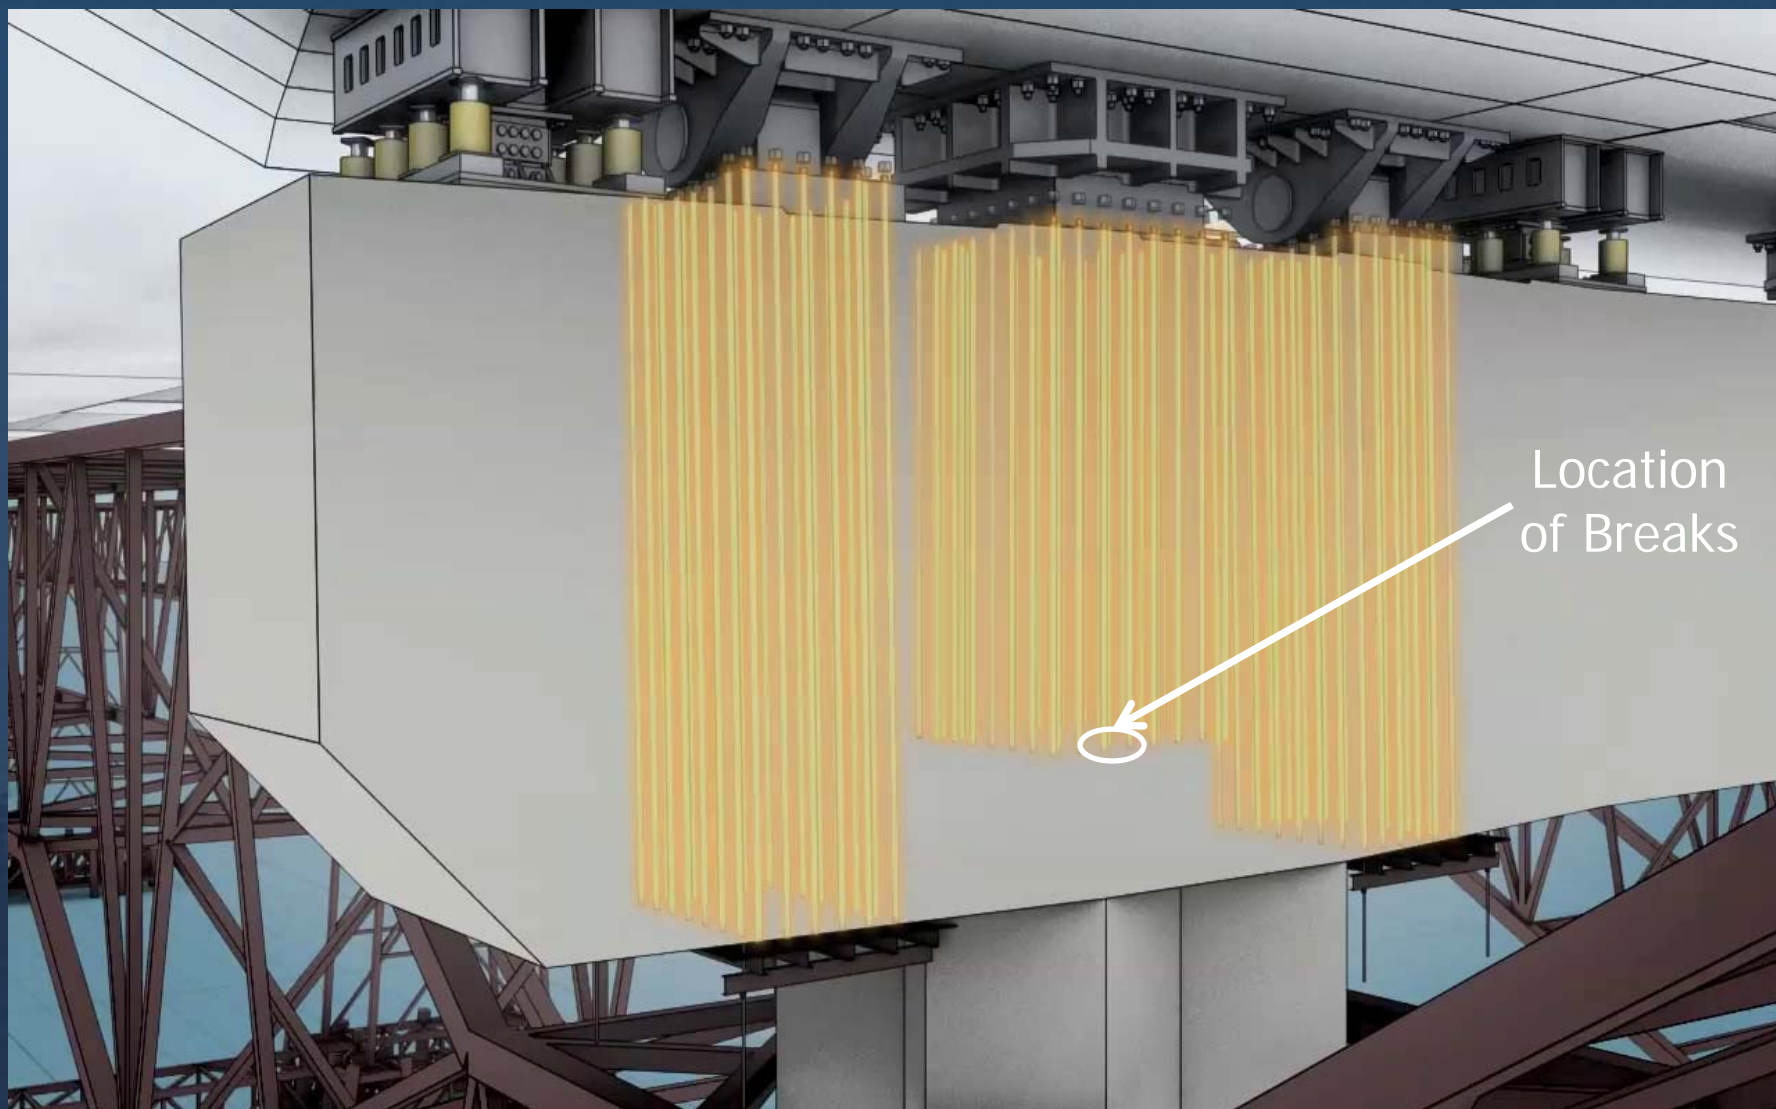
Location
of Breaks

And here we, again, have a slide showing you sort of an x-ray image of the rods in place, again, showing you how those center rods are sitting right on top of the column, which does present some access challenges at this point in time. You also see on this diagram where we have observed the location of the fractures. This is an important forensic piece for us. Again, we've extracted four rods at this point from shear key S1 and S2. We will be extracting more in the future, but with respect to the four that we have extracted, all of the fracture locations are the same. They are all down at the

bottom of the rods. They are all occurring right at the first thread immediately above the nut that's located on the bottom portion of the rod. Next slide.

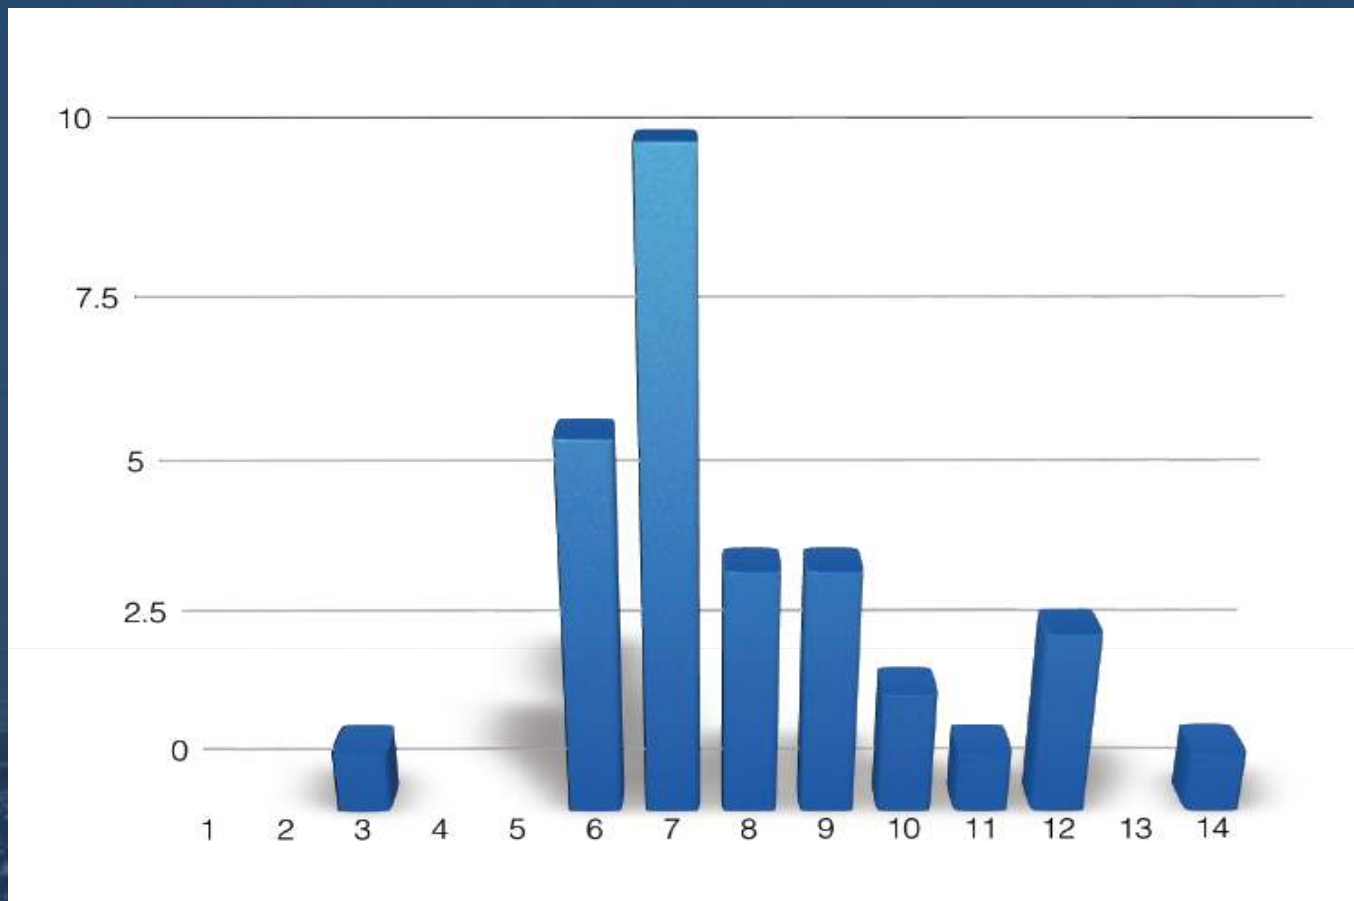
ROD FRACTURES

DAYS AFTER STRESSING

- Remaining rods were detensioned after 14 days.

Another piece of information that is of significance: This basically is a histogram showing you when the fractures began to occur. It's reflective of how many days after stressing, where we're at, and how many fractures did we see. And, as you can see on this histogram, the fractures started occurring fairly quickly after these rods were stressed, with the majority of what we observed happening within a fairly condensed period between days 6 and 12. It's important to understand in reviewing this, however, that after day 14, we did detention. We reduced the pressure on these rods significantly, so there was a significant change that occurred at day 14. Next slide.

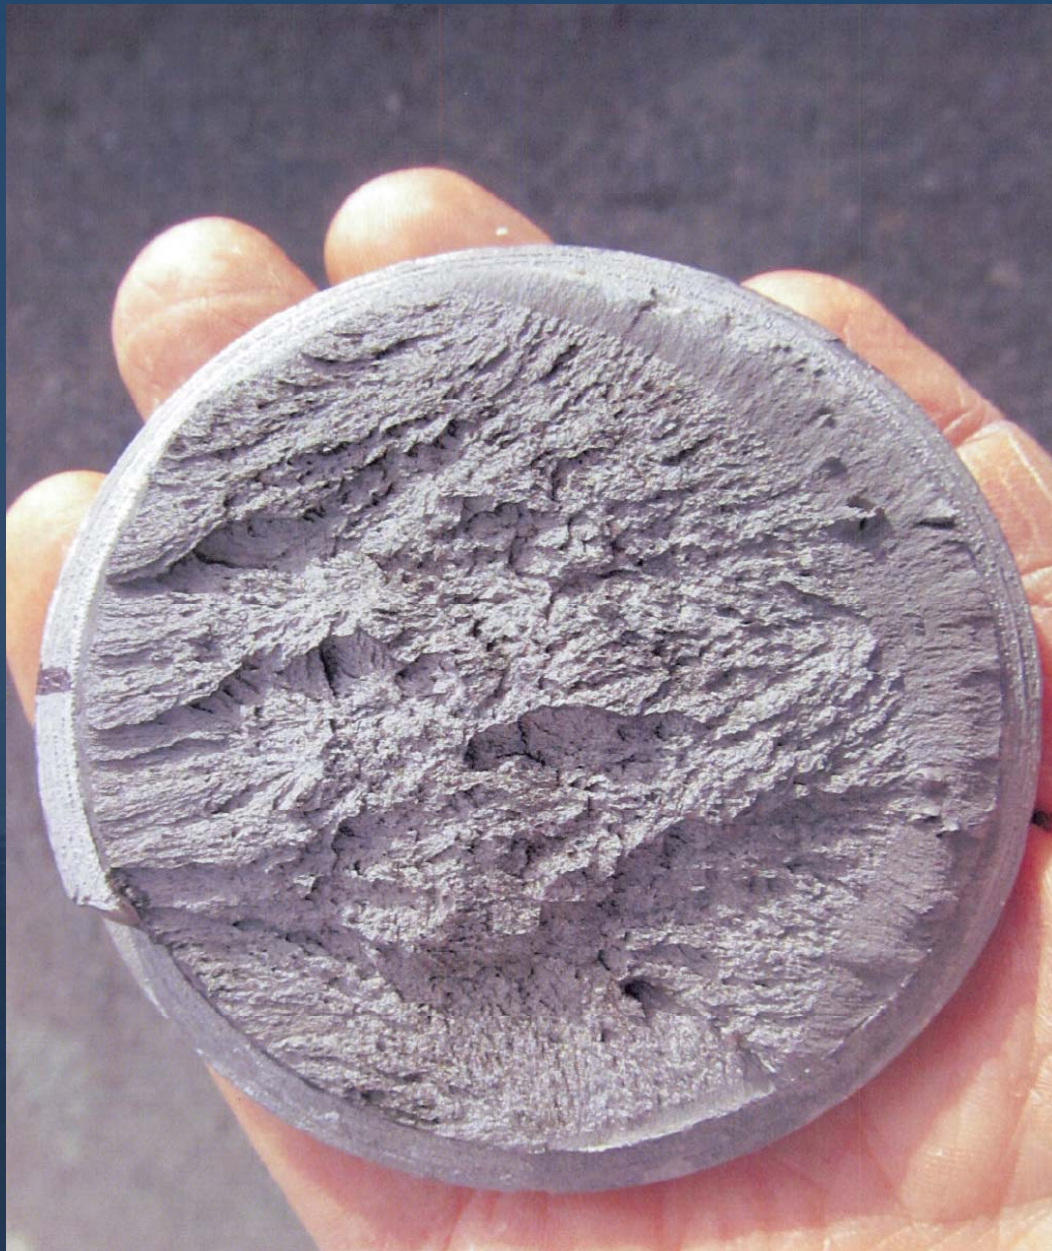
**One fractured rod
sent to lab for
testing**

**Testing included
electron
microscopy and
mechanical
property tests**

Another forensic step that was taken, we did take one of the fractured rods, which would have been at the bottom of the rod you're taking a look at in front of me here, and we sent it out for metallurgical examination. So the picture you see here is a picture of the actual fractured surface where the fracture occurred. And one thing of note in this image—it's a little it probably hard to see, displayed up on the screens, but if you look to the right of the actual image, you see a little sort of darker and flatter crescent moon shape that starts right up at the top of the rod fracture area and goes all the way down at the bottom, and goes in for about, oh, maybe, oh, an eighth of the distance inside of the fracture area. That's an important indicator. That tells us that's the area where the fracture began. It also provides us with some additional information that I'll touch on when we go to the next slide.

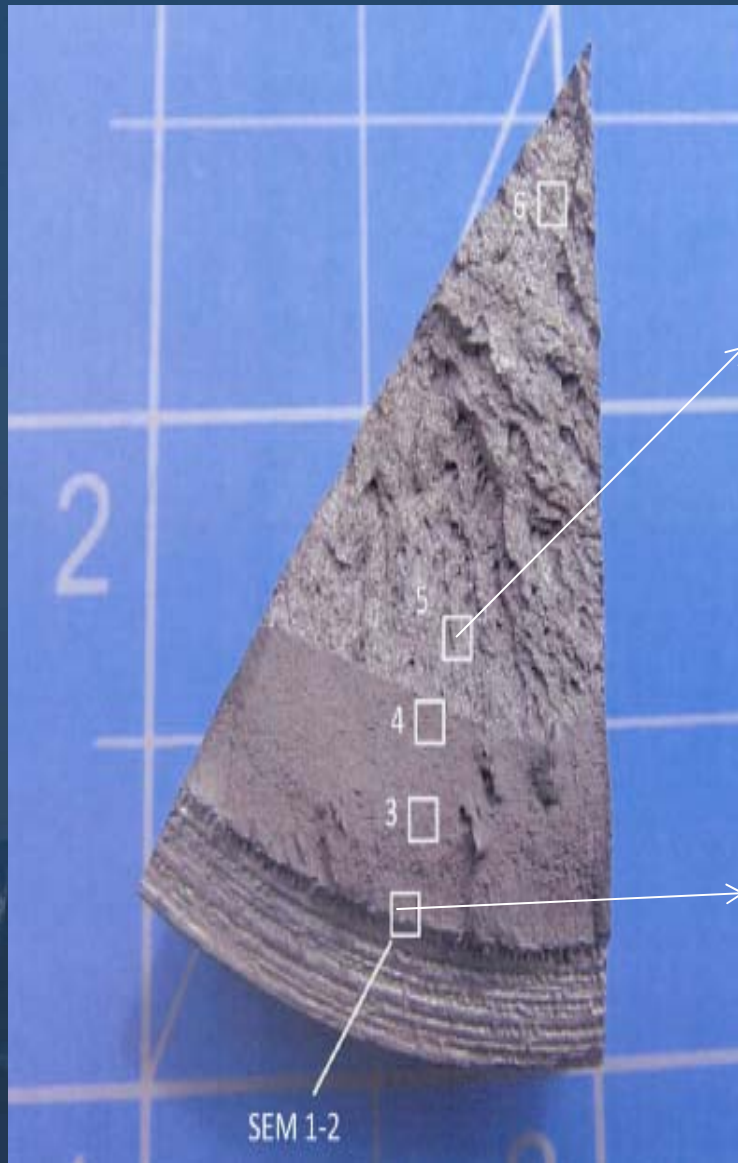
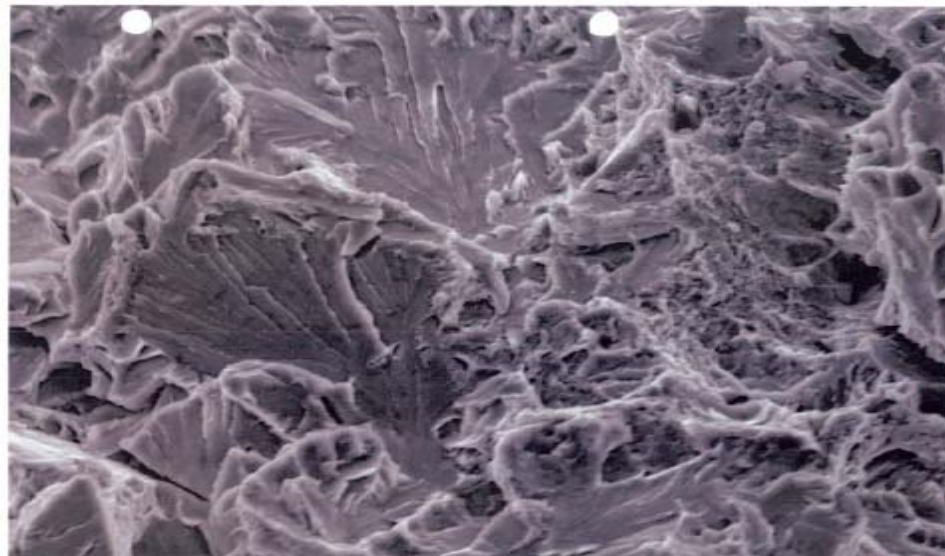
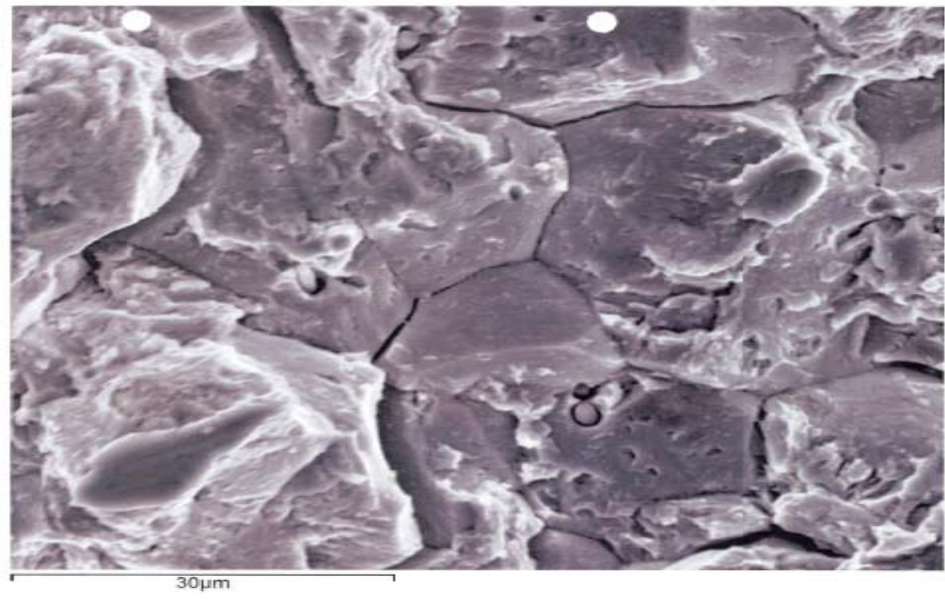
SEM 5

SEM 2

1000X Magnification

That sample was then cut into a little wedge and put under a scanning electron microscope. And you can see the actual wedge here and then two images that were taken from the electron microscopy. These are both at a thousand times magnification. The image on the top is a view of the interior portion of the rod, and the view on the bottom is taken from the exterior portion in the area where the fracture began, that little crescent moon area that I referenced in the prior photo. And you notice on that bottom picture, you see basically some geometric shapes with little spaces between them.

Those are the spaces between the actual grains of the material of the steel. And you see that there's a bit of a separation between those grains, whereas you look at the top piece and you do not see that. That is fairly strong evidence at this point that there was hydrogen present in the rods and that that hydrogen initiated the fracture. We do not know at this point what the source of the hydrogen was. Hydrogen can be introduced through production potentially. It can be introduced environmentally potentially after production, and that is a key question that we will continue to look at but it's very important to understand we not have the answer to that question. We're going to continue our examination on that issue.

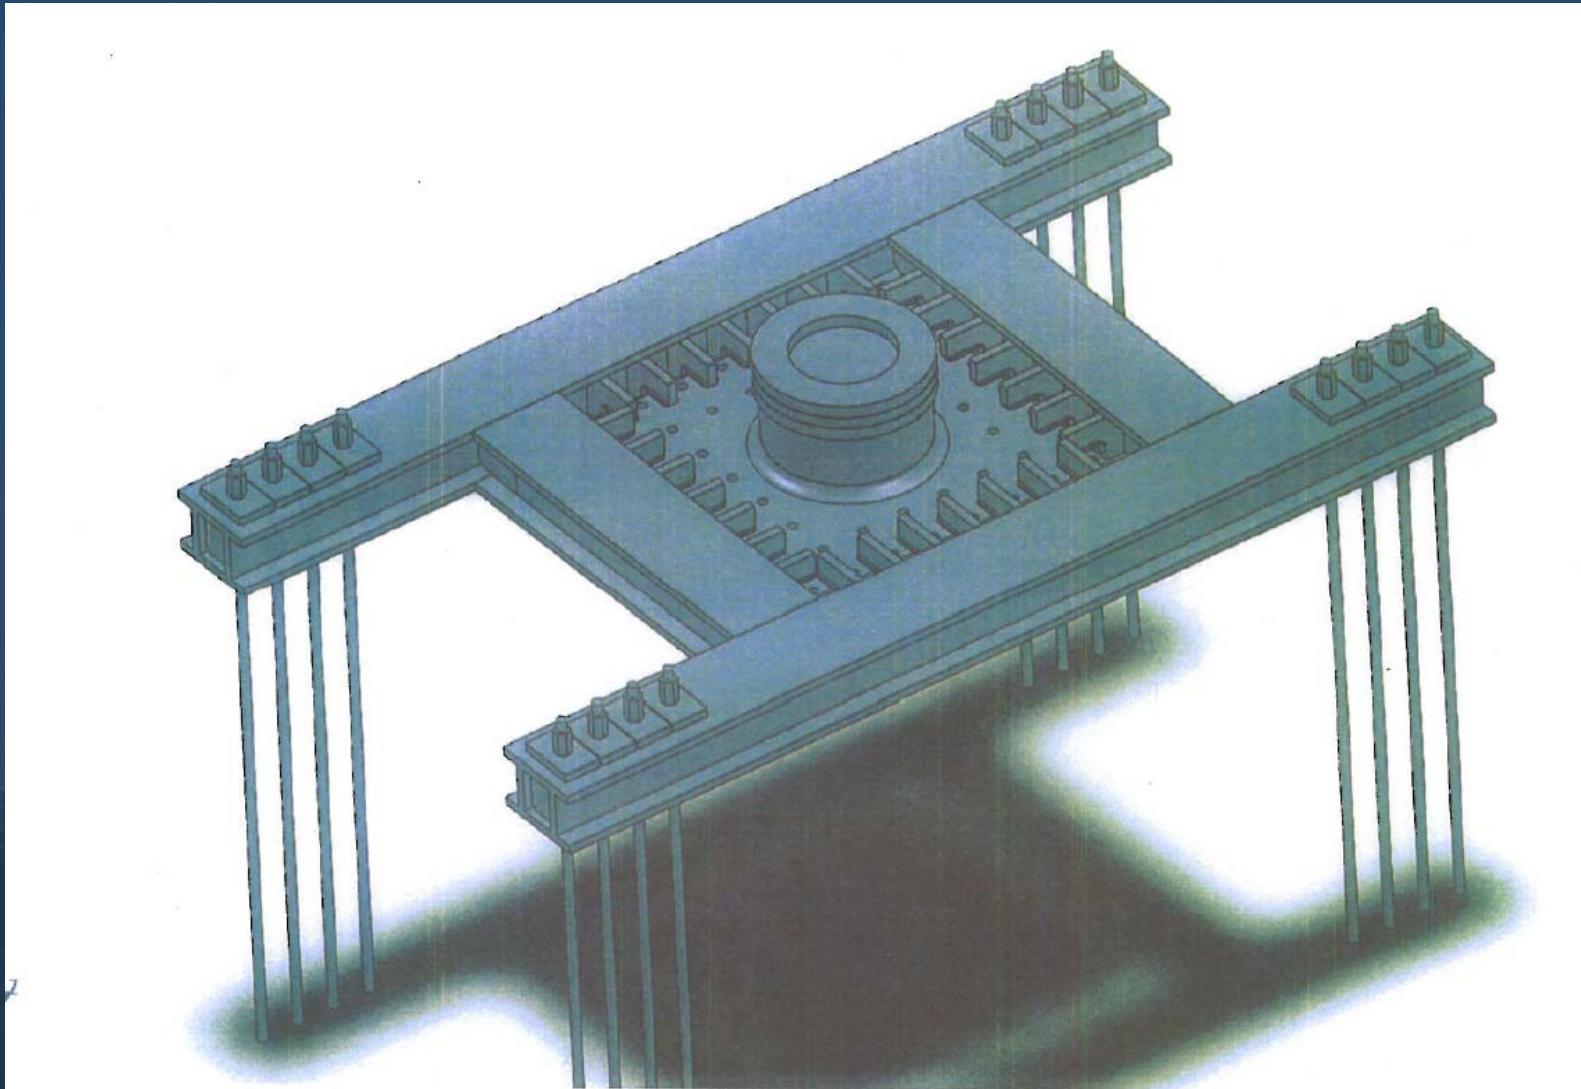
Conceptual design – steel collar

And, as Tony mentioned previously, the rods that have fractured are in a location that it's not very easily accessible to us, so we need to devise a retrofit strategy for the two shear keys where the broken rod are. What you see on the screen is a representation of one of the alternatives that our design engineers are looking at, which is basically a steel option of how to put a collar around the shear key base and connected back up to the pier.

We have other options. We've got about three or four options that we're working on. And another one is a concrete option. Another one is extracting the rods that have broken and trying to install some kind of a new device into the holes, but all of these things are still very much in the conceptual stages. The engineers are working on this. These will be then presented to our pier review committees who will weigh in onto it. Then it will be brought up to the PMT members who will vet this stuff and then the PMT will make a recommendation to the POC, and the POC will make the

MALLER: Where you see the nuts kind of elevated, those are the ones that are failing on us, so we would put the steel elements in those areas and then extend them out to the sides and then put something on the underside and bolt them together.

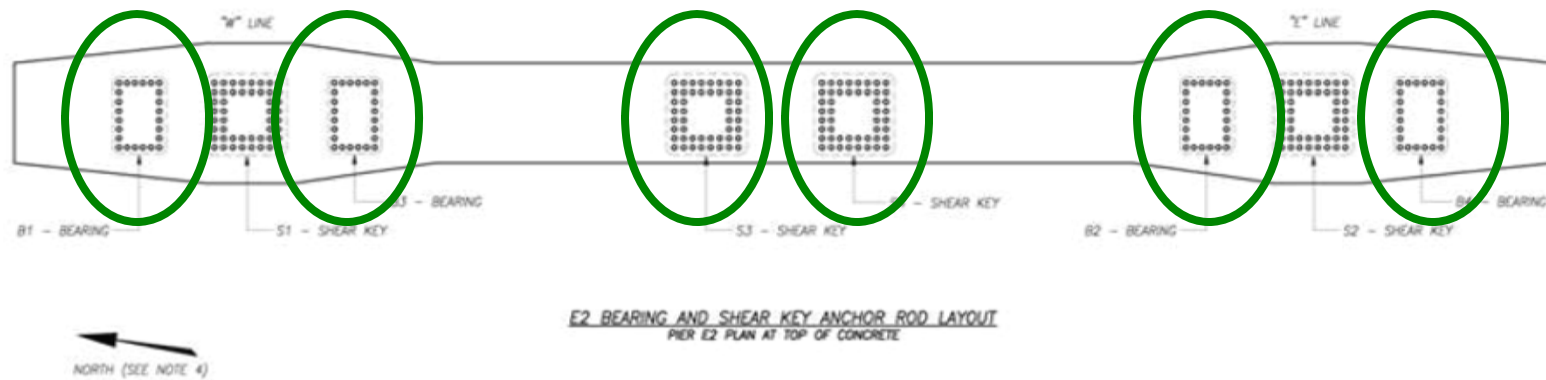
- Remaining 192 anchor rods for other shear keys and bearings were fabricated later in 2010 and installed in 2011.
- These rods have passed all Quality Control/Quality Assurance steps and testing.
- As of April 9, these rods have all been stressed.
- Rods are inspected daily.
- To date, no rods have fractured.

FREMIER: Thank you, Stephen. Going back to the slide that Tony started with, this is the same pier view, so we're looking down on top. The six, green circles represent the remaining two sheer keys... I'm sorry, the four shear keys that are under each of the box sections on the left and the right of the page, and then two more seismic elements in the middle that are similar to the ones that Tony described with the embedded rods. It's important to remember that overall there's 288 rods in this cap that hold the bridge in place and deal with the seismic work. One-hundred and ninety-two of them, while they are similar, are also very different. They were fabricated in 2010. They were installed in 2011. They're what we call through bolts. They go through the entire cap, and so they don't have the problems associated with sitting in water, potentially, that the embedded ones do, and they can also be replaced, in effect, if they have damage at some point in time. In addition, when you go back and look at the quality control and quality assurance records, they don't have any of the non-conformance reports that Tony was talking about and they passed all of their various tests. In addition, as of the beginning of April, the contractor has stressed them all to the same loads that are referred to in the embedded rods—.7... 70% of their ultimate capacity and they have been stressed and are in place. They're being inspected daily to identify whether there's any signs of failure. And, to-date, there has been no failure. So, it is, in effect, an in situ test that is helping us evaluate whether or not they have a similar problem.

The Toll Bridge Oversight Committee has approved a sampling and test method for these bolts to give us a level of assurance that they're fit for their purpose. And so in addition to having them all stressed and visually inspecting them, we are going to... or we have instrumented 10 of them that mechanically, electronically take a look at what's going on inside the rod.

And those electronic measurements can tell us whether or not a crack is growing. So that information will be evaluated over a period of time and then 10 rods will be removed. About 5% will be removed and they will be subjected to complete destructive testing and, obviously, will have to then get replacement bolts for them. But the thought is that by going through these several steps, we'll have a very good indication as to whether or not these bolts have a similar deficiency that was identified in the embedded rods.
