**BAY AREA TOLL AUTHORITY (BATA) MEETING**

6. Bay Bridge Anchor Bolts Update (Peter Lee)

# Briefing on E2 Anchor Bolts – April 24, 2013

THE SAN FRANCISCO-OAKLAND  
**BAY BRIDGE**  
SEISMIC SAFETY PROJECT

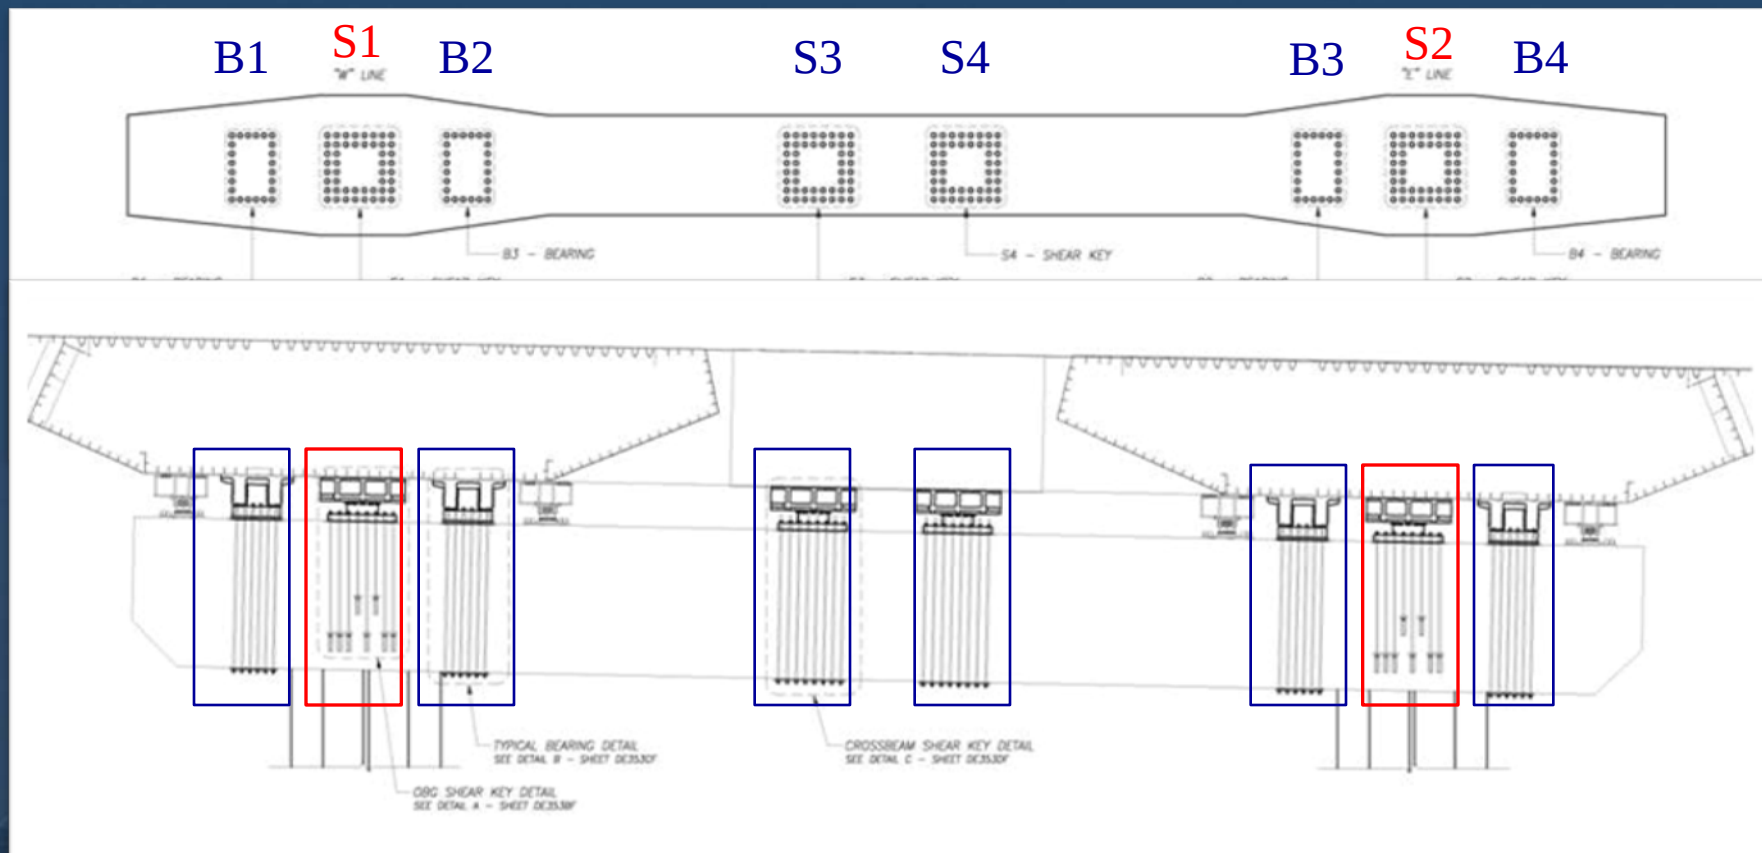
- Bearings and shear keys are secured to E2 by 3 inch diameter anchor bolts, ranging from 9 feet to 24 feet in length.
- 96 bolts manufactured in 2008 shown in red are embedded in the pier.
- 192 bolts manufactured in 2010 shown in blue are not embedded in pier.

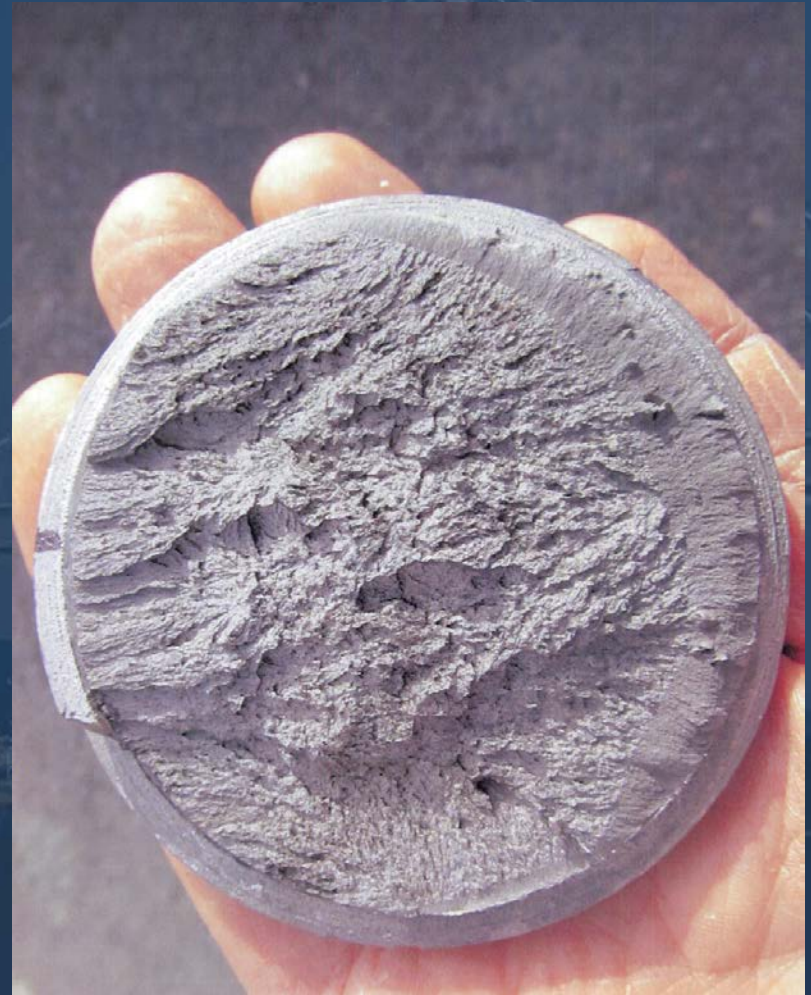
# Failure of 2008 Bolts Due to Hydrogen Embrittlement

- Under detailed investigation, 2008 bolt failures are due to hydrogen embrittlement.
- Excess hydrogen in the 2008 bolts caused the threaded areas of bolts to become brittle and fracture under high tension.

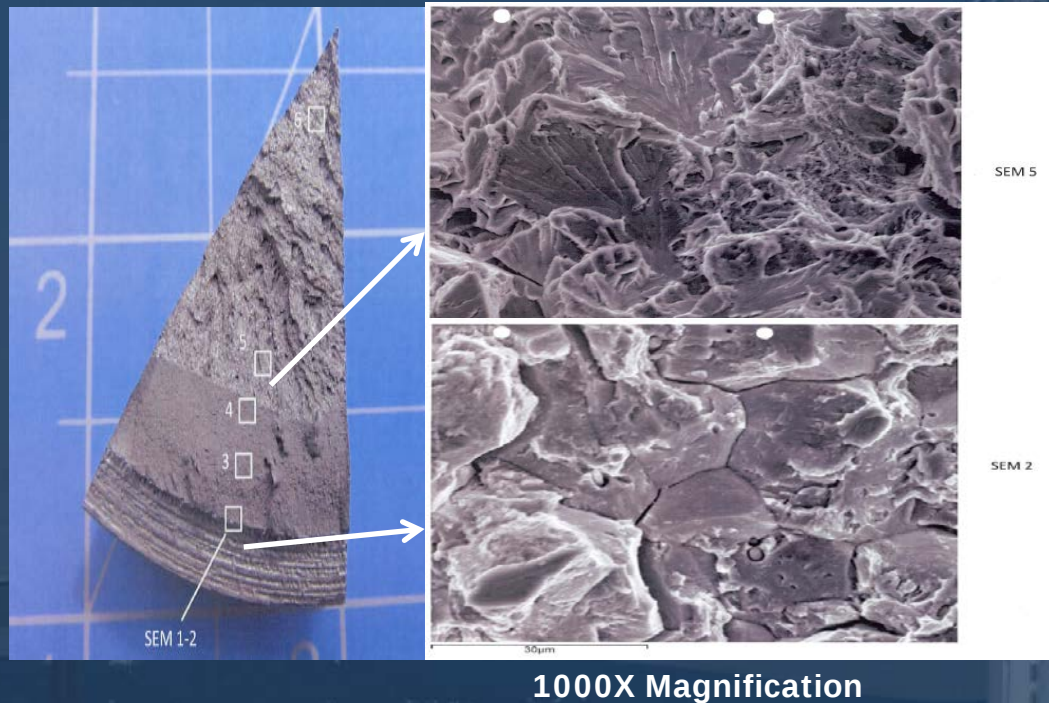
- On-going metallurgical analysis indicates 2008 bolts were susceptible to hydrogen embrittlement due to “a lack of uniformity in the microstructure of the steel”
- Identified under electron microscope.

This slide shows specific pictures under the microscope of the failed rods that we have studied very carefully. It confirms that hydrogen embrittlement is the culprit of the rods that have broken. It also shows in this slide a lack of uniformity in the microstructure which adds to the susceptibility of these rods and the metal to hydrogen embrittlement. And

this specific slide actually shows a difference in the hardness between the perimeter in the center of the failed rods.

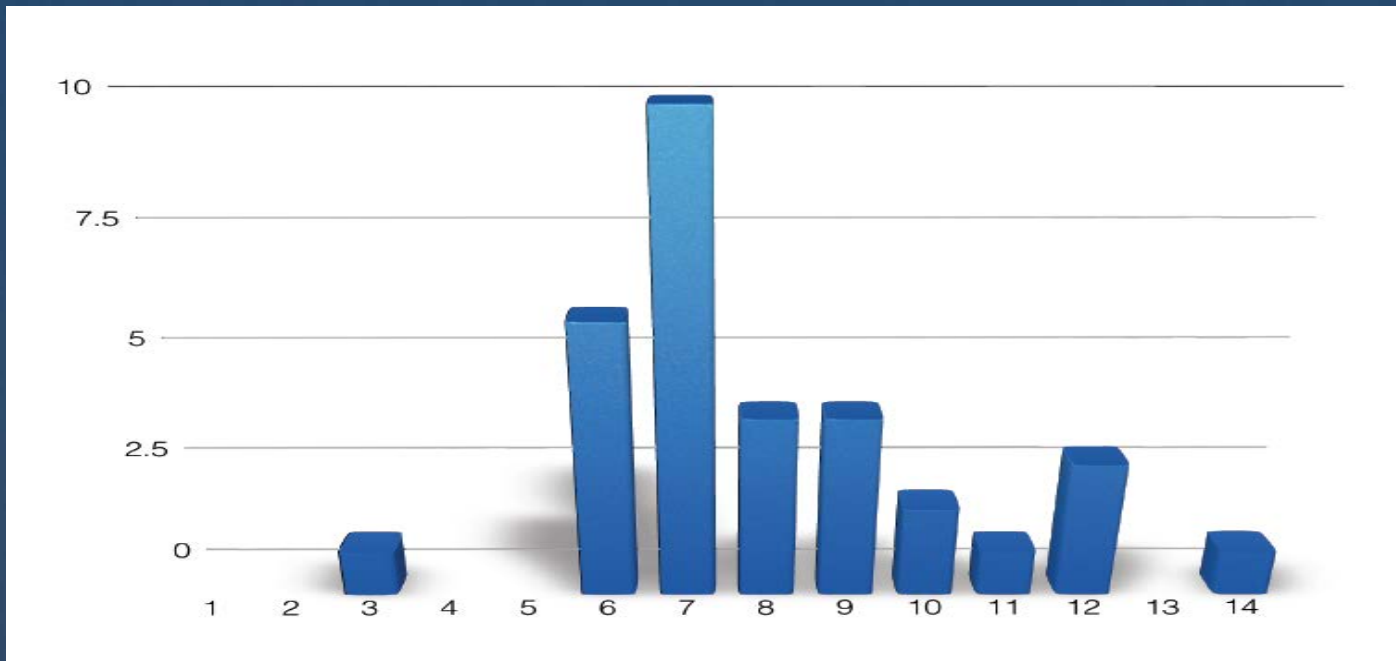
DAYS AFTER STRESSING (2008 BOLTS)

- Failure by hydrogen embrittlement is time dependent and should happen within weeks of tensioning.
- 2008 bolts failed days after tensioning. After 14 days, all 2008 bolts were de-tensioned.
- Industry standard testing protocols for A354 bolts are not time-dependent. Lesson learned: Additional material specifications and testing protocols could have reduced risk of hydrogen embrittlement.

This shows the timeline of the failed bolts that fractured. All of these were from shear key-1, shear key-2 from the 2008 batch of bolts. After 14 days, which is the length of the time represented on this chart, the remaining rods were detentioned. This is the total of the 32 rods that did fail in that time period. And, again, hydrogen embrittlement is a time-dependent phenomenon and should happen within weeks of tensioning. Industry-standard testing protocols, which were utilized on these rods when they came to the project is not necessarily a time-dependent evaluation, and, therefore, current testing of the 2010 bolts, which we'll talk about a little bit later, were substantially expanding the amount of testing that were due into those 2010 bolts to evaluate their disposition. And, again, we'll talk about the 2010 bolts in a little bit.
