## **BATA OVERSIGHT COMMITTEE**

# Briefing on E2 Anchor Bolts – May 8, 2013

THE SAN FRANCISCO-OAKLAND  
**BAY BRIDGE**  
SEISMIC SAFETY PROJECT

Metallurgical Analysis of Bay Bridge Broken Anchor Rods S1-G1 & S2-A6

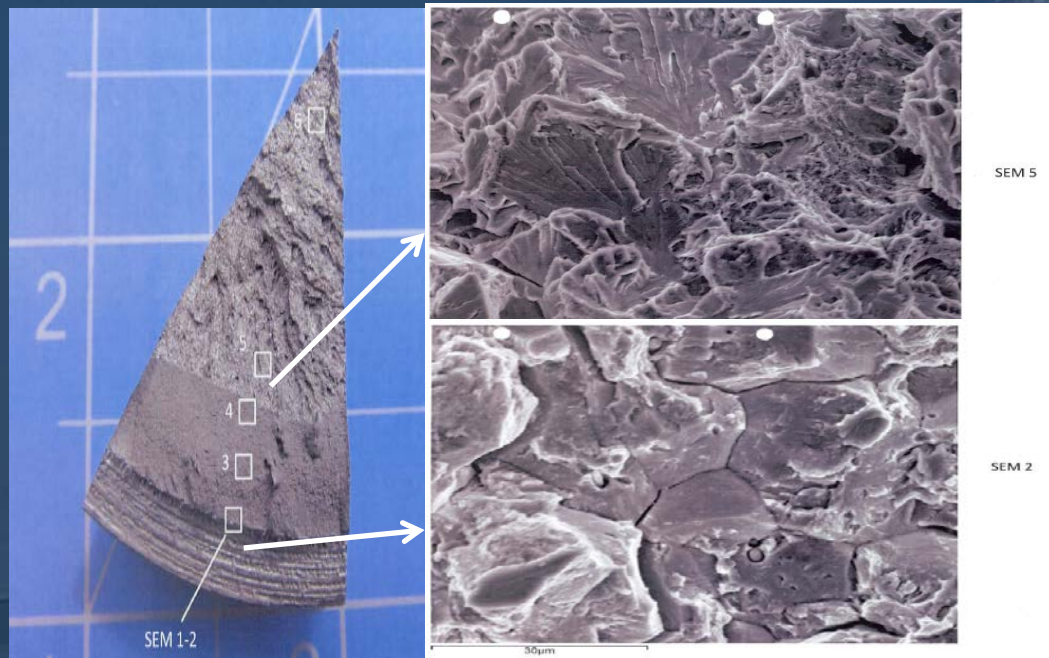
1000X Magnification

- **Metallurgical analysis shows a lack of uniformity in the microstructure of the steel, with large differences in hardness from center to edge and high local hardness near surface. Further, the material exhibited low toughness and marginal ductility.**

- Procurement of future A354 grade BD anchor rods should include a number of supplemental requirements to assure against hydrogen embrittlement failure.

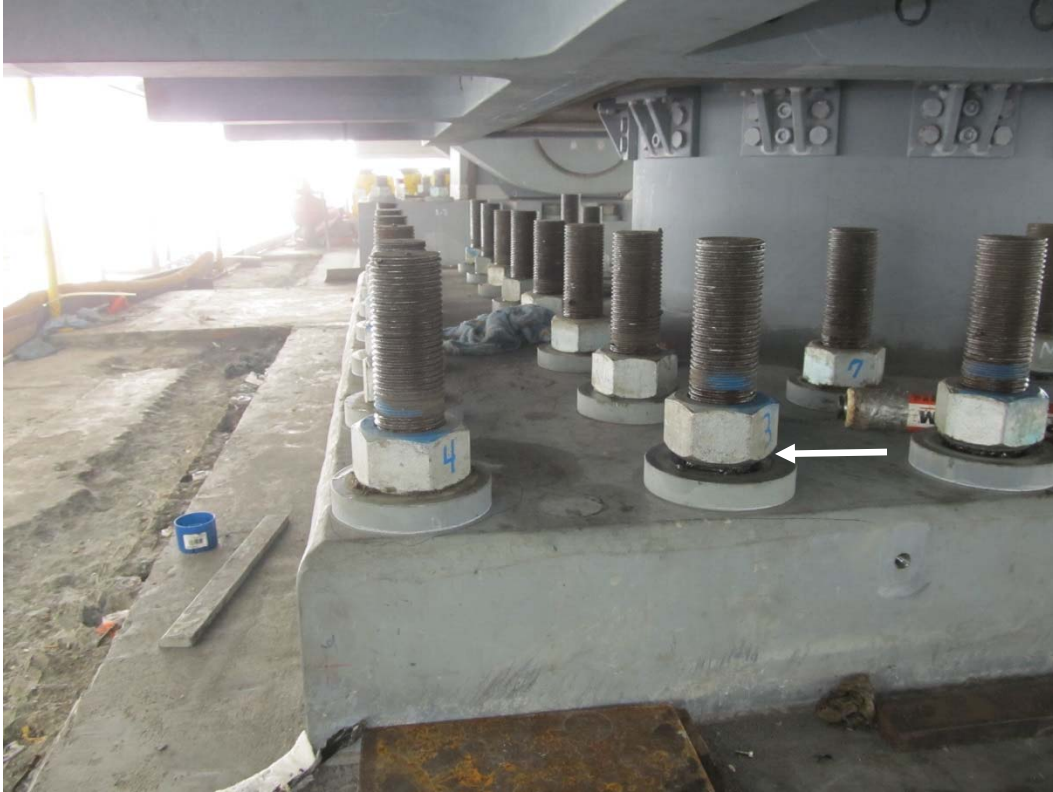
Photo 1) Anchor rod installation at shear key with broken rod at arrow.

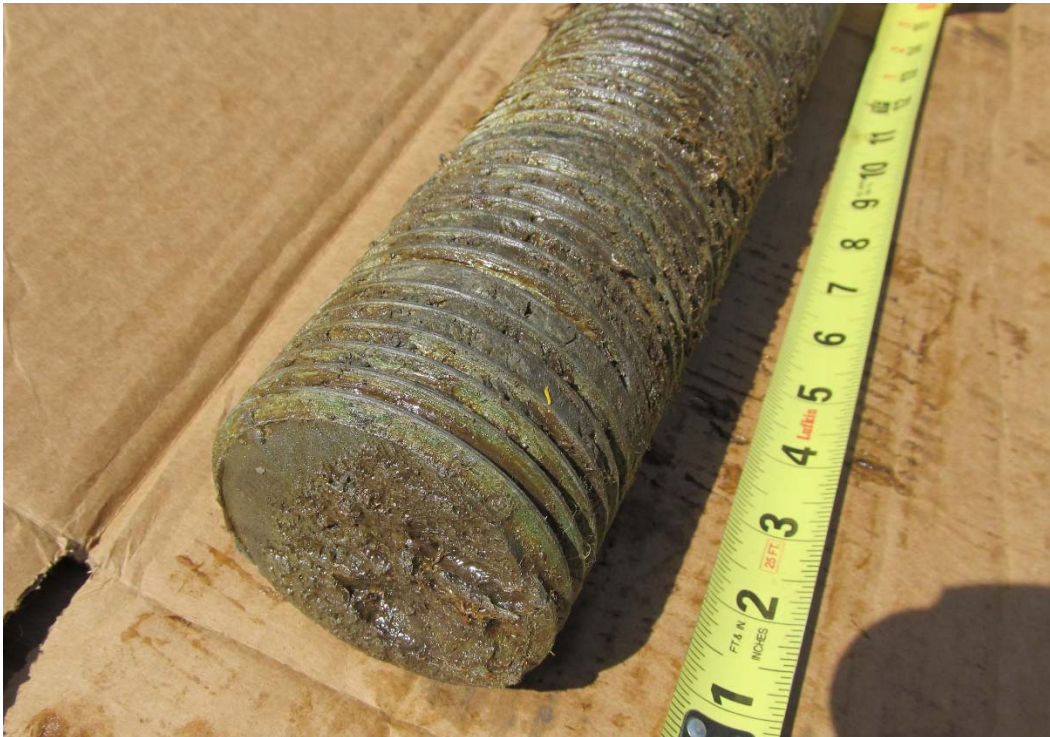
The overall appearance of both rod fractures was brittle (i.e., there was no thread elongation/stretching to suggest plastic deformation/yielding occurred prior to fracture). Photos 2-8 show the observed fracture features. There was evidence indicating that hydrogen assisted cracks were present in both rods prior to failure. The cracks initiated and extended from the thread root up to a depth of 0.6 inches in Rod S1-G1, and 0.4 inches in Rod S2-A6 (see Photos 4 and 8). The presence and appearance of the cracks, and the delayed nature of the fractures point to time dependence of the failure mechanism. Cracks developed and grew in both rods, which progressively exceeded their capacity with time, and resulted in final failure by fast fracture.

Photo 2) Broken anchor rod S1-G1.

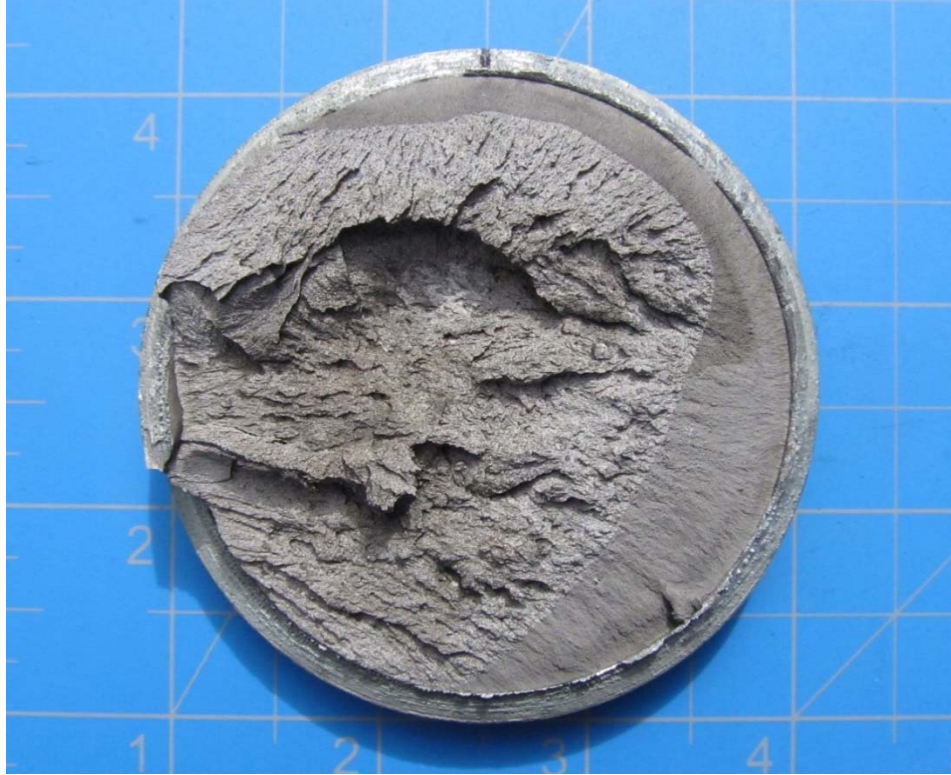
Photo 3) Fracture surface of Rod S1-G1 after cleaning.

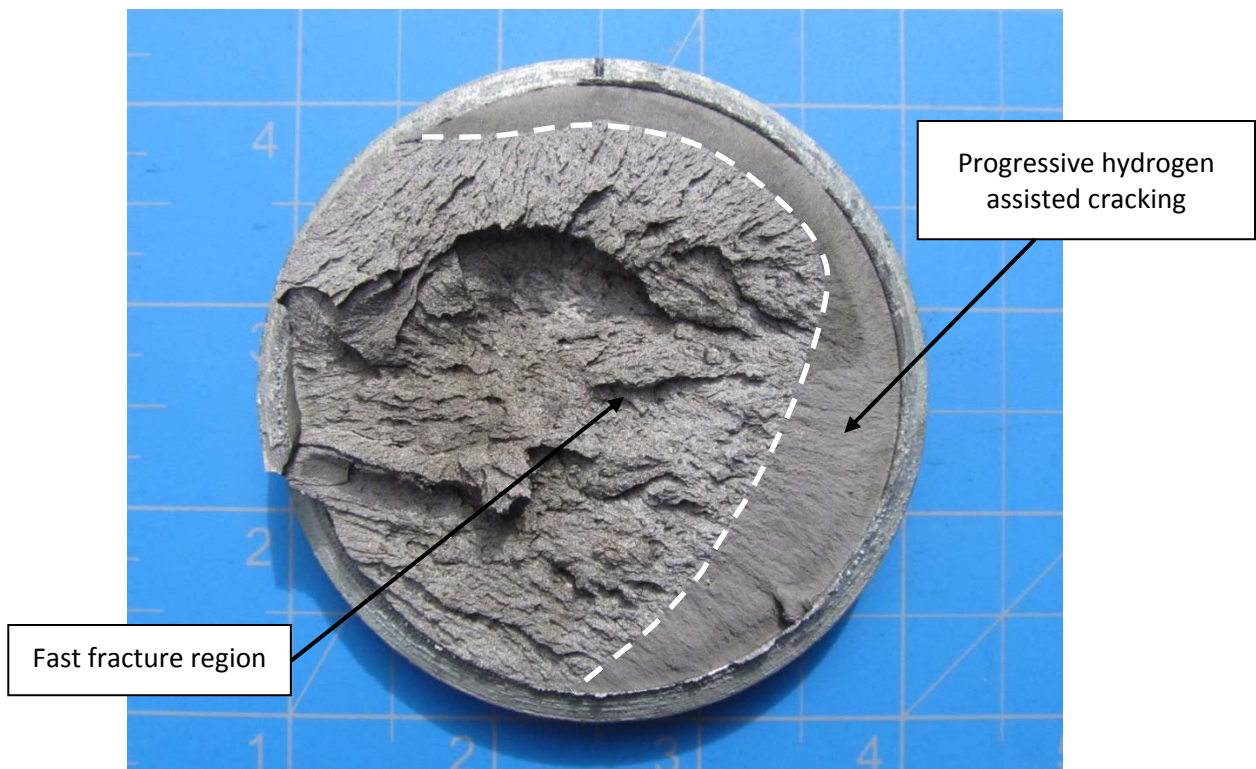
Photo 4) The fracture surface showing progressive hydrogen assisted cracking and fast fracture areas.

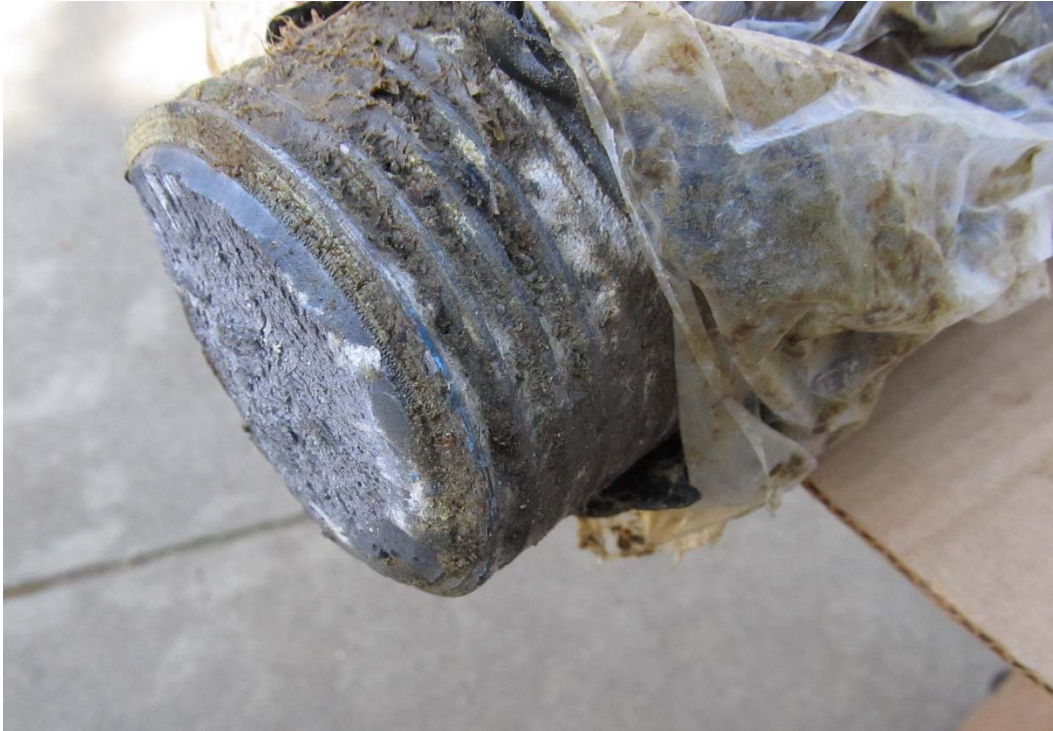
It was observed that the threads and fracture surface of the as-received rod S1-G1 #11 were covered with Denso paste (part of the Denso Tape system) as required by the Contract Documents. There was Denso paste and grout in the threads and on the fracture surface of rod S2-A6 #12. The fracture surfaces were cleaned and the fractured ends cut from the rods to facilitate further visual and stereo microscopic (up to 80x magnification) examinations.

Photo 5) Broken end of Rod S2-A6. Grease and grout were present on the fracture and threads.

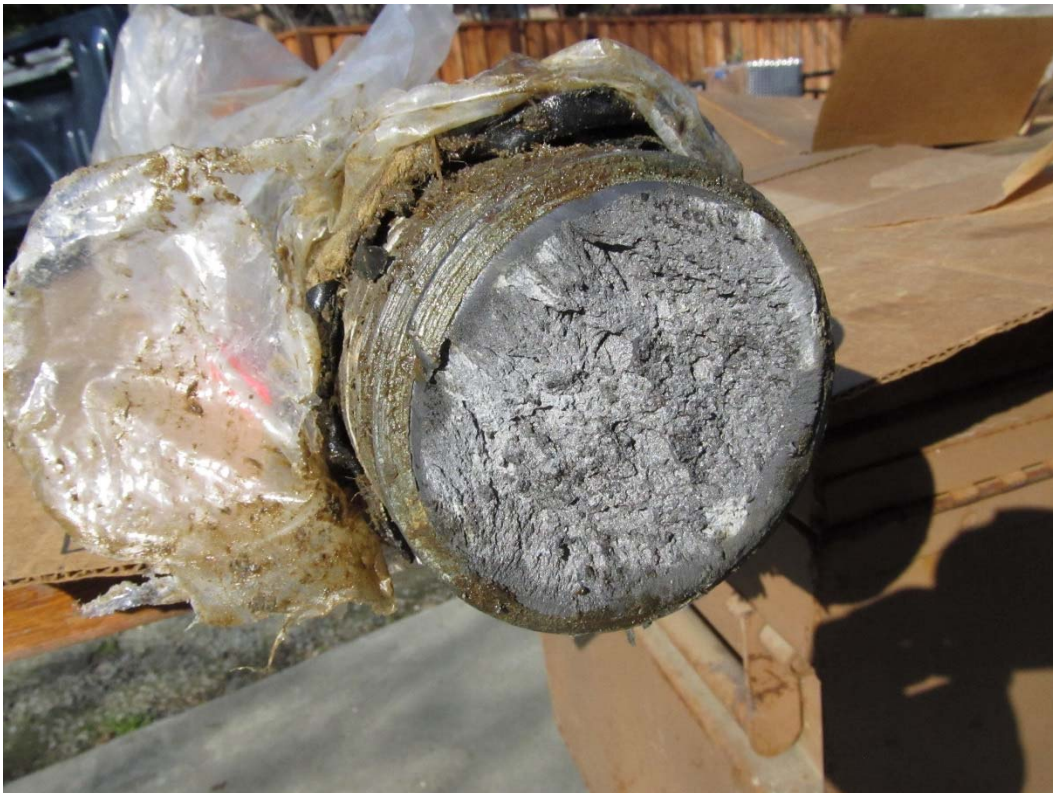
Photo 6) Another view of Rod S2-A6 fracture surface.

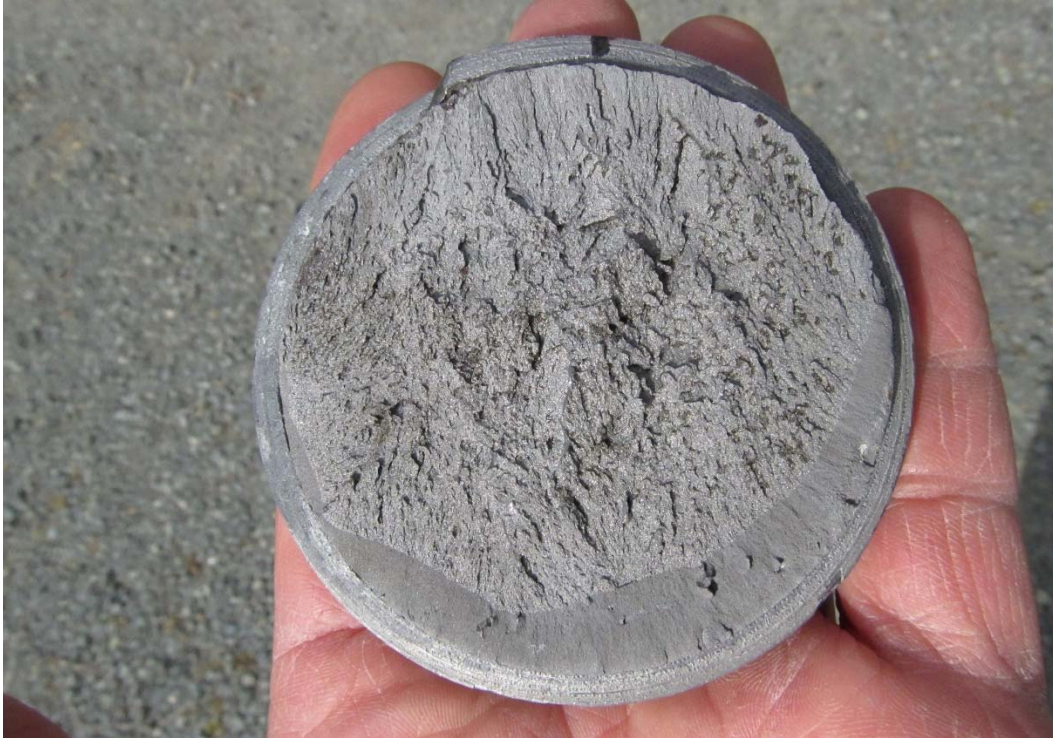
Photo 7) Fracture surface of Rod S2-A6 after cleaning.

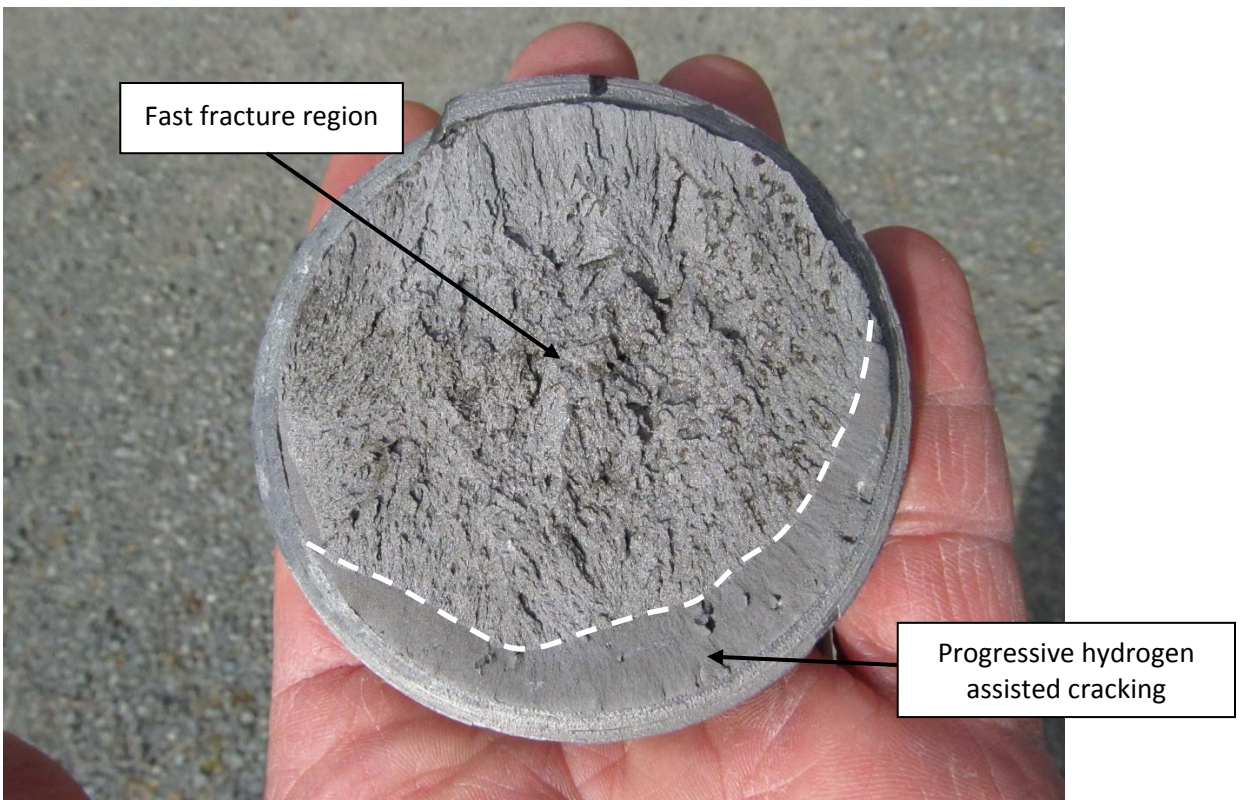
Photo 8) The fracture surface showing progressive hydrogen assisted cracking and fast fracture areas.

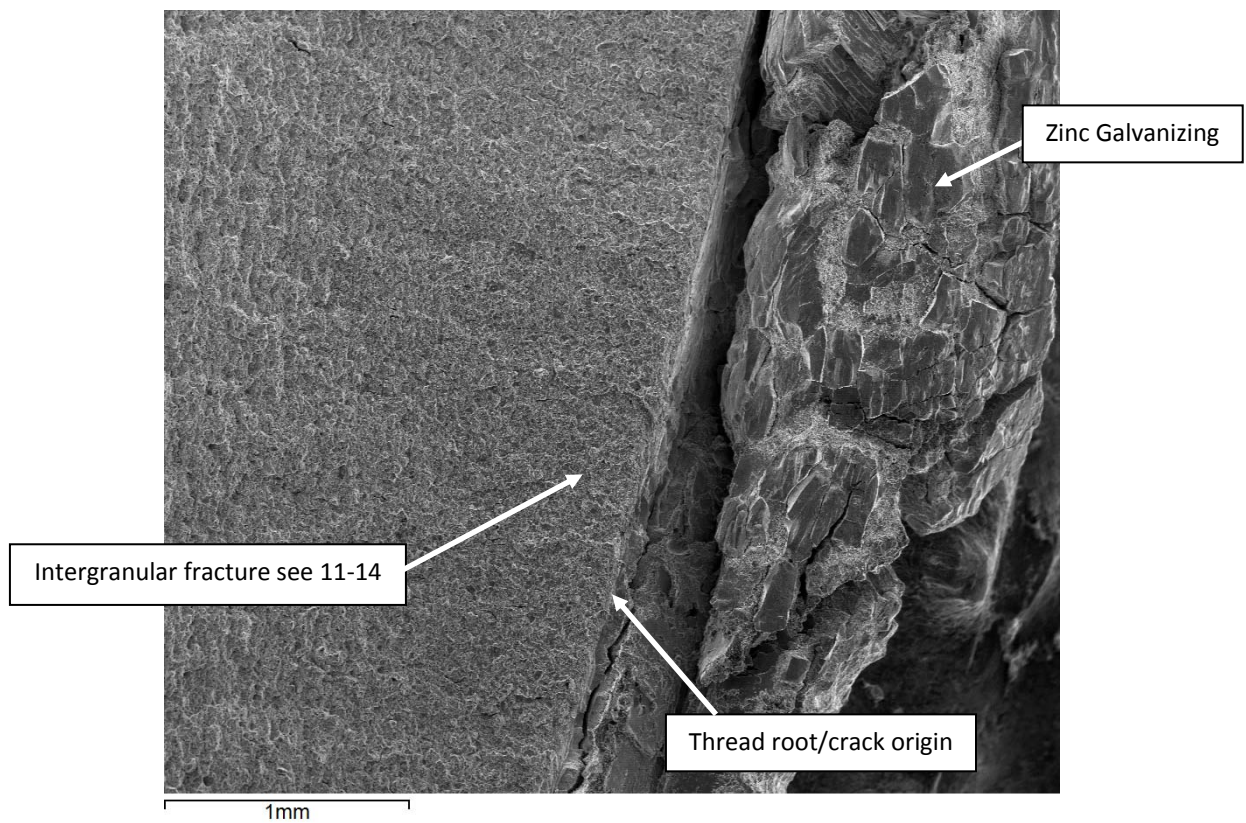
The fracture surfaces were examined at high magnification with a scanning electron microscope (SEM) to further characterize the failure mechanism. Intergranular fracture morphology was observed at, and near, the thread root (i.e., crack origin). See Photos 9-14. Intergranular cracking is a characteristic feature indicative of a number of brittle fracture mechanisms, including hydrogen assisted cracking. Intergranular features were predominant at the thread root (i.e., crack origin). Gradually increasing mixed morphology was observed as the crack progressively grew and extended inward from the thread root (i.e., more ductile tearing, and less intergranular features). See Photos 15-17. Sudden fast fracture occurred when the crack reached a critical size, wherein the reduced capacity of the rod could no longer sustain the applied load. The morphology across the final fast fracture zone was almost exclusively cleavage (brittle fracture mechanism). See Photos 18-20. This observation is considered unusual. Final rupture of bolts (in the strength range of A354 grade BD) caused by tensile overload following crack propagation typically occurs in ductile mode.

Photo 10) SEM image of S1-G1 at crack origin.

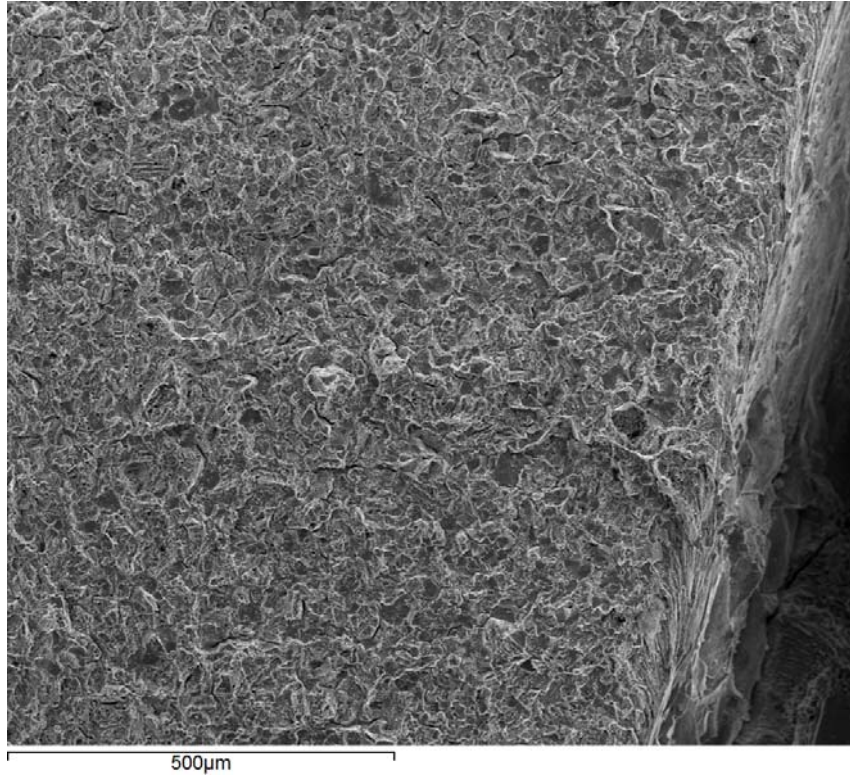
Photo 11) Same as Photo 10 except higher magnification.

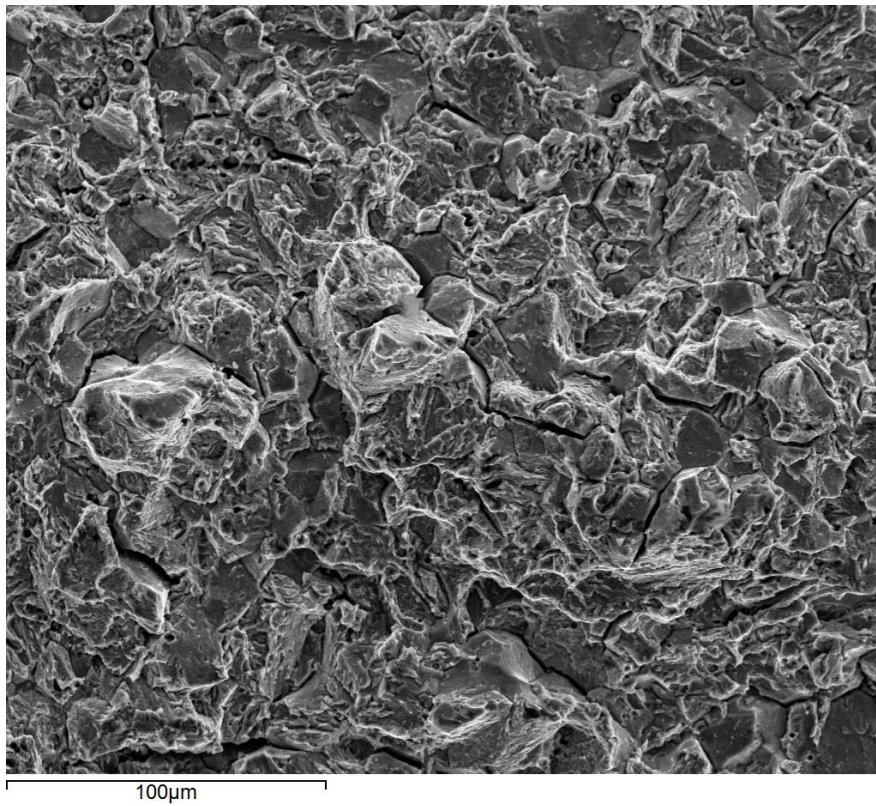
Photo 12) Same as Photo 11 except higher magnification.

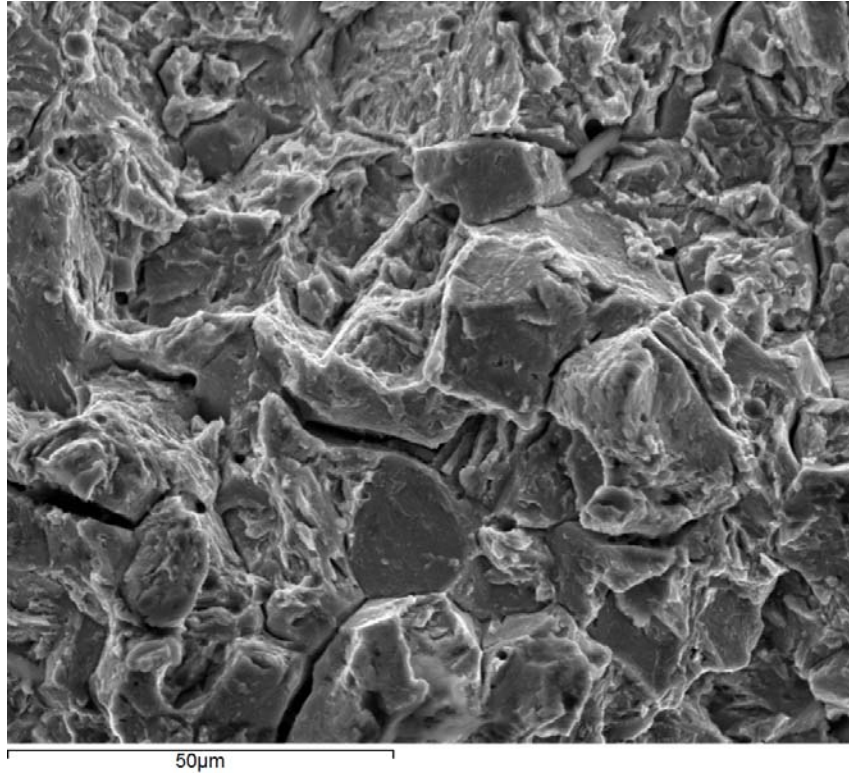
Photo 13) Same as Photo 12 except higher magnification showing intergranular fracture features.

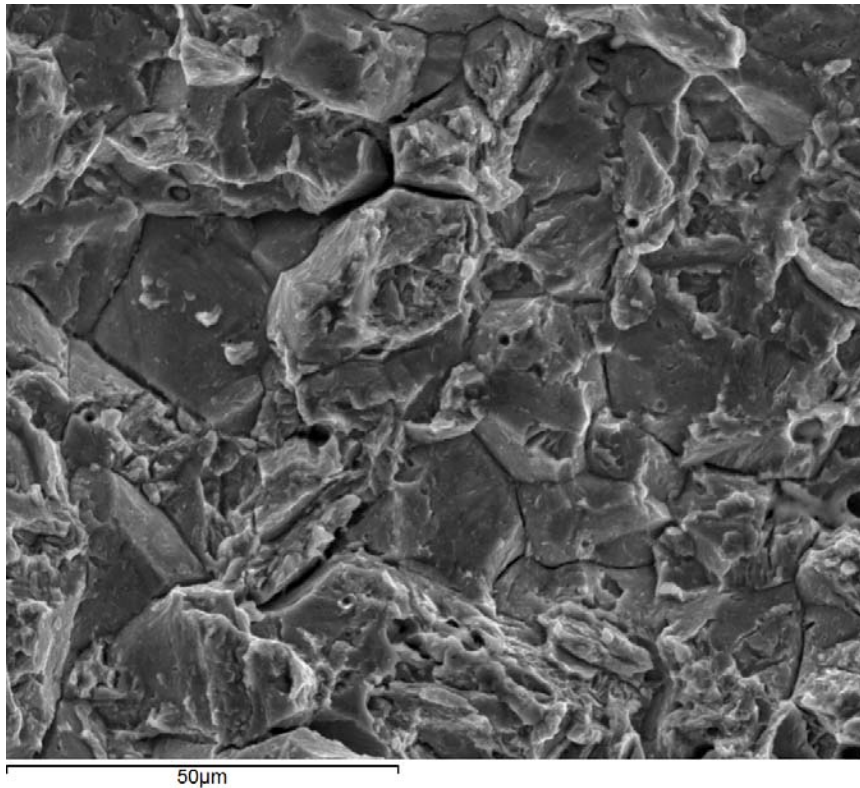
Photo 14) Same as Photo 11 except higher magnification showing more intergranular fracture features.

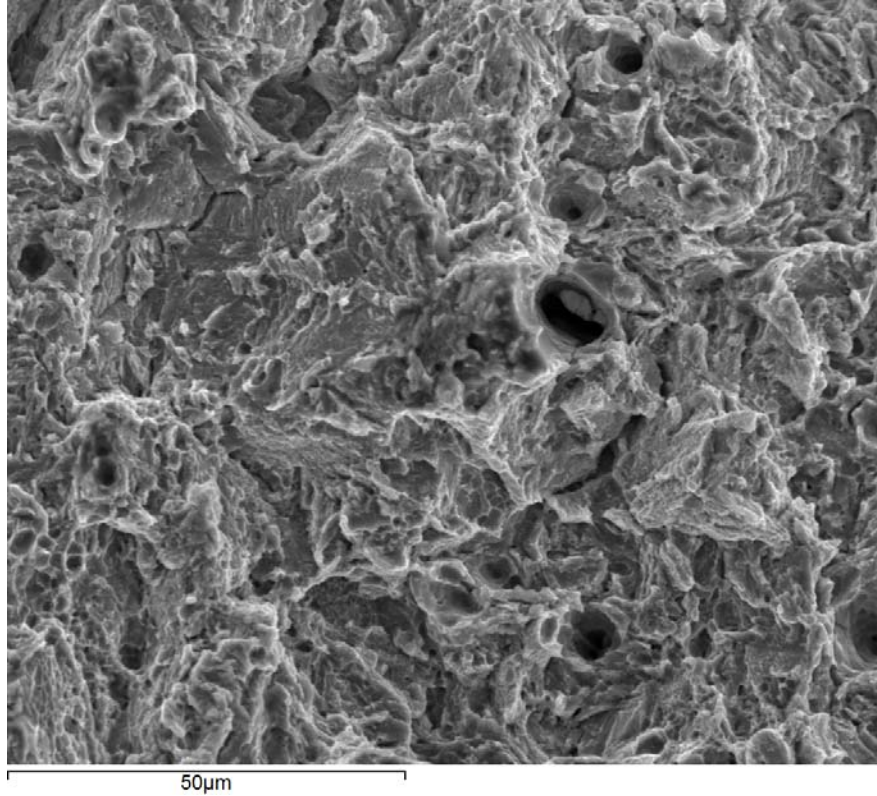
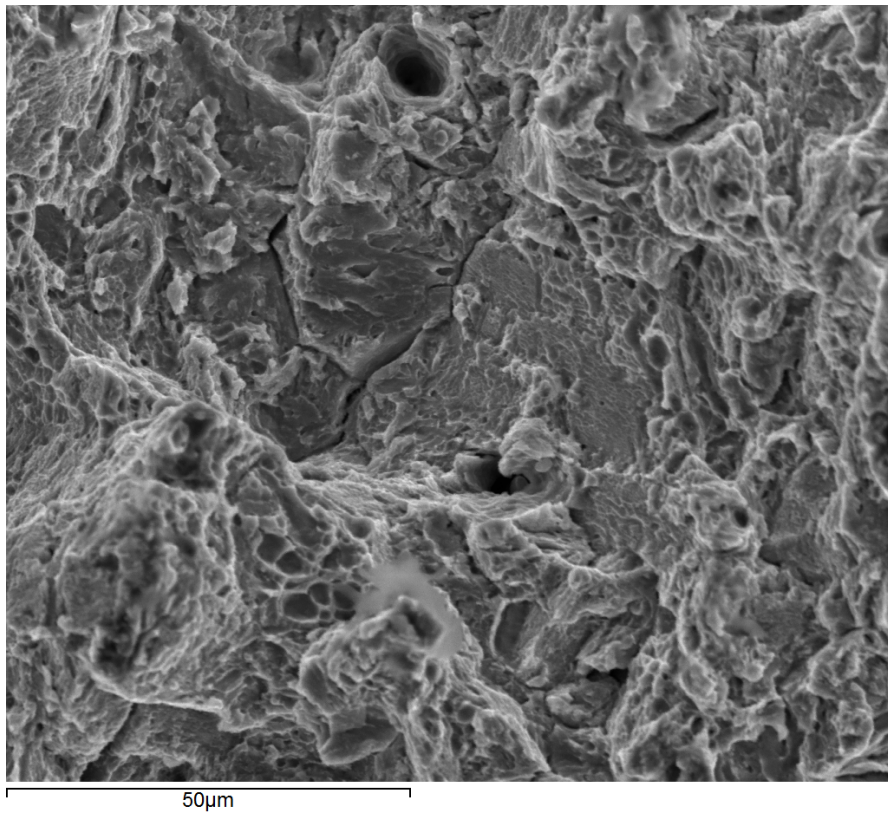
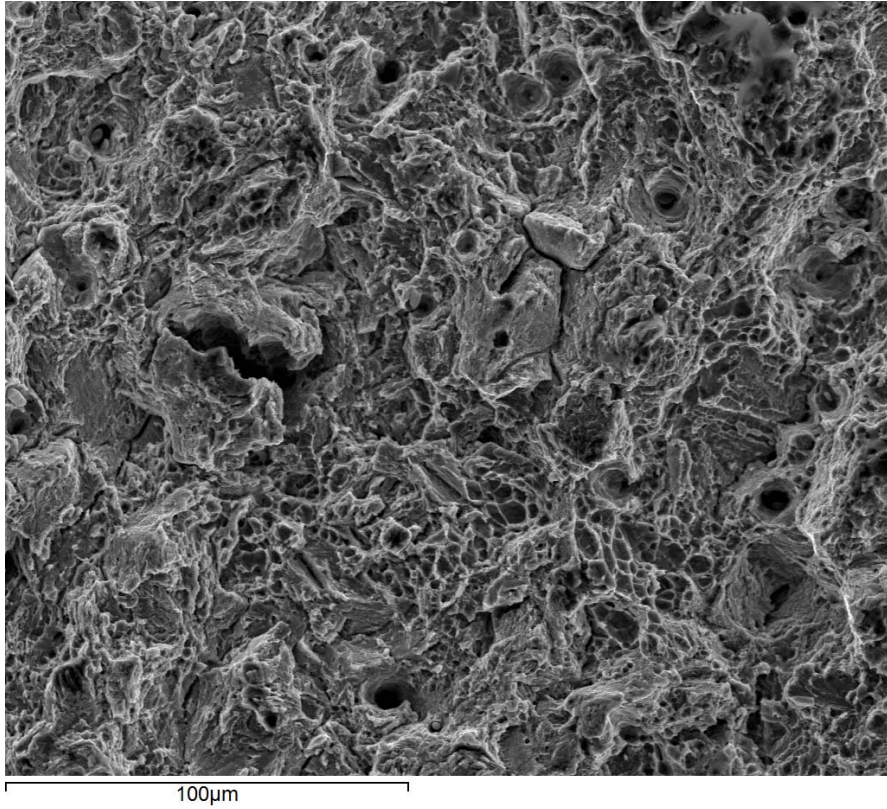
Photo 15) Mixed ductile tearing and intergranular fracture features.

Photo 16) Mixed ductile tearing and intergranular fracture features.

Photo 17) Mixed ductile tearing and intergranular fracture features.

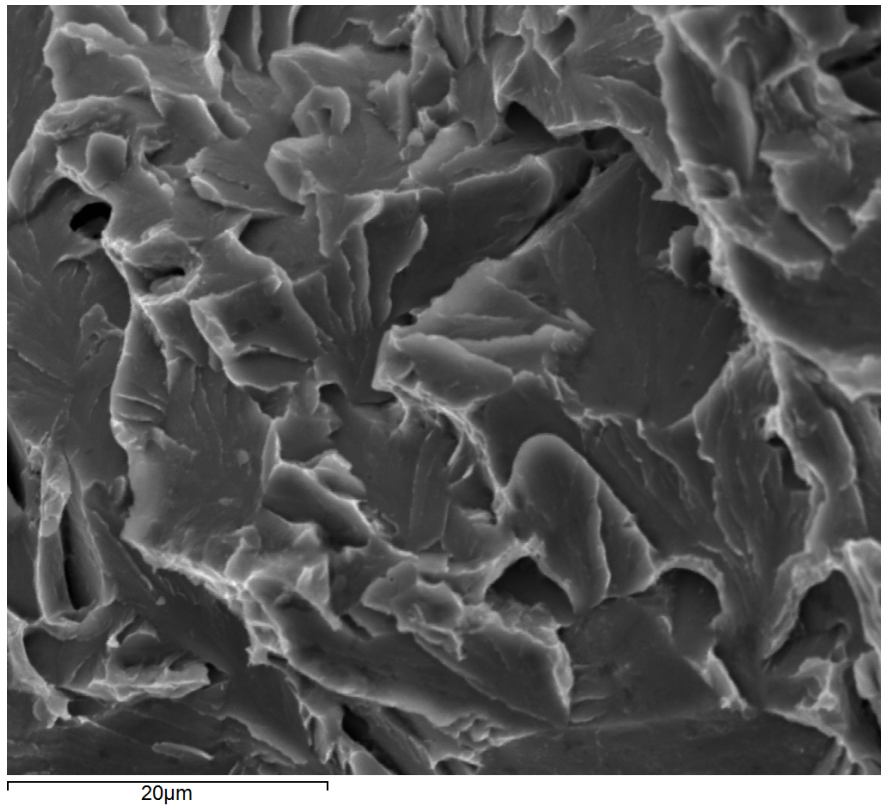
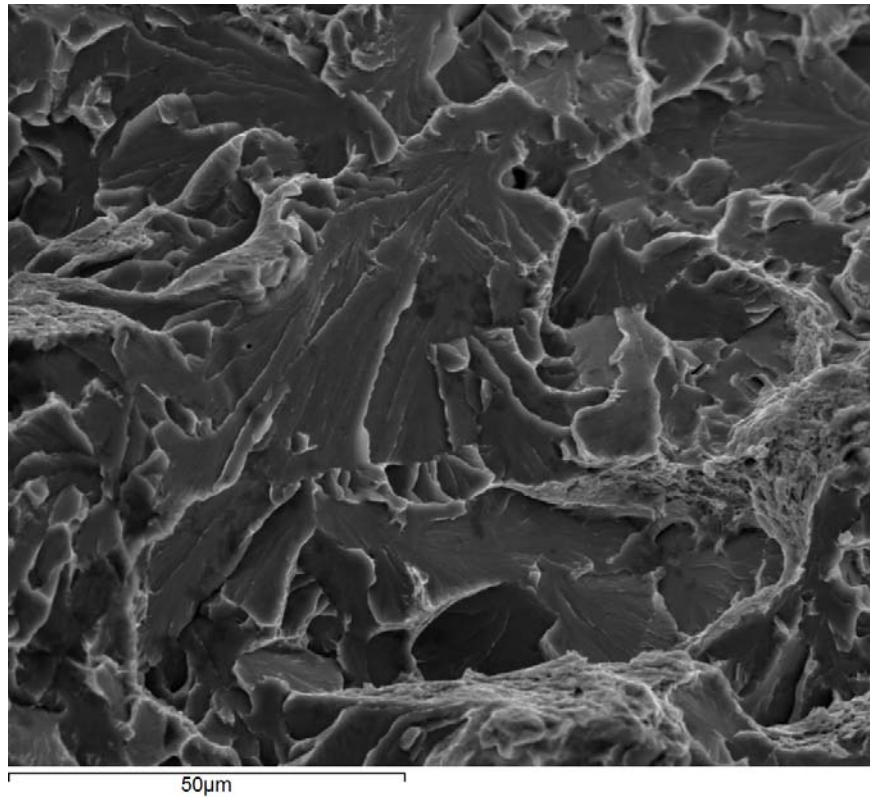
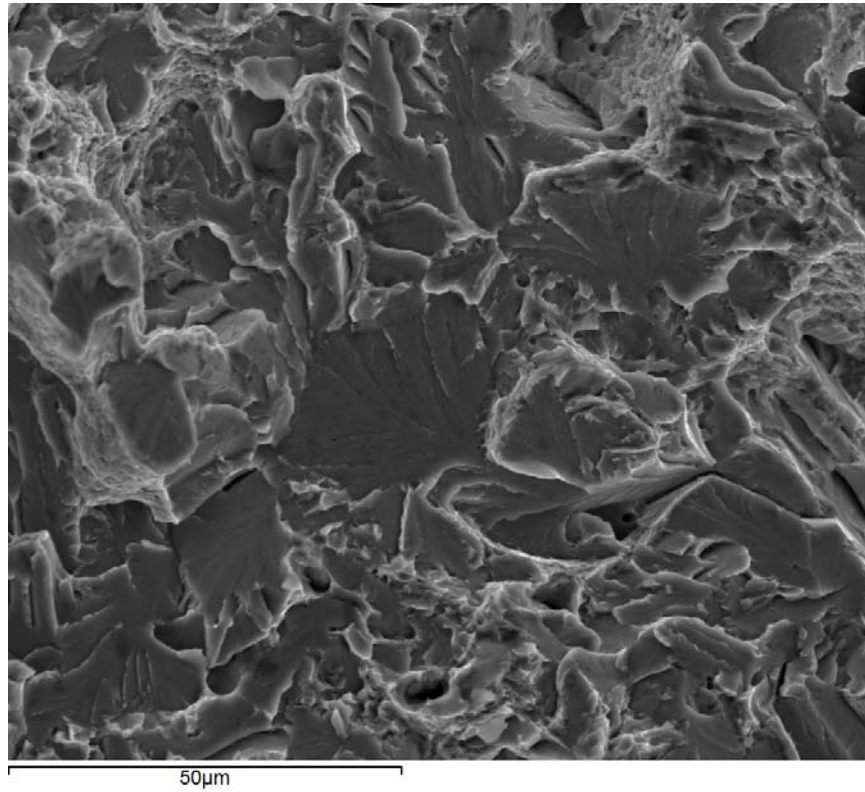
Photo 18) Cleavage fracture features – brittle fast fracture.

Photo 19) Cleavage fracture features – brittle fast fracture.

Photo 20) Cleavage fracture features – brittle fast fracture.

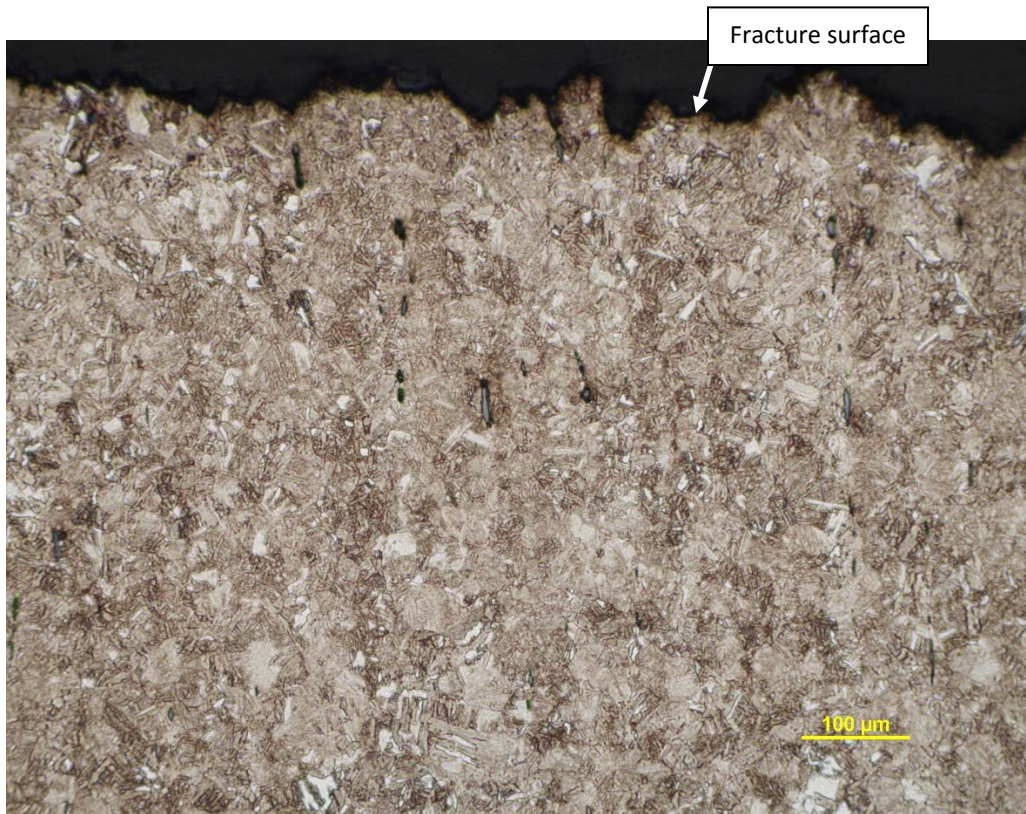
Cross-sections were cut from both rods and metallurgically prepared (i.e., mounted/potted, polished and etched). The location of the cross-sections is shown in Photos 21-22. The observed microstructure was generally tempered martensite, which is the normal structure associated with quenched and tempered AISI 4140 steel. However, many areas especially toward the center of the rod, showed evidence of incomplete martensitic transformation. The regions of incomplete transformation, as characterized by the observed presence of ferrite and pearlite, appeared to alternate in banded layers between regions of fully transformed martensitic structure. The banded nature of the microstructure is an indication that the material is not homogeneous. See Photos 23-26. Additionally, there was a relatively high amount of non-metallic stringer inclusions present in the microstructure. See Photos 27 and 28.

Photo 23) Example of microstructure observed in S2-A6 at Section A. (Etchant 2%Nital)

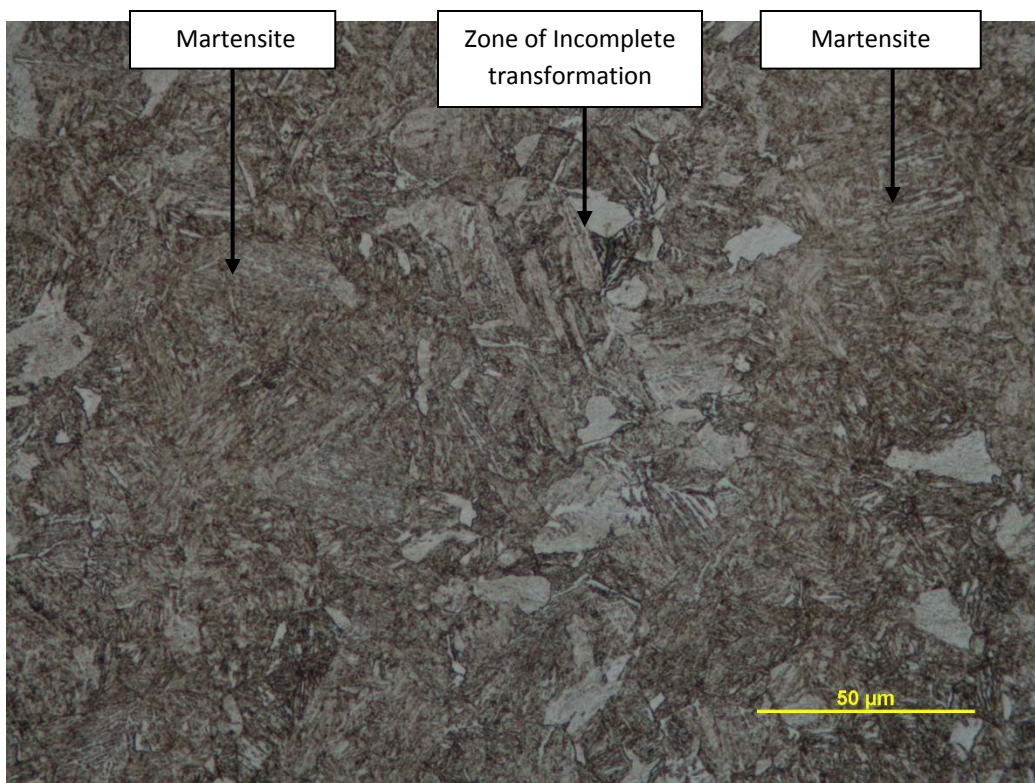
Photo 24) Same as above except higher magnification. Note the structure is not fully tempered martensite. The center region did not fully transformed to martensite.

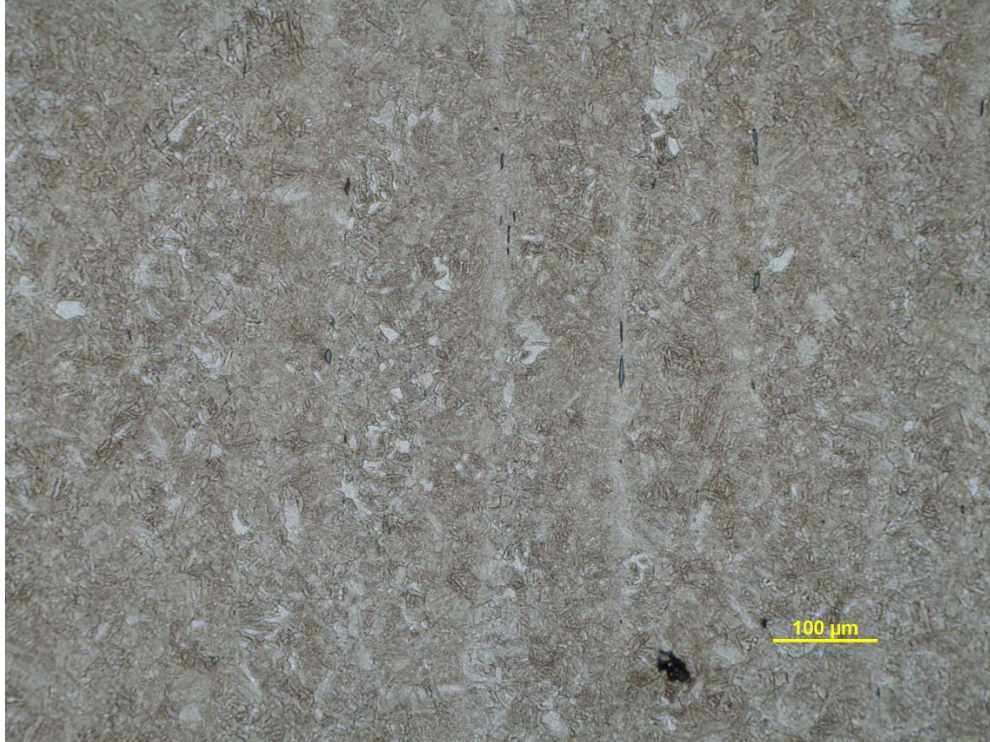
Photo 25) Another example of microstructure observed in S2-A6. Note vertical banding (alternating light-dark streaks) in grain direction. (Etchant: 2% Nital)

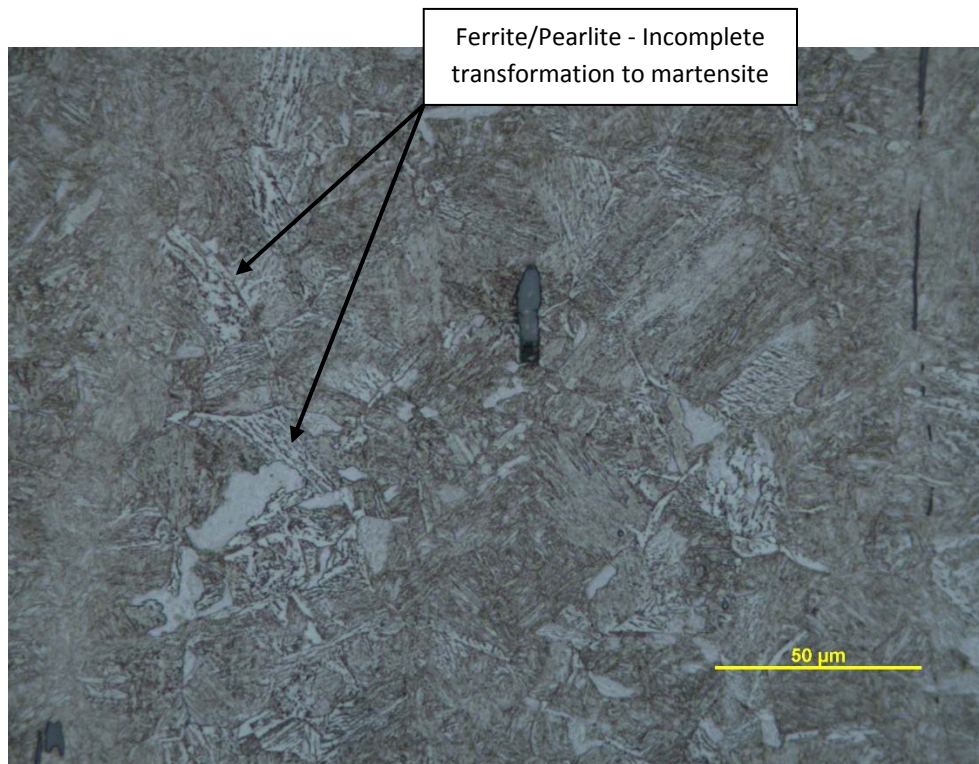
Photo 26) Same as above except higher magnification. Note ferrite/pearlite where the structure is not fully tempered martensite. (Etchant: 2% Nital)

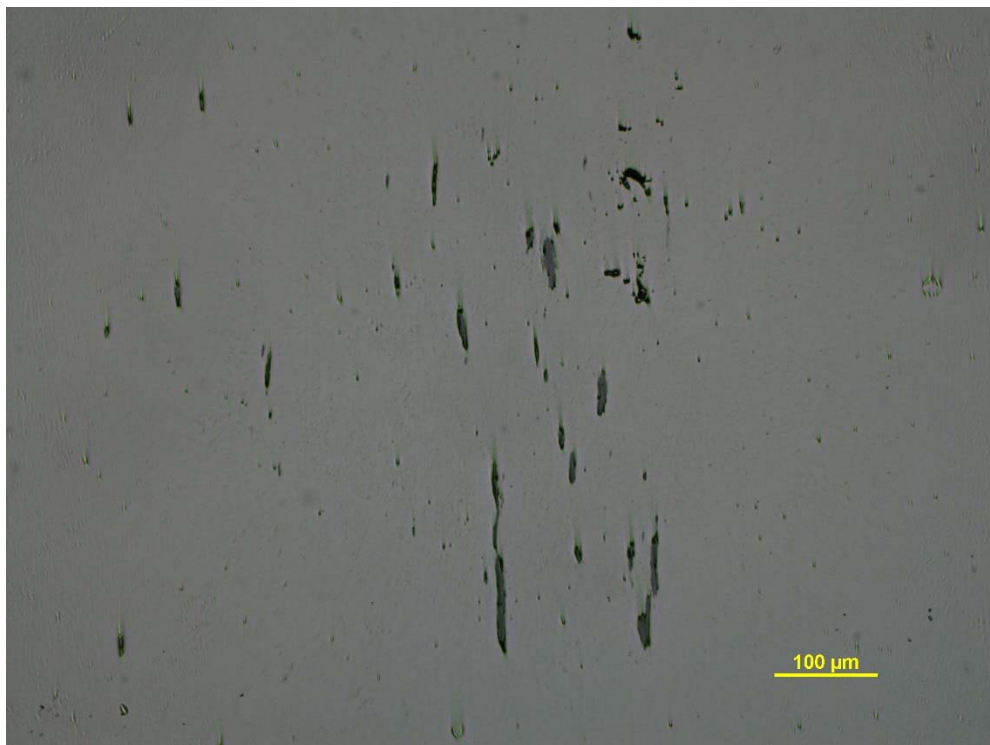
Photo 27) Example of stringer inclusions observed in microstructure. (Unetched)

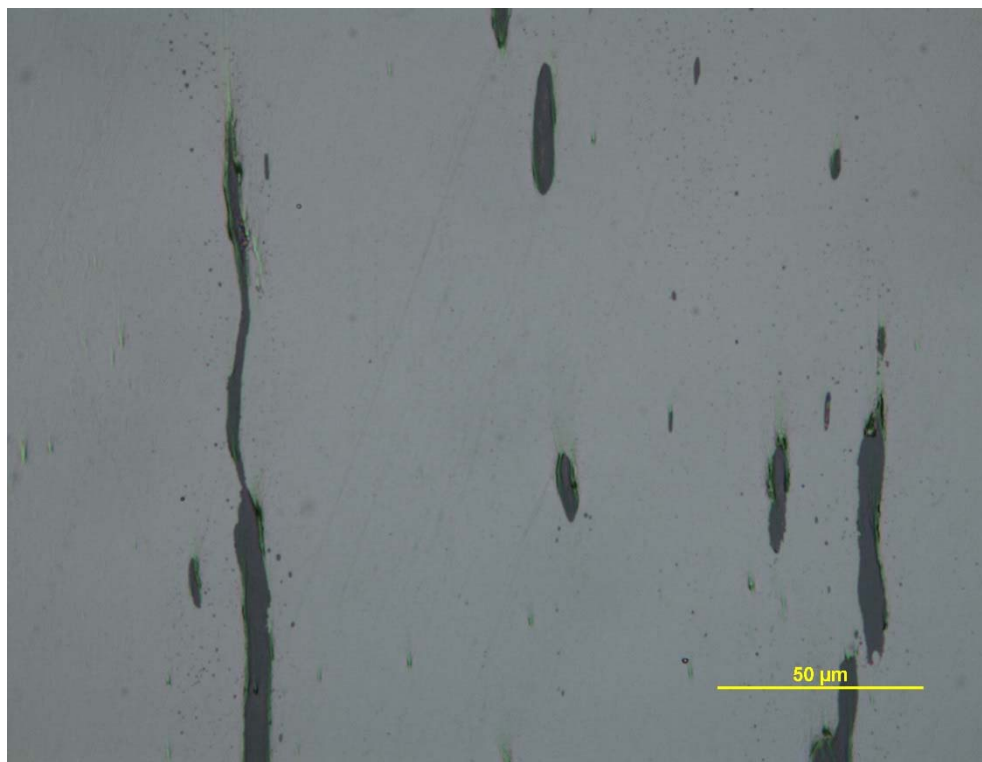
Photo 28) Same as Photo 28 except higher magnification of non-metallic stringer inclusions.
