**CALTRANS:
THE STATE AUDITOR'S RECENT INVESTIGATION
AND A BAY BRIDGE UPDATE**

Briefing on E2 Anchor Bolts – May 14, 2013

THE SAN FRANCISCO-OAKLAND
BAY BRIDGE
SEISMIC SAFETY PROJECT

Failure of 2008 Bolts Due to Hydrogen Embrittlement

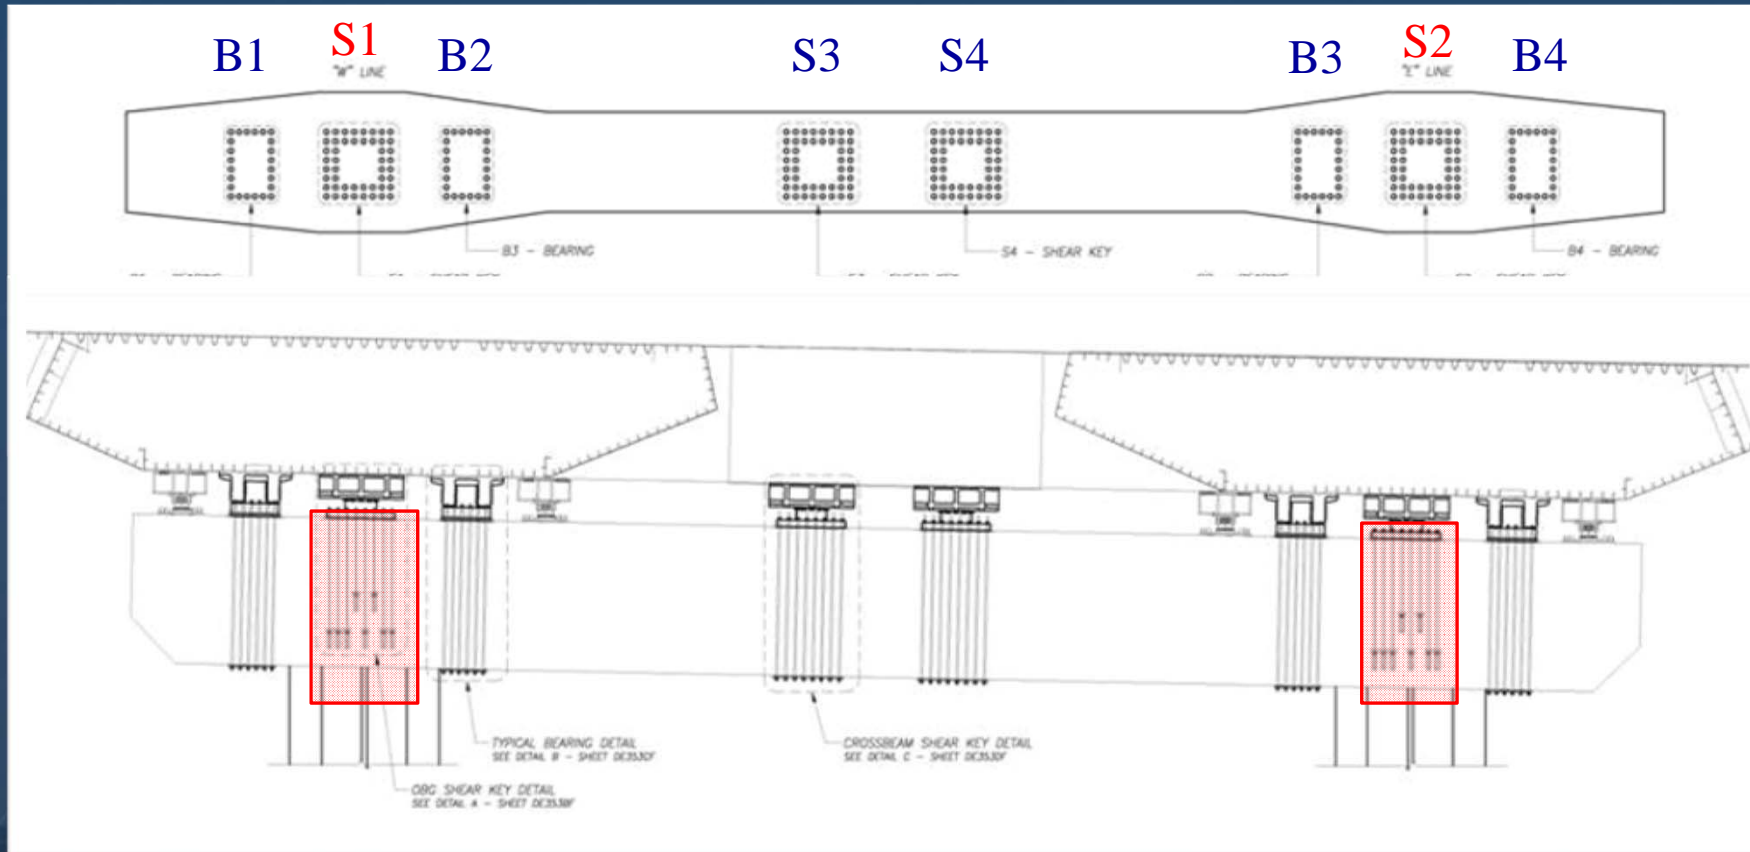
- Bearings and shear keys are secured to E2 by 3 inch diameter bolts, ranging from 9 feet to 24 feet in length and to the OBG by 2 to 3 inch diameter bolts ranging 2 to 5 feet in length.
- 96 bolts manufactured in 2008 shown in red are embedded in the pier.

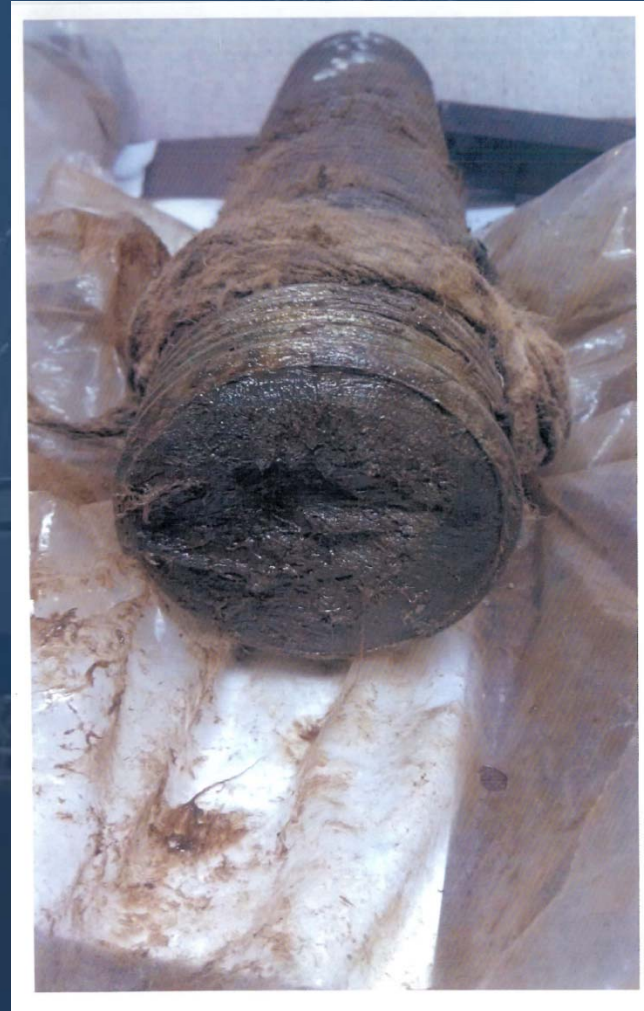
- As determined by Caltrans and the Contractor, the anchor bolts failed as a result of hydrogen embrittlement.

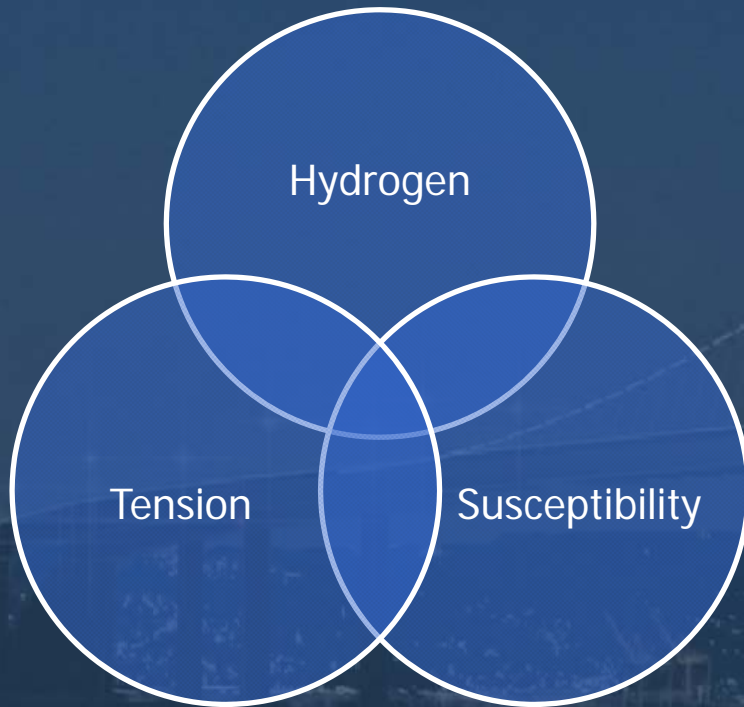
Hydrogen Embrittlement

- **Hydrogen embrittlement requires three elements**
 - Susceptibility
 - Hydrogen
 - Tension
- **Root cause of the failure is attributed to higher than normal susceptibility of the steel to hydrogen embrittlement.**

- Procurement of future A354 grade BD anchor rods should include a number of supplemental requirements to assure against hydrogen embrittlement failure.

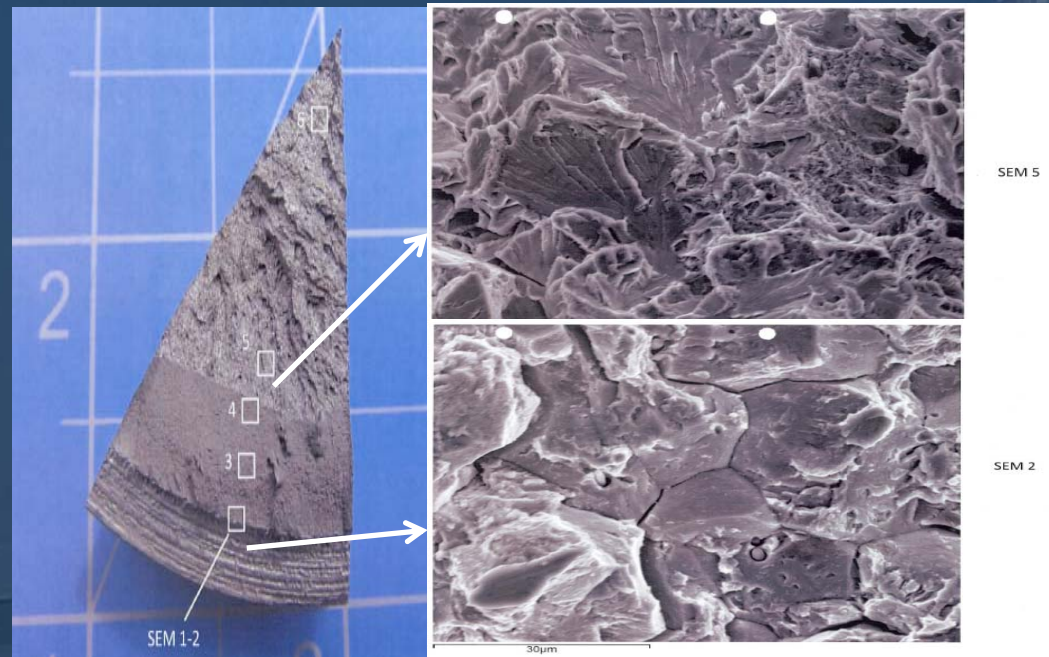
1000X Magnification

- Metallurgical analysis shows a lack of uniformity in the microstructure of the steel, with large differences in hardness from center to edge and high local hardness near surface. Further, the material exhibited low toughness and marginal ductility.

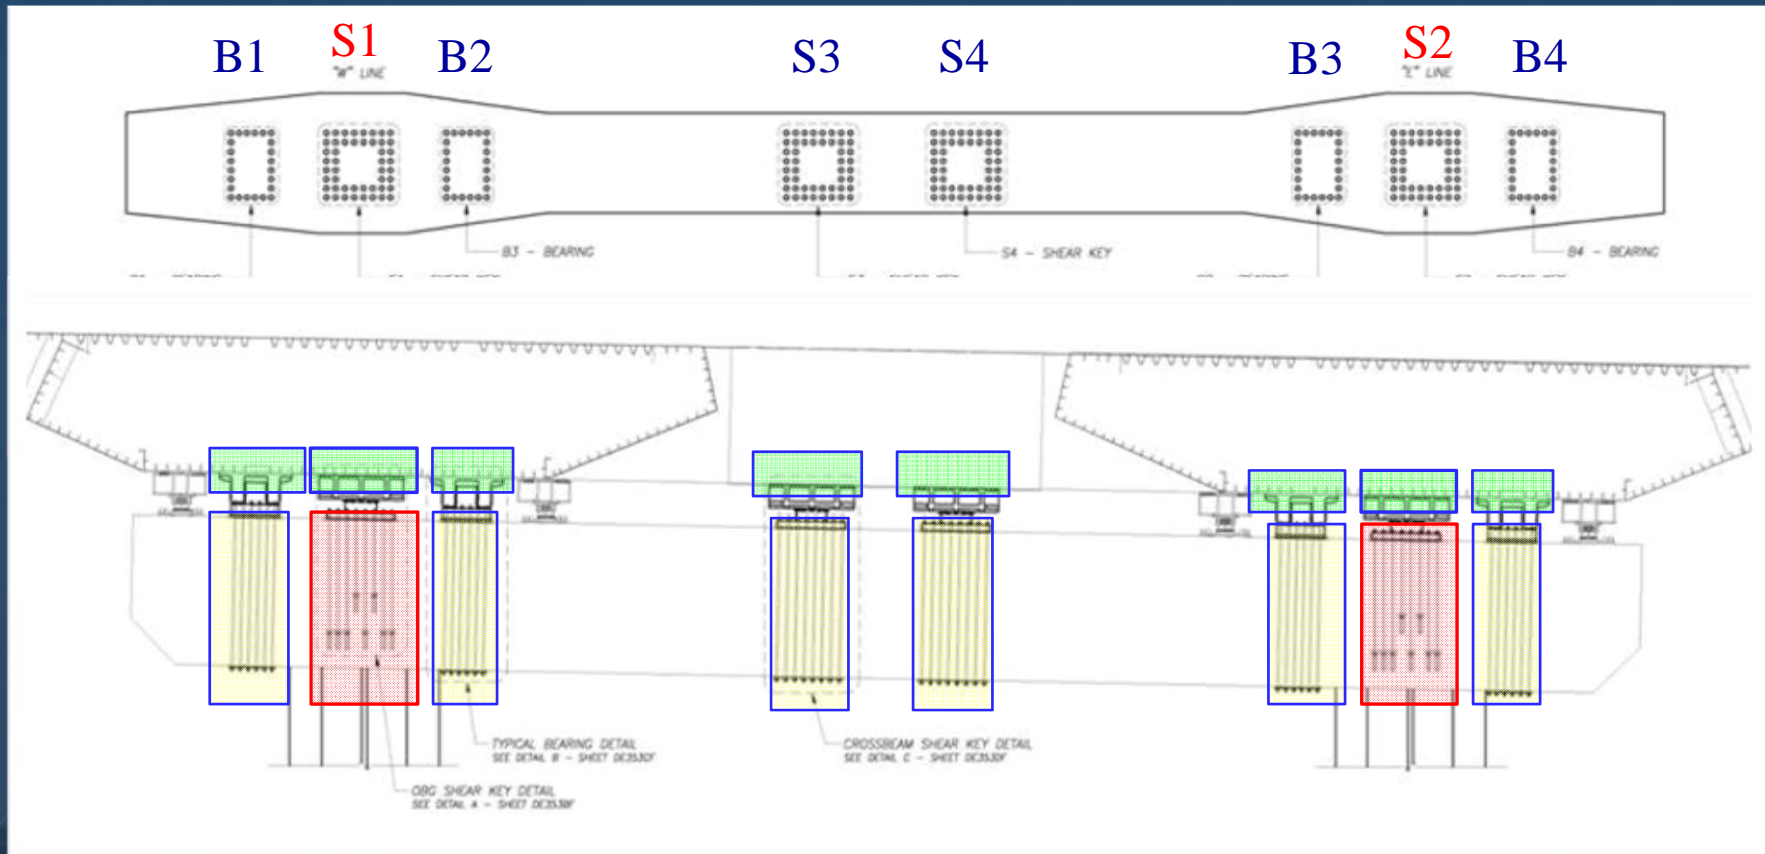
- 96 bolts manufactured in 2008 shown in red are embedded in the pier.
- 192 bolts manufactured in 2010 shown in yellow are not embedded in pier.
- 544 bolts manufactured in 2010 shown in green are connected to the OBG.
- There are an additional 432 bolts of 1 inch diameter, varying from 2 inches to 2 feet in length, that are internal to the E2 bearing assembly.

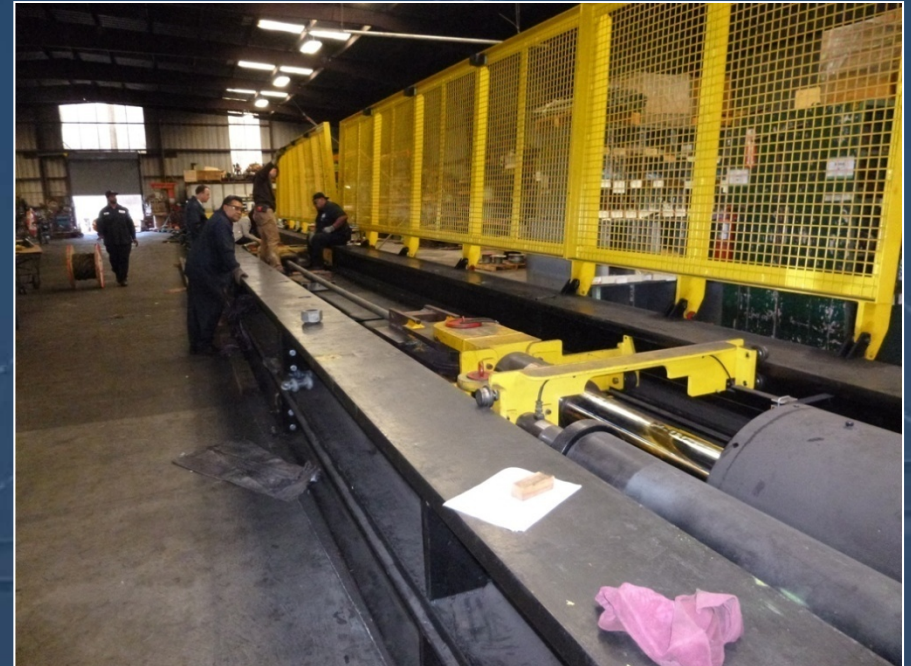
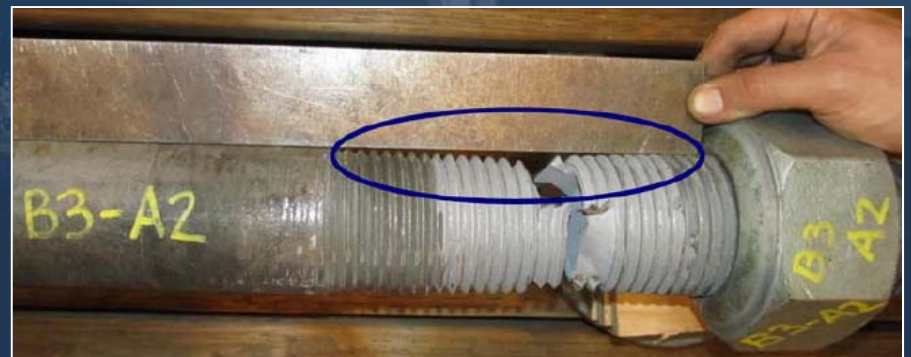
Preliminary 2010 Bolt Results

- No bolts have broken after more than a month of tensioning.
- Preliminary test results for 2010 bolts, including full sized destructive testing, show more ductile material properties and no hydrogen embrittlement.
- Additional testing results are anticipated, including surface hardness, toughness, microscopic examination, and corrosion testing

Tensile (KSI)	Yield (KSI)	Elongation (%)	Reduction of Area (ROA)	Hardness (HRC)	Charpy Toughness (ft-lb)
ASTM Requirements D > 2 1/2"	140 (min)	115 (min)	14 (min)	40 (min)	31-39	N/A
2008 E2 Bottom Average	164	142	14	48	37	@40° - 13.5 @70° - 16.2
2010 E2 Bottom Average	159	139	16	51	34	@40° - 37.2 @70° - 37.7
E2 Shear Key Top Average	159	141	16	46	35	N/A
ASTM Requirements D = 1/4" to 2 1/2"	150 (min)	130 (min)	14 (min)	40 (min)	33-39	N/A
E2 Bearing Top Average	161	135	16	54	35	N/A
E2 Bearing Assembly Average	166	154	18	56	36	N/A
E2 Retaining Ring Average	166	148	16	50	35	N/A

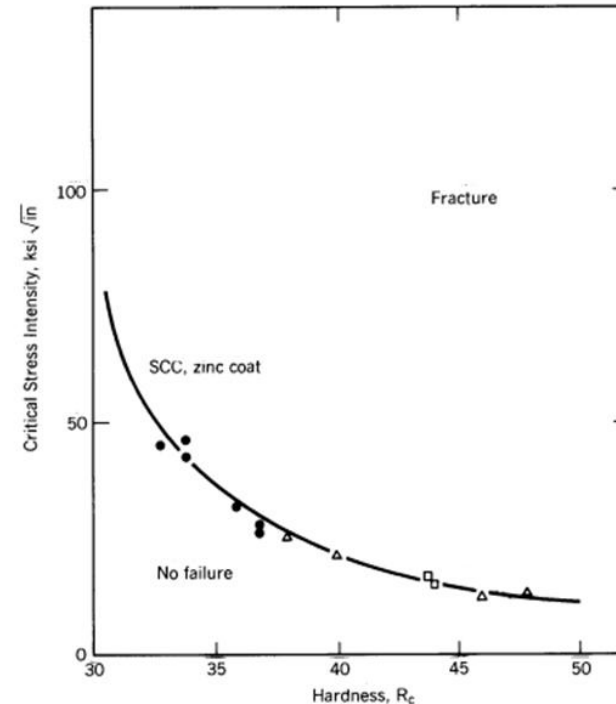
- Long term stress corrosion susceptibility is a function of the size and hardness of material, and level of tensioning.
- With the “wet” testing data, staff will be able to evaluate all similar high-strength bolts used on the project and help determine if additional remedial action is needed.

Fig 4.28. Critical Stress intensities in presence of corrosive environment;
● K_{SC} , hot-dip Al-Zn; ▲ K_{SC} , electroplated zinc; ■ K_{SC} , hot-dip zinc.

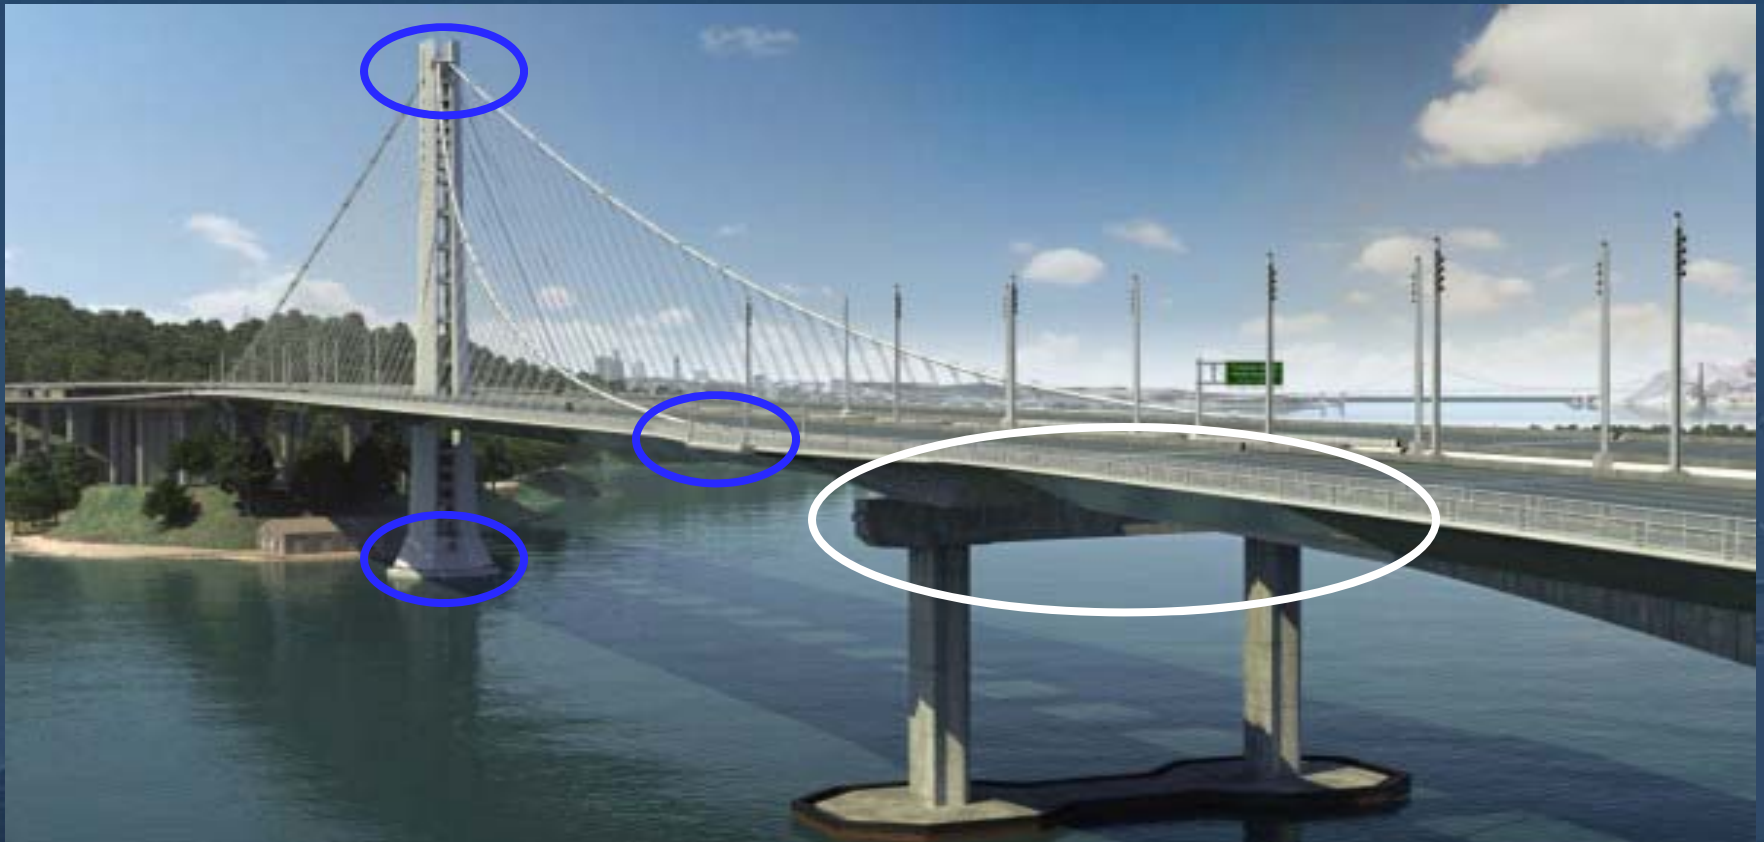
4. What should be done about other similar bolts on the SAS?

- Visual inspections of similar bolts revealed they are performing as required.
- Some E2 Bearing assembly bolts are not accessible to inspection.
- Most bolts at other locations are under lower tension levels.
