## Memorandum

Date: March 29, 2013

Subject: **BAY BRIDGE E2 CONNECTOR RODS**

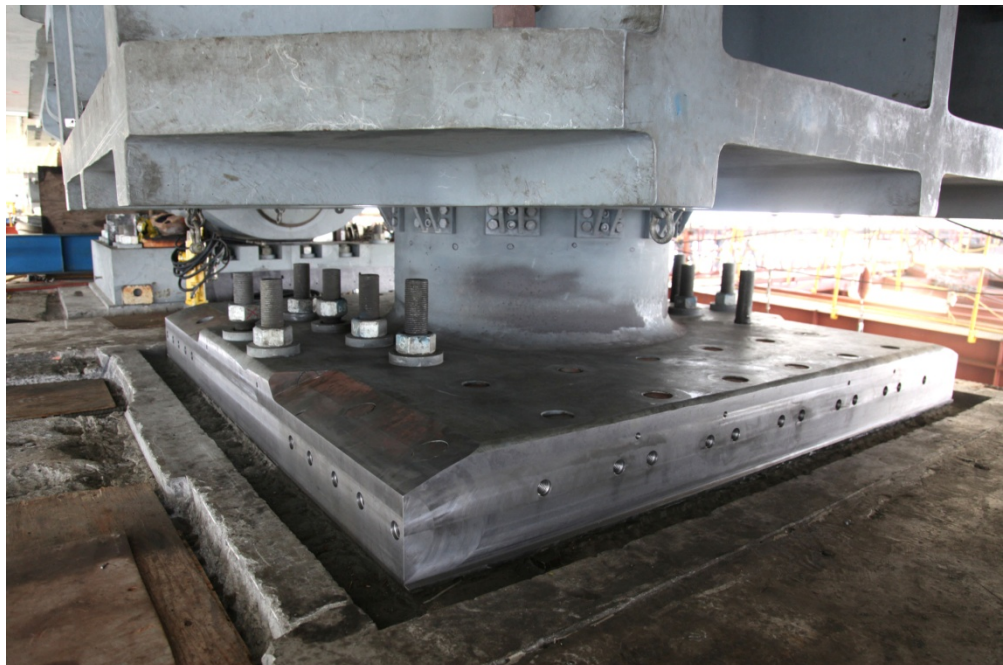
6/25. Drilling of shear keys ongoing. Saddle plate cut by XKT and material that will be processed by Steward has been delivered. XKT has started rolling of cut plate.
