# **SAS PIER E2 HOT DIP GALVANIZED GRADE BD ANCHOR ROD FAILURES**

**AMY REIN WORTH  
Commissioner/Chair  
Metropolitan Transportation Commission  
Oakland, California**

**April 21, 2013**

**Prepared by Yun Chung  
Alameda, California**

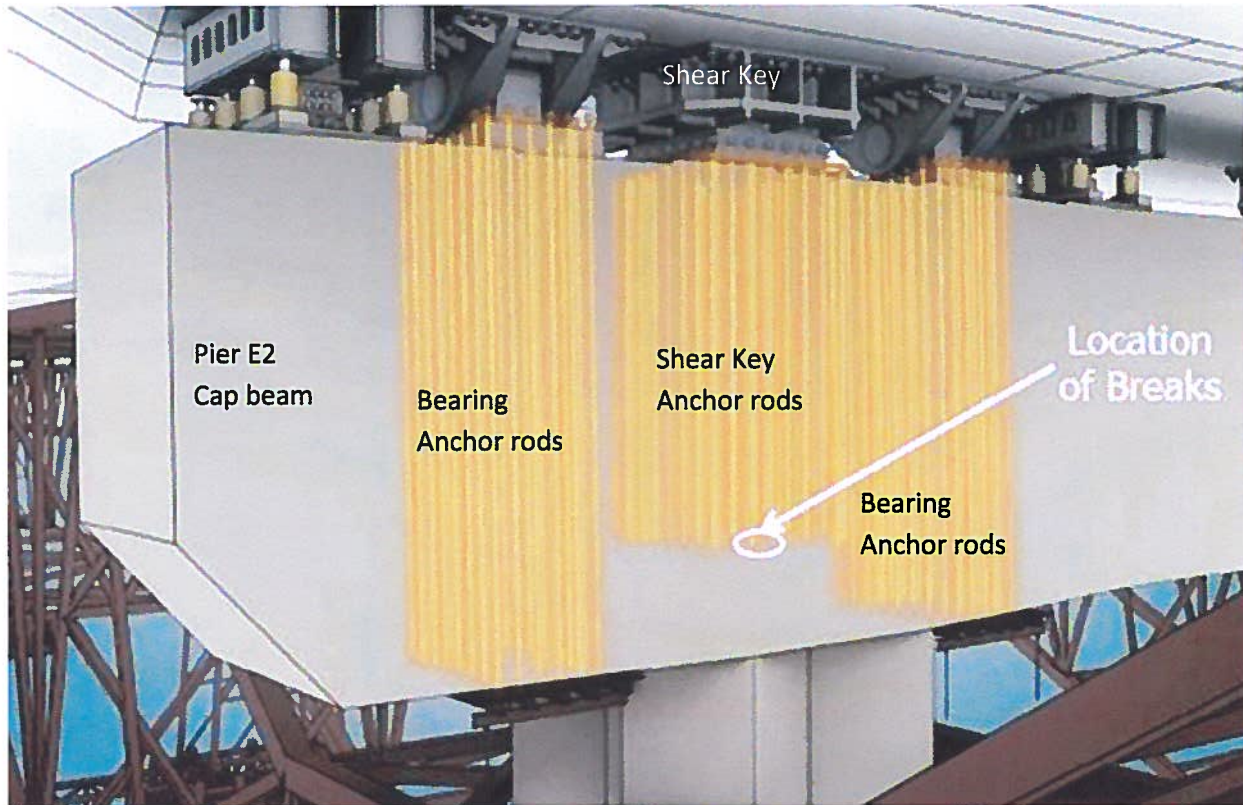
(a) Anchor rods in the Pier E2 Cap Beam

Figure 5 (a) Top of Pier E2 Cap Beam showing the anchor rods for bearings and a shear key. Several anchor rods failed at the bottom ends. (b) Underside of the Pier E2 cap beam showing the anchor rods for a bearing.

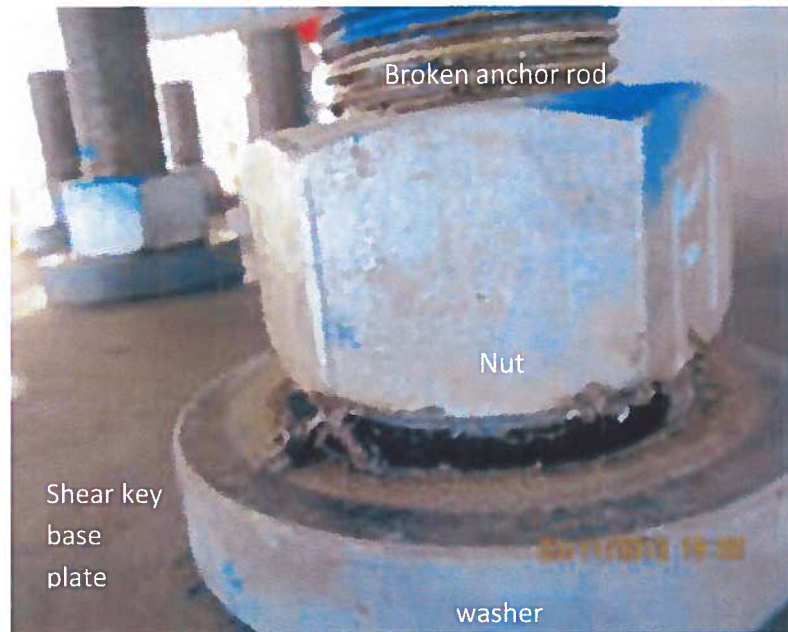
(a) One of failed anchor rods on a shear key base plate

All failures of the shear key anchor rods occurred at the bottom ends, which were held by anchor plates and nuts, embedded in concrete and grout (Figure 5a).<sup>11</sup> The top ends of the failed anchor rods would pop out as shown in Figure 6a since they remained under static tension ever since they were tensioned (or preloaded).

Figure 6 (a) One of shear key anchor rods that failed at the bottom end. It popped up when the residual tension was released upon failure. (b) Fracture face of one of failed shear key anchor rods. The crescent area at arrows A1-A2-A3-A4 is marked HEZ (hydrogen embrittlement zone), which formed while the anchor rod was under static tension. The rest, FFZ (fast fracture zone), was formed almost instantly.

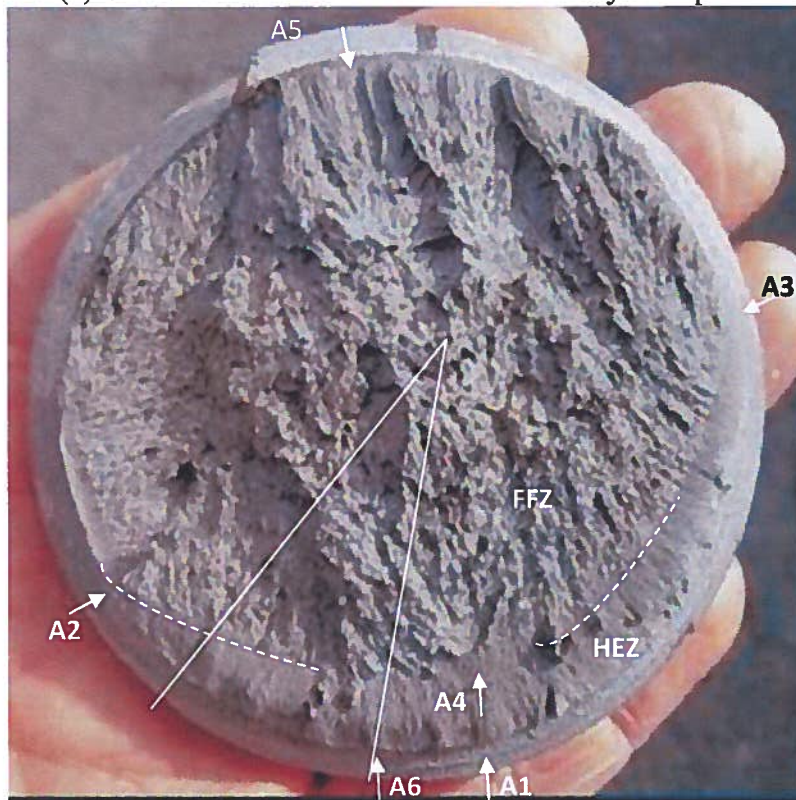
(b) Fracture face of a failed anchor rod.

April 10 BATA meeting,<sup>12</sup> reproduced in Figures 6b and 7, are unequivocal evidence that the anchor rods failed due to the HE mechanism. It is prone to occur in high strength steel fasteners including Grade BD anchor rods as will be discussed later.

The fracture face of one of the failed anchor rods, shown in Figure 6b, has a crescent shaped area at arrows A1-2-A3-A4. This area is relatively smooth as compared with the rest between arrows A4 and A5, marked FFZ (fast fracture zone). The crescent area, marked HEZ (hydrogen embrittlement zone), was formed by HE during the several days after the rod was tensioned to  $0.7F_u$  or to 95.5-ksi tensile stress.<sup>10</sup> Since this is below the specified minimum yield strength of 115-ksi for ASTM A354, Grade BD, the anchor rod should not have failed under a normal rising load or under a static sustained load without being influenced by HE.

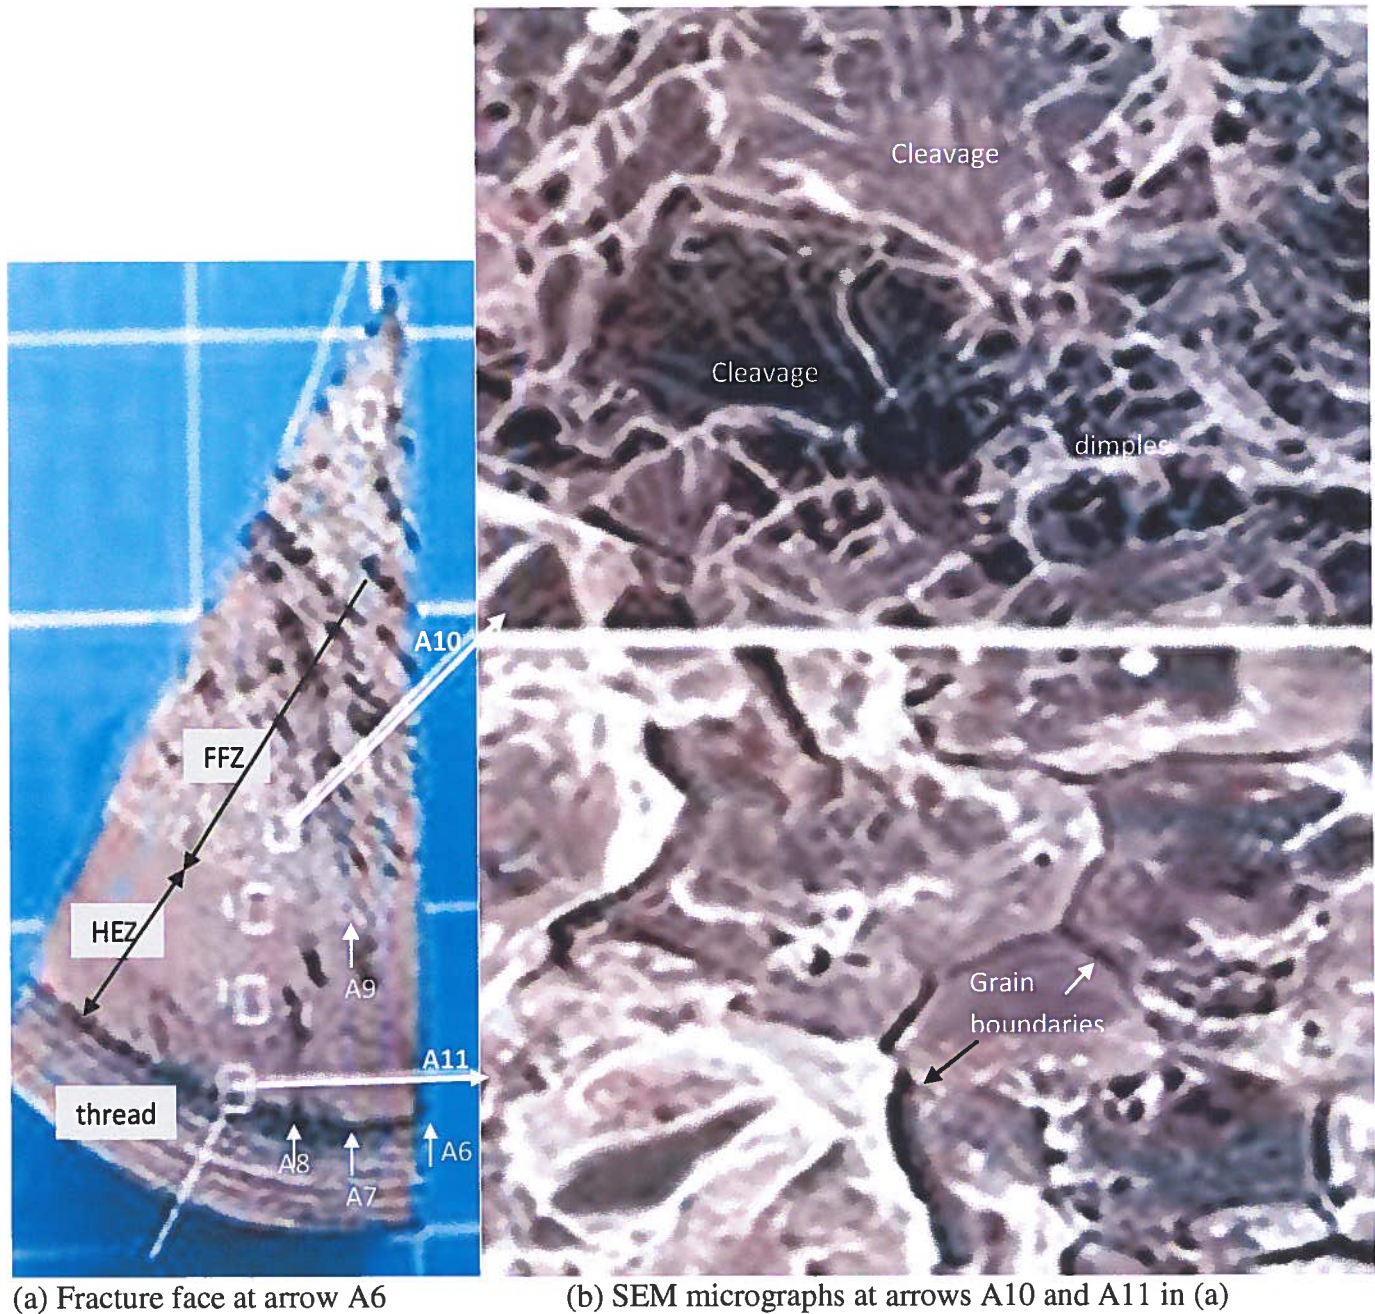
The pie-cut section at arrow A6 in Figure 6b is shown enlarged in Figure 7a. Arrows A6, A7, and A8 point to three of several ridges, called ratchet marks, along the thread root where microscopic cracks formed due to HE. These ratchet marks indicate that microscopic cracks initiated at multiple sites along the thread root and grew in size over time. Arrow A9 points to the demarcation line between the HEZ and the FFZ.

Figures 7b top and 7b bottom are scanning electron fractographs, magnified about 1000 times, of the boxed areas in Figure 7a. The fractographic appearance of the FFZ, shown at arrow A10 (or Figure 7b top), is distinctively different from that of the HEZ, shown at arrow A11 (or Figure 7b bottom). The latter shows that the fracture face of the HEZ consisted of grain boundary facets and numerous microscopic cracks along the grain boundaries. This is known as an intergranular fracture and is one of fracture characteristics of HE failure in high strength steels.<sup>17</sup> The FFZ at arrow A10, in Figure 7b top, displayed cleavage facets with river patterns and some fine dimples, characteristics of a relatively brittle and fast fracture in high strength steels.

Figure 7 (a) Enlarged view of the wedge at arrow A6 from the fracture face of a failed anchor rod in Figure 6b. Arrows A6, A7, and A8 point to ratchet marks, which resulted from multiple fracture origins. (b) Scanning electron fractographs of the HEZ (hydrogen embrittlement zone) at arrow A9 and the FFZ (fast fracture zone) at arrow A10. The fracture mode was predominantly intergranular for the HEZ and a mixture of cleavage and dimples for the FFZ.

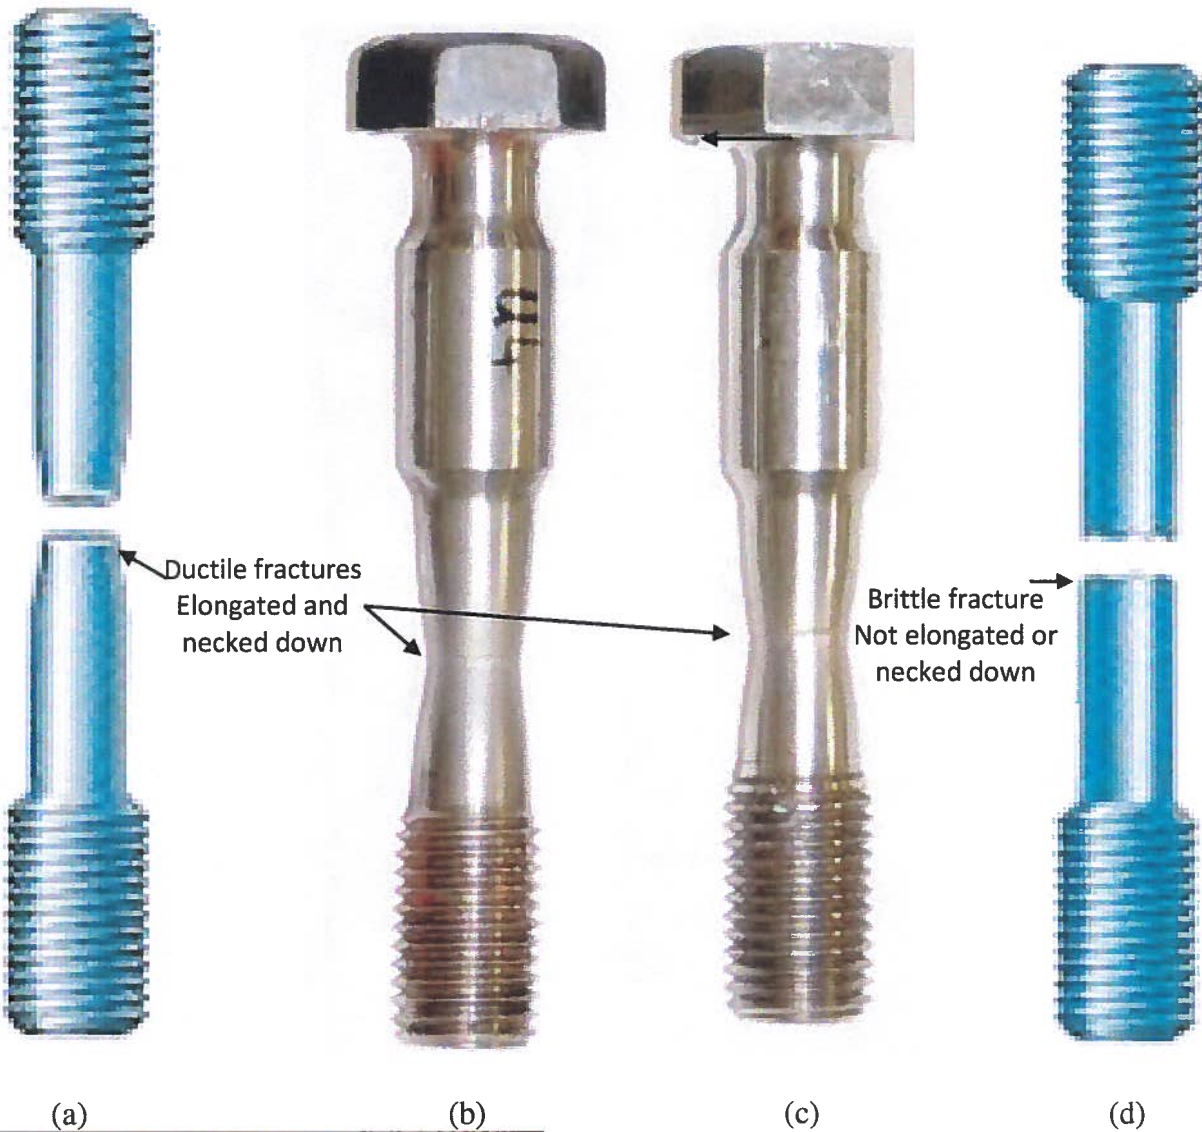
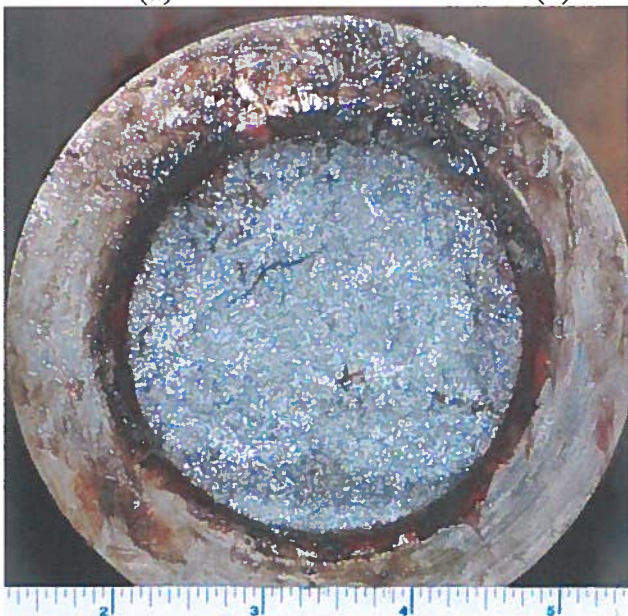
Examples of tensile specimens after testing showing ductile specimens in (a), (b), and (c) as compared with a brittle specimen in (d).

(e) shows the fracture face of a coupler pin between rail cars. The pin was made of 8620 steel in an as cast condition. It displayed a ductile behavior in tensile tests (80-ksi tensile strength, 45-ksi yield strength, 20% elongation, and 30% reduction area); yet broke in a brittle manner at a section change when overloaded due to an accidental bumping between rail cars one cold morning (around 40°F). The fracture started at the top and propagated down.

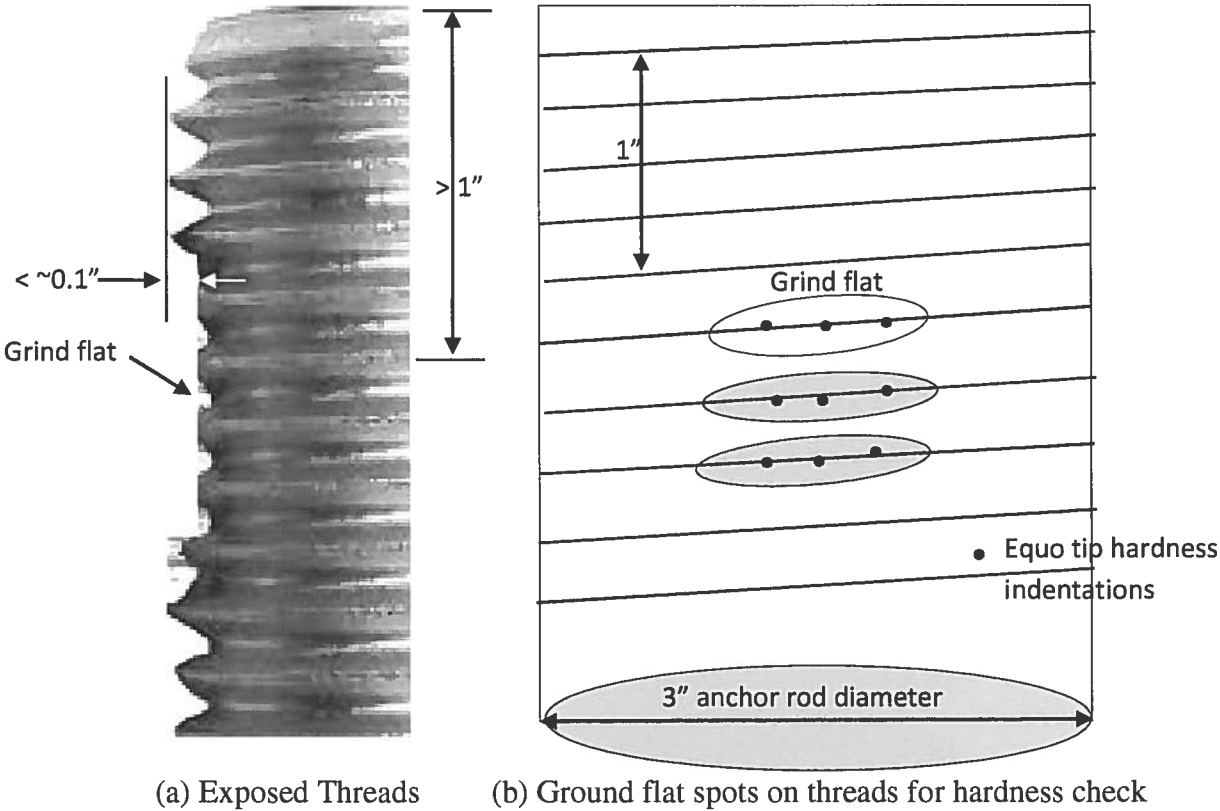
Figure 14 Equo tip hardness test location on exposed threads of anchor rods in Pier E2.

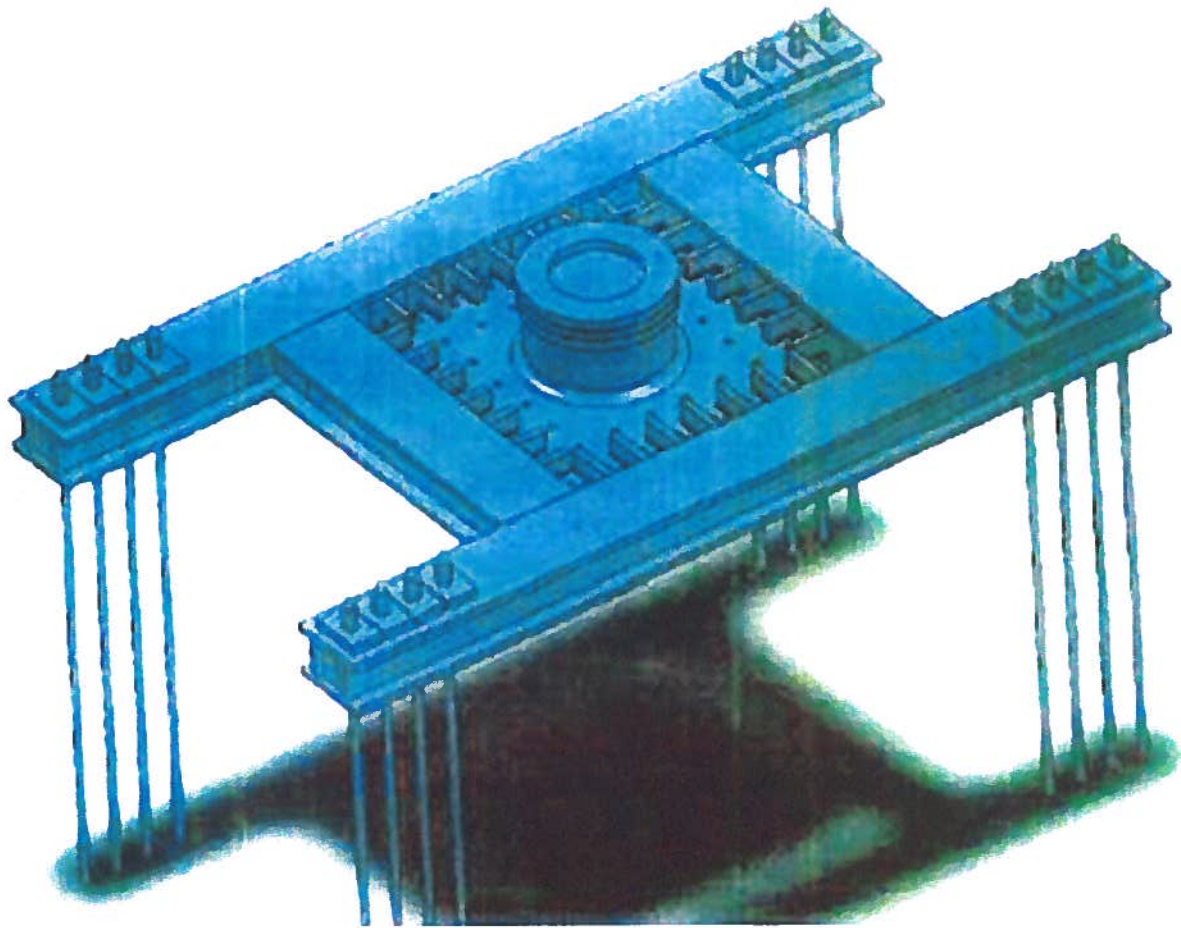
Figure 15 One of Caltrans' conceptual design of a "steel collar" to substitute for the failed shear key anchor rods.<sup>51</sup> "Fingers," seven per side, attached to steel beams, are supposed to clamp the shear key base plate down to the Pier E2 cap beam. Two shear keys, S1 and S2, each has 48 Grade BD anchor rods, 3-inch diameter. Of these, 21 failed for S1 and 11 for S2. One side of S1 had 9 out of two rows of 8 anchor rods failed and a total of 21 out of 48 anchor rods for S1 failed. Out of 48 anchor rods for S2, 11 failed, all due to hydrogen embrittlement in early March 2013.

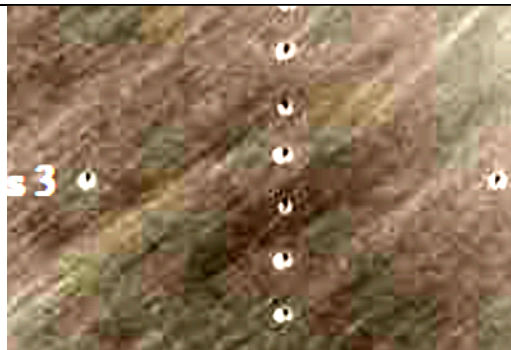
| | Anamet Report No. 5004.8612<br>Page 2, Figure 1<br><br>Some of the HRC indentations are within streaks caused by surface grinding, which may have lowered the hardness. See Photo at right. | <br><br>HRC traverse tests may have to be redone on a properly prepared surface. |
