*Appendix F –  
Borescope Investigation of Pier E2 Rods  
Holes, SMR Reports (2011 and 2013)*

Self-Anchored Suspension Bridge

Borescope Observation of Pier E2 Rod Holes – 2011

Borescope Investigation of Pier E2 Rod Holes – 2013

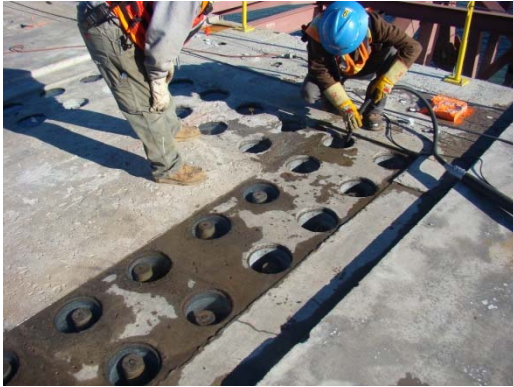
After the Pier E2 concrete pour, the rod holes were left open, exposing them to atmospheric conditions and accumulation of debris. The Contractor extracted the water and used compressed air to

**Figure 5: Extraction of water**

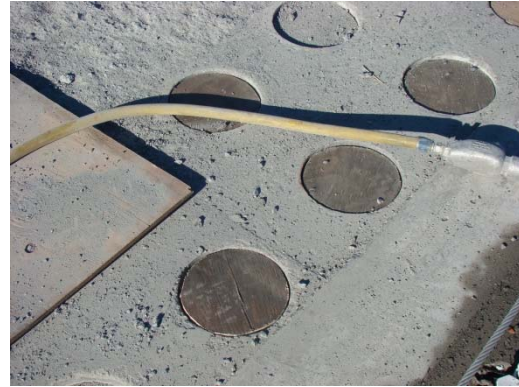
remove debris. In order to prevent future water and debris intrusion, the Contractor covered the holes with plywood. See **Figures 5** and **6**.

**Figure 6: Capped Rod Holes**

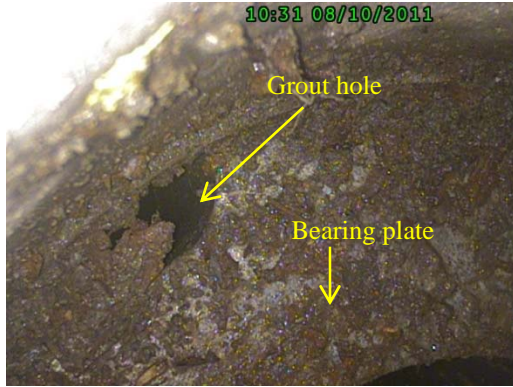
**Figure 7: Grout Hole Blocked**

- Some grouting holes were clogged by debris. (**Figures 7 and 8**)
- Initially, as stated in Revision 0 of this report, some of the rods indicated oxidation of the bottom portion of the rod. This was based on a recent review of borescope imagery associated with the report being prepared regarding all A354BD rods on the bridge in 2014. Upon further review of the contract documentation, the portion of the rod visible in Figure 8 is coated with grease and then Denso tape. The Denso tape does not allow for the examination of the condition of the galvanized rod. It is not possible to determine the source of the white residue as it could be debris from the surrounding environment. It should not be characterized as oxidation. **Figures 8A and 8B** show the rods were wrapped in Denso tape prior to assembly and installation. [Revision 1]

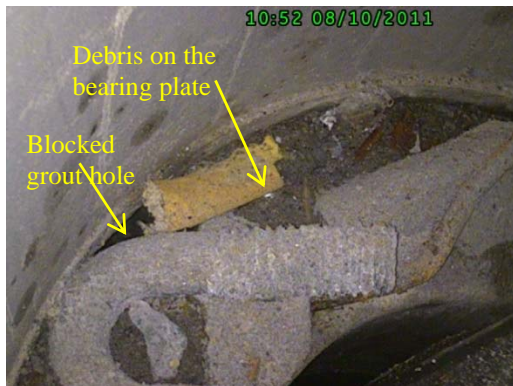
**Figure 9: Various Debris on the Bearing Plate**

- Objects such as cigarette butts, U-bolts, and wood chips were found at the bottom of the holes, on top of the bearing plate. (**Figures 9 and 10**)
- Standing water was observed in some rod holes (**Figure 11**) and below the bearing plate (**Figure 12**)

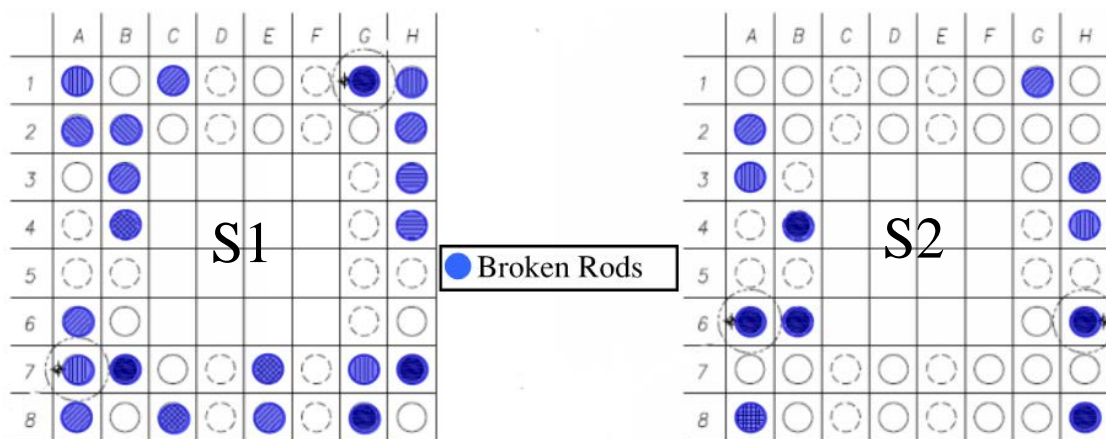
Once the grouting was complete, in Mar. 2013, thirty-two (32) of the shear key anchor rods fractured shortly after tensioning. The specific rods are highlighted in **Figure 1**. The top portions of the rods were extracted in segments for fracture analysis. It was not possible to retrieve the bottom fracture surfaces. The Department requested that METS investigate the interior of the rod holes with a borescope to evaluate the in-situ conditions and provide images of the fracture region.

Figure 1: Locations of Failed Rods in Shear Keys S1 & S2

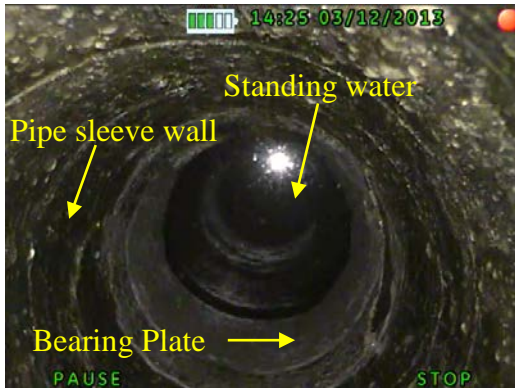
**Figure 7: S2-H6 borescope snapshot**

Standing water was observed as shown in **Figure 7**. The water is right below the bearing plate as shown in **Figure 8**. A gap appeared to be between the fractured rod and the bearing plate as shown in **Figure 9** suggesting movement of the assembly away from the bearing plate. The views of the borescope images are at cross section A-A of **Figure 3**.

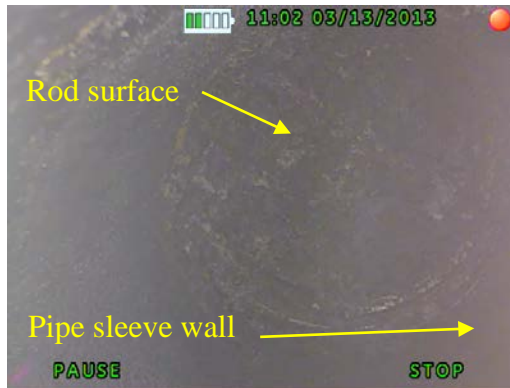
**Figure 10: S2-A6 borescope snapshot**

Contamination of the borescope lens reduced the range of visibility. The rod's fracture surface was identified and was dry (**Figures 10 and 11**). Corrosion products were visible on the rod fracture surface (**Figure 11**). The threads exhibited rusting as well (**Figure 12**). The views of the borescope images are at cross section A-A of **Figure 3**.

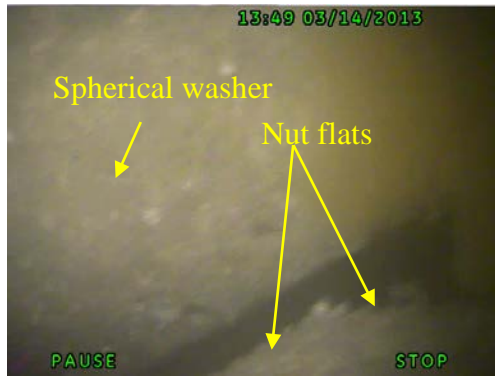
Figure 73: S1-A7 boreoscope snapshot

Standing water was observed during the inspection. No fracture surface was visible. It appears that the nut had rotated and only the flats of the nut were visible (**Figure 13**). There are gaps between the bearing plate and the spherical washer edge. The gaps vary in size, further suggesting the rotation of the nut as shown in **Figure 14** and **Figure 15**. The views of the borescope images are at cross section A-A of **Figure 3**.

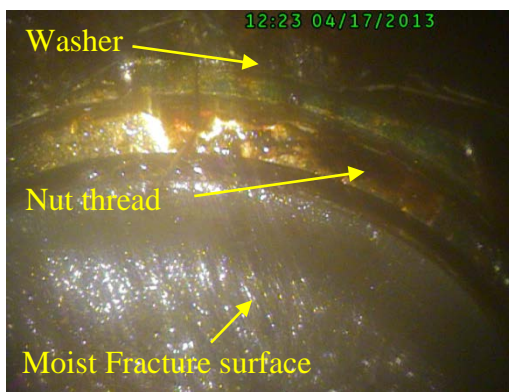
Figure 16: S1-G1 boreoscope snapshot

The fractured rod was not submerged in water, but moisture was present (**Figure 16**). The camera lens was rotated to observe the threads on the rod and the nut and as shown in **Figure 17**; the threads exhibited rust deposits. The fracture surface was clearly visible. The nut appeared to be seated within the spherical washer (**Figure 17**). The views of the boreoscope images are at cross section A-A of **Figure 3**.

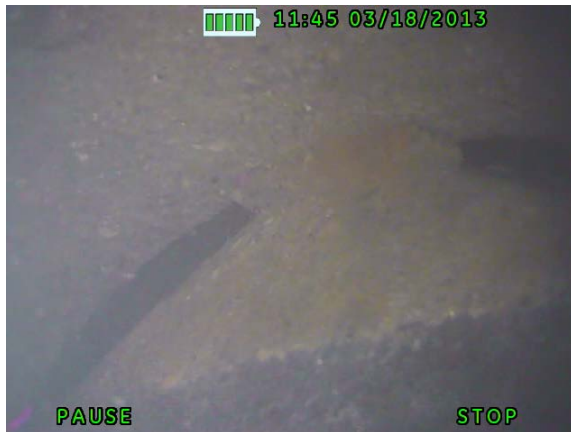
*Figure 18: S2-A8 borescope snapshot*

Standing water was observed in the hole and the rod was submerged. Particulates in the water reduced clarity and visibility. A gap appeared between the spherical nut and the spherical washer

which is indicative of the nut moving away from the spherical washer. The flats of the nut are visible as shown in **Figures 18** and **19**. **Figure 19** also appears to show the fracture surface of the rod. **Figure 20** is a close up of the fracture surface visible in **Figure 19**. The views of the borescope images are at cross section A-A of **Figure 3**.
