*Appendix F –
Borescope Investigation of Pier E2 Rods
Holes, SMR Reports (2011 and 2013)*

Self-Anchored Suspension Bridge

Borescope Investigation of Pier E2 Rod Holes – 2011

Borescope Investigation of Pier E2 Rod Holes – 2013

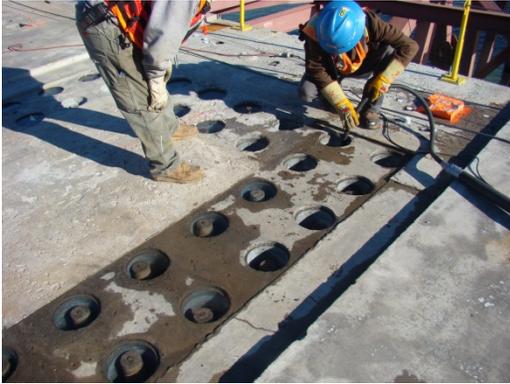
After the Pier E2 concrete pour, the rod holes were left open, exposing them to atmospheric conditions and accumulation of debris. The Contractor extracted the water and used compressed air

Figure 5: Extraction of water

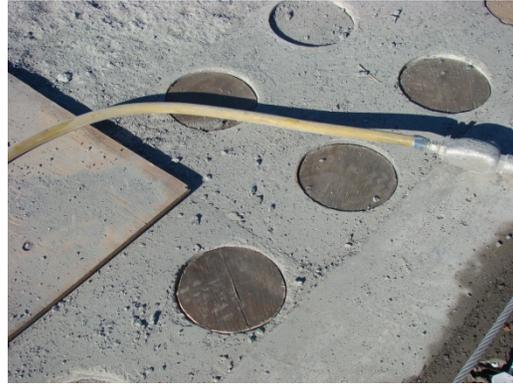
to remove debris. In order to prevent future water and debris intrusion, the Contractor covered the holes with plywood. See **Figures 5** and **6**.

Figure 6: Capped Rod Holes

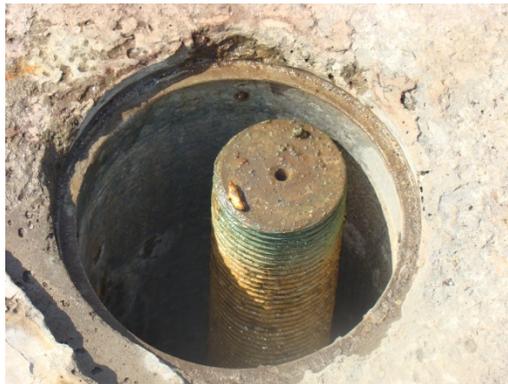
Quality Assurance Associate Steel Inspector Jason Gramlick performed borescope inspections of various rods in Shear Keys S1 and S2 on Aug. 8, 2011, with a GE XL Go Videoprobe Borescope. Prior to the borescope inspection of the anchor rod sleeve, an initial visual inspection of the accessible area was conducted. The visible part of the rod exhibited corrosion in the threads. No physical damage to the threads was documented (see **Figure 7**).

Figure 7: Exposed rod at Pier E2

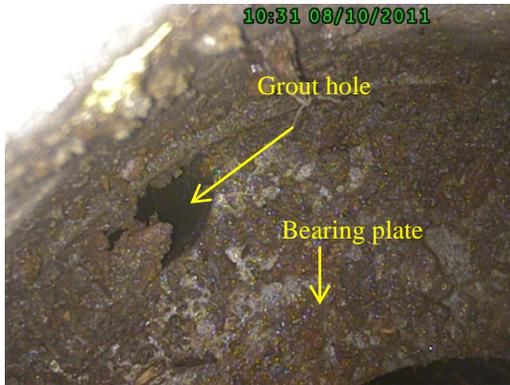
- Some grouting holes were clogged by debris. (**Figures 8 and 9**)
- Based on the borescope images, the bottom of the rods exhibited white corrosion product. Some of the rods indicated higher levels of oxidation at their bottom end suggesting direct exposure to water. (**Figure 9**)

Figure 8: Grout Hole Blocked

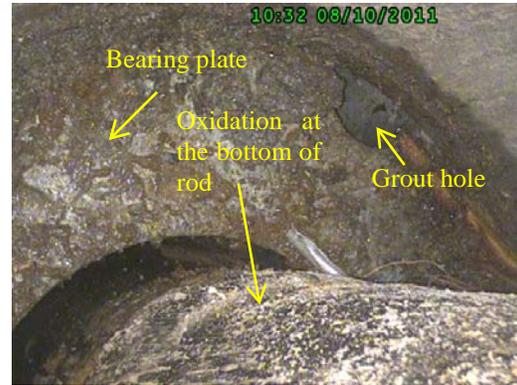
Figure 9: Debris on the Bearing Plate

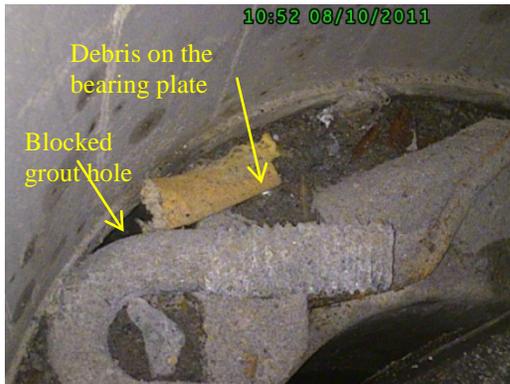
- Objects such as cigarette butts, U-bolts, and wood chips were found at the bottom of the holes, on top of the bearing plate. (Figures 10 and 11)
- Standing water was observed in some rod holes (Figure 12) and below the bearing plate (Figure 13)

Figure 10: Various Debris on the Bearing Plate

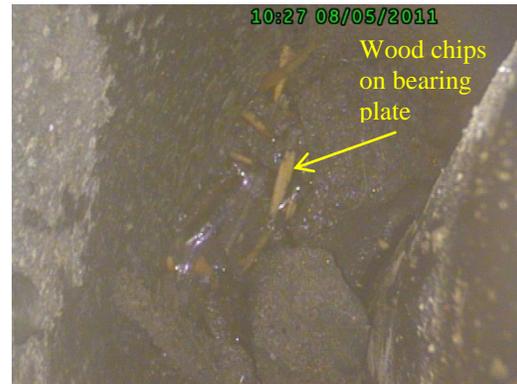
Figure 11: Various Debris on the Bearing Plate

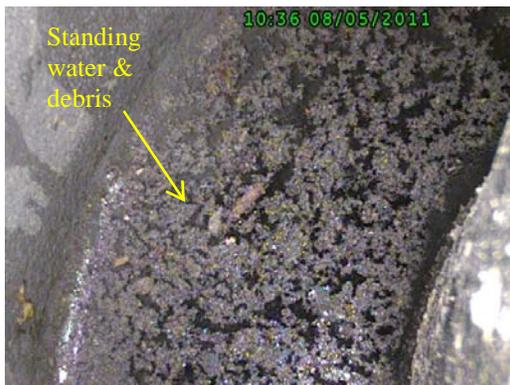
Figure 52: Standing Water in the Rod Hole

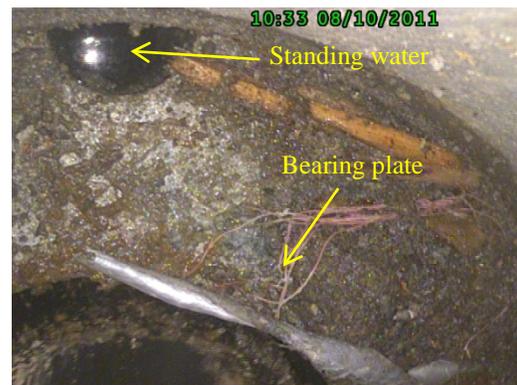
Figure 63: Various Debris on the Bearing Plate

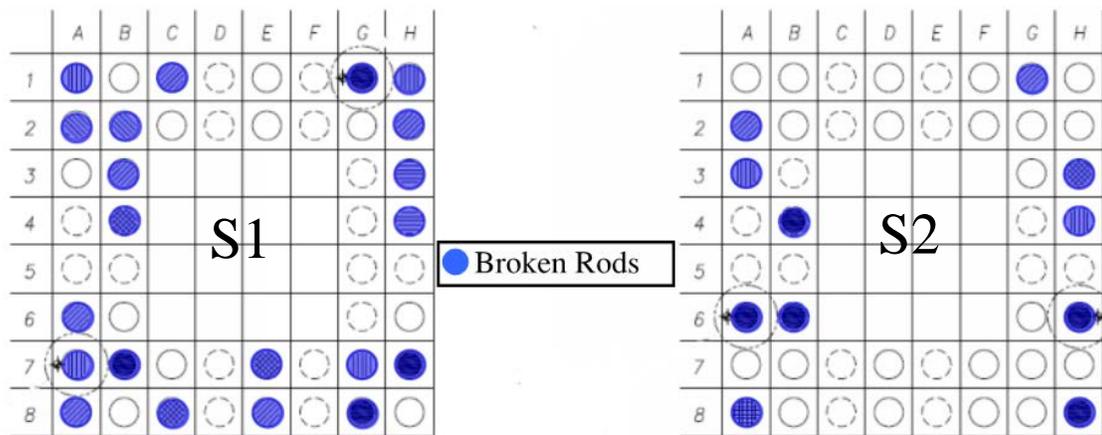
Once the grouting was complete, in Mar. 2013, thirty-two (32) of the shear key anchor rods fractured shortly after tensioning. The specific rods are highlighted in **Figure 1**. The top portions of the rods were extracted in segments for fracture analysis. It was not possible to retrieve the bottom fracture surfaces. The Department requested that METS investigate the interior of the rod holes with a borescope to evaluate the in-situ conditions and provide images of the fracture region.

Figure 1: Locations of Failed Rods in Shear Keys S1 & S2

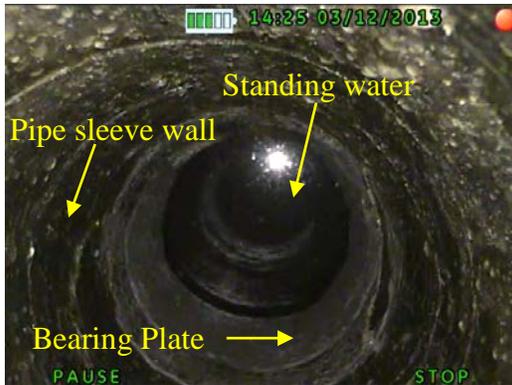
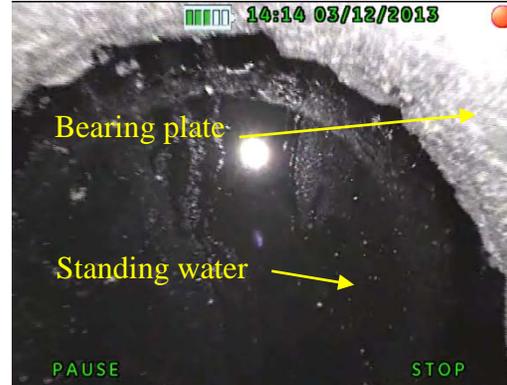
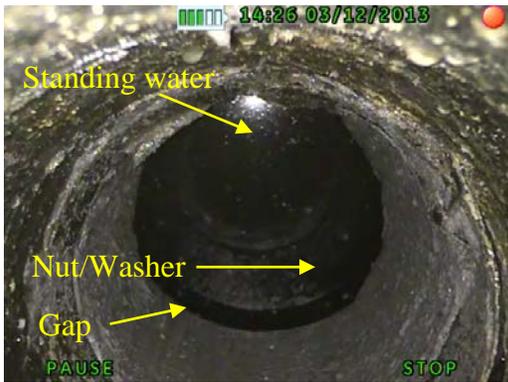
Rod ID S2-H6 (Mar. 12, 2013)

Standing water was observed as shown in **Figure 7**. The water is right below the bearing plate as shown in **Figure 8**. A gap appeared to be between the fractured rod and the bearing plate as shown in **Figure 9** suggesting movement of the assembly away from the bearing plate. The views of the borescope images are at cross section A-A of **Figure 3**.

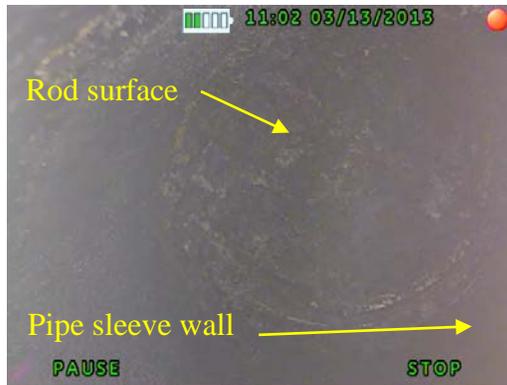
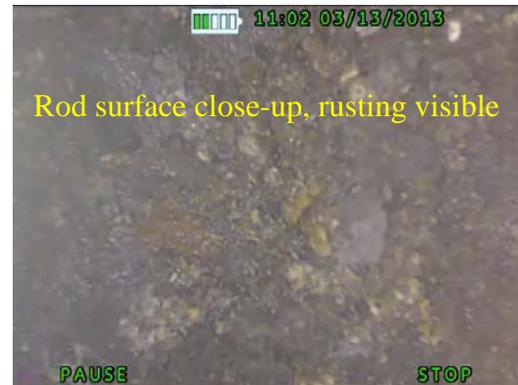
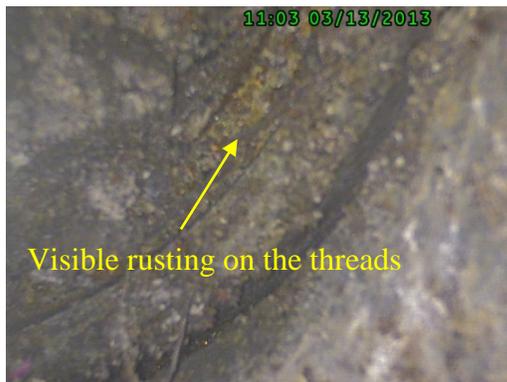
Rod ID S2-A6 (Mar. 13, 2013)

Contamination of the borescope lens reduced the range of visibility. The rod's fracture surface was identified and was dry (**Figures 10 and 11**). Corrosion products were visible on the rod fracture surface (**Figure 11**). The threads exhibited rusting as well (**Figure 12**). The views of the borescope images are at cross section A-A of **Figure 3**.

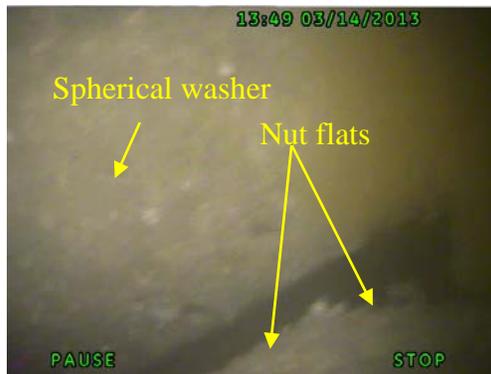
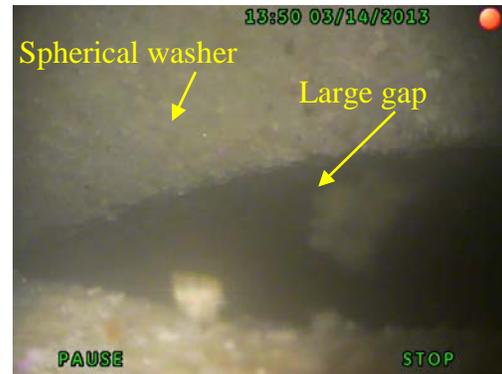
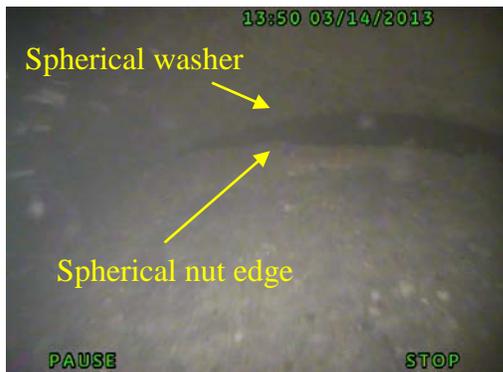
Rod ID S1-A7 (Mar. 14, 2013)

Standing water was observed during the inspection. No fracture surface was visible. It appears that the nut had rotated and only the flats of the nut were visible (**Figure 13**). There are gaps between the bearing plate and the spherical washer edge. The gaps vary in size, further suggesting the rotation of the nut as shown in **Figure 14** and **Figure 15**. The views of the borescope images are at cross section A-A of **Figure 3**.

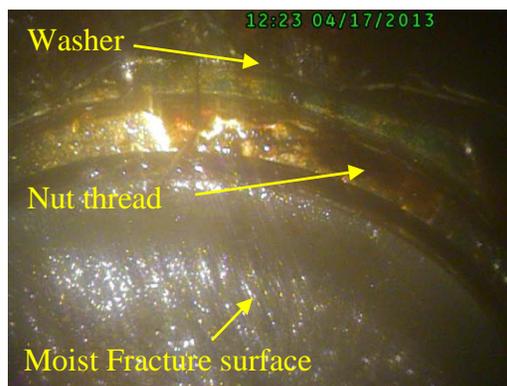
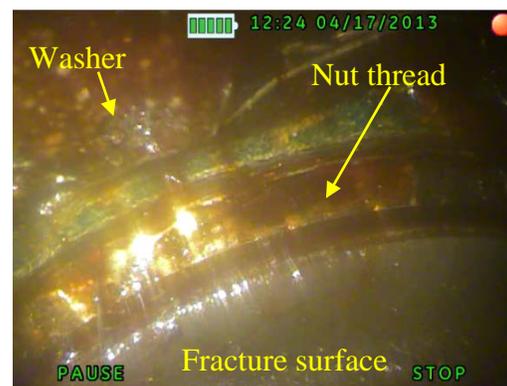
Rod ID S1-G1 (Mar. 17, 2013)

The fractured rod was not submerged in water, but moisture was present (**Figure 16**). The camera lens was rotated to observe the threads on the rod and the nut and as shown in **Figure 17**; the threads exhibited rust deposits. The fracture surface was clearly visible. The nut appeared to be seated within the spherical washer (**Figure 17**). The views of the borescope images are at cross section A-A of **Figure 3**.

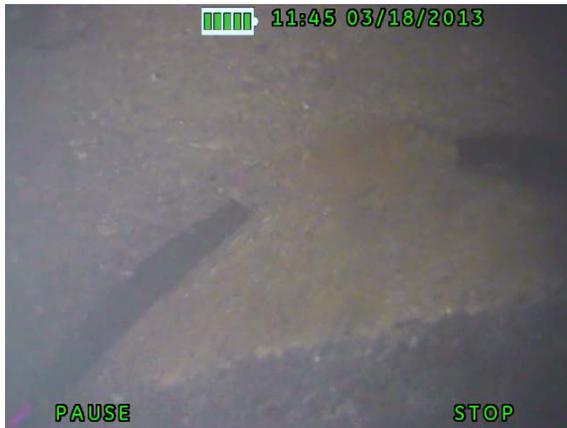
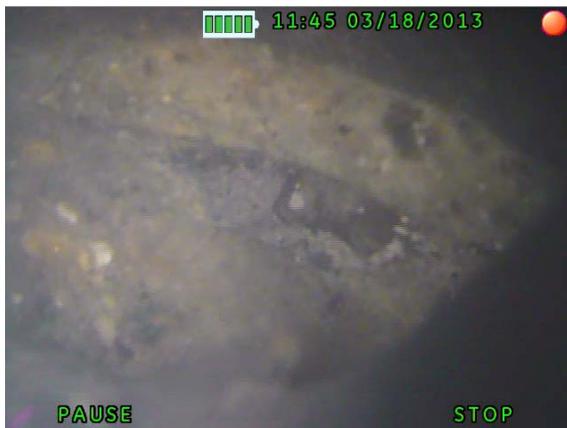
Rod ID S2-A8 (Mar. 18, 2013)

Standing water was observed in the hole and the rod was submerged. Particulates in the water reduced clarity and visibility. A gap appeared between the spherical nut and the spherical washer

which is indicative of the nut moving away from the spherical washer. The flats of the nut are visible as shown in **Figures 18** and **19**. **Figure 19** also appears to show the fracture surface of the rod. **Figure 20** is a close up of the fracture surface visible in **Figure 19**. The views of the borescope images are at cross section A-A of **Figure 3**.
