Report on the A354 Grade BD High-Strength Steel Rods on the New East Span of the San Francisco-Oakland Bay Bridge With Findings and Decisions

July 8, 2013

**TOLL BRIDGE PROGRAM
OVERSIGHT COMMITTEE**

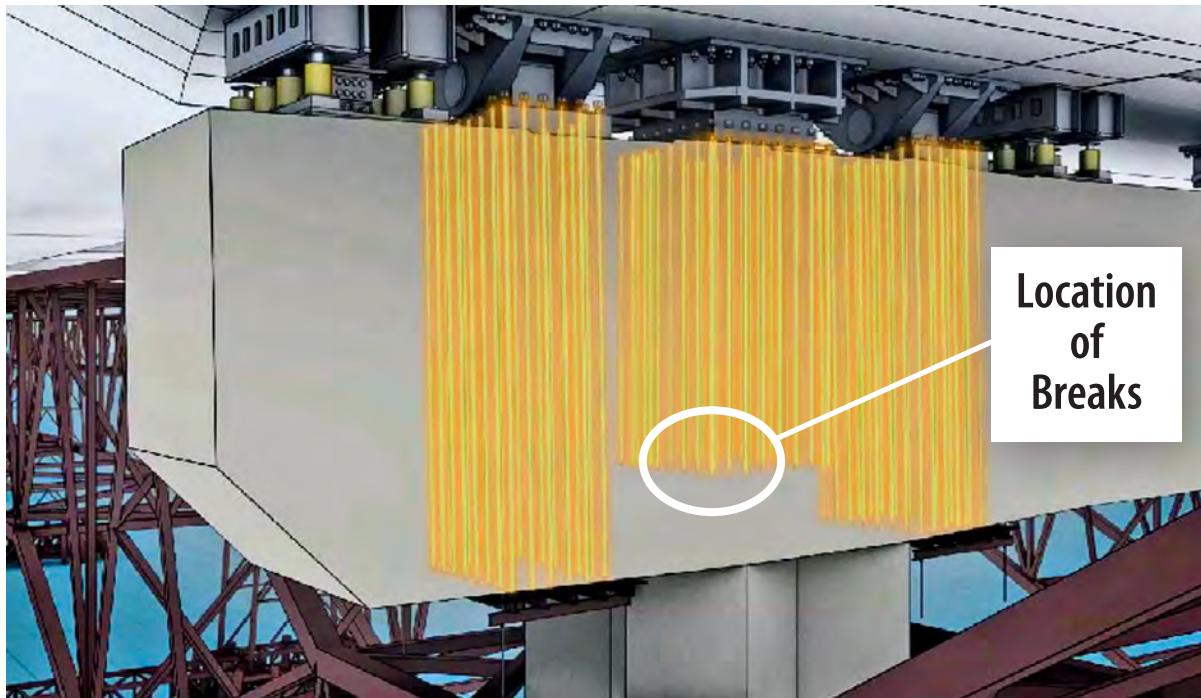
Figure ES-3: Location of Failed A354 Grade BD Anchor Rods

Between March 8, 2013 and March 14, 2013, 32 out of the 96 rods were discovered to have fractured. By March 14, 2013, Caltrans decided to lower the tension of the remaining unbroken rods from the 0.68 Fu to 0.45 Fu to avoid further fractures and to allow for investigation of the cause of the failures. The tension level was reduced on all unbroken rods. If the tension had not been reduced, it is possible that more of these 2008 high-strength steel rods at shear keys S1 and S2 would have fractured.

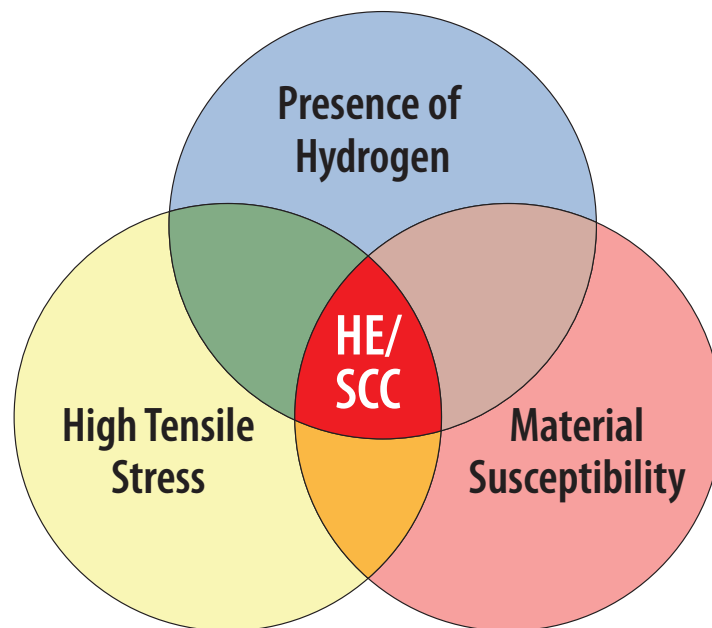
Figure ES-4 Causes of Hydrogen Embrittlement (HE) or Stress Corrosion Cracking (SCC)

Hydrogen embrittlement is the root cause for the failure of the A354 grade BD high-strength steel anchor rods at shear keys S1 and S2 (Item #1 in Table ES-1). As used in this report, hydrogen embrittlement is considered a short-term phenomenon that occurs in metals, including high-strength steel, when three conditions apply: a susceptible material, presence of hydrogen and high tensile stress (as shown in Figure ES-4). To trace what led to the rod failures, this summary calls out each of the three hydrogen embrittlement conditions, and then tracks the events and decisions that either caused or contributed to that condition. In their totality, these events and decisions led to the failure of the 2008 A354 grade BD rods in March 2013.

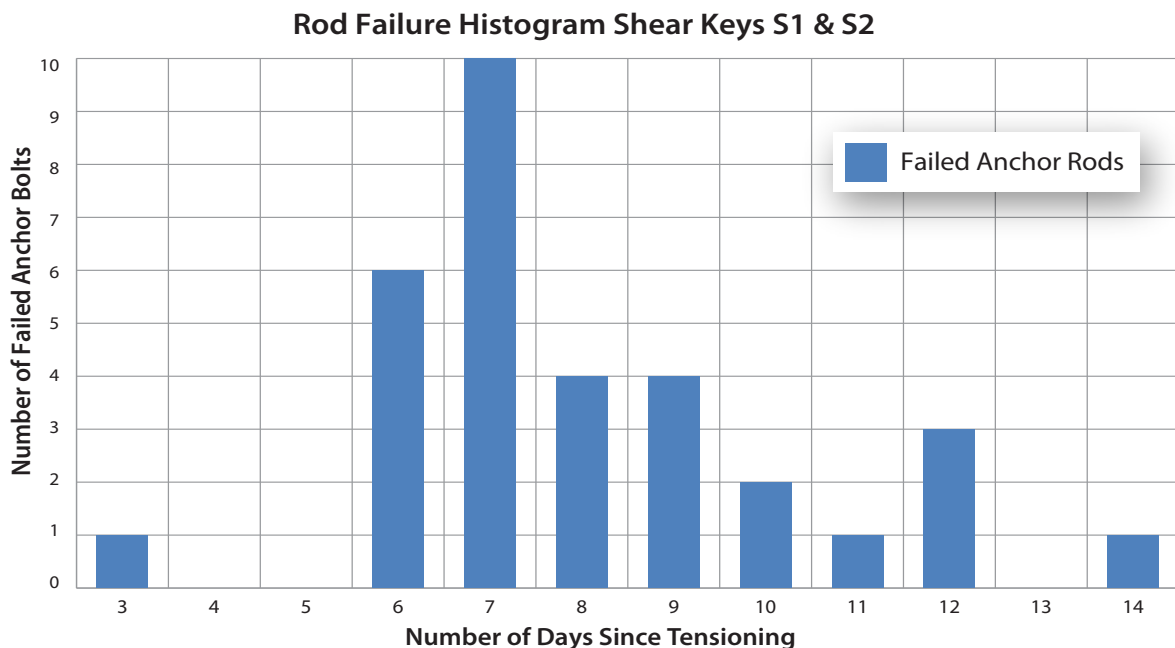
Figure 6 Timeline of 2008 Anchor Rod Fractures After Stressing*

* The time axis shows the number of days after tensioning each individual rod was discovered fractured. Note that the tension in all non-fractured rods was reduced to 0.45 Fu after 14 days.

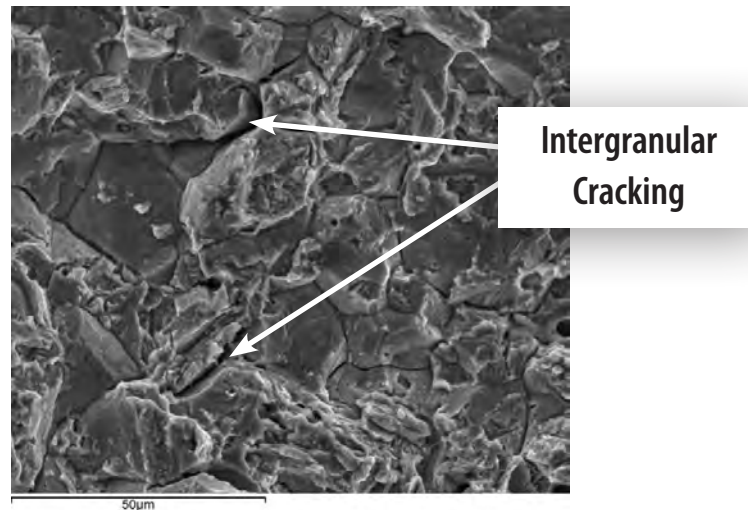
2 Scanning Electron Microscopy (SEM): Following visual observations, the fracture surfaces were examined at high magnification with a scanning electron microscope (SEM). Figure 9 is an SEM image of Rod S1-G1 at high magnification, which shows intergranular cracking at, and near, the crack origin. Intergranular cracking is a characteristic feature indicative of a number of brittle fracture mechanisms, including hydrogen-assisted cracking.

Figure 9 SEM Image of Rod S1-G1 Showing Intergranular Fracture Features

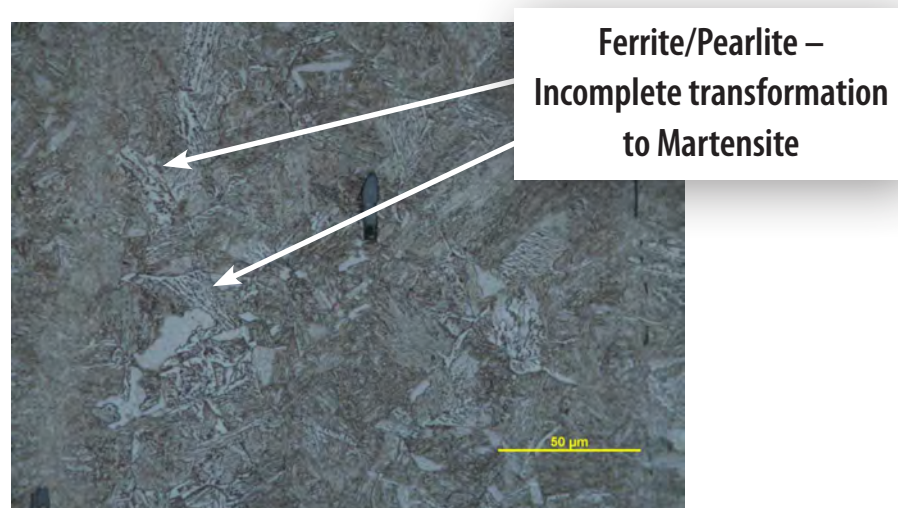
3 Microstructural examination: Following the SEM examination, cross-sections were cut from both rods and metallurgically prepared to examine the structure of the steel on a microscopic scale. The results of this examination (Figure 10) indicate the material is not homogeneous (i.e., not uniform in metallurgical structure across the examined sample of rod), as evidenced by the presence of ferrite and pearlite in between layers of martensite.

Figure 10 Microstructural Examination Indicating Non-Homogeneous Material

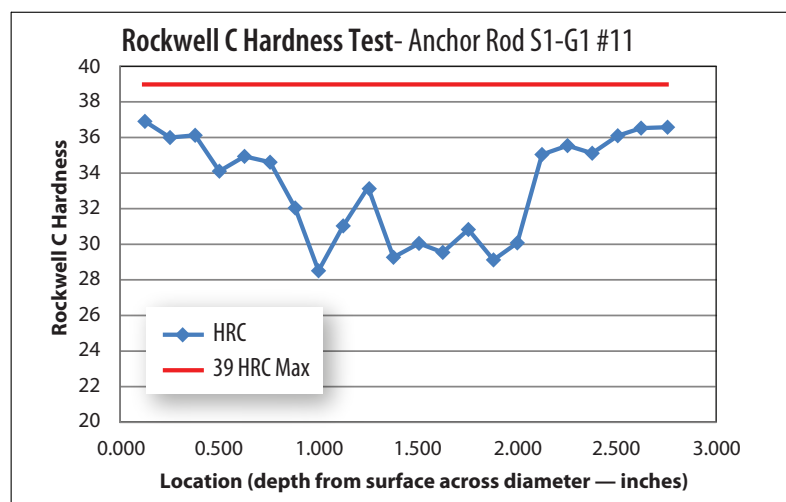
Figure 11 Rockwell Hardness Test Results — Rod S1-G1

4 Hardness testing: The Rockwell C hardness test is a technique that assesses a material's tensile strength, wear resistance and ductility. Samples were machined at Christensen Materials Labs and tests were performed in Hayward, California by Anamet Inc., where Rockwell C hardness measurements were made across the diameter and at mid-radius locations of both rods. Figures 11 and 12 illustrate the results of the Rockwell hardness tests conducted on Rod S1-G1 and Rod S2-A6, respectively. The results of the Rockwell hardness test show variation in hardness, with the outer diameter approaching 39 HRC (high hardness is generally considered greater than 35 HRC). The center hardness drops to as low as 25 HRC, indicating the material was not uniformly through-hardened. The metallurgical report states that completely uniform through-hardening is difficult to achieve in large diameter rods such as these; however, the large disparity in hardness from center to edge indicates that the steel may not have had optimal through-thickness hardenability or was improperly heat-treated. ASTM A354 for grade BD specifies a maximum rod hardness of 39 HRC, as shown by the solid red line in Figures 11 (Rod S1-G1) and 12 (Rod S2-A6).

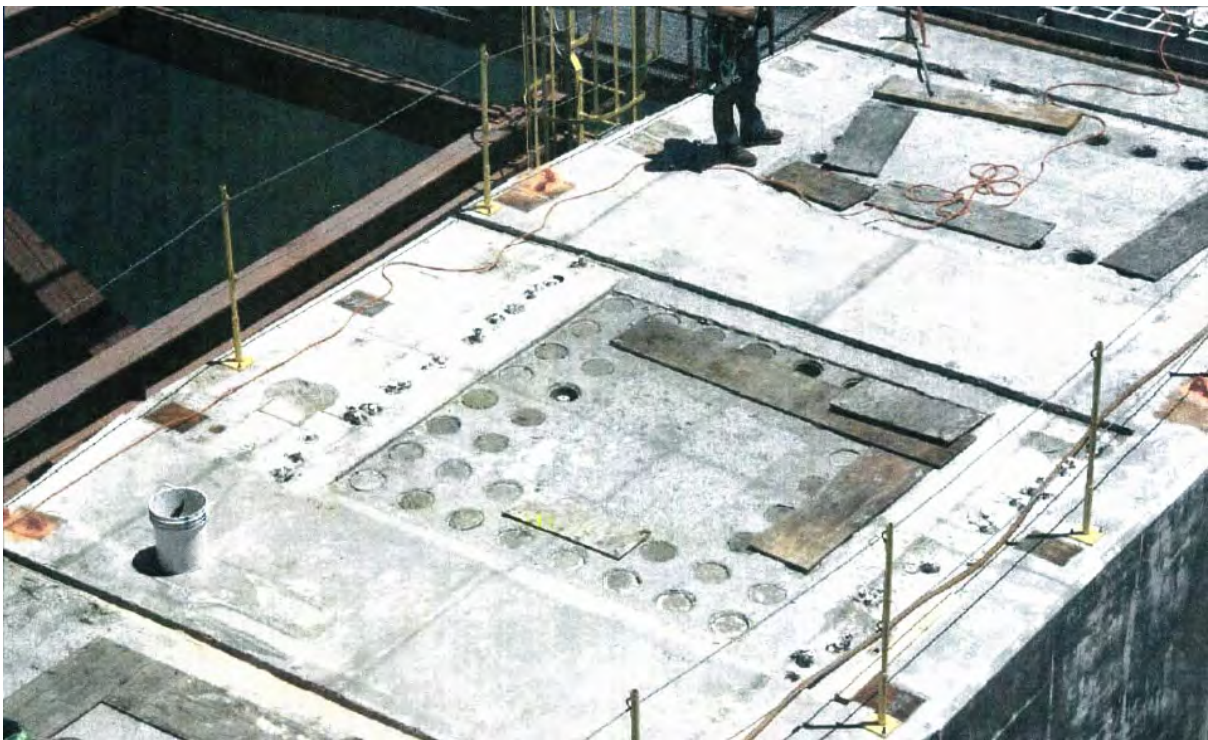
Figure 18 Pier E2 Cap Construction Photograph — Embedded rods are in holes
