HIGH STRENGTH STEEL ANCHOR ROD PROBLEMS ON THE NEW BAY BRIDGE

Revision 1

November 12, 2013

Senator Mark DeSaulnier

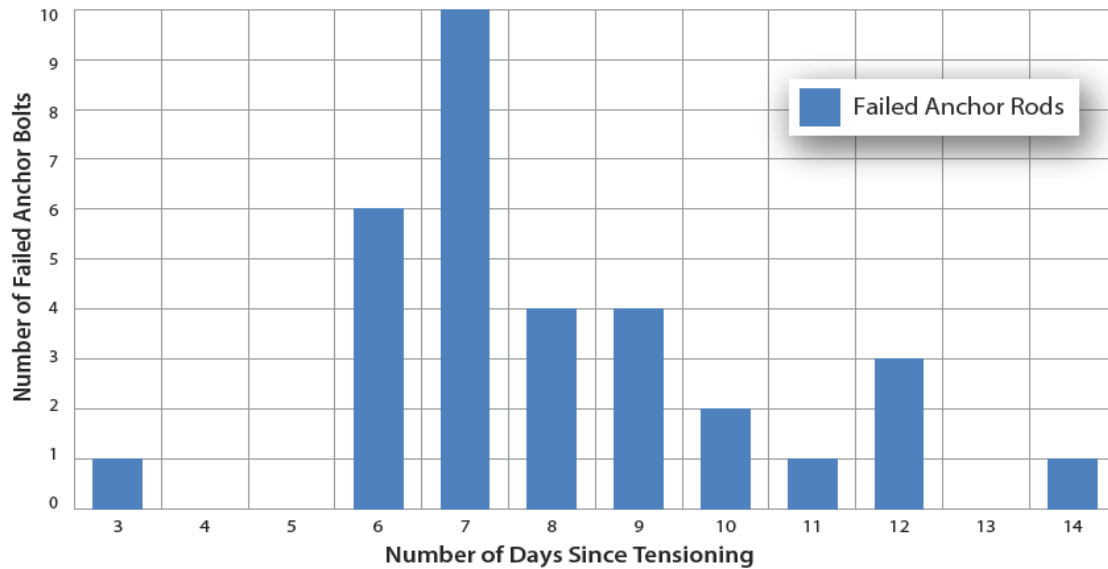
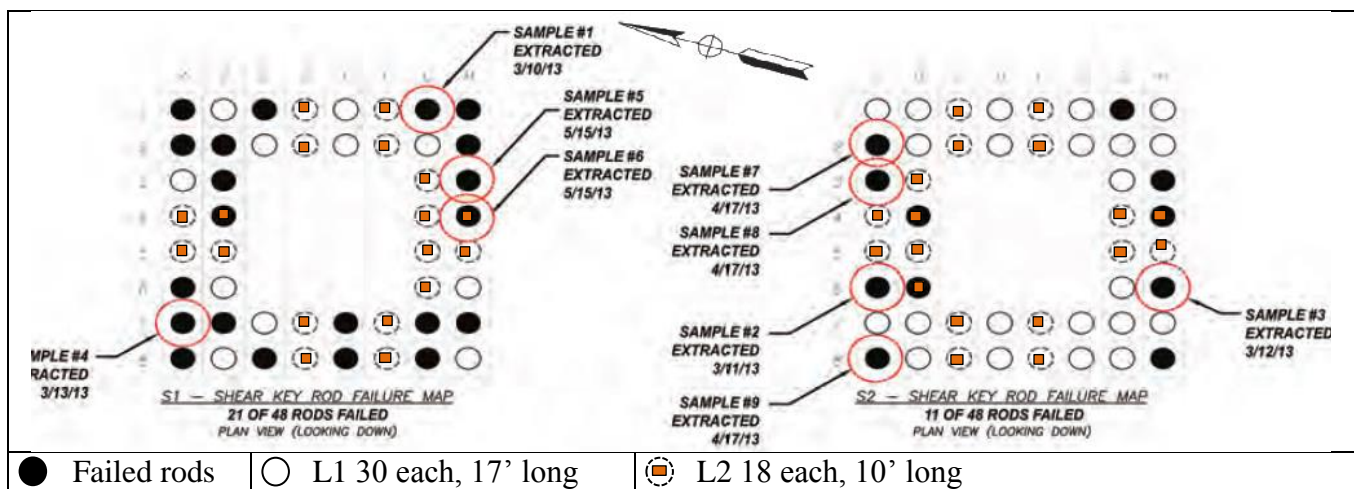
Figure 1 (a) A bar chart showing the number of S1 and S2 Shear Key anchor rod failures vs days after pretensioning. The total number of anchor rods failed in 14 days was 32. (b) Anchor rod location maps for Shear Keys S1 and S2.

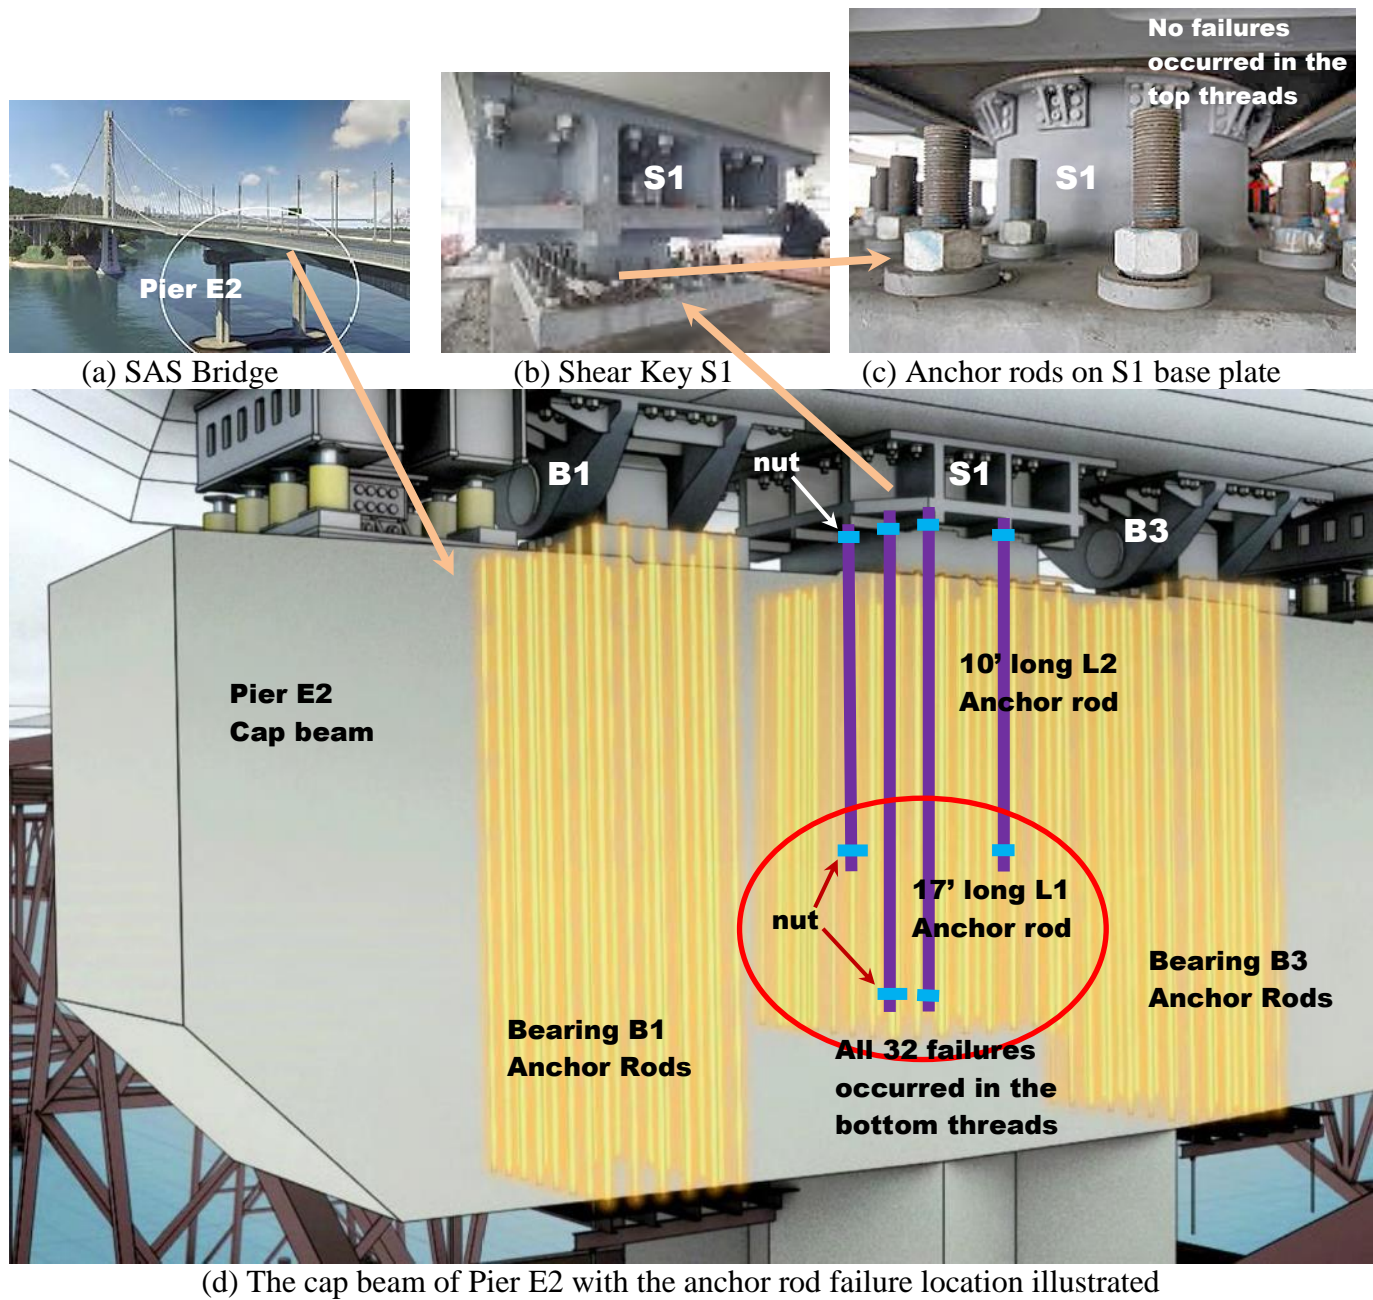
Shear Keys S1 and S2 are located directly above the two piers that support the cap beam. Since the bottom ends of their anchor rods, each 10 to 17 long, would have to be inside the cap beam of Pier E2, they were placed inside grout pipes when the reinforced steel concrete cap beam was produced (Figures 3b and 3c). Because of construction delays, the 96 anchor rods for Shear Keys S1 and S2 remained inside the grout pipes of the cap beam for some five years. When they were pretensioned in early March 2013, 32 of the 96 anchor rods failed as mentioned earlier. As indicated in Figures 3b and 4, all 32 failures occurred in the bottom threads.

Figure 4 Illustration of the bottom threads of the L1 and L2 anchor rods as the failure location for Shear Keys S1 and S2 in March 2013. The 32 anchor rod failures consist of 21 failures in S1 and 11 failures in S2.

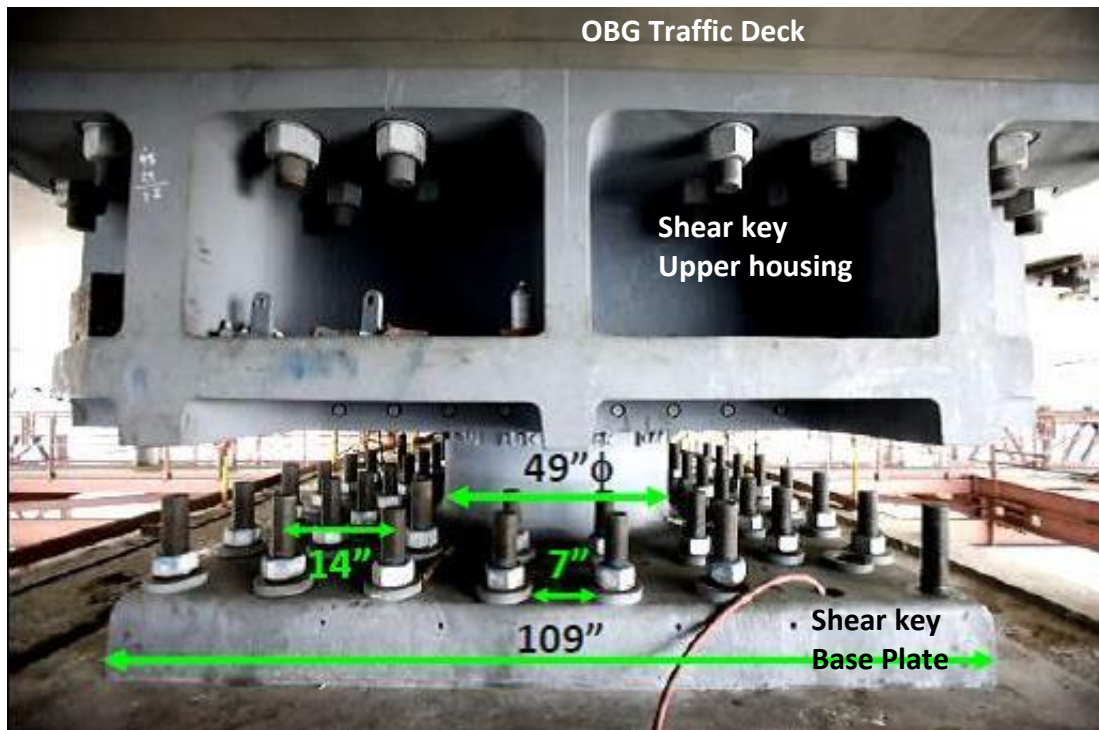
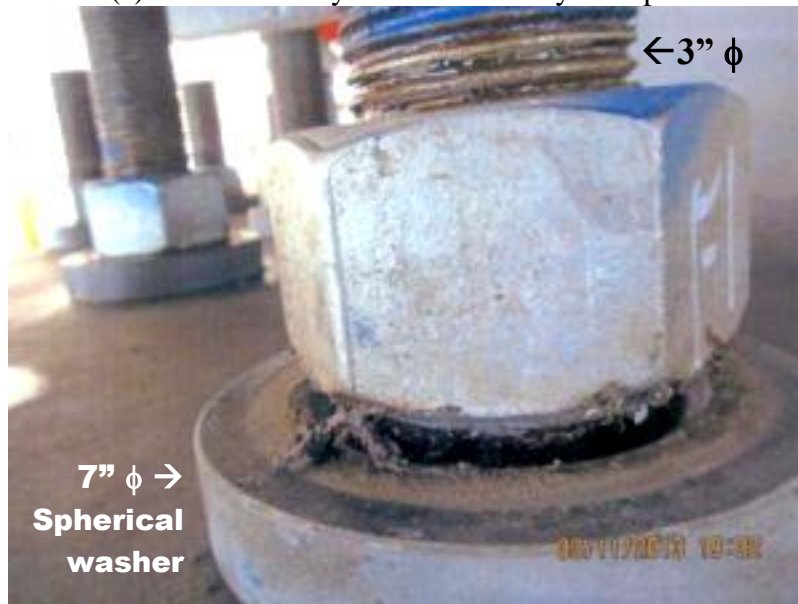
Figure 5a shows the anchor rod lay out in the base plate of Shear Key S1. When an anchor rod fails under pretension or under static load, its top end would pop out as shown in Figure 5b.

Figure 5 (a) Anchor rod lay out for the shear key base plate. The 3-inch anchor rods are 10 to 14 inches apart. The spherical washers are 7 inches in diameter. The shear key base plate, 109 x 109 x 10.8", can accommodate 3¼ inch Grade BC rods in lieu of 3 inch Grade BD rods for Shear Keys S1 and S2. The minimum tensile strength required is 816.5 kips for 3¼ - 4UNC Grade BC rods and 835 kips for 3 - 4UNC Grade BD rods. The former is 98% of the latter.

(b) One of shear key anchor rods that failed.

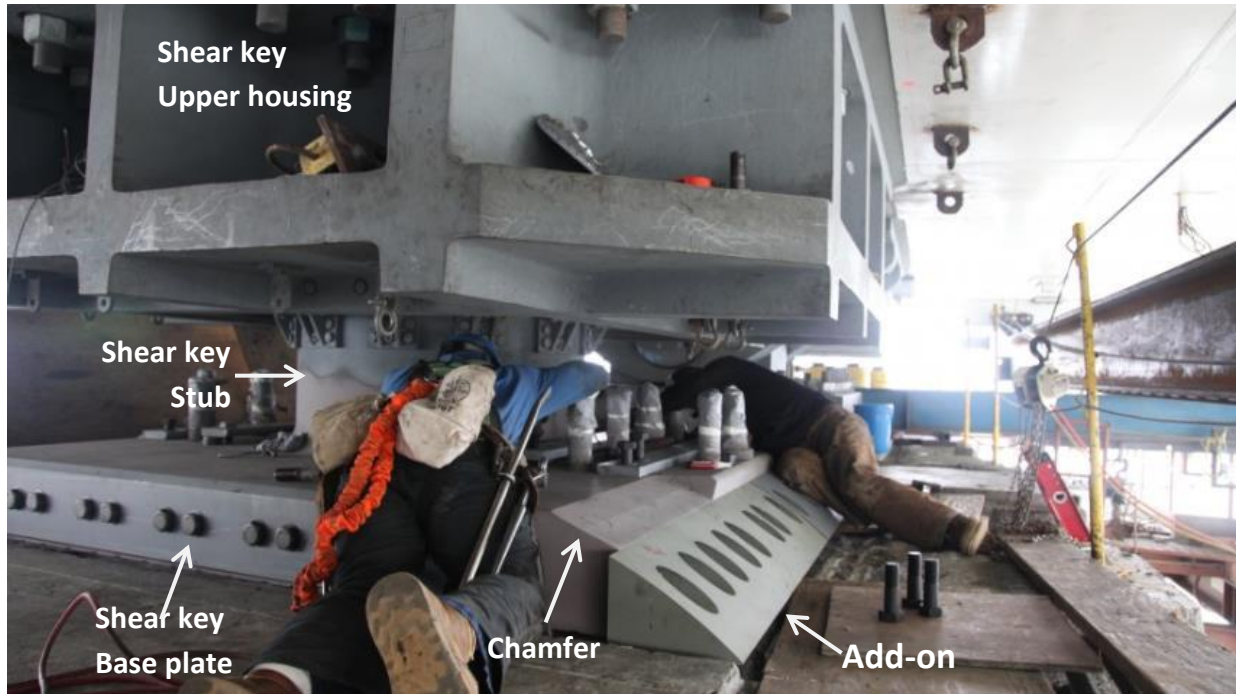
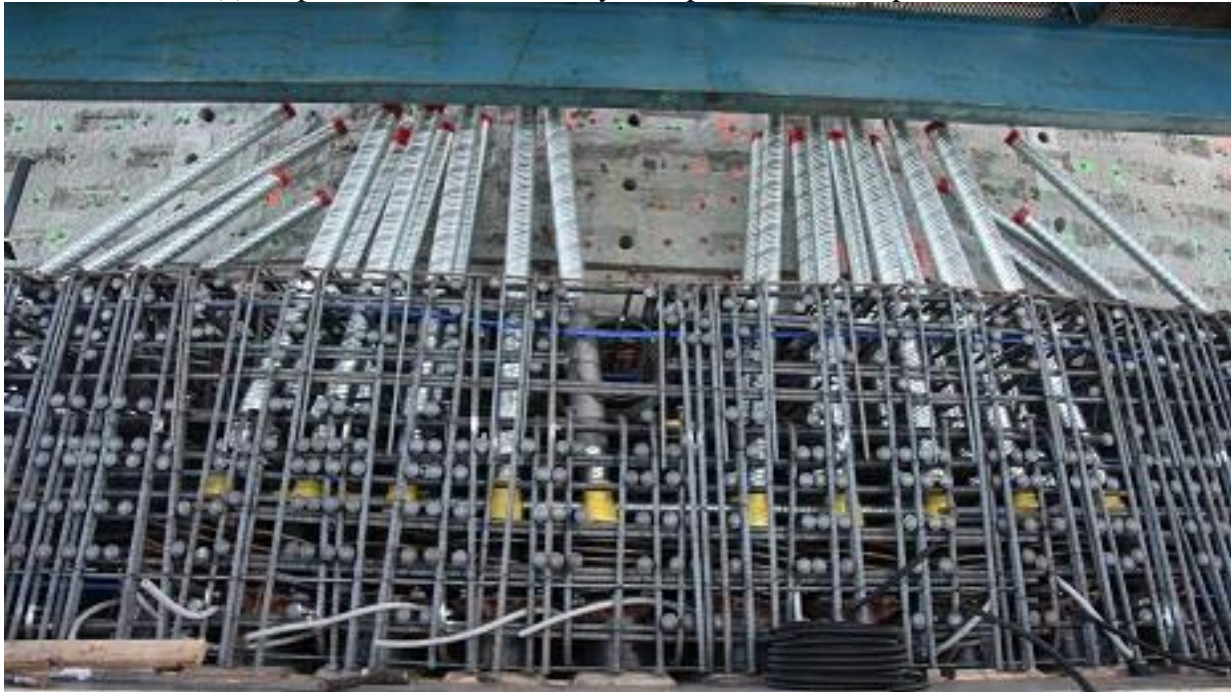
Figure 8 (a) A shear key base plate being prepared to receive saddles by machining corners and attaching a triangular add-on. (b) Placement of rebars and PT tendon grout cans for holding down the saddles over the shear key base plate.

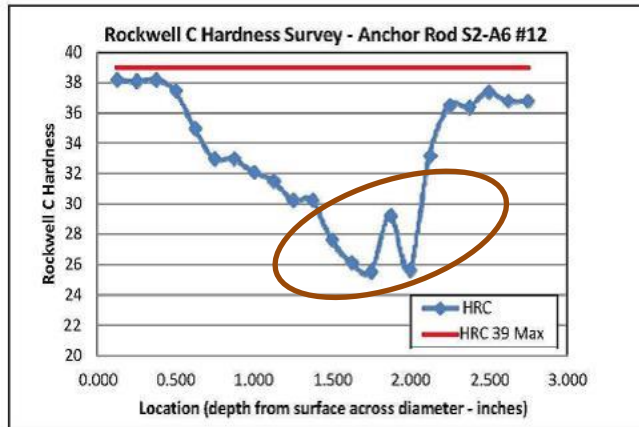
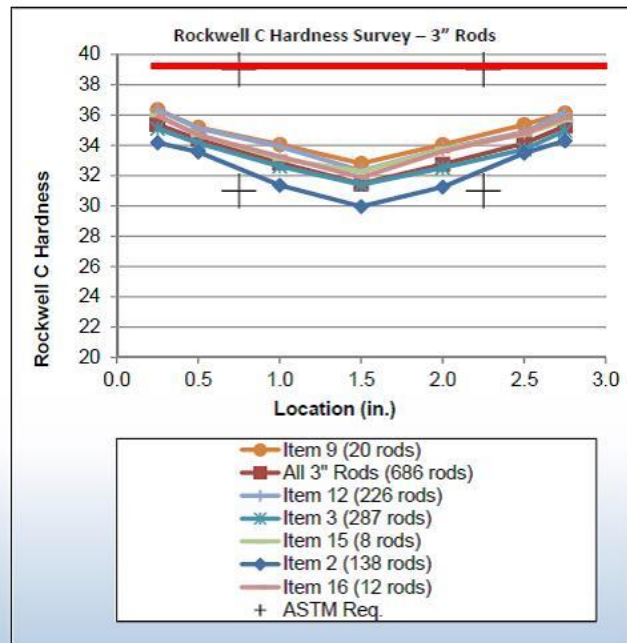
(1) The one on the left in Figure 9 is from a single rod that failed. It is not representative of "the 2008 bolts," but may represent one of the worst ones of the 32 rods that failed. It does not represent the

(2) The one on the right in Figure 9 represents average data of several lots of the "Other 3" Rods" that had highs and lows for individual rods. It is improper to compare the hardness traverse data of a single rod that failed against average hardness traverse data of a lot of many rods that did not fail. Therefore, Slide 23 may not be used as a support for "Improved Hardness" for the "Other 3" Rods."

Figure 9 A comparison between (left) a hardness traverse data from a single anchor rod that failed due to HE and (right) average hardness traverse data of many rods. This is not a proper comparison to support “improved hardness” for the “other 3” rods.” Individual rods among the latter had surface hardness higher than the average data shown by the graph for the “other 3” rods.”

Furthermore, the hardness traverse at left may have been obtained from a specimen that was improperly prepared. That is, “hard surface grinding” of the specimen surface may have tempered the local area, lowering the hardness to around 25.5 HRC from 30 HRC. Thus, the hardness data encircled may be erroneous.

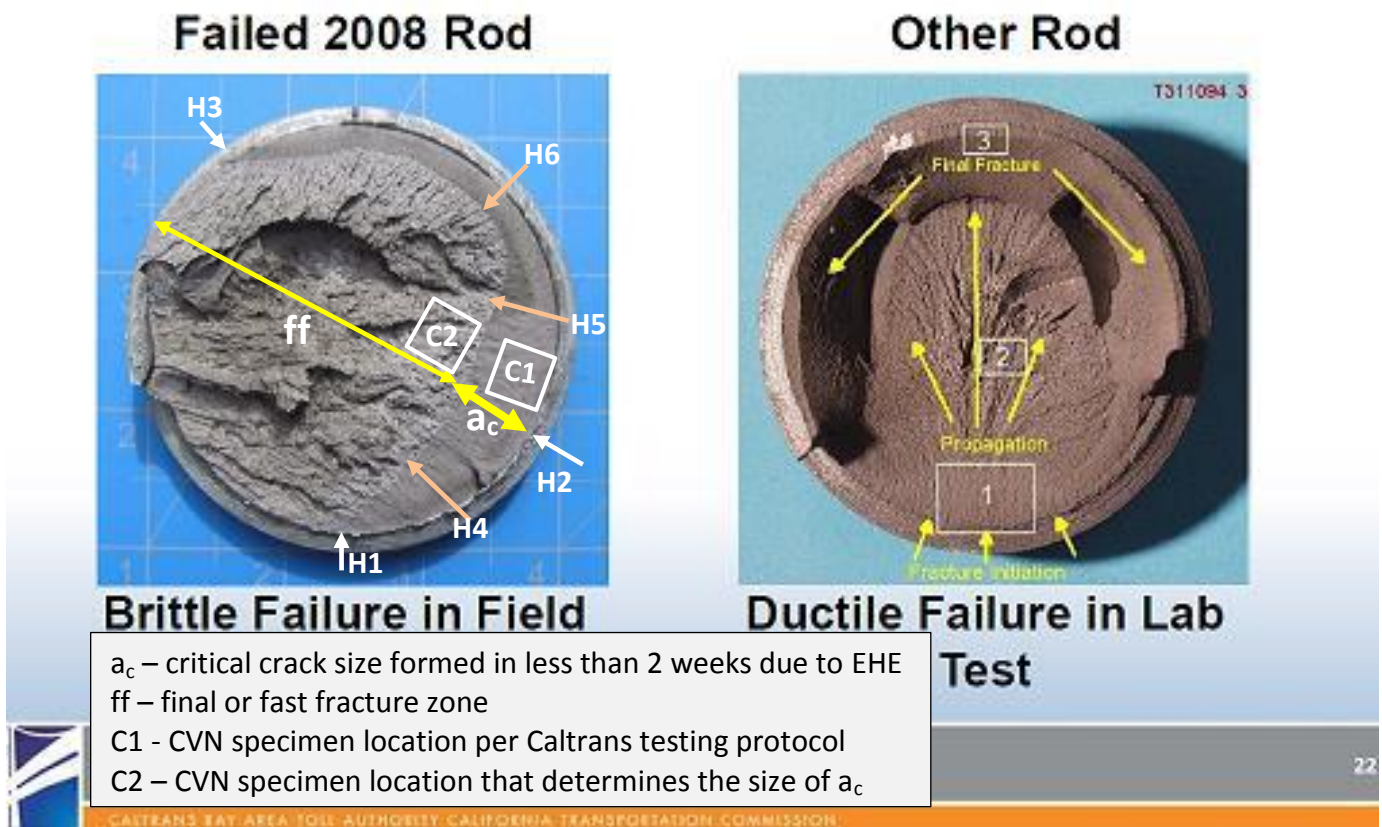
Figure 12 An example of blooper slides presented by the Caltrans Director during the July 10, 2013 BATA Briefing. The two fractures were produced under different load conditions and may not be used as evidence for “Improved Microstructure” of the “Other Rod.” The top two yellow arrows in the “Ductile Failure in Lab Test” are wrong if they were drawn there to indicate the direction of crack propagation.¹⁰³

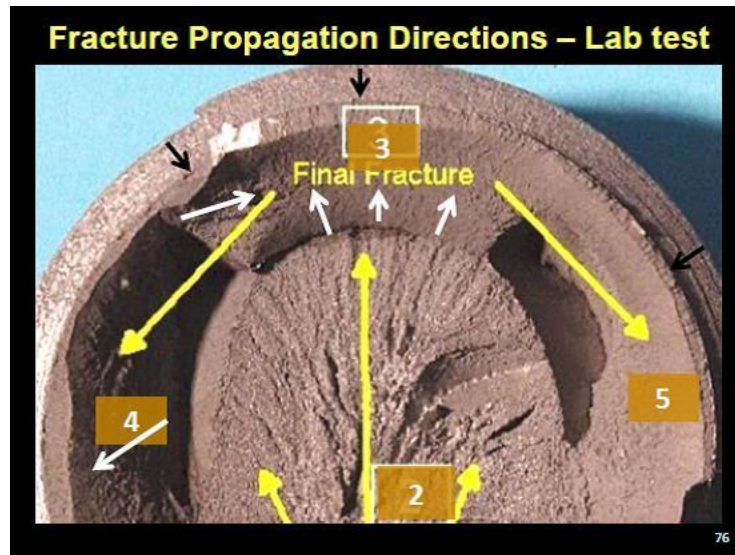
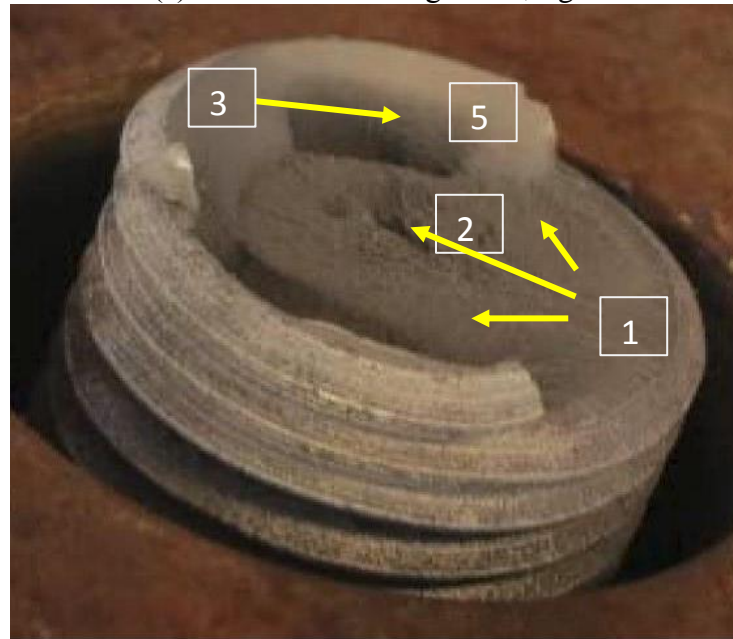
Figure 13 (a) An enlarged view of the fracture face of the “Ductile Failure in Lab Test” in Figure 12, right. A continuous fracture face as implied by the yellow arrows from “3” will not form the sharp “cliffs,” which are a visual proof that the two yellow arrows are wrong as crack propagation direction indicators.

(b) The fracture face of the same specimen as in (a) from File E17,¹⁰⁴ showing that the fracture propagation from 3 to 5 cannot occur as indicated by the top yellow arrow.

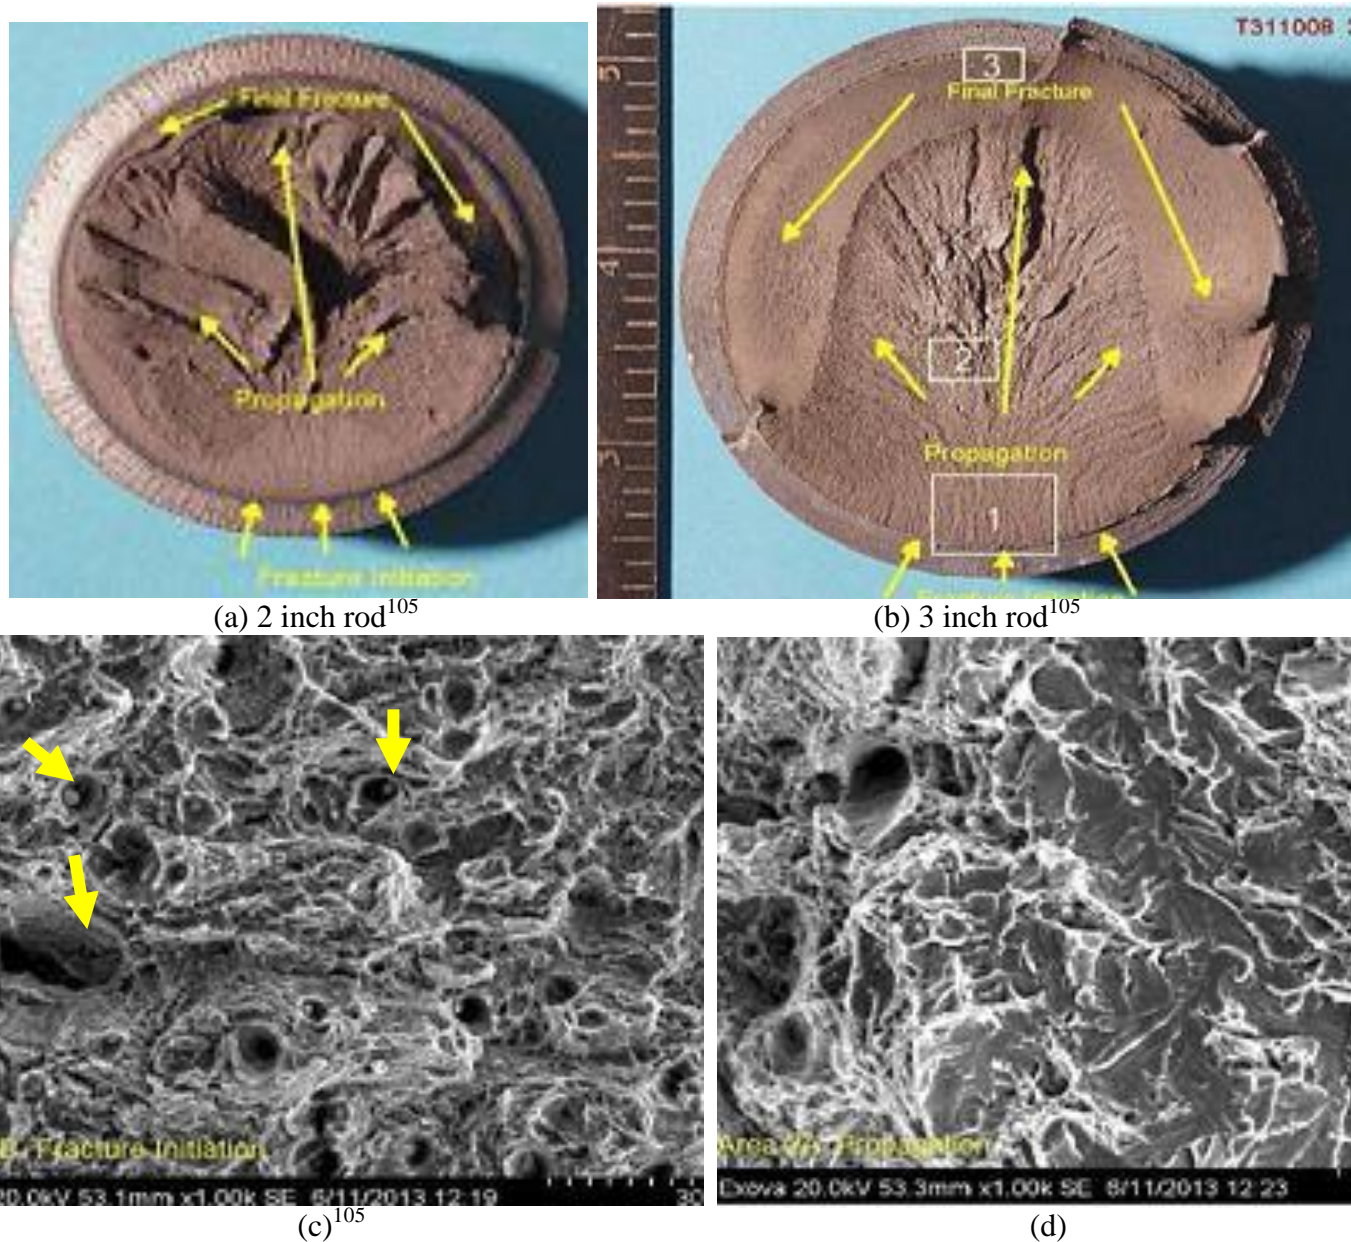
Figure 14 (a) & (b) More examples of 2 inch and 3 inch anchor rod full size tensile test fracture fracture faces. The top two yellow arrows are wrong. (c) & (d) Scanning electron fractographs of areas 1 and 2, respectively, in (b). (c) consists entirely of dimpled fractures. Large holes usually form around inclusions. (d) consists of 50:50 dimples and cleavages. Dimples are associated with ductile fractures in steel; cleavages with brittle fractures. The fractograph of (d) is a good example of what looks like a brittle fracture macroscopically is not all brittle microscopically.

“Dimples” are not known as or described as “cup and cone features.” The former is a fracture mode description in a microscopic scale and the latter in a macroscopic scale.

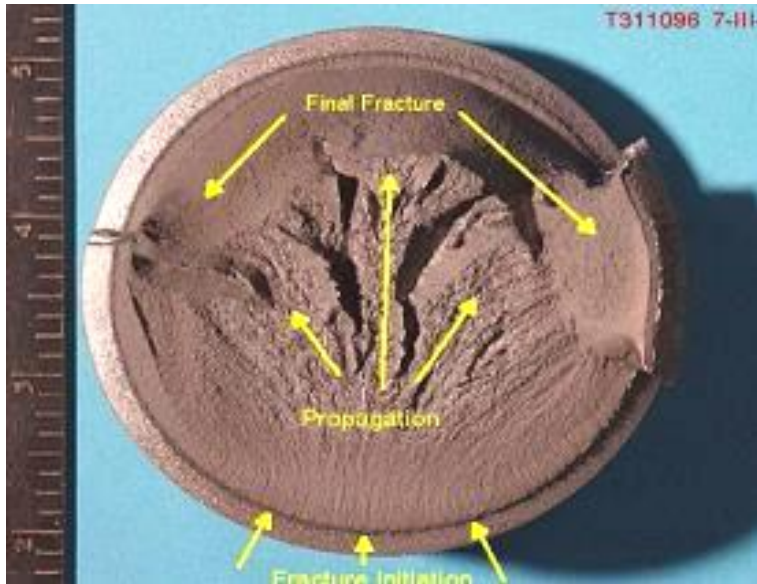
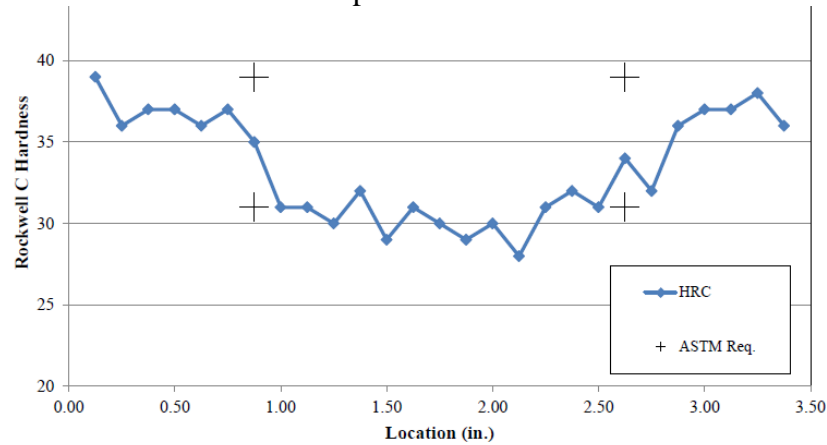
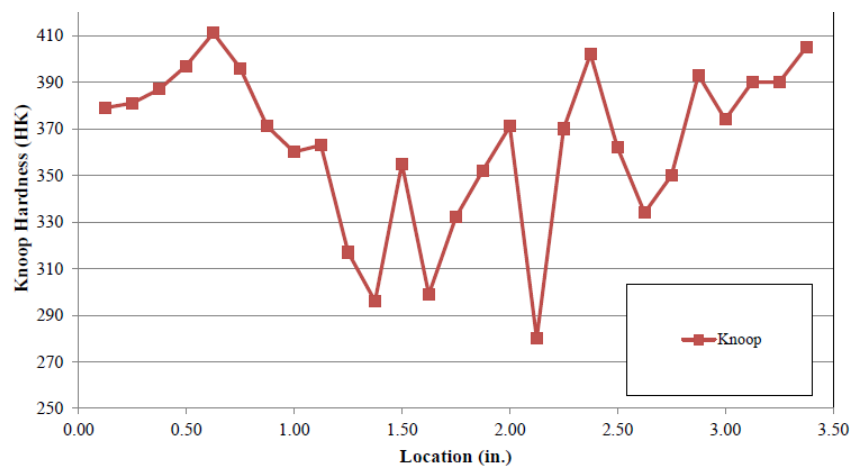
Figure 15

(a) The fracture face of a full size PWS (Parallel Wire Strands - main cable) anchor rod tensile test specimen. The top two yellow arrows are wrong.

The fracture appearance as well as the HK data in (c) indicate this was not one the 219 PWS anchor rods with rolled threads.

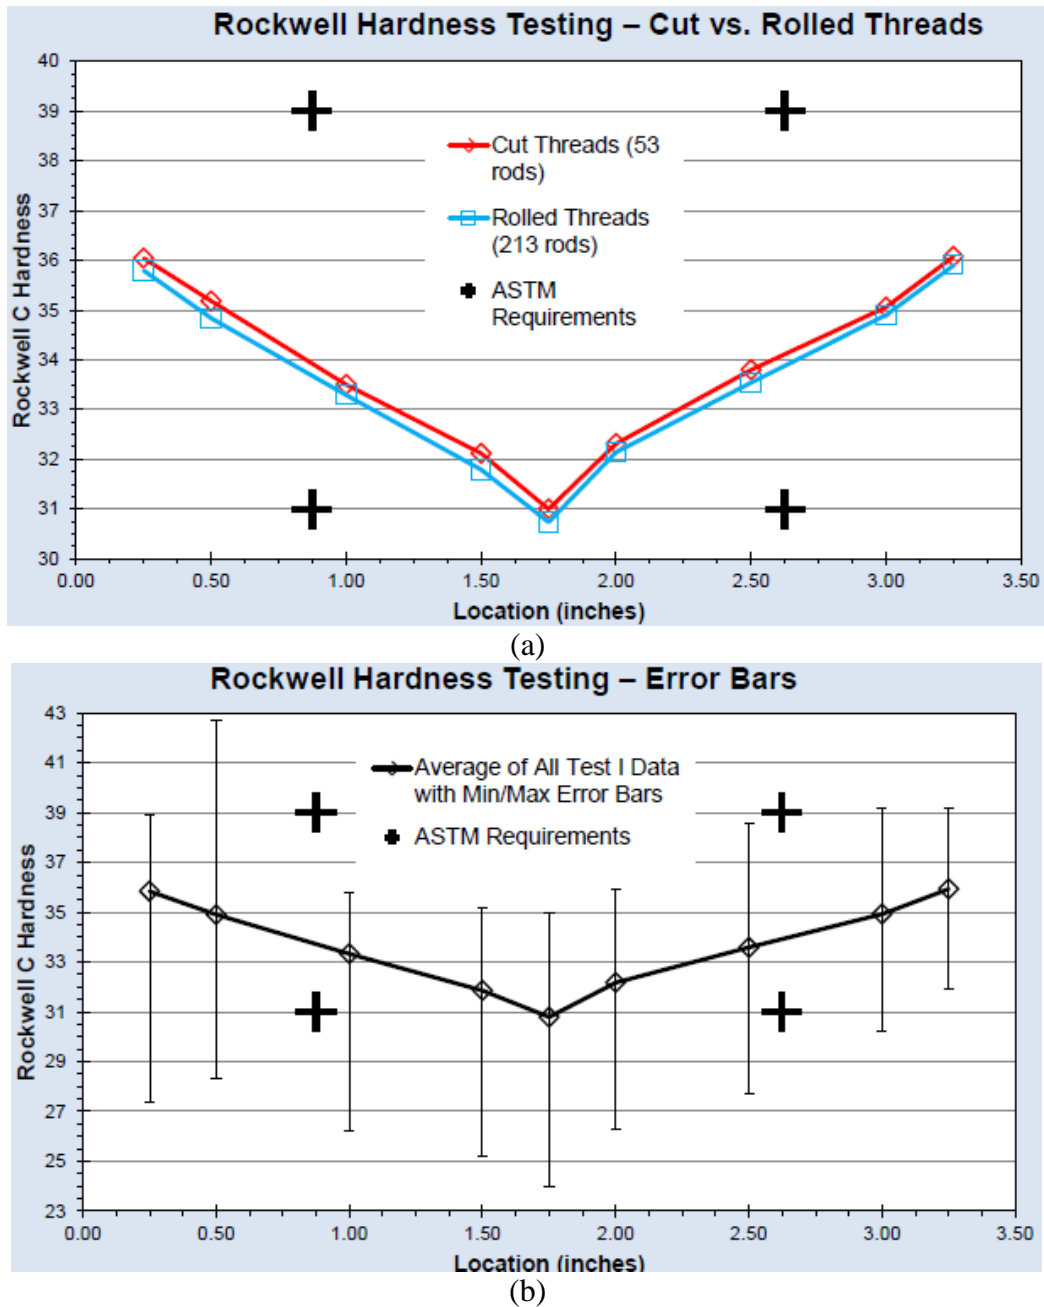
Figure 23 Hardness traverse data for Item #7, 3½ inch PWS anchor rods, from File E17.

The title of (b), “Error Bars,” is mislabeled for “Range Bars.” The spread in the hardness data should not be labeled as a testing error.

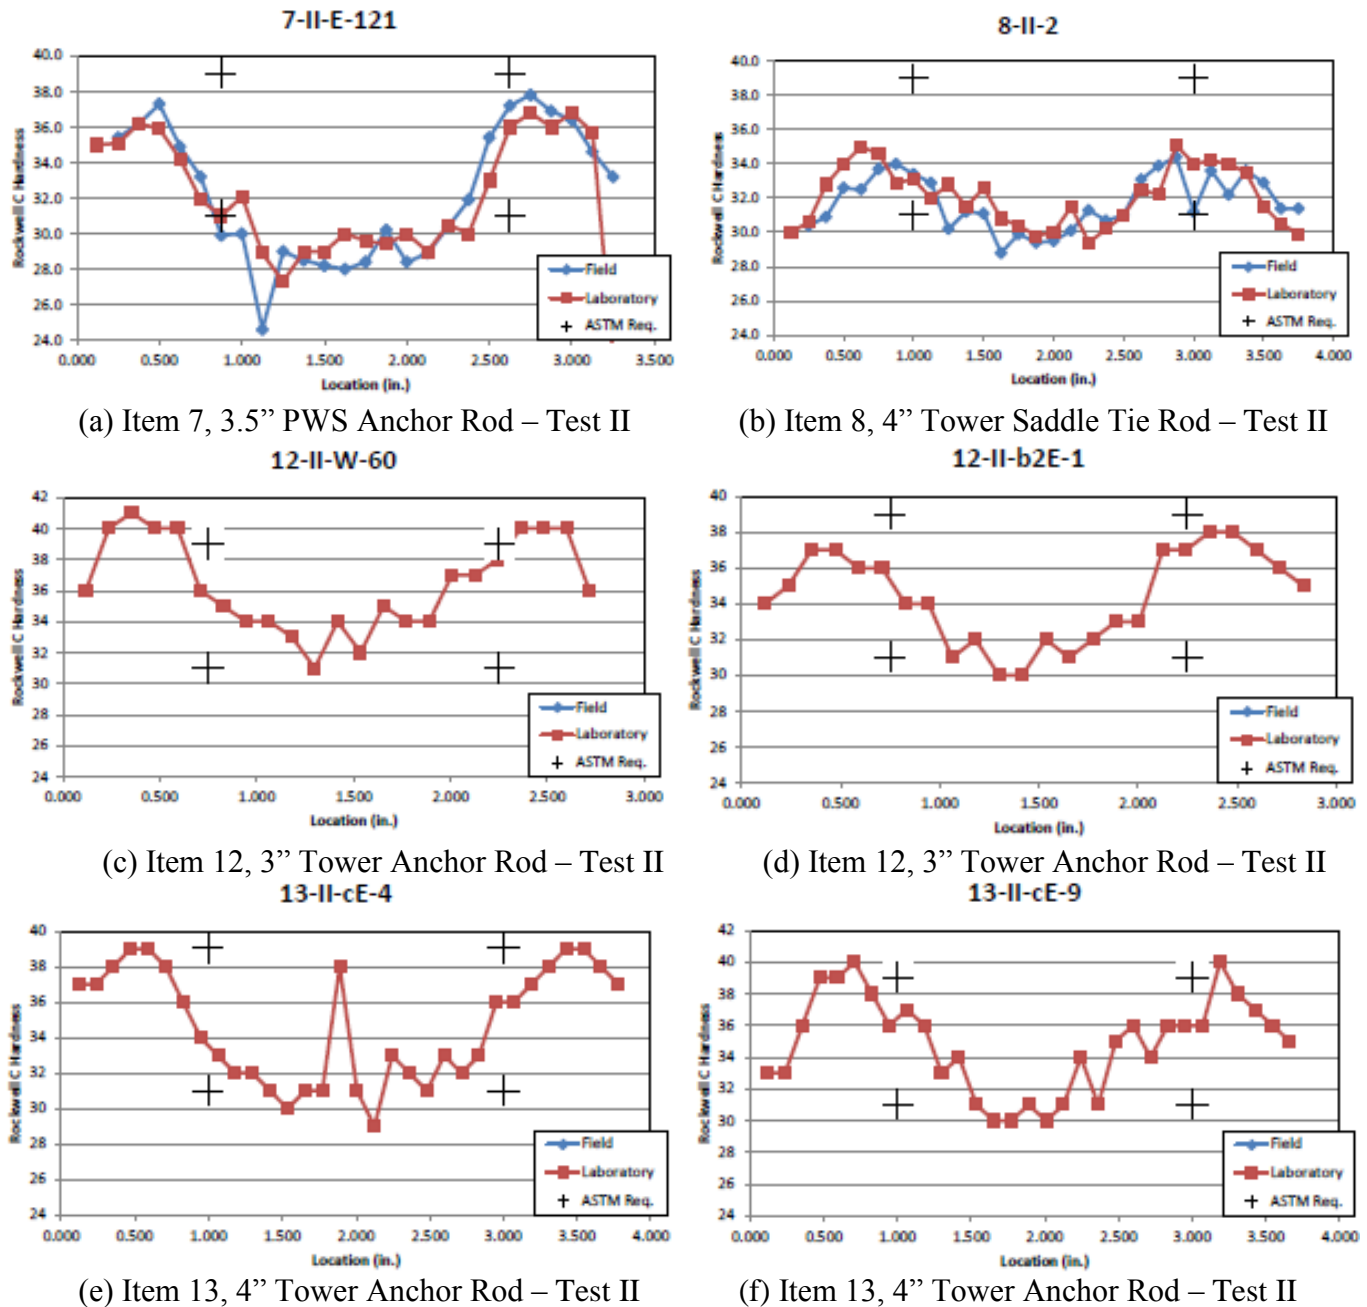
Figure 26 Examples of hardness traverse curves that are M shaped. The hardness for surface layer is lower than that at 1/2 inch from the surface. This is an anomaly for 4140 steel rounds that were quenched and tempered properly.

Caltrans needs to conduct a metallurgical evaluation to determine the reasons why the hardness traverse are M-shaped, rather than bowl shaped, and the effects of M-shaped hardness distribution on environmental hydrogen embrittlement (EHE) or long term stress corrosion cracking as defined by the TBPOC.
