*Appendix E –
Hood Canal Floating Bridge Report
(3/20/2014 Revision)*

HOOD CANAL FLOATING BRIDGE

High Strength Anchor Bolts
Example of Application of Greased and
Sheathed Double Corrosion Protection Systems

March 20, 2014

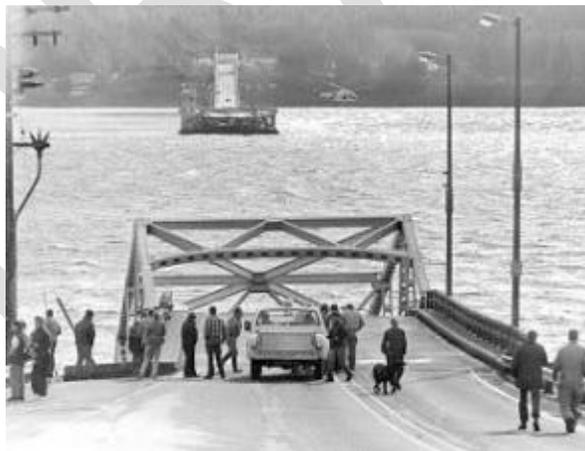
Hood Canal Bridge – West Half Under Water, February 13, 1979

Contributing factors to the sinking of the West Half included severely corroded post tensioning wires, many of which had fractured previous to the storm and some that may have been compromised enough to have fractured during the storm, corrosion of the steel hatches at the top of every pontoon compartment that led to them being left open at the time of the storm,

and missing bulk head seals at all of the bulkheads where the post tensioning cables passed between compartments - which negated the purpose of the bulkheaded compartments and allowed water that entered through the hatches to migrate the length of the bridge.

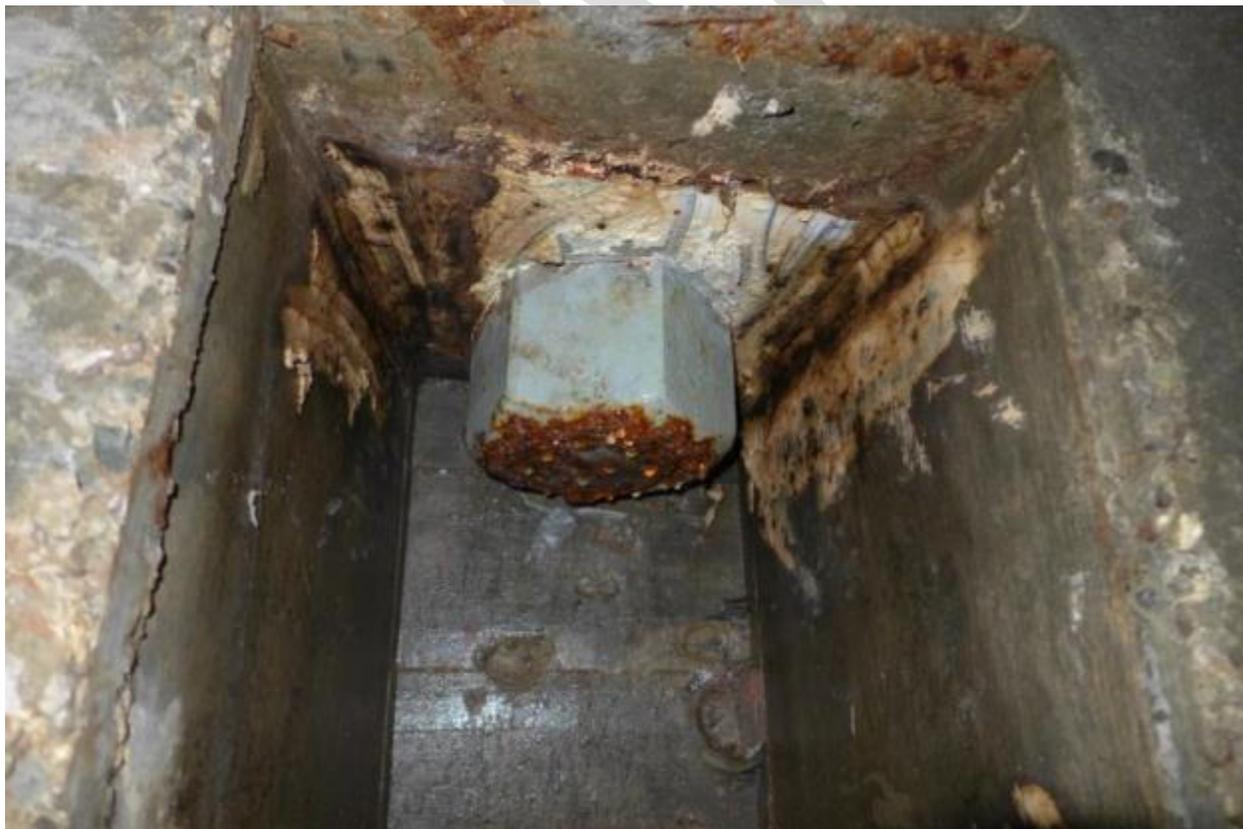
Bottom End of 4 inch Ungalvanized A354 BD Bolt

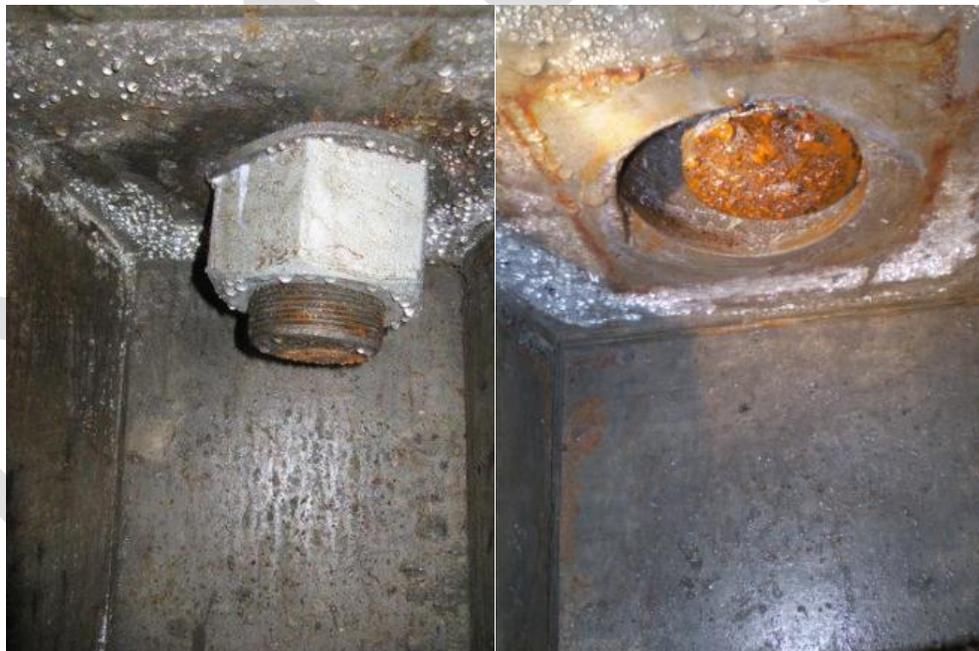
Bolt 8E/7EN Prior to and after Failure

not all of these washers bent and/or sheared under the pretension force applied to the bolt. In all cases in which the bolts completely fractured, the bolt was not perpendicular and the washers were noticeably bent and/or sheared.

Pictures above show Bolt 8E intact but with a deformed washer and then after its subsequent failure later in the same day. Note that the failed bolt is off center in the pipe sleeve. The combination of the bolt being off center in the hole combined with an undersized washer may have led to the failure of the washer and may have contributed to the failure of the bolt.

Note: WSDOT (after the fact) calculations indicated that 2 inch thick washers of a higher tensile strength were necessary and 2" thick square plate washers were supplied for all 12- 3" replacement bolts.

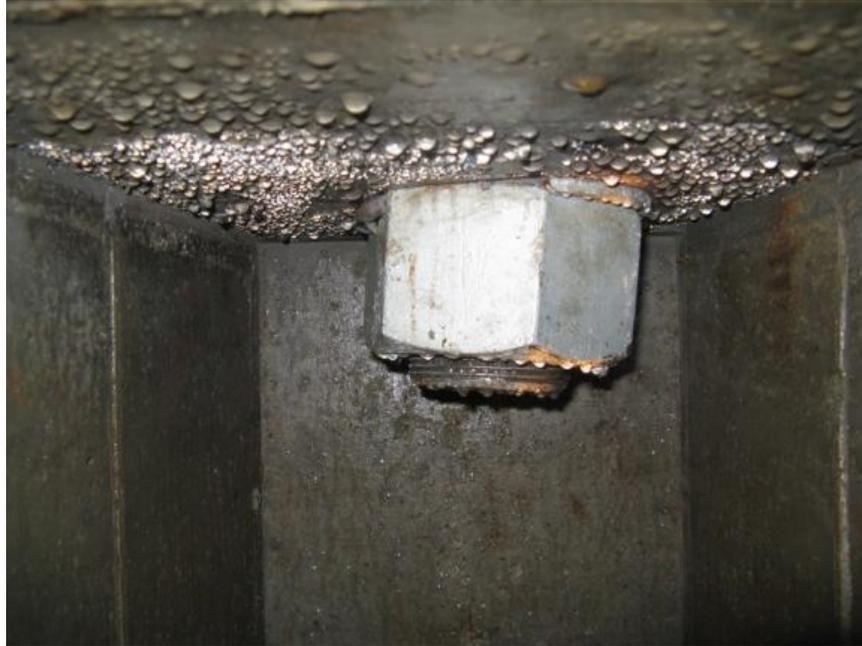
9W/6EN Prior to Failure

The next photo of bolt 9W was taken prior to bolt failure and shows the washer bent/sheared.

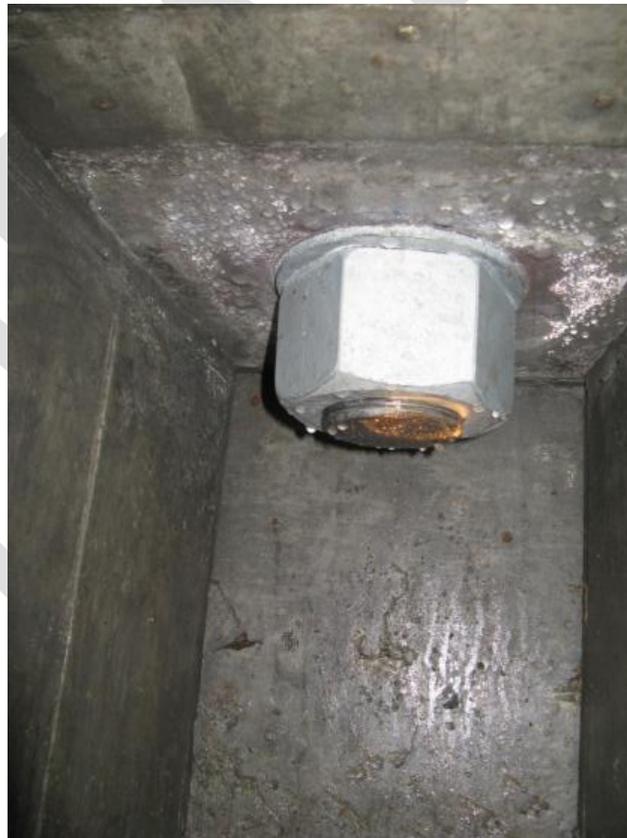
10E/5EN

The last picture shows bolt 10E with a non-deformed washer. Records do not indicate if this bolt failed. However, records indicate that six total bolts completely failed and six did not – this matches with six washers that were severely bent or sheared and six washers that were not noticeably damaged or were slightly deformed.

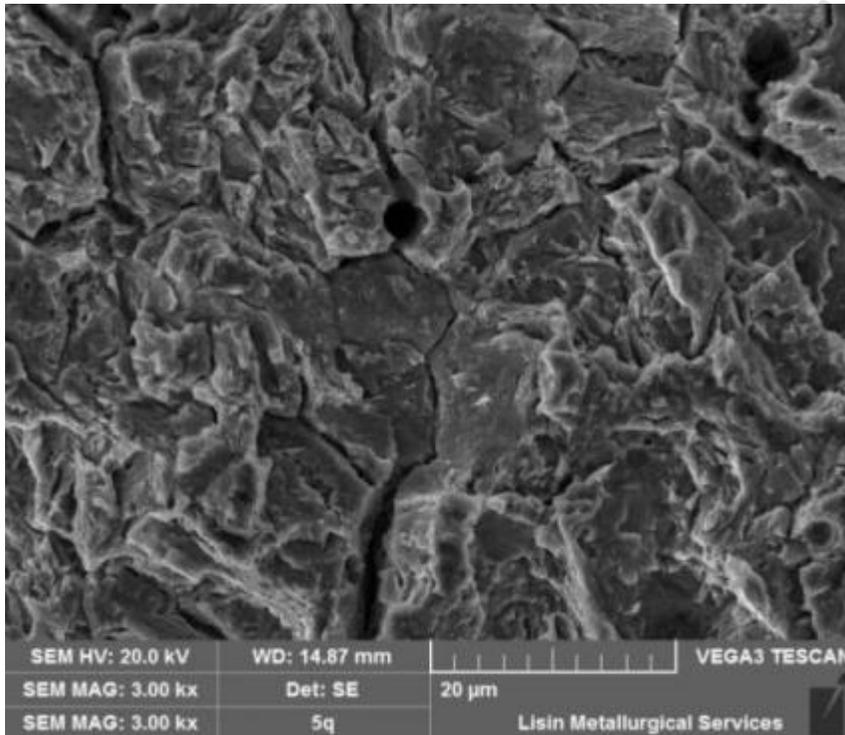
BOLT 5 – Intergranular Fracture Surface

Above is the secondary electron image acquired from the fracture surface of Bolt 5. The location is approximately 1 to 2 mm below the thread root, within the crescent shaped band of smoother fracture near the fracture initiation. The location shown is the most pronounced example of intergranular fracture revealed by an extensive search.

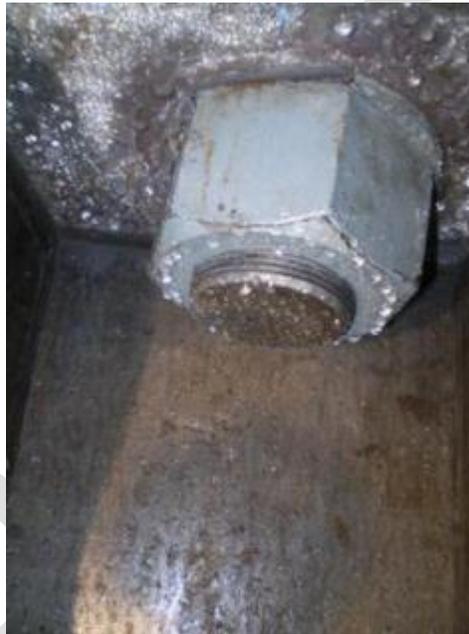
Per the recommendations of Dwight Co., Mayes Testing Engineers were contracted to perform NDE inspection – magnetic particle testing and ultrasonic testing – on the six remaining intact bolts. Mayes Testing Engineers also assisted WSDOT in the visual inspection of the bolts. The full threads and 1 in of the shaft were prepared for inspection with focus on the thread roots. No cracks were found by the NDE inspections but visual inspection confirmed that all six bolts showed indications of inelastic deformation, and all six were found not acceptable for reuse.

Deformed Bolt 9E/6EN

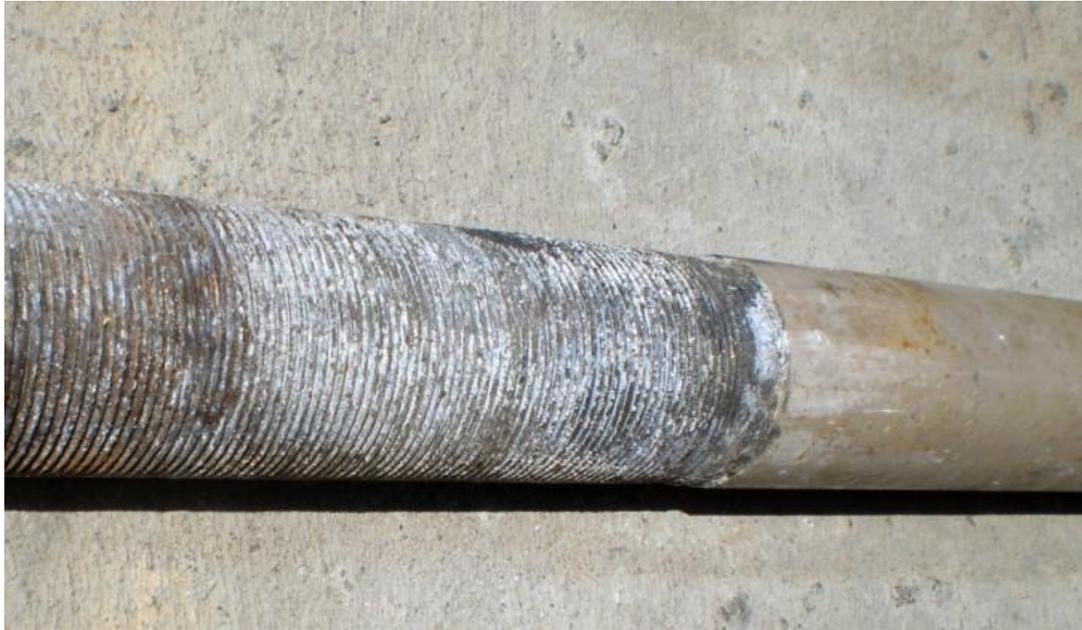
- Shown below is a photo of the bottom threads and shank of a failed rod taken three days after it was found to be fractured. Corrosion can be seen on the threads and the shank of the rod. It is also clear that the rod is unprotected – i.e. there is no indication of paint or grease.

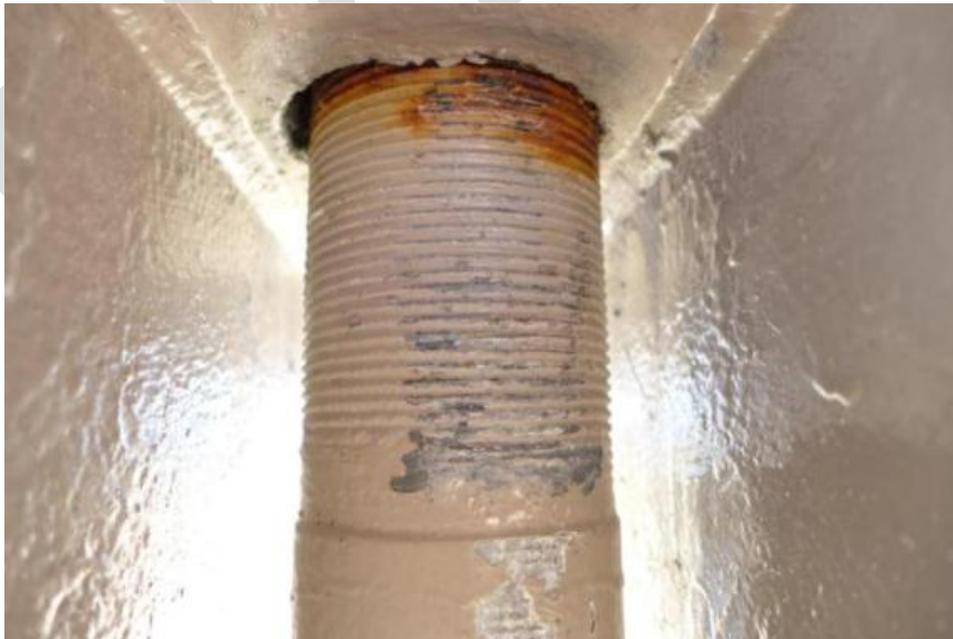
There could be SCC problems for these bolts in the future but at this time the only way to ascertain if there is a long term concern for SCC would be to allow them to further corrode. However, WSDOT Maintenance does intend to clean and paint these bolts, and to bolster their painting program for all bolts going forward.

Corrosion at Galvanized Stressed Top Threads of Bolt 7WS

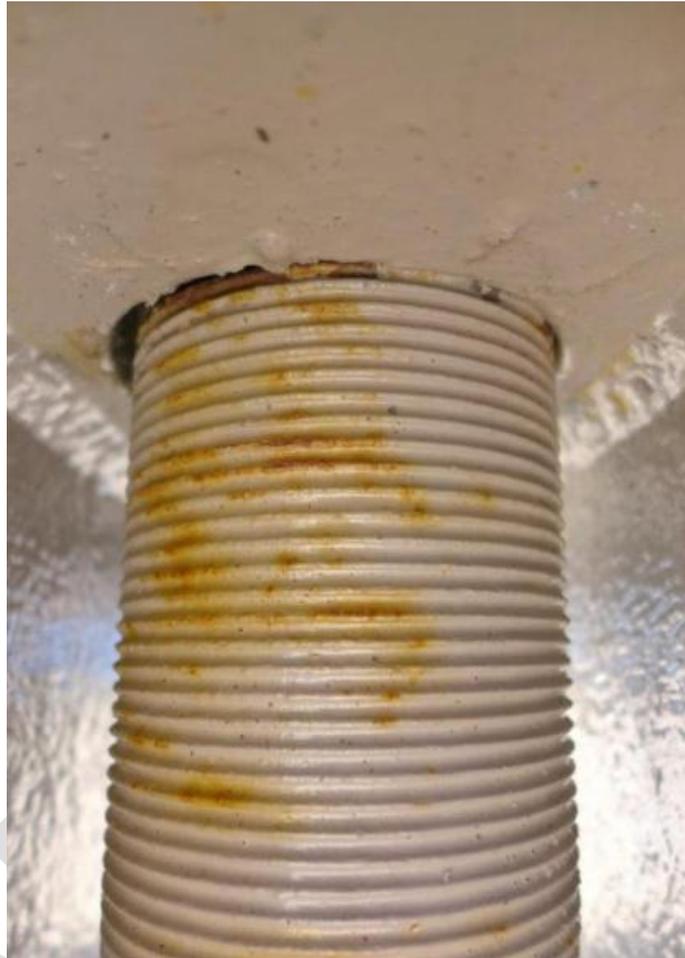
Corrosion at Galvanized Stressed Top Threads of Bolt 7EN

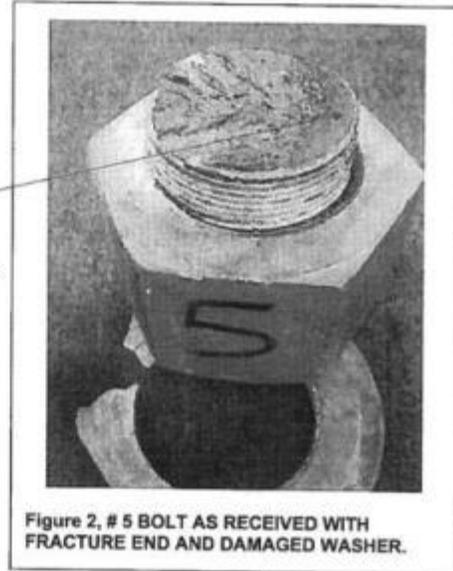
Figure 2, # 5 BOLT AS RECEIVED WITH FRACTURE END AND DAMAGED WASHER.

The washers on both assemblies were also heavily damaged, Both washers showed significant deformation from compressive stress.

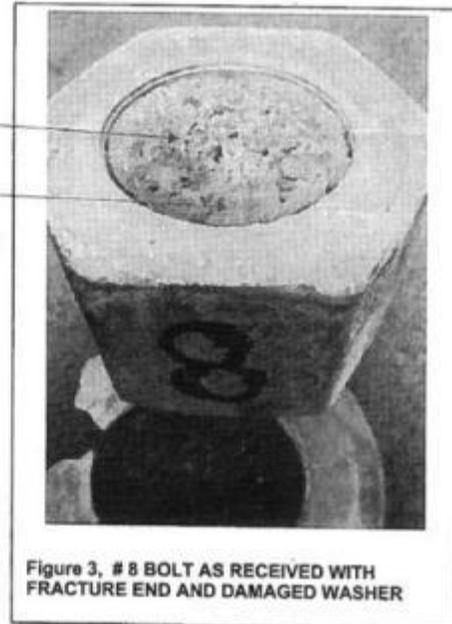
Figure 3, # 8 BOLT AS RECEIVED WITH FRACTURE END AND DAMAGED WASHER

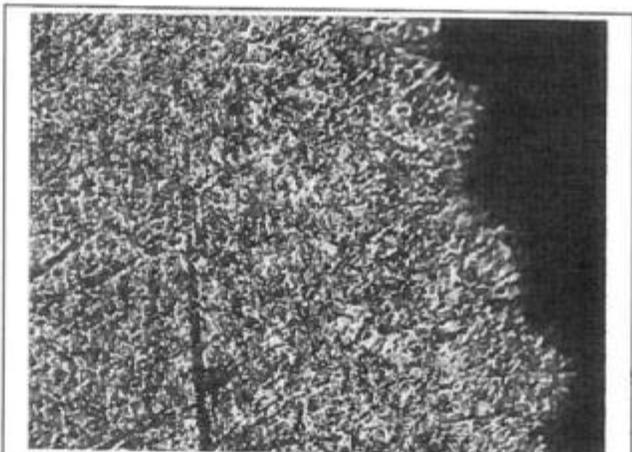
Figure 5, 400X MICROPHOTO OF THE CYCLIC CRACK START REGION OF BOLT #5.

Again there is no evidence of hydrogen damage.

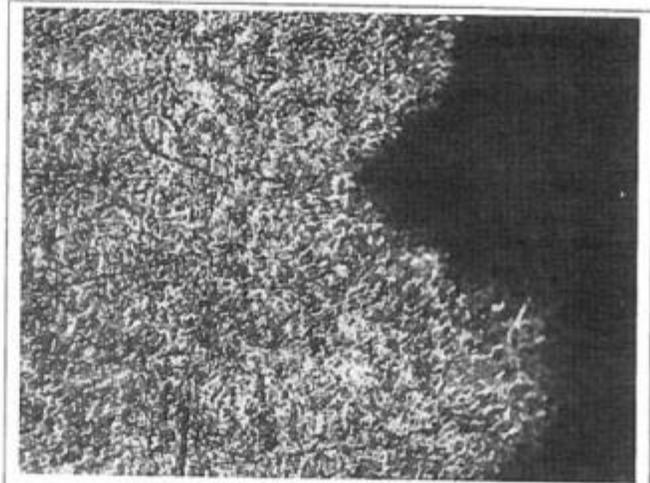
Figure 6, 400X MICROPHOTO OF THE FAST FAILURE REGION OF BOLT #5

Hydrogen induced damage is not visible at the root .

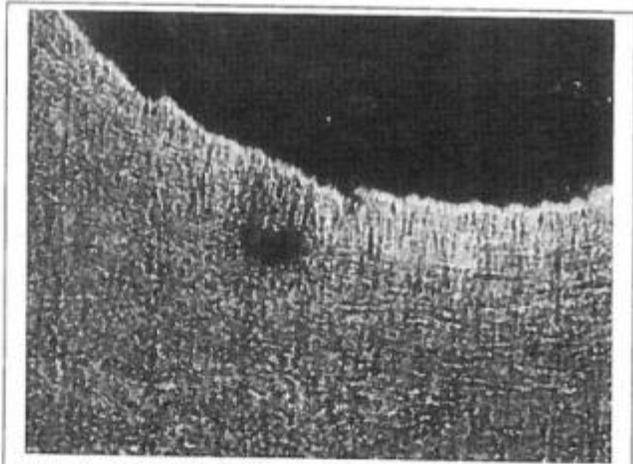
Figure 7, 100X MICROPHOTO OF #8 BOLT IN THREAD ROOT. THERE IS ONE SMALL NON-METALLIC INCLUSION AT THE ROOT

There are no small tears at the surface and no evidence of hydrogen damage.

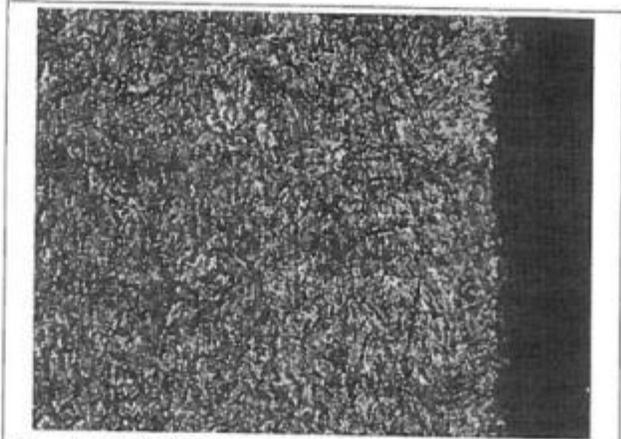
Figure 8, 400X MICROPHOTO OF THE CYCLIC CRACK START REGION OF BOLT #8.

Again there is no evidence of hydrogen damage.

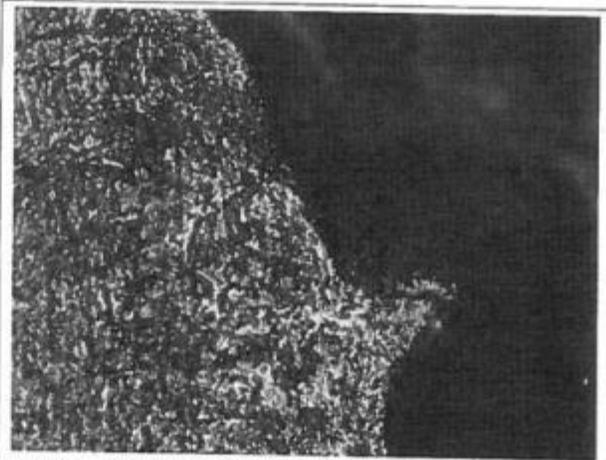
Figure 9, 400X MICROPHOTO OF THE FAST FAILURE REGION OF BOLT #8.

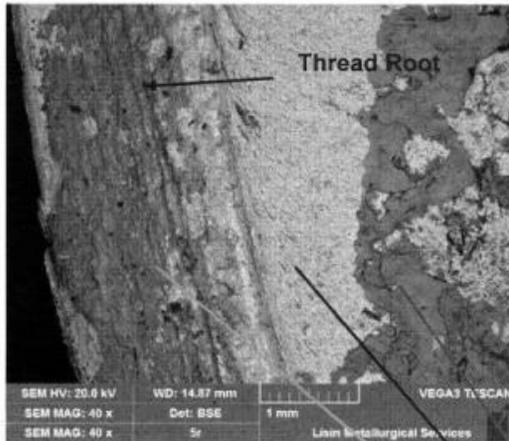
Figure 12 Backscattered electron image and energy dispersive x-ray spectra acquired from the fracture surface near the fracture initiation site, Bolt 5. The bolt fracture had been coated with lacquer when received by the laboratory, and the fracture surface was therefore ultrasonically cleaned in organic solvents and a mild alkaline cleaner prior to the analysis. Fracture surface deposits consisted primarily of iron oxide. Zinc on the threads is consistent with a galvanized surface. The alloy composition is consistent with an alloy steel such as Grade 4140 or similar.

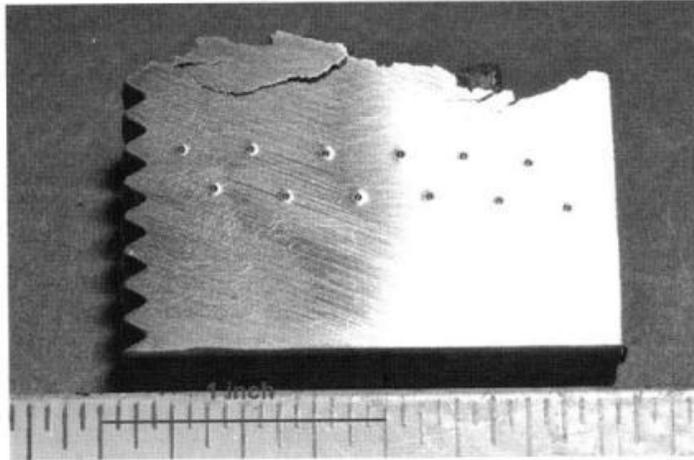
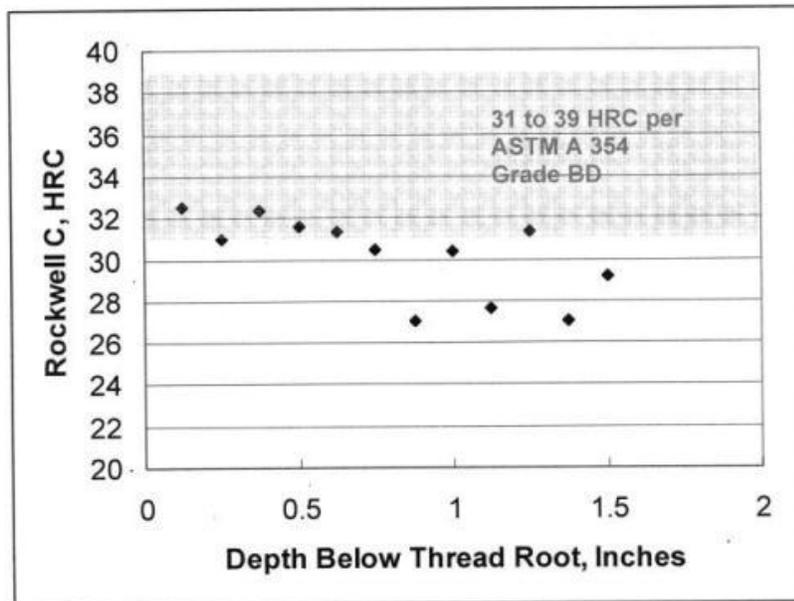
Figure 18
Direct Rockwell C hardness data obtained from a radial-longitudinal section and located three to four thread roots below the fracture. The specified hardness range for an ASTM A 354 Grade BD bolt is shown by the green band. The measured hardness at multiple locations is below the requirements of the ASTM specification.

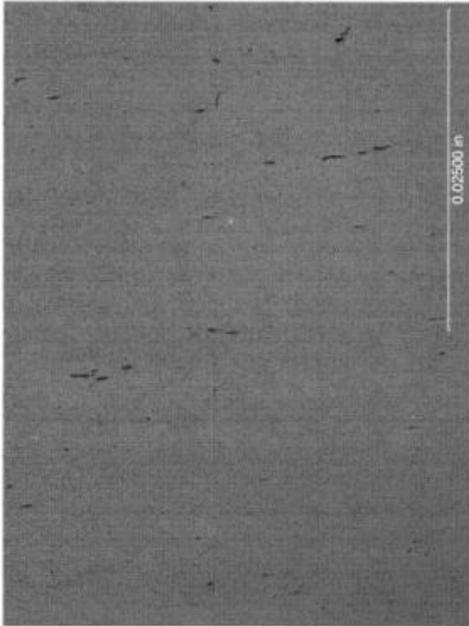
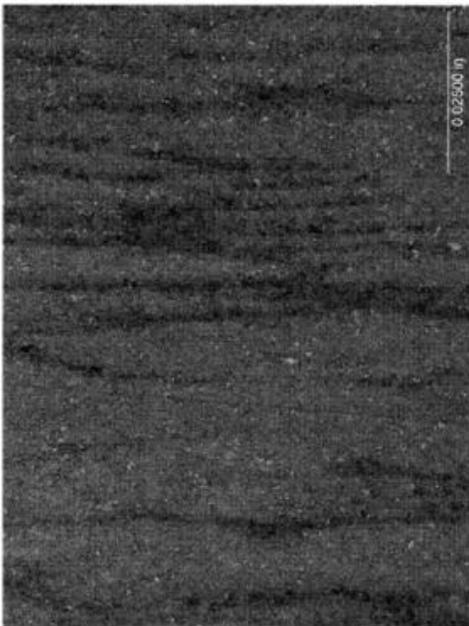
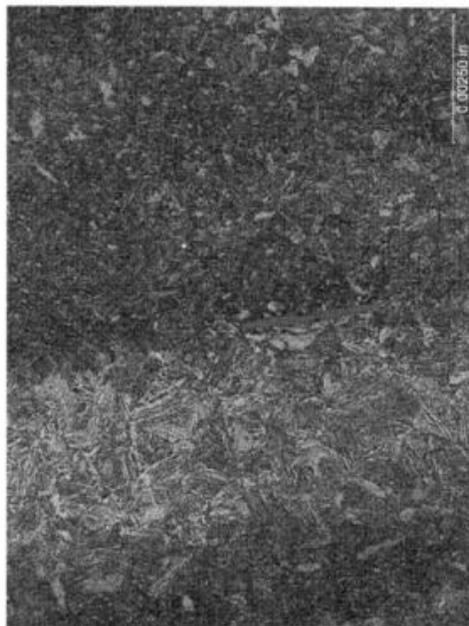
Figure 22

Longitudinal metallographic sections through Bolt 5 at a mid-radius location. The non-metallic inclusion content appeared normal for a commercial quality steel. The metallographic examination revealed a mixed microstructure of longitudinal bands of martensite and other transformation products. The microstructure is consistent with a hardened and tempered 4140 alloy steel in this diameter. A higher alloy steel such as 4340 would exhibit improved hardenability, more complete transformation to martensite, and likely better impact toughness at the same hardness level. As-polished (top) and 2% nital etch (bottom).
