**BAY AREA TOLL AUTHORITY (BATA) MEETING**  
 9:30 a.m. Wednesday, March 27, 2013  
 Joseph P. Bort MetroCenter  
 Lawrence D. Dahms Auditorium  
 101 8<sup>th</sup> Street, 1<sup>st</sup> Floor  
 Oakland, CA 94607

THE SAN FRANCISCO-OAKLAND  
**BAY BRIDGE**  
SEISMIC SAFETY PROJECT

**A number of S1 and S2 shear key anchor rods at pier E2 have broken after tensioning.**

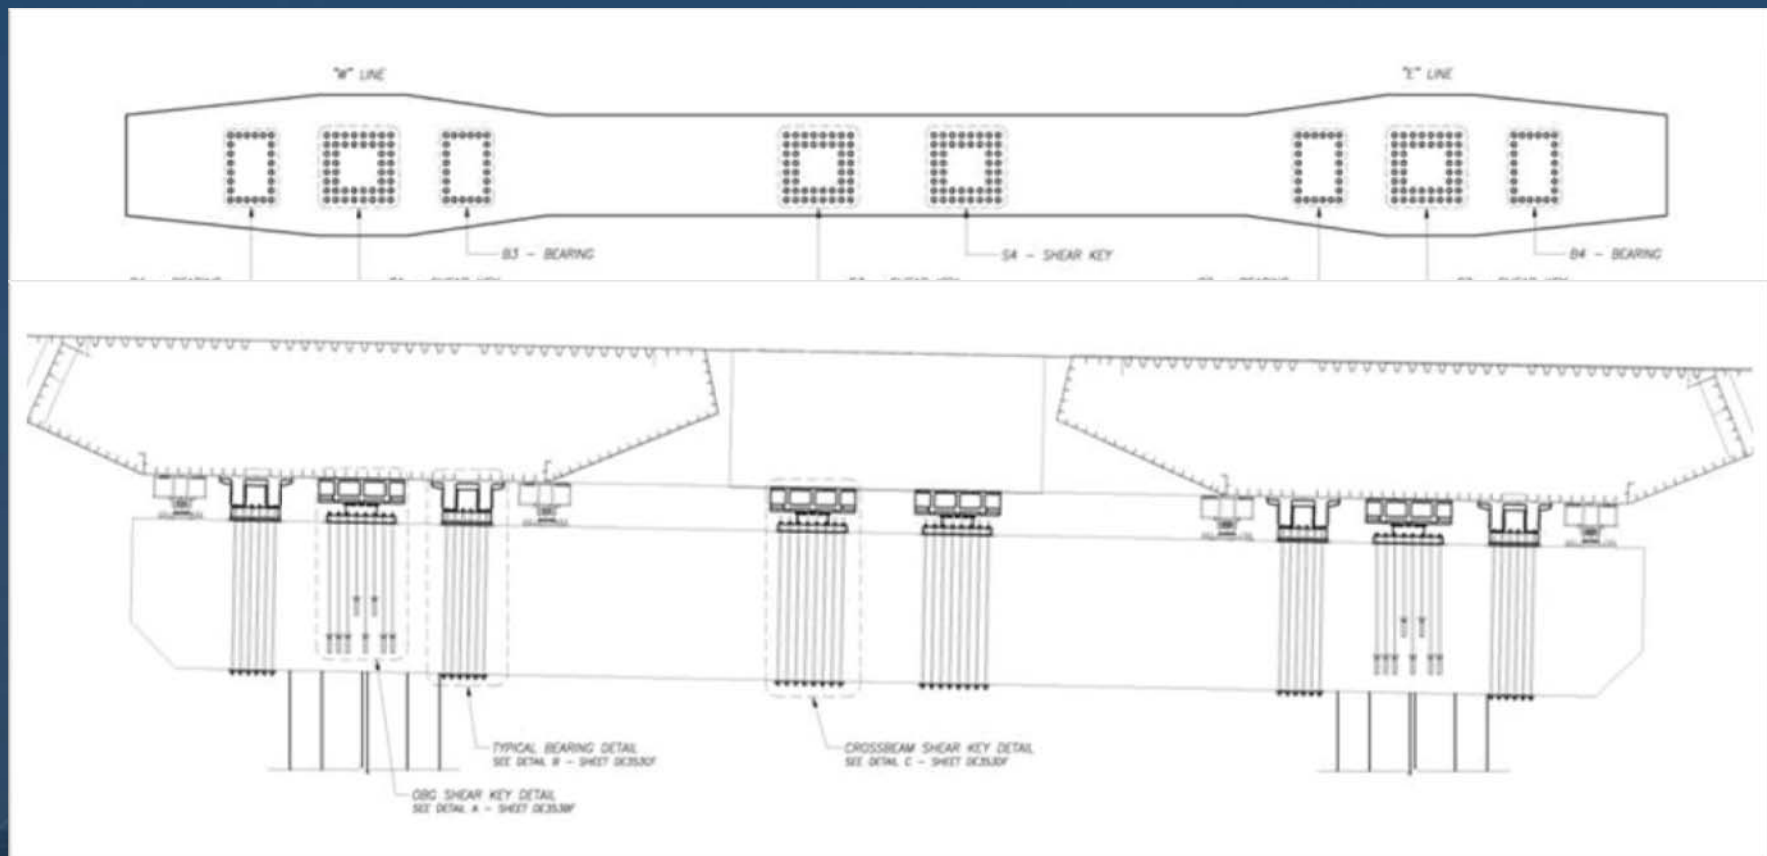
**Bearings and shear keys are secured to E2 by 3 inch diameter anchor rods, ranging from 9 feet to 24 feet in length**

**Each bearing has 24 anchor rods and each shear key has 48 anchor rods for a total of 288 anchor rods**
