TBPOC MEETING May 1, 2013, 2:00pm – 5:00pm Director's Conference Room, 1120 N Street Sacramento, CA

SAN FRANCISCO OAKLAND BAY BRIDGE EAST SPAN SEISMIC SAFETY PROJECT SELF-ANCHORED SUSPENSION BRIDGE (SUPERSTRUCTURE & TOWER)

E2 SHEAR KEYS ANCHOR RODS RETROFIT (ALT. BD2-4)

2008 A354 Gr. BD Anchor Rods [96 Rods]

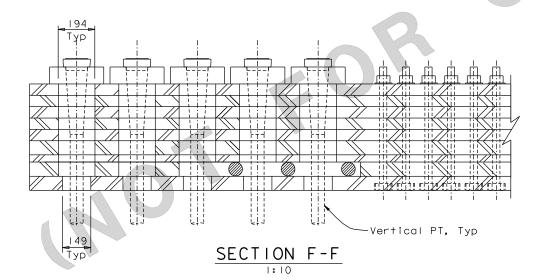
SECTION D-D

PT duct

OD 65, Typ

- I. Plate thickness may vary due to milling. Add additional plates to build up required thickness.
- 2. For plate layers, see "E2 SHEAR KEYS ANCHOR RODS RETROFIT (ALT. BD2-6)" SHEET.

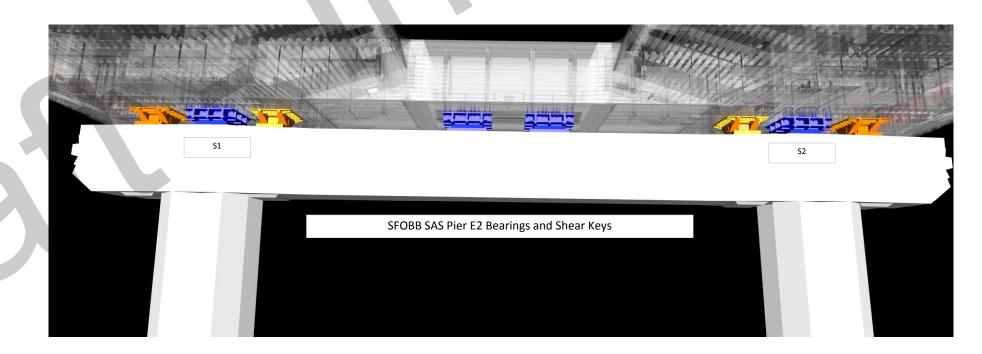
SFOBB SAS Option BD 2

RETROFIT ALTERNATIVES FOR SHEAR KEYS S1 & S2

ID Tag	ID Text Label	Image	Major Steps	Major Pros	Major Cons
	Steel Collars		1) Procure material (PT strands/ steel plate/ bolts) 2) Fabricate steel frame/ transverse steel grillage 3) Tap holes in existing lower housing and prepare surface 4) Core existing concrete and cast supplemental concrete 5) Install steel frame and grillages 6) Grout under steel frame and grillages 7) Tension PT and grout 8) Cast cover concrete	 Potentially faster Shear keys do not need to be removed Does not require splitting the bushing 	- Requires more steel fabrication (milling/ welded steel grillages/ bolted steel frame) - Requires multiple vertical and horizontal cores - Requires an alternative procedure for future bearing replacement
C(2)	Prestressed Collars		1) Procure material (PT strands/ steel plate) 2) Fabricate steel frame/ saddle 3) Concrete surface preparation/ drill and bond 4) Core existing concrete 5) Cast concrete jacket 6) Install steel frame/ saddle 7) Grout under saddle 8) Tension PT and grout	- Potentially faster - Shear keys do not need to be removed - Requires fewer horizontal cores and no vertical cores	- Requires concrete jacket - Requires complex saddle fabrication - Requires splitting of the bushing

o 1. Retrofit strategy for 2008 rods B. Maroney referred to page 2 of the booklet and with the help of a mockup of the SAS Pier E2 bearings and shear keys, and bolt samples, demonstrated Alternatives BD (Steel Collars) and C (Pre-stressed Collars), described the major steps required for each alternative and compared the pros and cons for each.

₩ Weet Weet Calc	N. Sale Barrier
	Items	Action
	 At 65% design, estimated cost (with contingency and mark-up) for Alt. BD is \$16 million and for Alt. C, \$5 million. Alt. BD requires more work and a lot of steel and coring; Alt. C requires less coring and is five times stronger than normal steel. B. Maroney/M. Nader agreed that Alt. C is faster and requires less work than Alt. BD. While both options work, cost advantage, potential 	
	schedule benefits, complexities, and	
	confidence level all seem to favor	
	Alt. C. Recommendation:	
0	B. Petersen indicated that design	
	details change every day. While Alt.	
	BD was an early frontrunner, recent	
	input received leaves them leaning	
	towards Alt. C; but the process is not	
	over and there is more work to be	
	done before a decision can be made	
	on which option to implement.	ABF, the Peer Review Panel, and
	The Peer Review Panel members have just received the plans, which	the PMT to present their recommendations to the TBPOC at

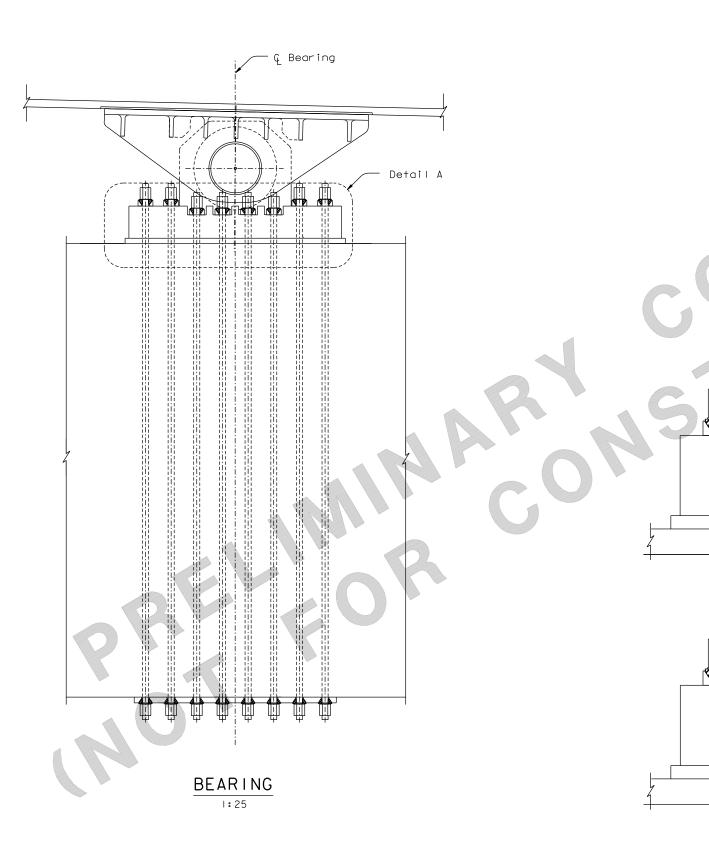
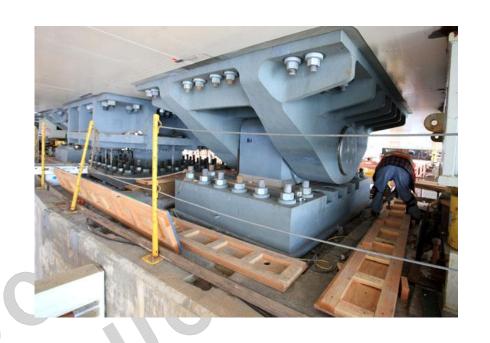
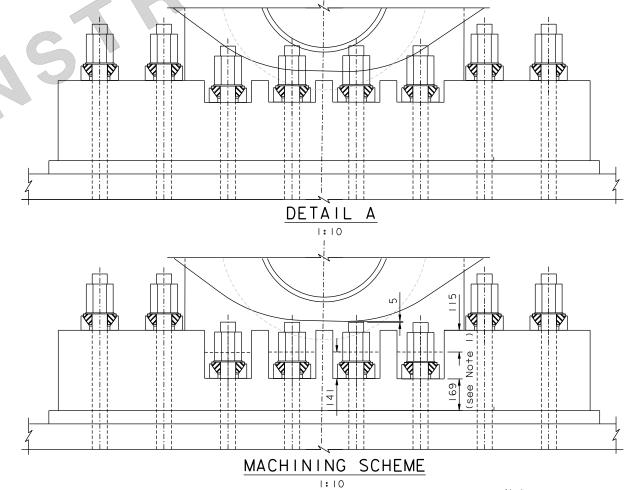
Date: 2013-04-29
File Name: 0PTION-B

I. Machine recess holes by 169 Min to fit.

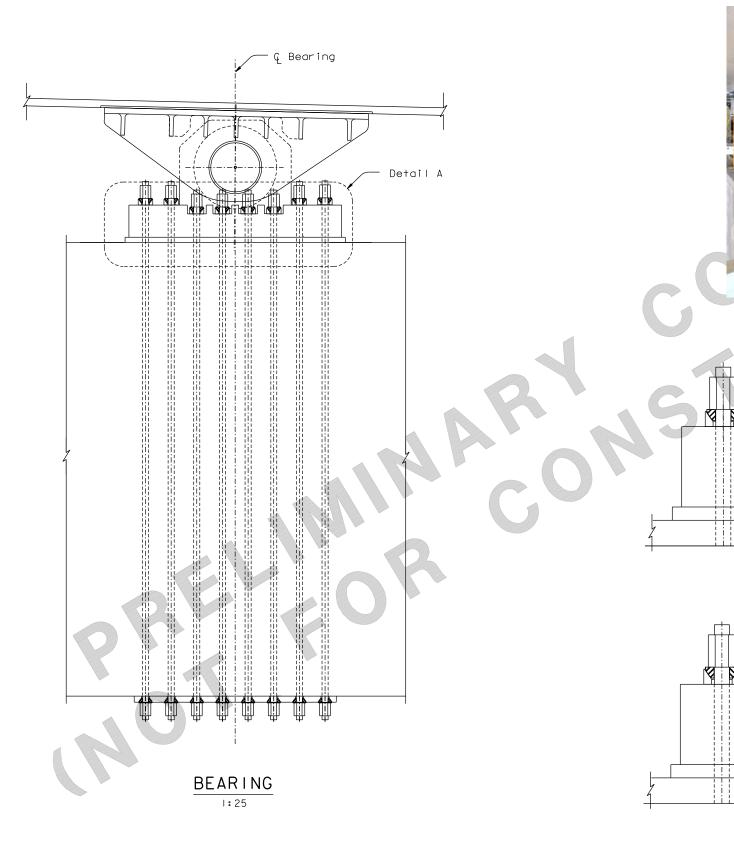
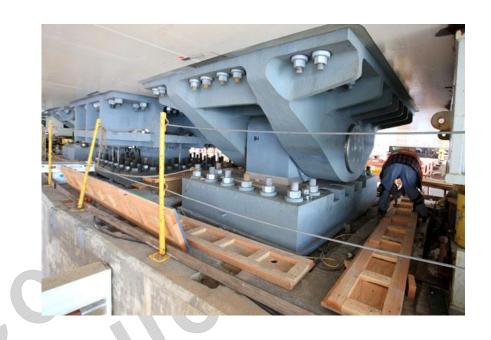
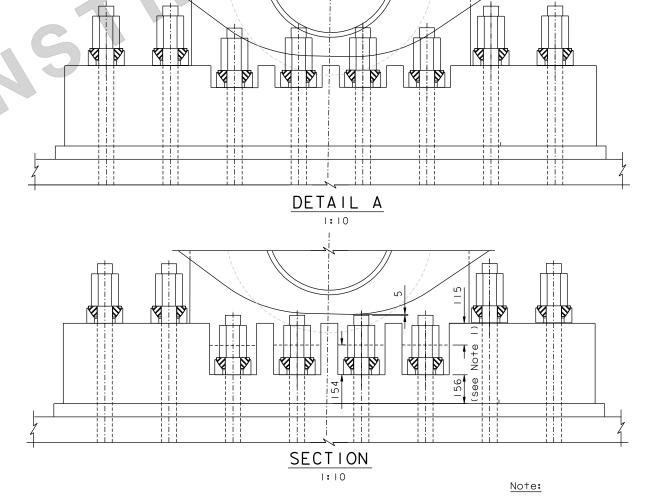
WILLIAMS RODS

I. Machine recess holes by 156 Min to fit.

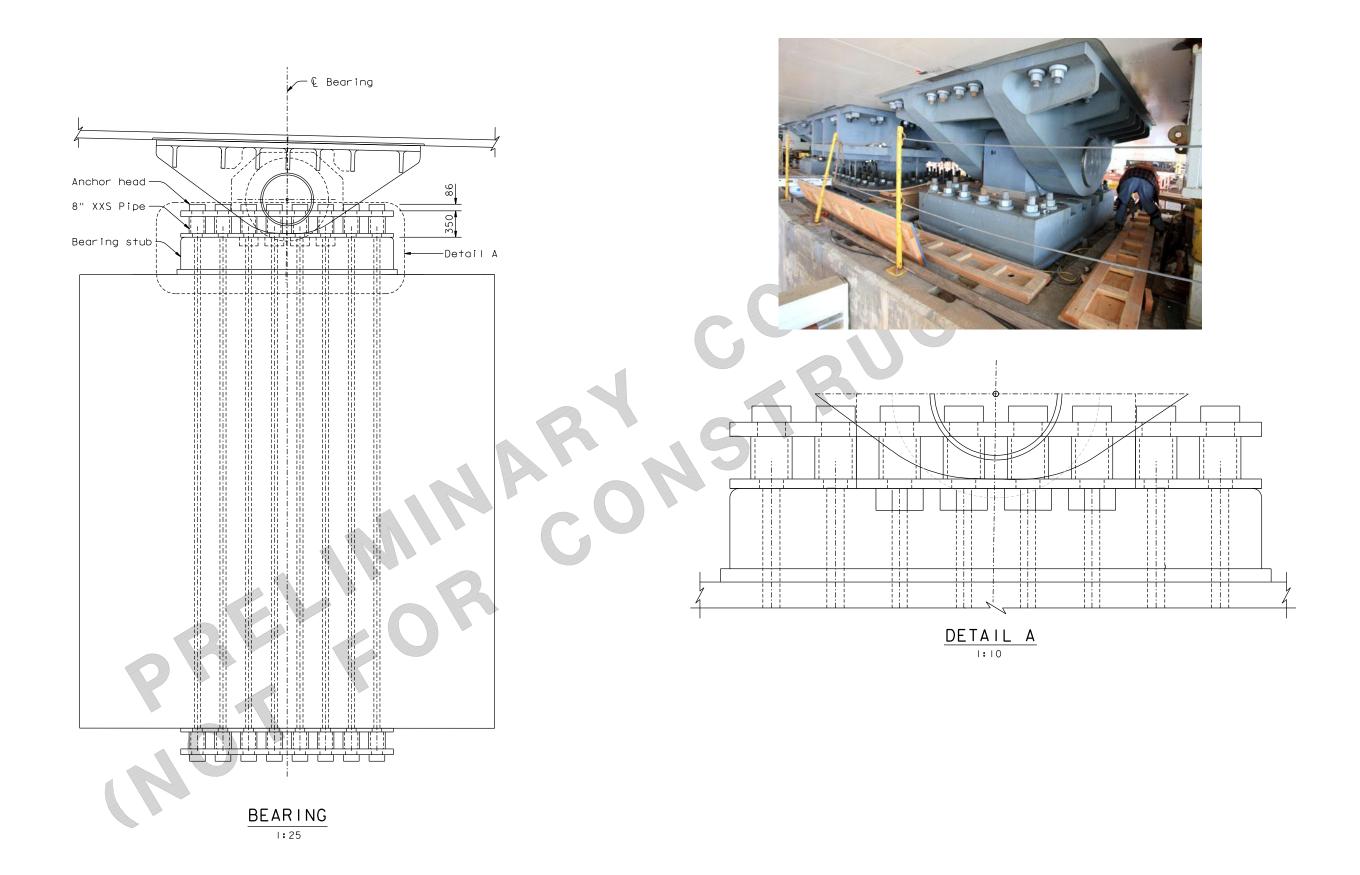
PRESTRESSING STRANDS

5	Prestressing Strand	16 strands	270	0.44 Fu	585	- ASTM A 416		strands and
			before losses	after losses			 Requires reaming of holes of the bearing bottom housing and the shear key bottom housing by 10mm to for strands Requires re-evaluation of the bearing bottom housing by FEM analysis to confirm if it is fit-for-purpose 	anchors readily available; anchor rame assembly time estimated at 6-8 weeks

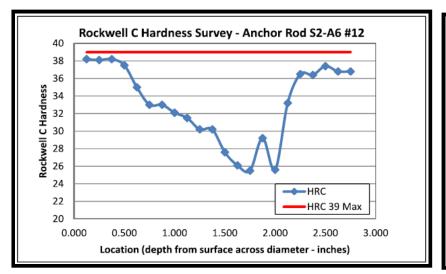
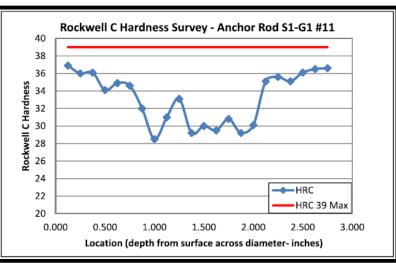
7. Hardness Testing

- Contract compliant, hard on exterior

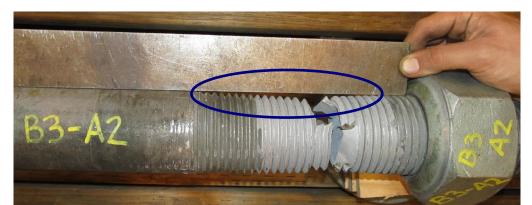
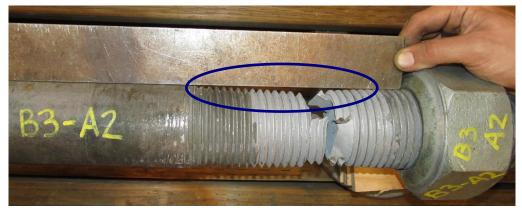
- Ductile failure
- Visible reduction in area
- C. In-Process Testing
 - a- Charpy Testing
 - b- Reduced Section Tensile Testing
 - c- Hardness
 - d- Spectro-Chemical Analysis
- 3. In-Situ Hardness Testing: See Page 4/5 for details.
- 4. Wet Test developed by Dr. Herb Townsend, Dr. Karl Frank, and Doug Williams - See Page 5/5 for details.

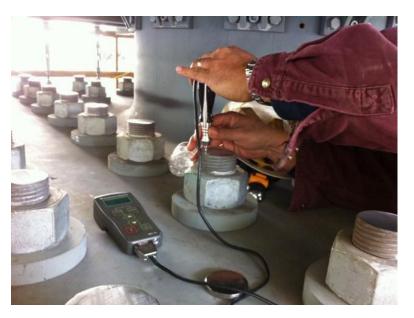
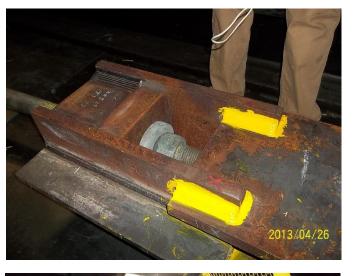
- 1) Galvanizing was ground off the top surface of the rods using a grinder.
- 2) Suitable sand paper was lightly applied after grinding to achieve a surface profile of 15 µm or less per ASTM A1038.
- 3) A profile meter was utilized to ensure surface roughness is acceptable.
- 4) The surface was free from oil, grease, dust, rust, and surface coatings.
- 5) Measurements were taken as shown on Section A above.
- 6) After measuring the hardness on each rod, the equipment readings were verified against a certified hardness reference block by taking 2 additional measurements.

- Note 1: Field hardness equipment is subject to greater variability than lab equipment. In addition, factors including wind and difficult access conditions can contribute to such variability.
- Note 2: <u>Some</u> of the rods tested in this report may have been cut at the ends after heat treatment. Cutting the rods will remove the hardened exterior layer. This will result in a decrease in the measured hardness.

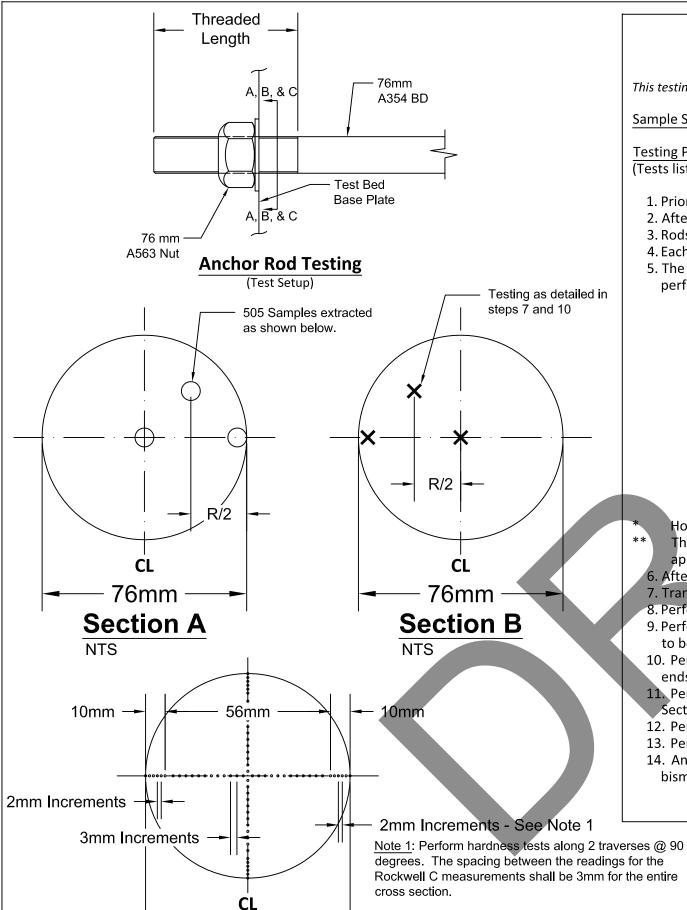
Section C

76mm

The spacing between the readings for the Knoop

2mm increments for the first 10mm from the exterior.

measurements only shall be as follows:

3mm increments in between.
