SAN FRANCISCO-
OAKLAND BAY BRIDGE
SELF-ANCHORED SUSPENSION BRIDGE

EVALUATION OF THE ASTM A354 GRADE BD RODS

SEPTEMBER 30, 2014

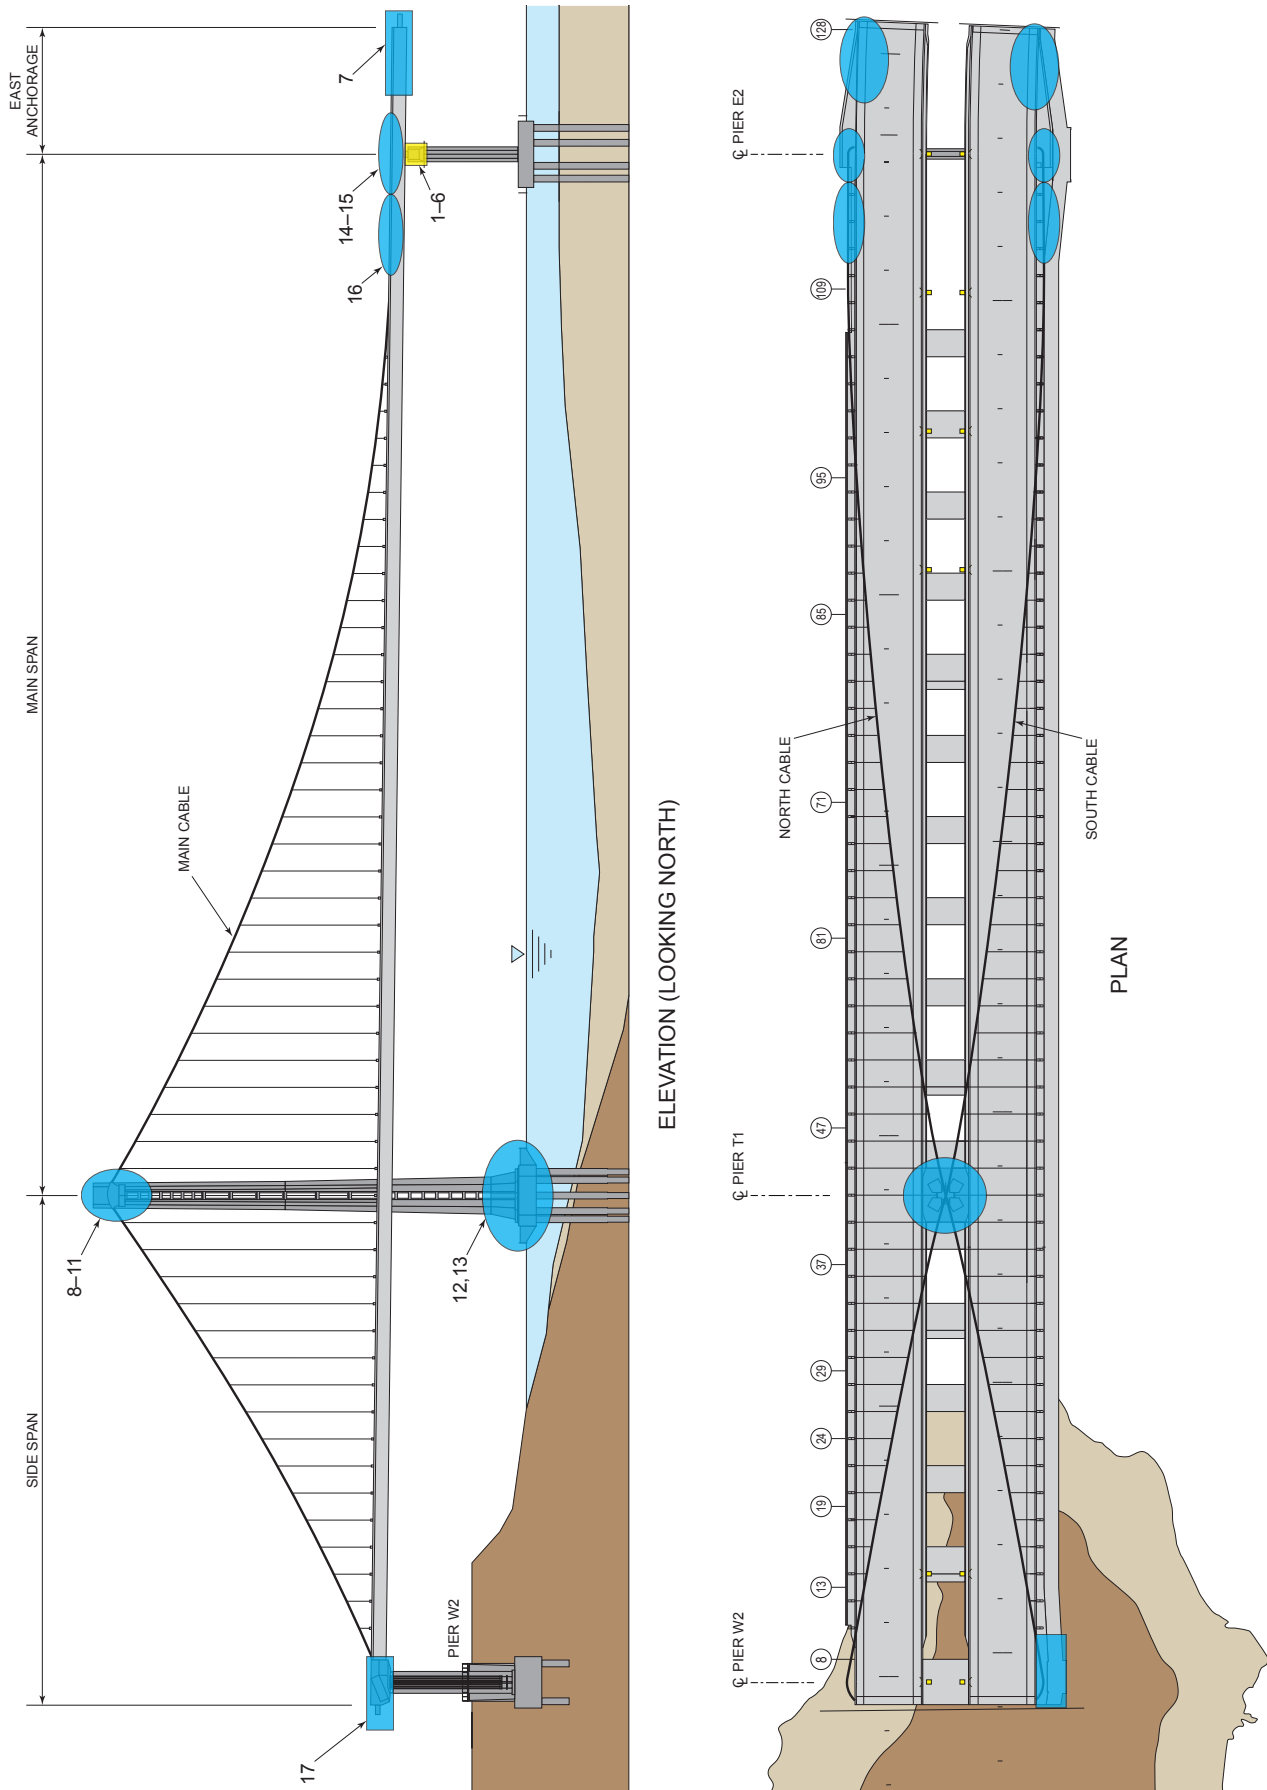
Figure 1.2-1: A354BD Rods Across SF0BB-SAS

The A354BD rods on the SAS are classified in 17 groups; an additional group is added to represent the 2013 Pier E2 replacement rods. The groups account for the locations of A354BD rods on the SAS, and other characteristics that differentiate the rods. The locations of the various components are identified in plan and elevation views of the SAS on Figure 1.2-1. The list of rod groups including rod diameter and pre-tension levels is presented on Table 1.2-1. Photographs of all the rods as installed in the structural component are shown in Figure 1.2-2.

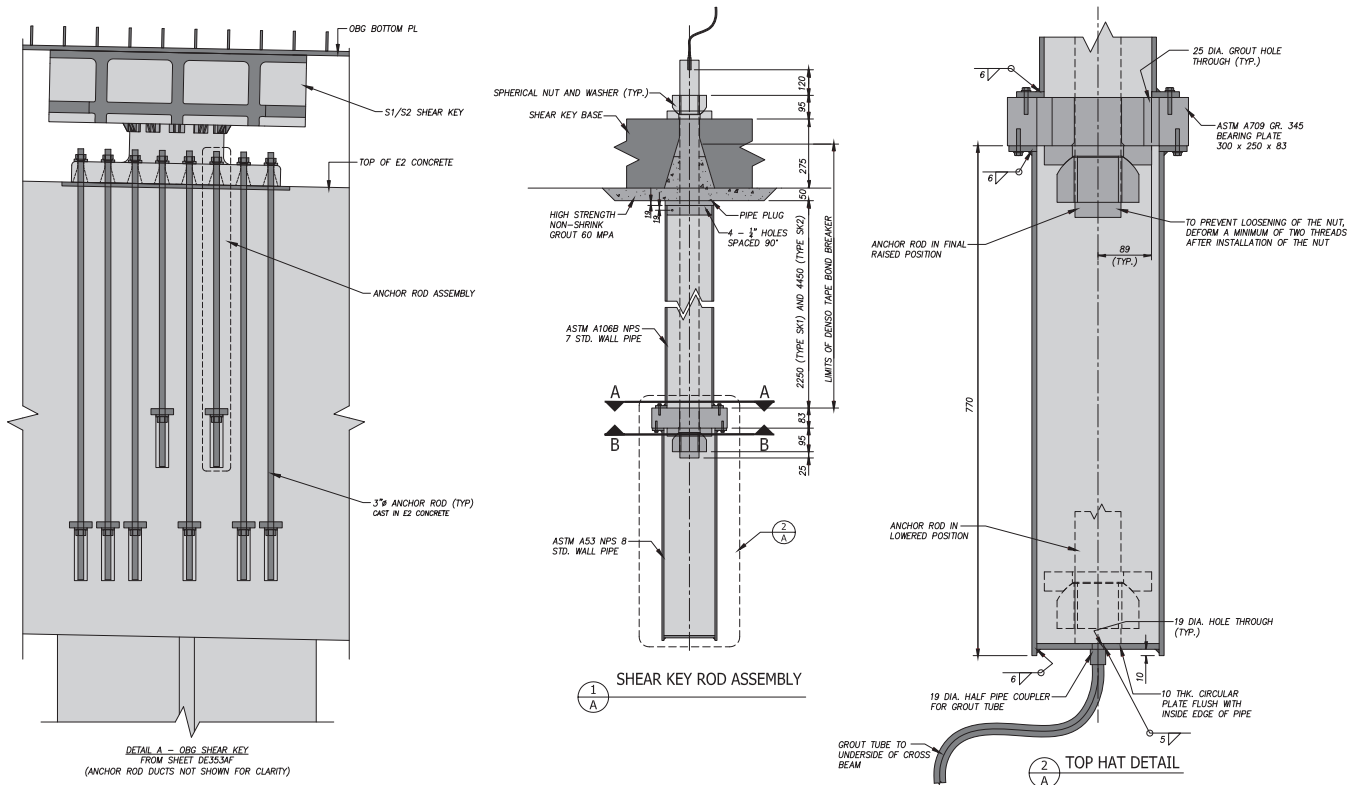
Figure 1.3-3: Shear Keys S1/S2, Rods, Pipe Sleeves, and Top Hat Details

The 3-inch diameter 2008 rods were installed into 7-inch diameter pipe sleeve assemblies that include an 8-inch diameter chamber at the bottom (top-hat), to allow for tensioning and grouting. These assemblies were installed inside the Pier E2 concrete cap beam prior to placement of concrete. A review of construction documents revealed that rods were exposed to water that had entered the pipe sleeve assemblies enclosing the rods prior to grouting and tensioning. Also, water was found in the rod cavities during the in-situ boroscope examinations that followed the removal of a few fractured rods. Accordingly, there is no doubt that the rods were exposed to water at the time of tensioning. This is significant because water is a source of hydrogen that could cause embrittlement when a rod is tensioned above its critical threshold load.

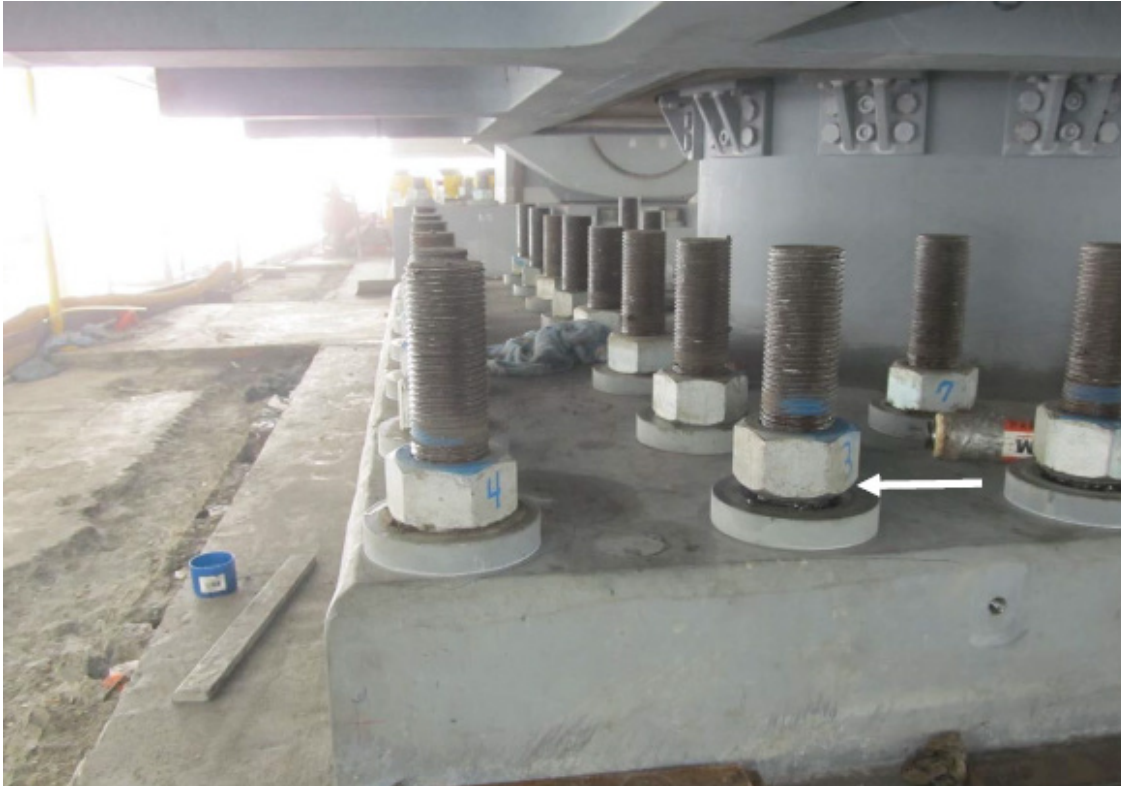
Figure 1.3-4: First Indication of Rod Failure

On March 8, 2013, a few days after the anchor rods were tensioned, Caltrans Construction personnel observed that the nuts on nine shear key rods had lifted about 2 inches above the washers, indicative of rod failure (see Figure 1.3-4). Within the next four days, another 20 nuts were found to be in a similar condition. It was then decided to reduce the tension on the remaining rods to 0.40 Fu to avoid further failures while the situation was being evaluated. During that process, three more rods failed, bringing the total number of failed rods to 32 in 14 days. Figure 1.3-5 provides a histogram of the rod failure timeline.

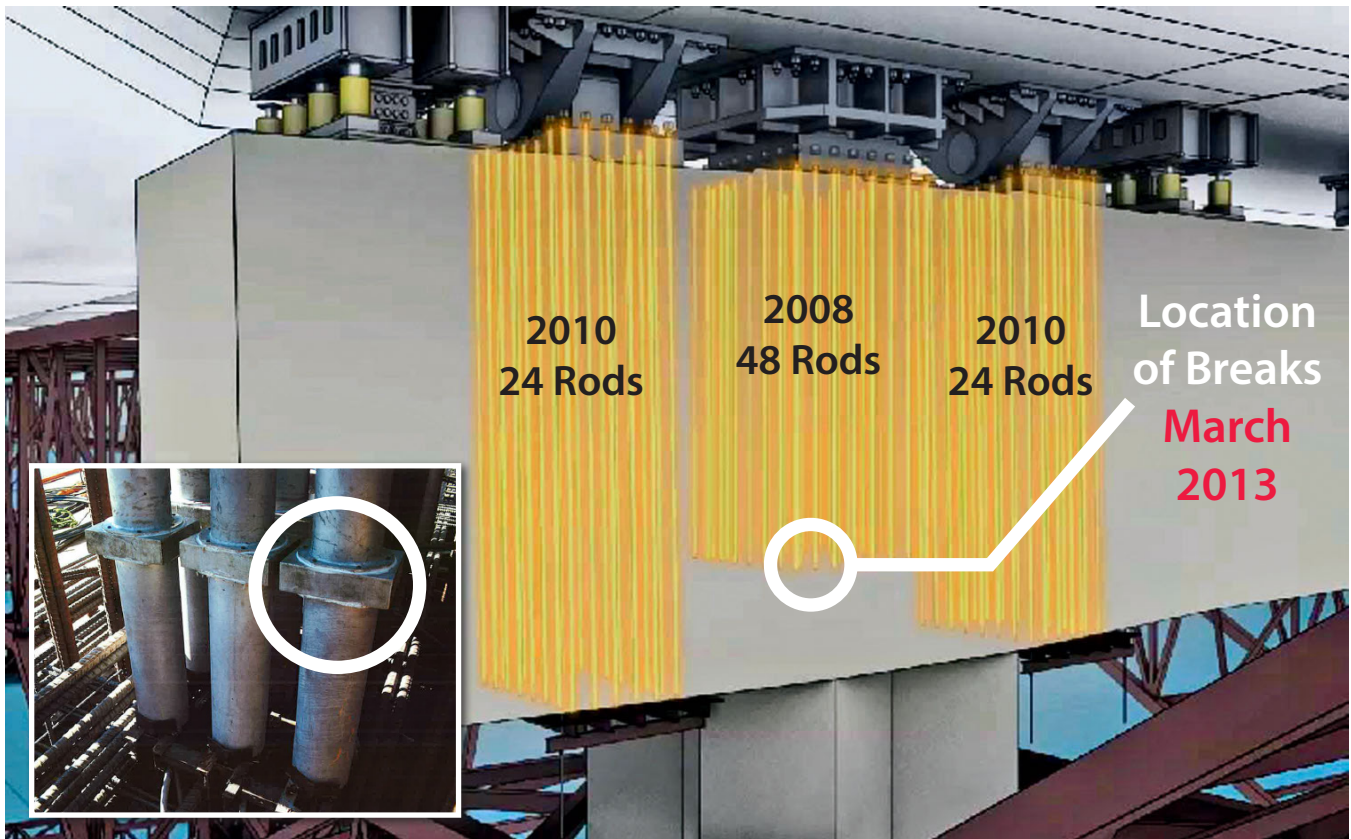
Figure 1.3-6: A354BD Rods at Pier E2 — Break Locations

All of the failed rods fractured at or near the bottom nut connection (See Figure 1.3-6). To investigate what had happened and determine the cause of the failures, it was decided to extract a sample population of the failed rods for testing and analysis. Due to the limited overhead clearance, removing the rods required raising each rod by increments and cutting it into lengths of one to two feet. Figure 1.3-7 shows two such pieces of rods with the fractured sections. The initial failure analysis report identified hydrogen embrittlement as the failure mechanism of the S1 and S2 shear key anchor rods. The report with the findings is provided in Appendix H.

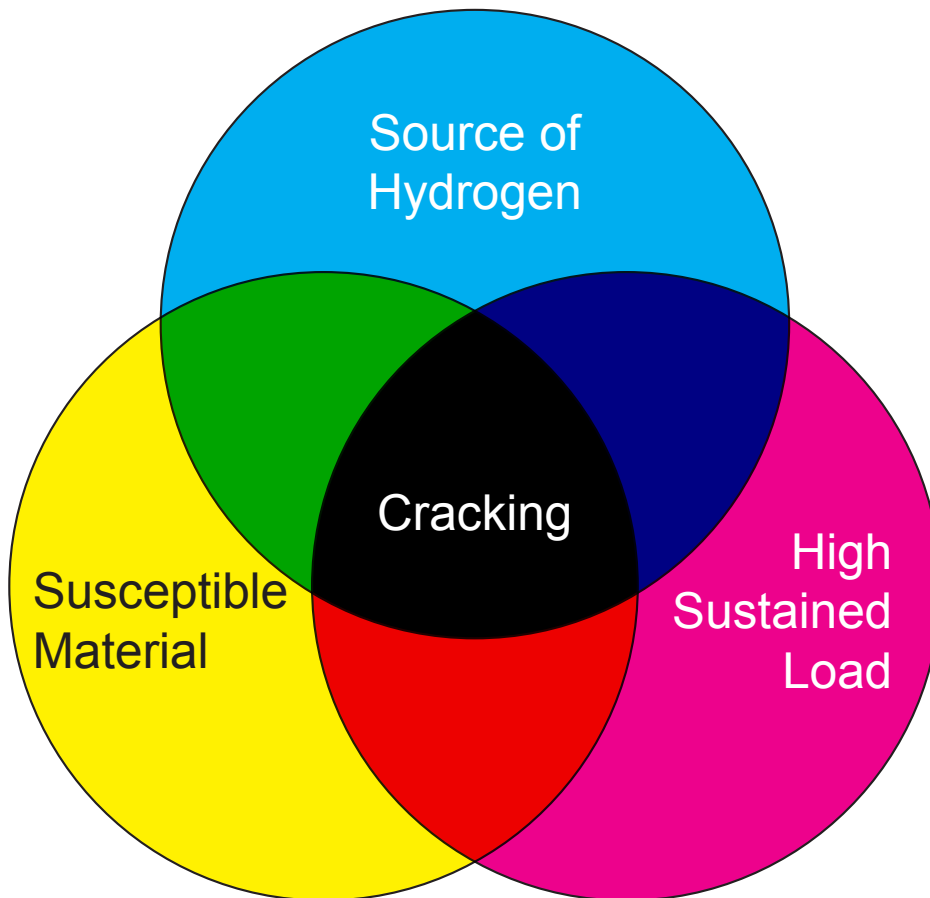
Figure 1.3-8: Conditions for Hydrogen Embrittlement Cracking

All results of this study indicate that the 2008 rods on E2 failed by environmentally induced hydrogen embrittlement because they were tensioned above their hydrogen embrittlement threshold while simultaneously immersed in water, which served as the source of hydrogen. The low hydrogen embrittlement threshold of the 2008 rods is likely due to rod fabrication methods.

All remaining A354BD rods on the SAS exhibit hydrogen embrittlement thresholds that are higher than their pre-tension stress levels and are safe. All A354BD rods on the SAS were designed to have both primary corrosion protection (galvanization) and supplemental corrosion-protection measures, such as dehumidification, paint sys-

tem, or grout, which would prevent corrosion and further rule out any future possibility of hydrogen embrittlement. Such measures already have been implemented except for painting the Pier E2 top housing shear key and bearing rods.

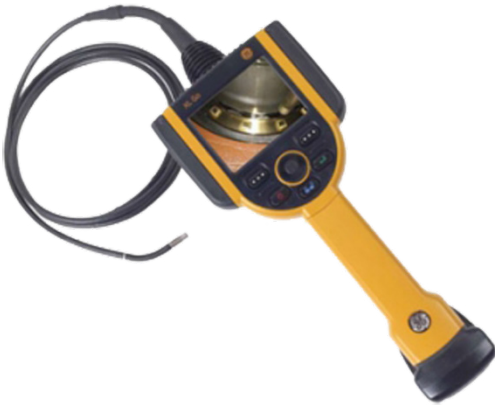
Figure 2.1-5: Borescope

Construction requested METS to later inspect the interior of the rod holes to assess the condition of the rods. The borescope inspection of various rods was performed at Shear Keys S1 and S2 on Aug. 8, 2011, with a GE XL Go Videoprobe Borescope (Figure 2.1-5). Prior to the borescope inspection of the anchor rod sleeve, an initial visual inspection of the accessible area was conducted.

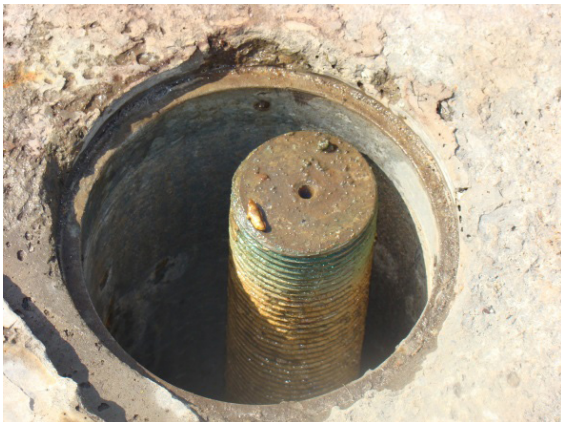
Figure 2.1-6: Exposed Rod at Pier E2

The visible portion of the rods exhibited rust stains on the threaded portion of the rod. No physical damage to the threads was documented (see Figure 2.1-6).

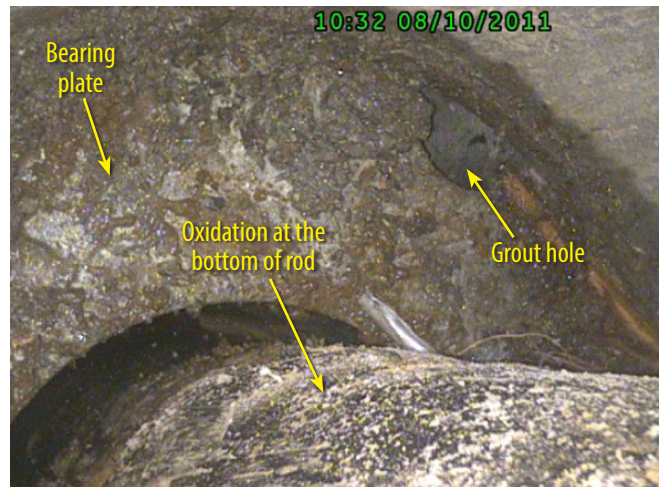
Figure 2.1-8: Debris on the Bearing Plate

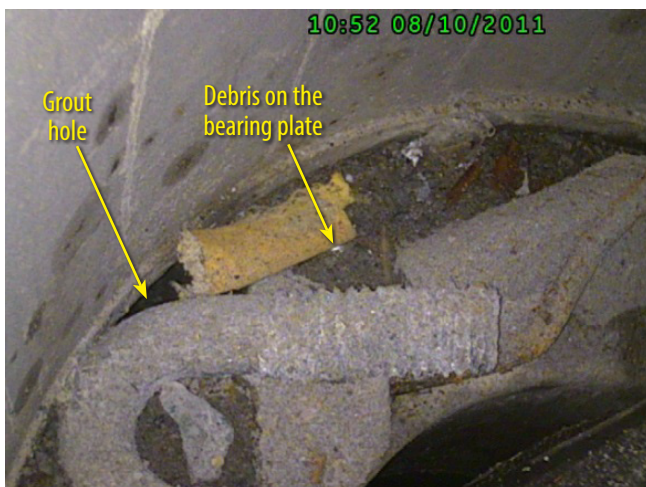
Figure 2.1-9: Various Debris on the Bearing Plate (1)

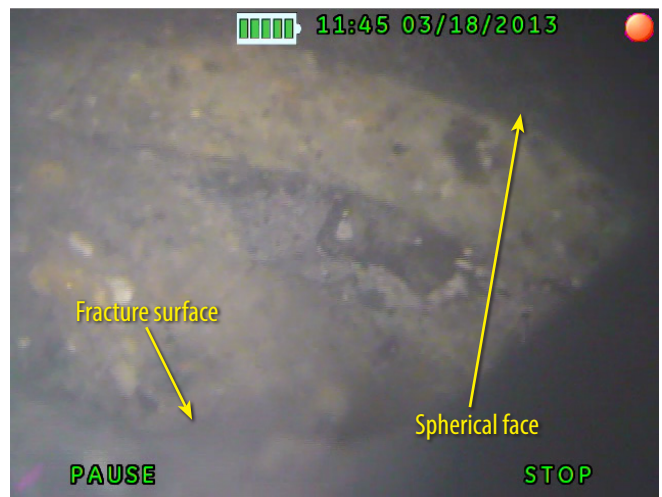
Figure 2.1-17: S2-A8 Borescope Snapshot

A water sample was taken for testing from the S2-A8 sleeve in Pier E2. The water sample was taken after the rod failed and was extracted. The sample was tested for pH and conductivity, as well as levels of chloride, sodium,

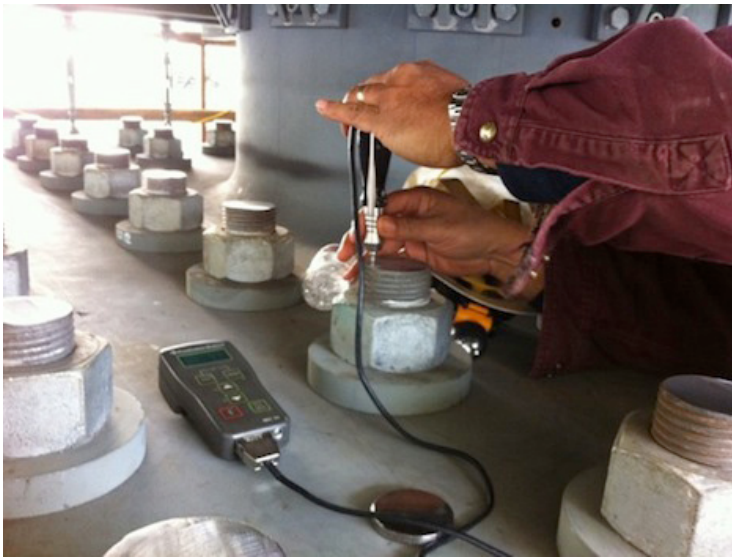
Figure 2.2-1: In-Situ Hardness Testing

The following is the test procedure for the in-situ hardness testing:

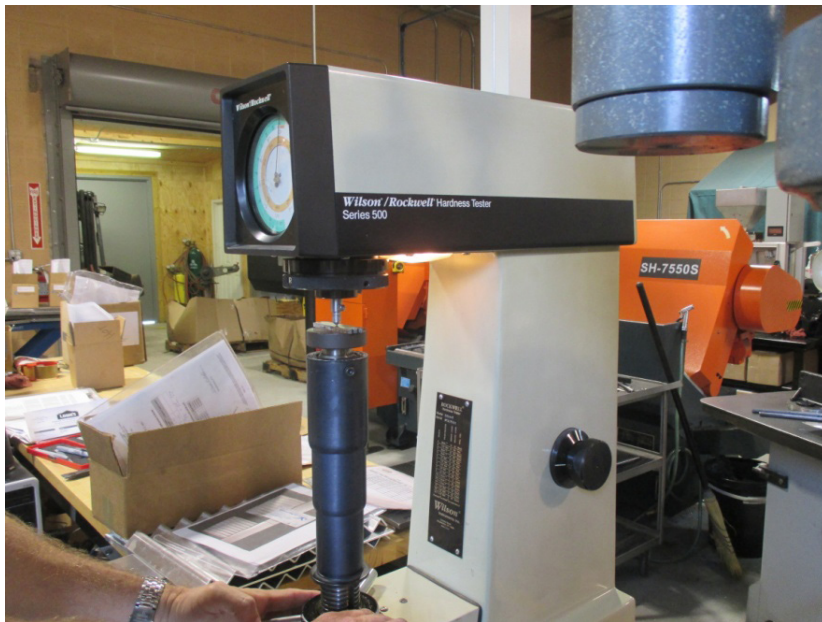
Figure 2.2-5: HRC Tester

Each test coupon is cut with a saw using a cutting fluid that reduces heat input. Since surface preparation is crucial for the hardness testing, the surfaces are then polished to a dull shine to achieve the required surface profile. This surface profile provides a clean testing surface and ensures accurate and reproducible results. The test is typically performed with a Rockwell Hardness Tester as shown in Figure 2.2-5.

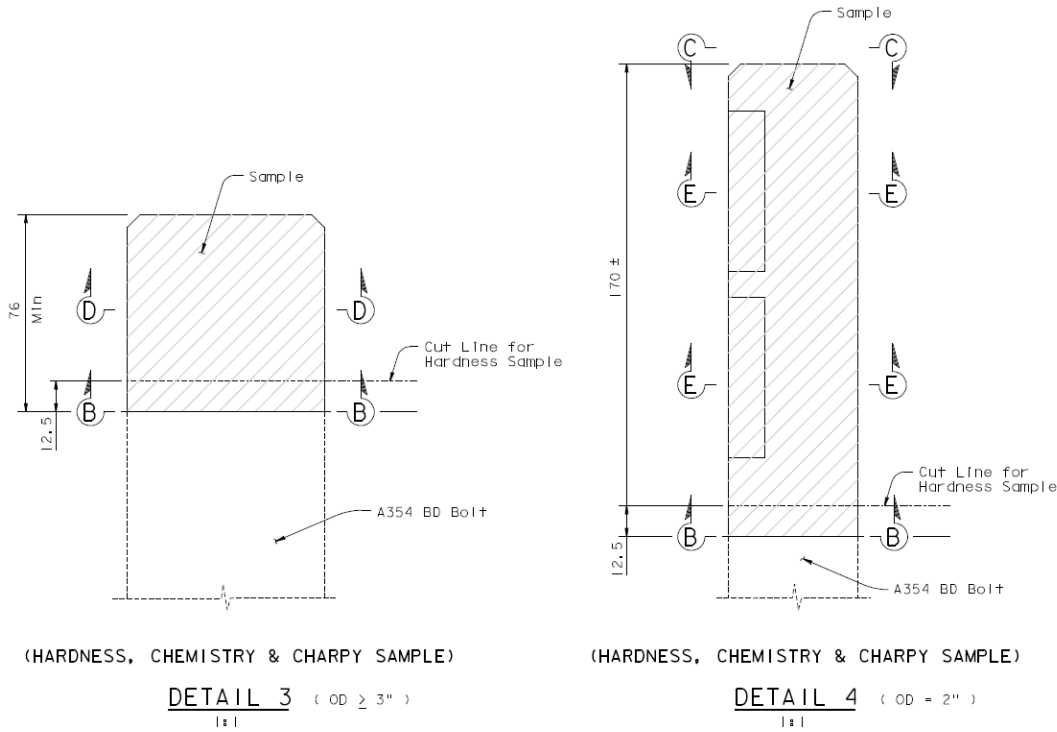
Figure 2.2-6: Hardness, Chemistry and CVN Coupon Extraction Layout

Hardness testing was performed at locations across the diameter and radius at 3-mm increments, in accordance with ASTM E18 requirements. As noted in Figure 2.2-7, an additional measurement was taken at mid-radius in each quadrant.

Samples were removed from the stick-out end of the rod as shown in Figure 2.2-6. CVN testing was performed in accordance with ASTM E-23. The rods in Group 14 (East Saddle Anchor Rods) did not have enough material to extract samples for this test.

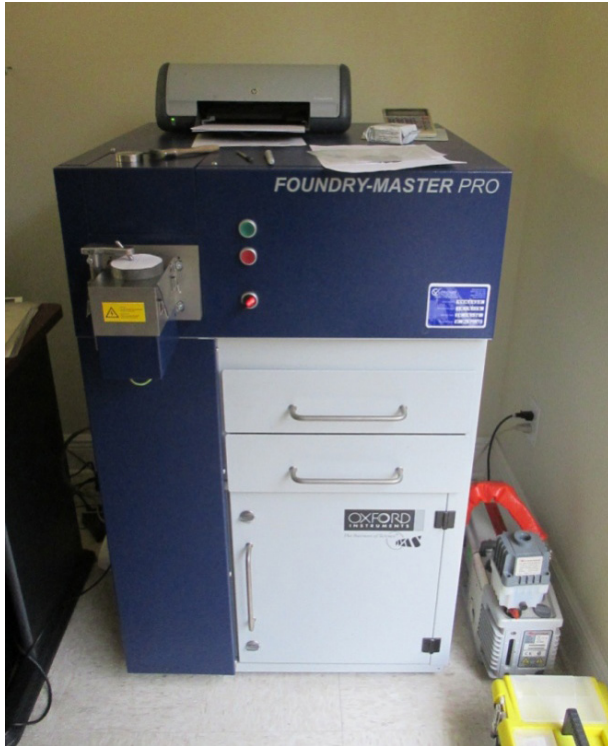
Figure 2.2-8: Chemical Testing Analysis Layout

Three chemistry samples were analyzed from each rod using the OES method: close to the edge of the rod, at the center, and at mid-radius. These locations are shown in Figure 2.2-9.

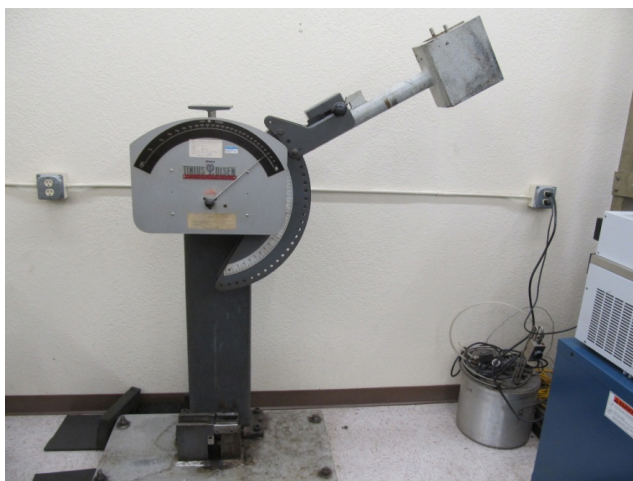
Figure 2.2-10: Charpy Testing Machine

The standard Charpy specimens were extracted using wire Electrical Discharge Machining (EDM) closest to the surface of the rod. Once specimens were extracted, they were machined to the standard size (10 mm × 10 mm × 55 mm). A V-notch was then made at the center of each specimen. The notch had edges that were at 45° from the centerline in both directions and was 2 mm deep with a 0.25-mm radius at the tip. The notches were oriented for the fracture travel from the outside of the rod towards the interior of the rod, similar to the crack propagation direction for a full-size rod. See Figure 2.2-10 for a Charpy testing machine.

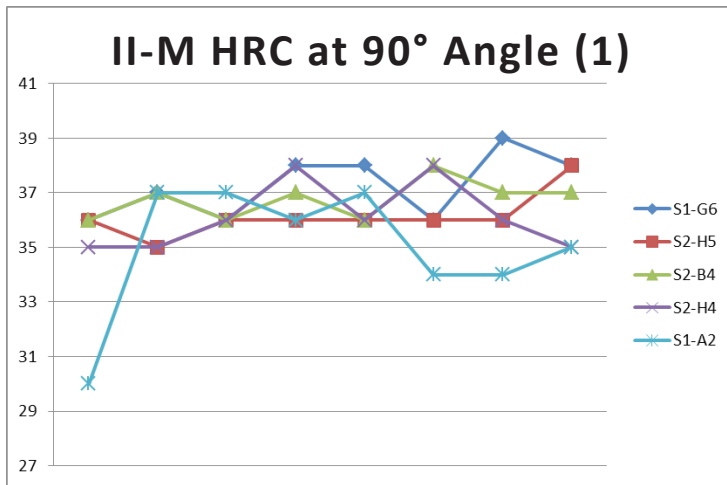
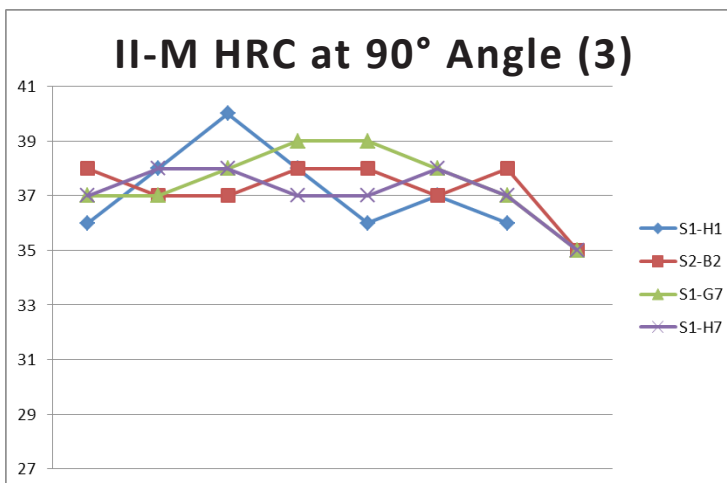
Additionally, the rods were tested at the 90° traverse and the results were found to be consistent. The hardness values of the rod from center to edge are represented in each graph from left to right; see Figure 2.2-24 through Figure 2.2-26 for reference.

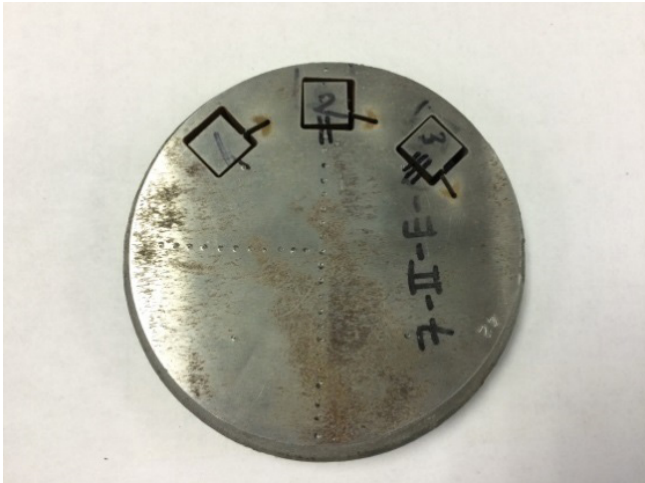
Five HRC measurements were taken on Surface A, per ASTM E18. Surface A was then sanded to achieve a smooth surface without any HRC impressions. Five additional HRC measurements were taken on Surface B, per ASTM E18. See Figure 2.2-31 and Figure 2.2-32 for laboratory specimens extracted. Surfaces A and B were then compared to the hardness values previously measured on cross-sections at 0.1 in. and 0.5 in. during Test II.

Figure 2.2-31: Group 7 Sample with Cut Samples

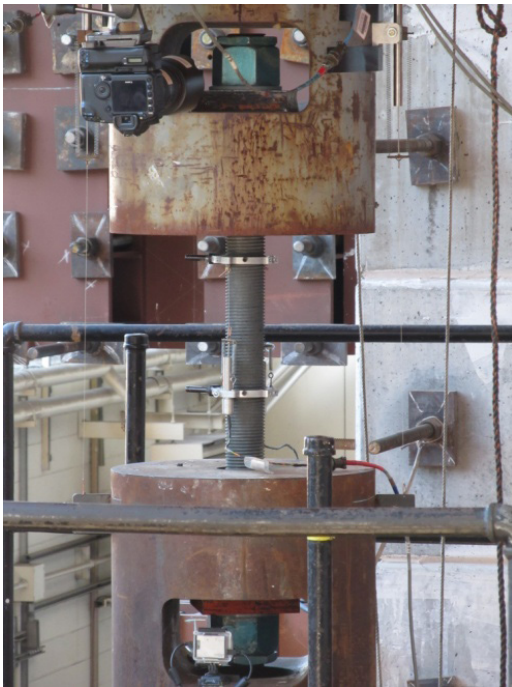
Figure 2.2-35: Full-Size Tensile Testing at Laboratory

For samples that were being tested full-diameter, the load was applied axially through sufficient thread engagement to develop full strength of the product until failure. The acceptance criteria for full-diameter testing is specified by ASTM A354, Table 3, where the yield and tensile strength are the only measurements evaluated.

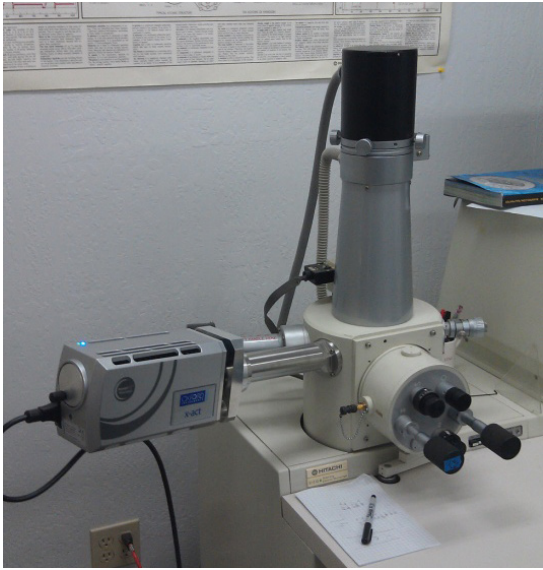
Figure 2.2-41: Scanning Electron Microscope

The types of failure observed on the rod fracture surfaces were evaluated using Scanning Electron Microscopy (SEM), which generates images based on the interaction of the electrons with the material. Images of the fracture surface were analyzed for fracture type as a result of tensile overload, which was represented by dimples and cleavage morphology. Additionally, the homogeneity of the material was analyzed by looking for banded features or inclusions. See Figure 2.2-41 for a typical microscope used for metallurgical analysis.

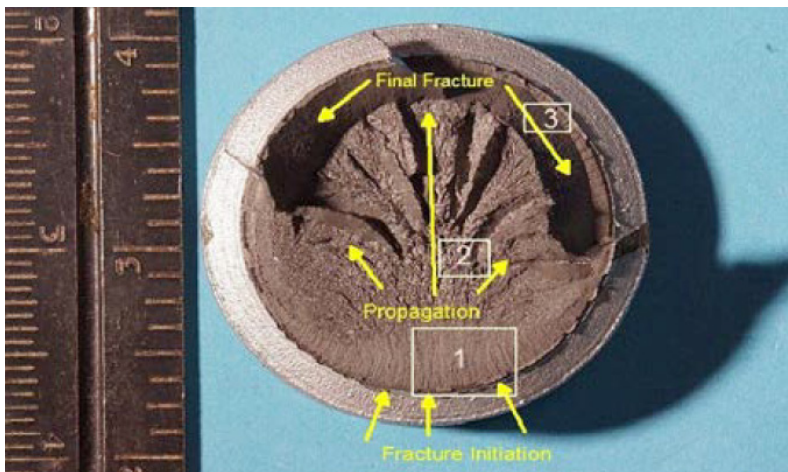
Figure 2.2-44: Fracture Surface Zones

Based on the morphology of the fracture surfaces, initiation of the failures of all of the rods was due to ductile tearing, although later stages of the fracture involved some cleavage. As shown in Figure 2.2-45, the fracture initiation zone shows dimples or “cup and cone” features typical of ductile fracture; in this area, these features indicate that failure was caused by tensile overload.

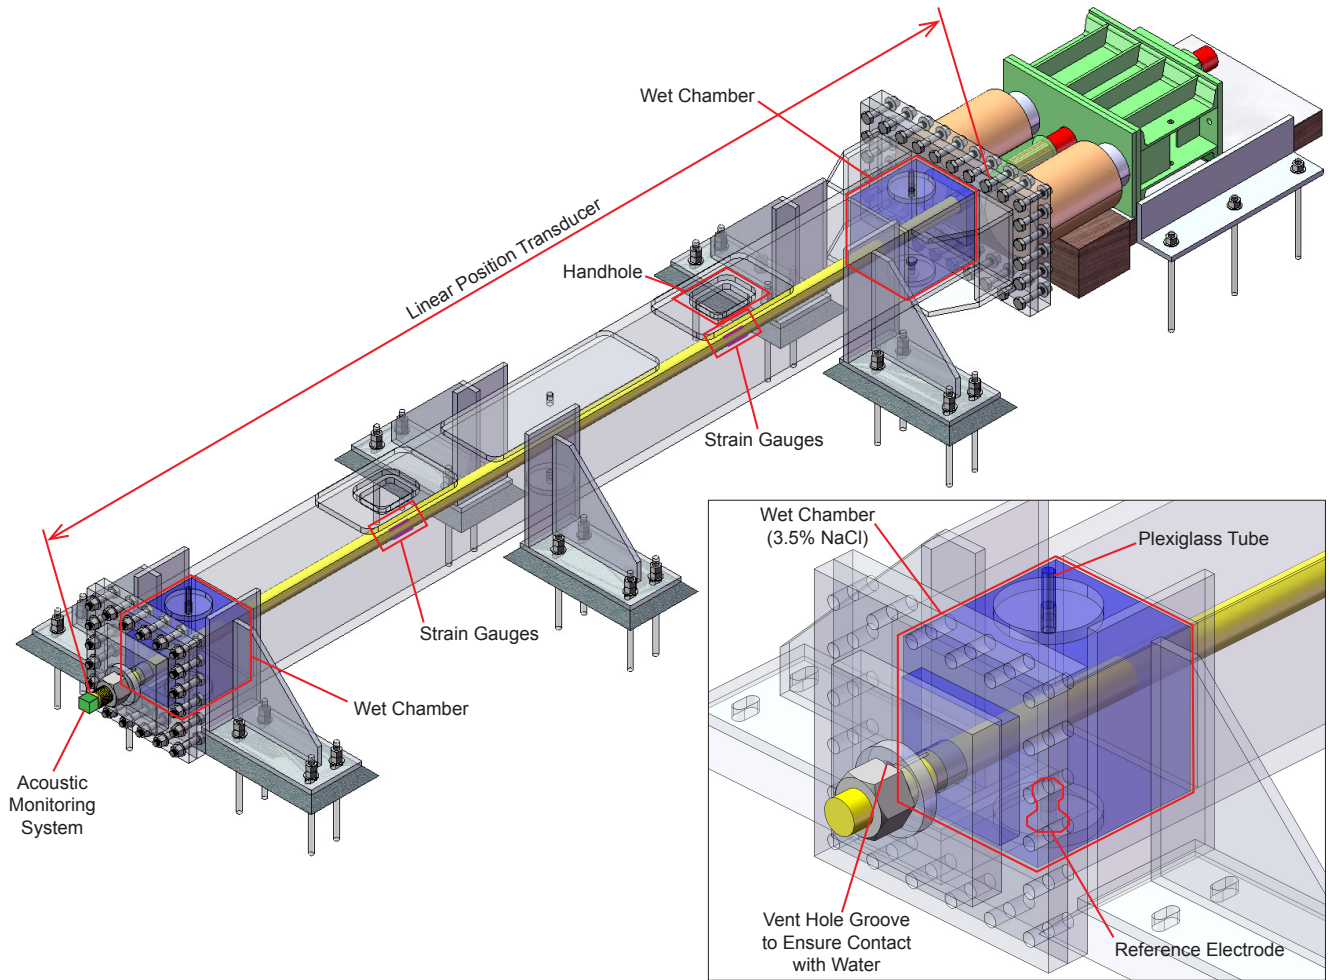
Figure 3.1-1: Test Rig for Full-Length Rods

The Townsend Test for Stress Corrosion Cracking (SCC) or hydrogen embrittlement susceptibility was performed on full-diameter rods selected from the various groups of SAS rods. This test is named after and was designed, together with the assistance of other team members, by Dr. Herbert Townsend, who conducted a small scale version of this test in 1972. The 1975 paper by Dr. Townsend summarizing his work of 1972 is fundamental to the field of hydrogen embrittlement. The selected rods were representative of the population of rods on the SAS in terms of hardness range, diameter, and thread forming. In this test, the tensile load is increased very slowly (in steps) until a threshold load level is established for the onset of cracking due to hydrogen embrittlement. The slow rate of loading is essential to detect the effects of hydrogen that requires time for diffusion. With applied loads up to 1.86 million pounds, the scale of this test is unprecedented for hydrogen embrittlement testing.

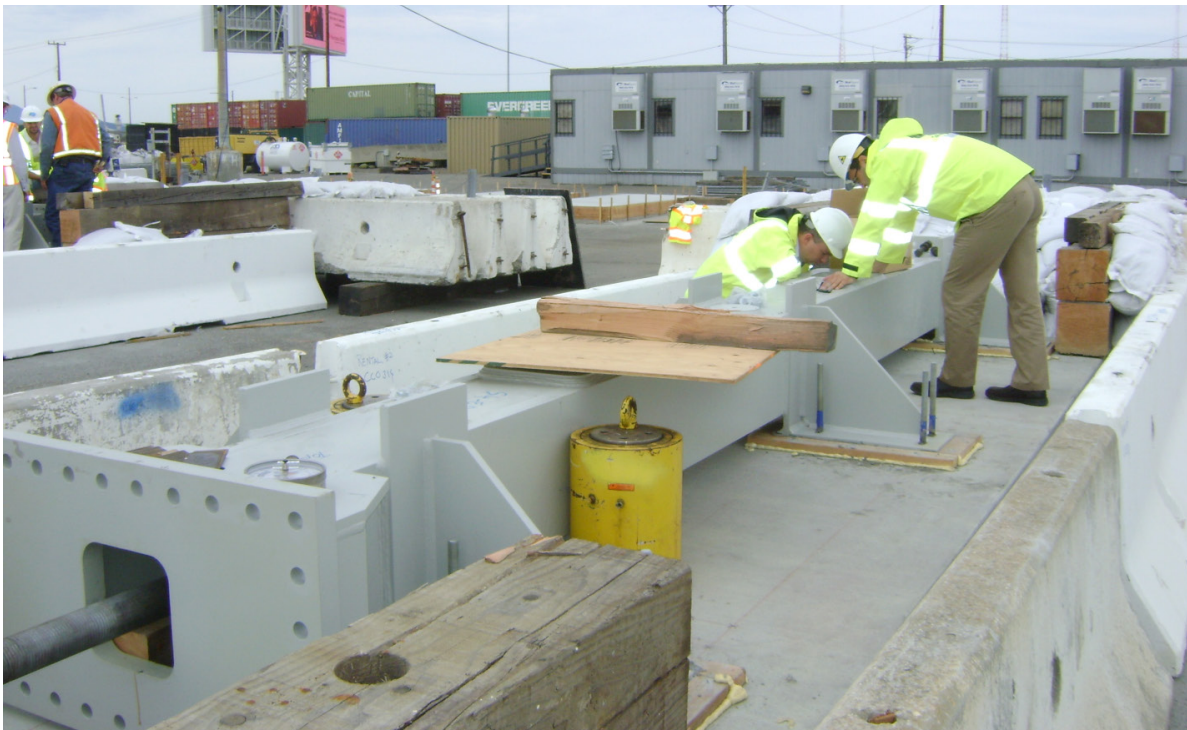
Figure 3.1-2: Test Rig for Full-Length Rods during Setup

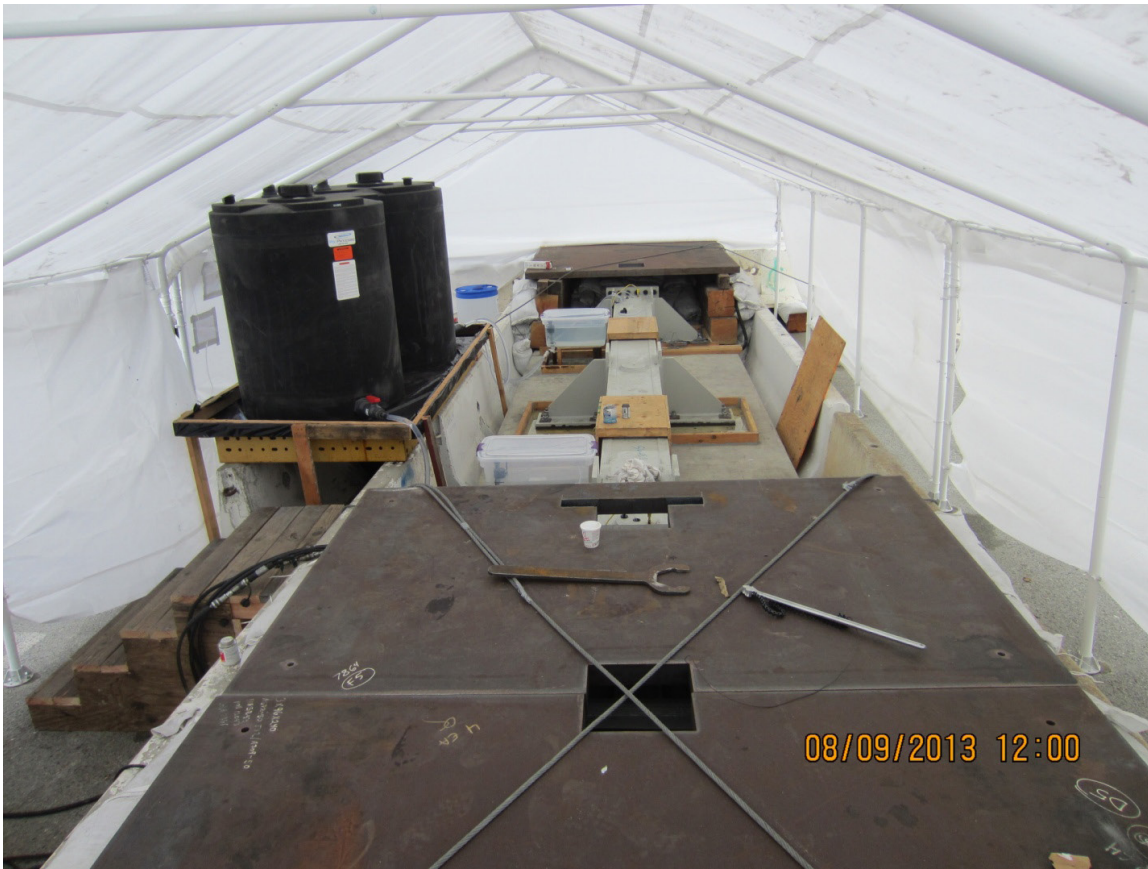
Figure 3.1-3: Test IV in Progress under Protective Tent

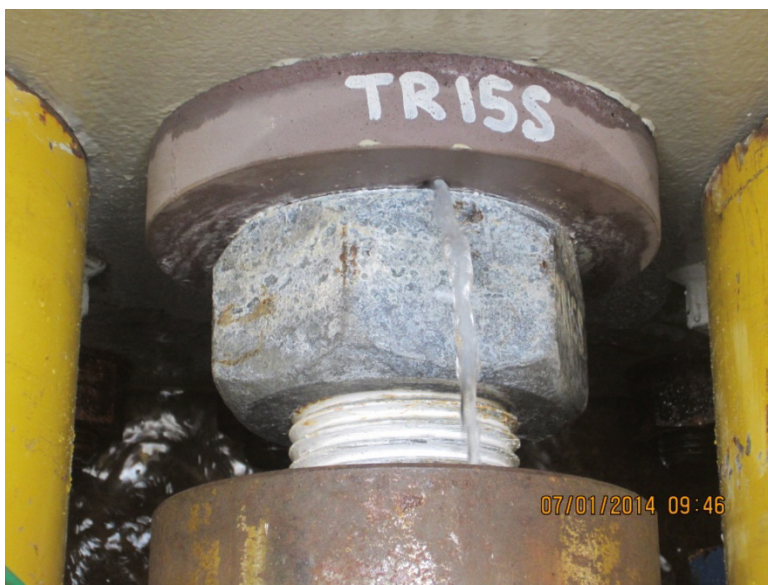
For all the wet chambers in the test rigs, the spherical washer has a groove to permit venting of the NaCl solution (See Figure 3.1-5). This is to ensure flow of the NaCl solution to the first thread of the nut and remove any trapped air. After verifying the flow of the NaCl solution, the groove is sealed with a piece of closed cell backer rod, which is held in place with plumber’s putty. Because this operation happens with the rod under load, the acoustic emissions (AE) are continuously monitored for safety during this operation.

Figure 3.1-5: Venting of Test Solution

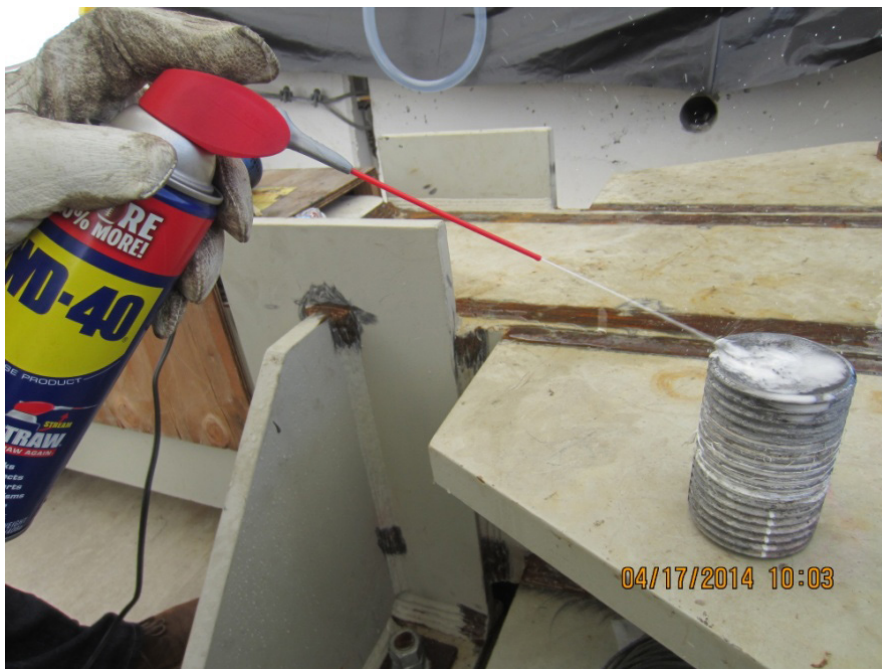
1. The fracture surface and adjacent threads are cleaned with water to remove NaCl from the wet chamber solution and sand from the protective sandbags placed behind the rod.
2. The cleaned areas are dried with compressed air, a heat gun, or a blow drier.
3. The dried areas are sprayed with denatured alcohol to capture any residual water.
4. The areas are dried again with compressed air, a heat gun, or a blow drier.
5. The cleaned and dried fracture surfaces are preserved with WD-40 (See Figure 3.1-6).
6. The pieces of the rods with fracture surfaces are stored in an air-conditioned office with additional WD-40 periodically applied until they are sent to a lab for the post-fracture analysis.

Figure 3.1-6: Fracture Preservation Operation

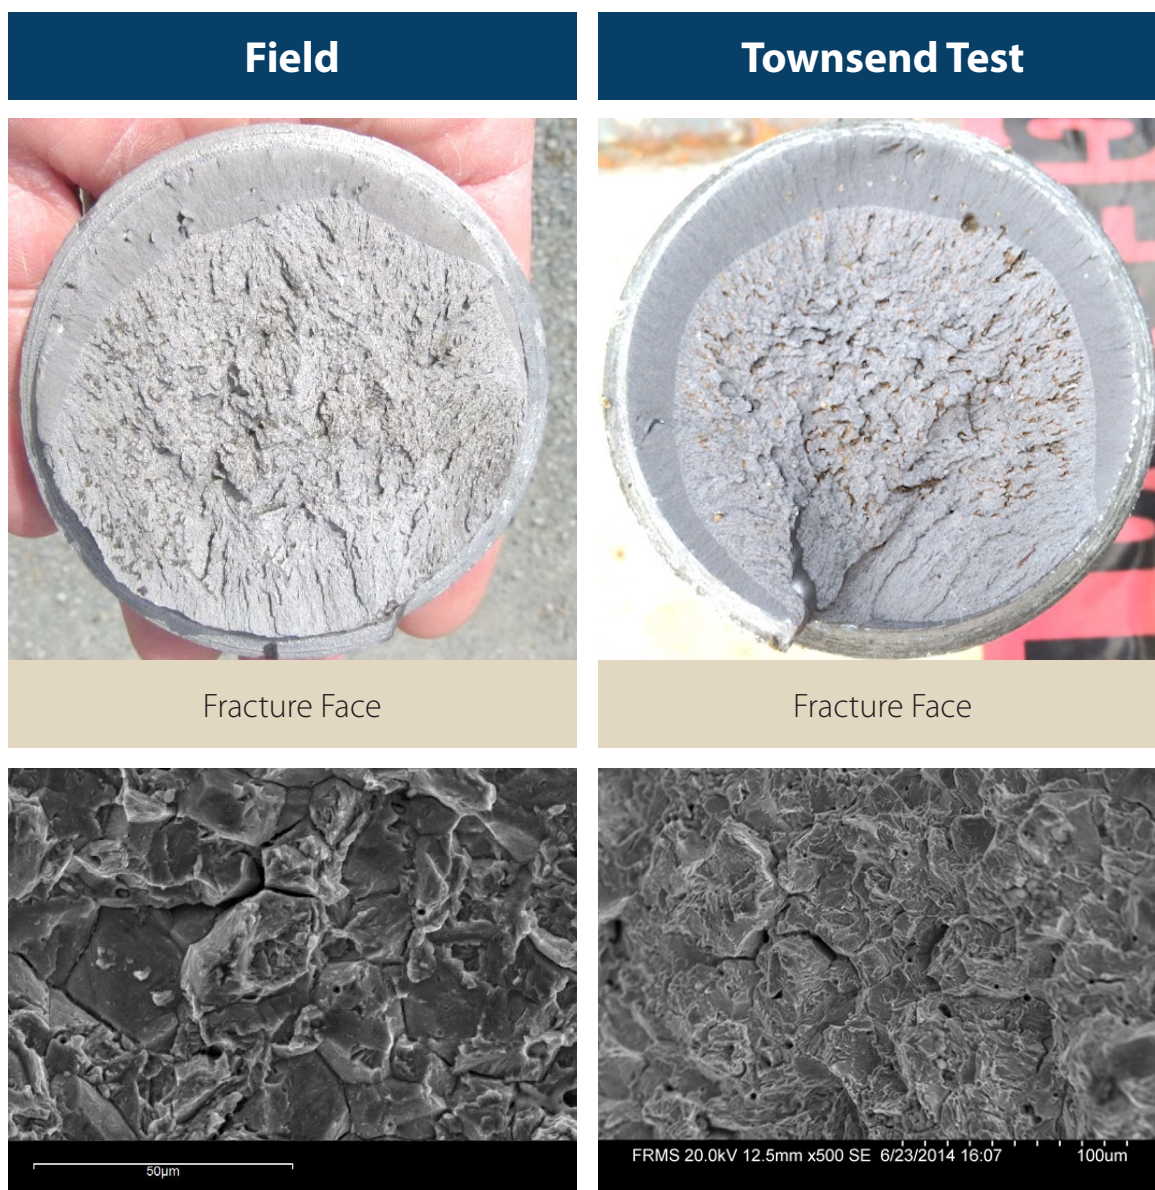
Figure 3.1-9: Test IV — Townsend Test Results Comparison

Hardness values near the outer surfaces of the 2010 Rods 1-4 and 2008 Rods 12 and 13 are virtually identical at HRC 37. Two possible explanations for the lower threshold of the 2008 rods as compared to the 2010 Pier E2 rods have been considered:

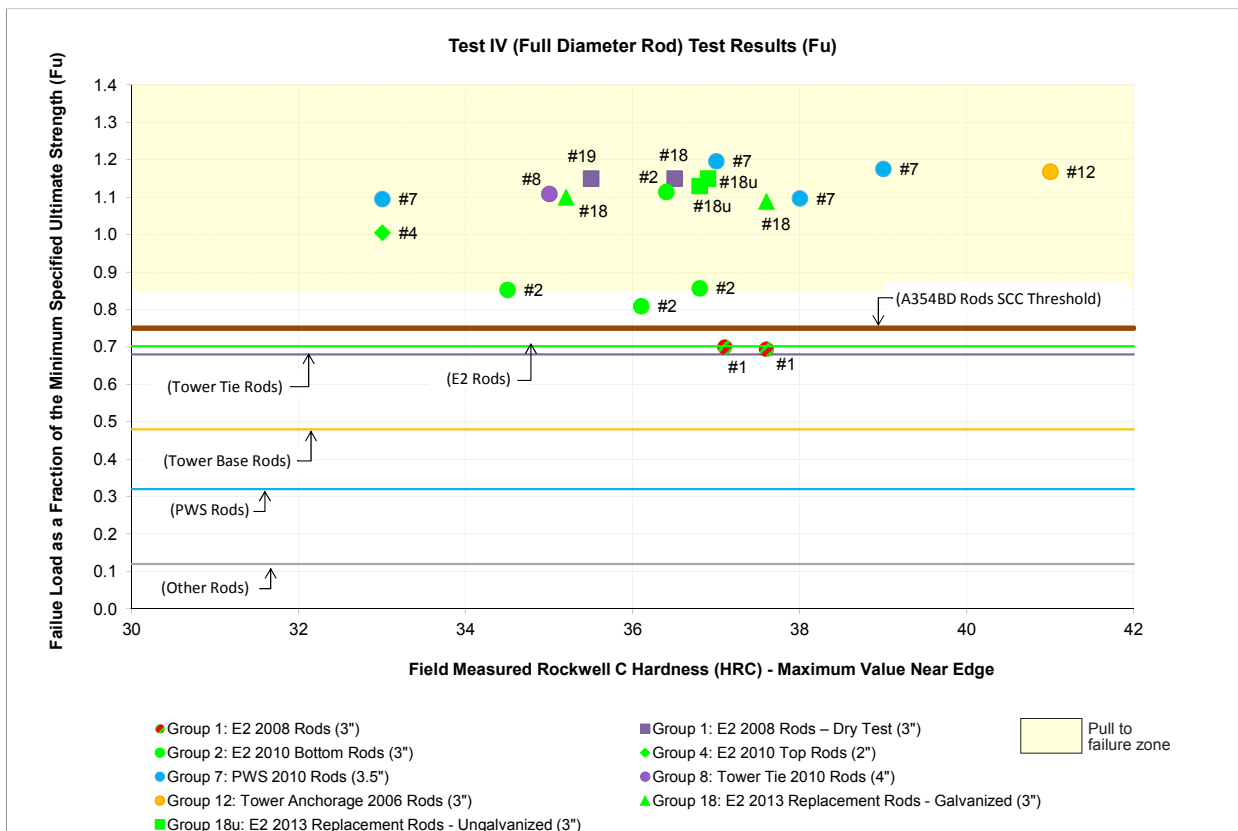
Figure 3.1-10: Test IV Failure Loads for A354BD Rods

The fact that all Phase 4 rods had to be pulled to failure after the six-day hold at 0.85 Fu may also indicate that there is no effect of the galvanized coating on the EHE threshold of this very high-toughness material up to a level of 0.85 Fu. Hardness profiles, which are currently underway, are also needed to determine if the behavior of these rods is a result of higher fracture toughness or lower surface hardness.
