SAN FRANCISCO-
OAKLAND BAY BRIDGE
SELF-ANCHORED SUSPENSION BRIDGE

EVALUATION OF THE ASTM A354 GRADE BD RODS

SEPTEMBER 30, 2014

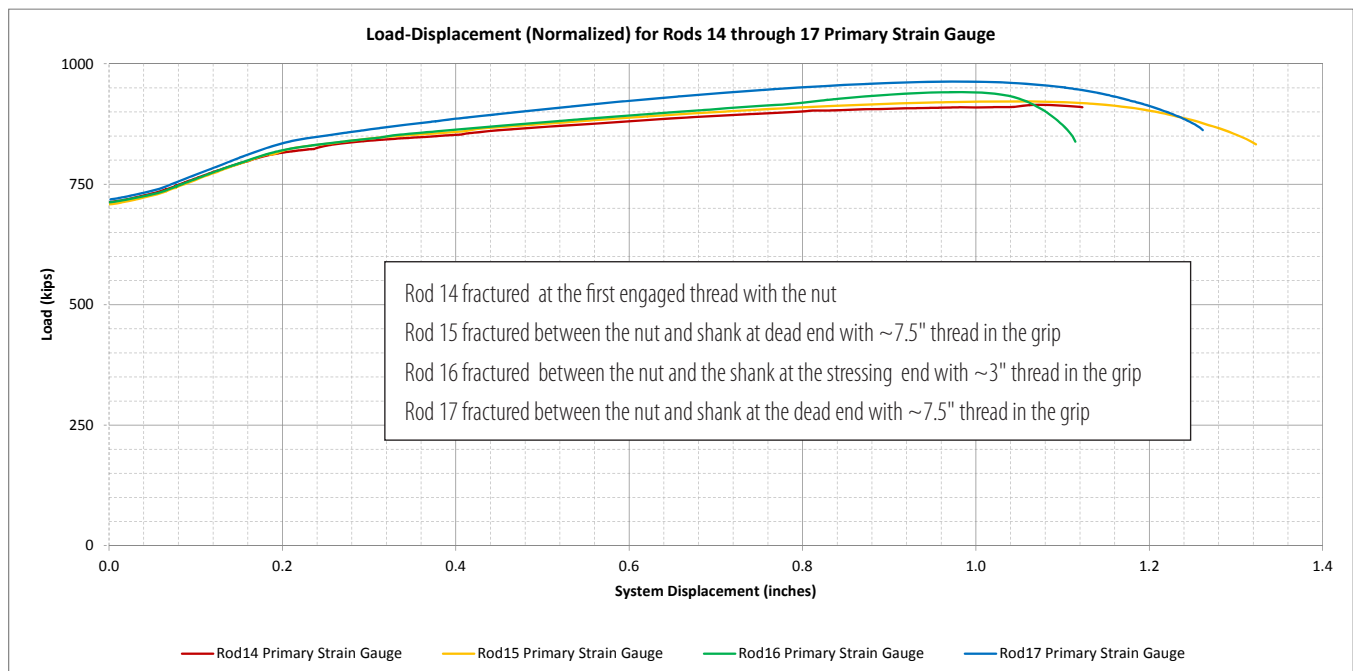
Figure 3.1-11: Load Displacement Graphs for Rods 14–17

Test IV duplicated the failures of 2008 rods on Pier E2 in terms of breaking loads and mechanism of failure. This provides confidence in the results obtained with these and the other rods, as follows.

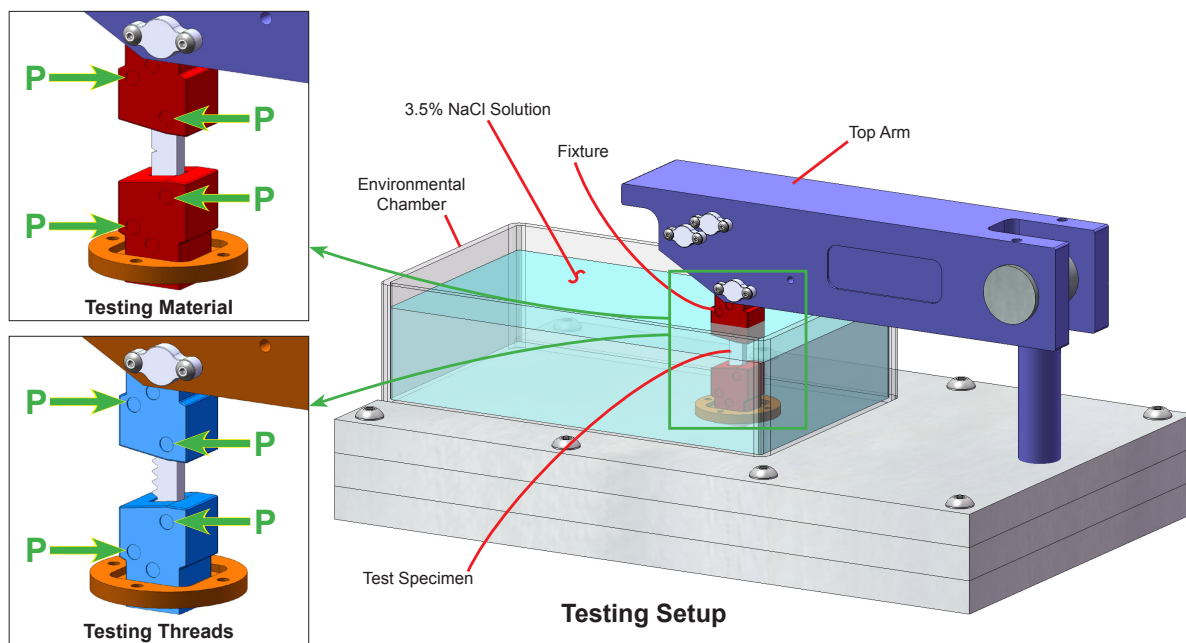
Figure 3.2-1: Bend Test Machine for Incremental Step Loading, Manufactured by FDI

Fixtures: Various types of adapters were used in four-point bending to transmit the measured load applied by the testing equipment to the test specimen.

The Raymond Test is a slow, rising step-load laboratory bend test for susceptibility to hydrogen embrittlement. This test is named after and was conducted, with input from other team members, by Dr. Louis Raymond, who developed a national standard test for establishing hydrogen embrittlement thresholds (ASTM F1624). It was conducted with two types of small specimens cut from full-size rods. In one type, a pre-crack was introduced into rectangular bars to establish material susceptibility according to fracture mechanics procedures. These results were consistent with previously published tests of pre-cracked specimens of this material. A second type of specimen included the threaded portion of the as-built rod without a pre-crack. Testing these specimens gave results that were consistent with the results of the Townsend Test, thus providing independent confirmation of the results obtained with full-diameter rods.

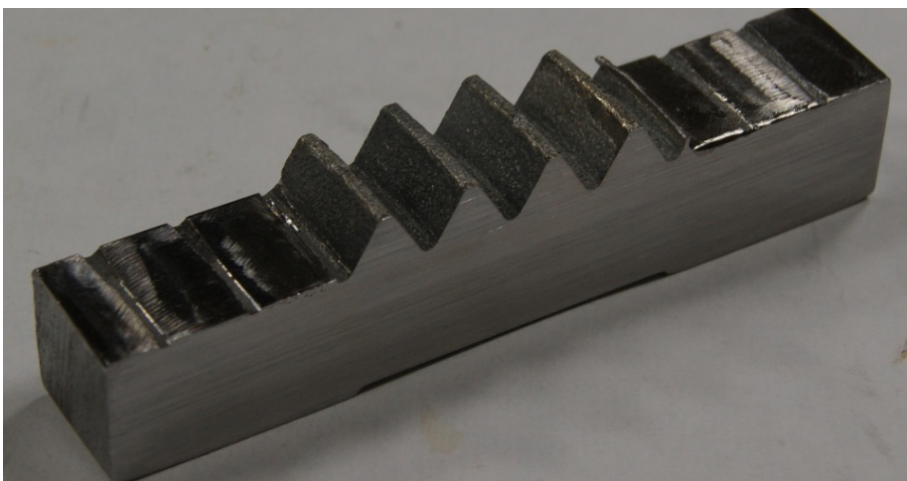
Figure 3.2-3: A Charpy-sized, Threaded Specimen for Determining KI_p

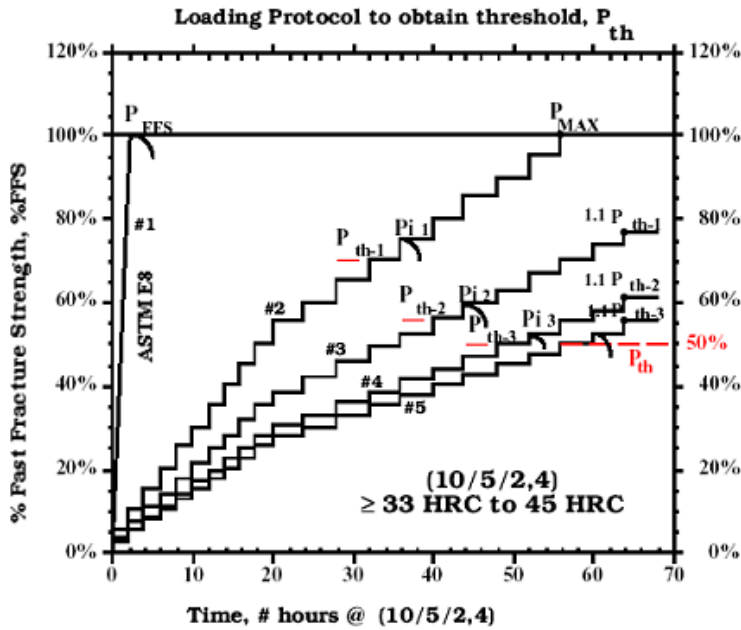
Figure 3.2-6: Schematic of a (10/5/2,4) Step Loading Profile to Determine Threshold for the Hardness of Steel ≥ 33 HRC to 45 HRC

ASTM F1624 was originally developed for testing aerospace steels with a hardness of 50 HRC. Because of the low-strength steel being tested, the net-section stress in bending at which the sub-sized specimen cracks is likely to be above the yield stress of the steel. At these stress levels, significant plastic deformation at room temperature is possible and will produce a load drop that can be confused with crack extension. Figure 3.2-7 shows the load drop curvature that can be used to separate the crack initiation load from yielding.

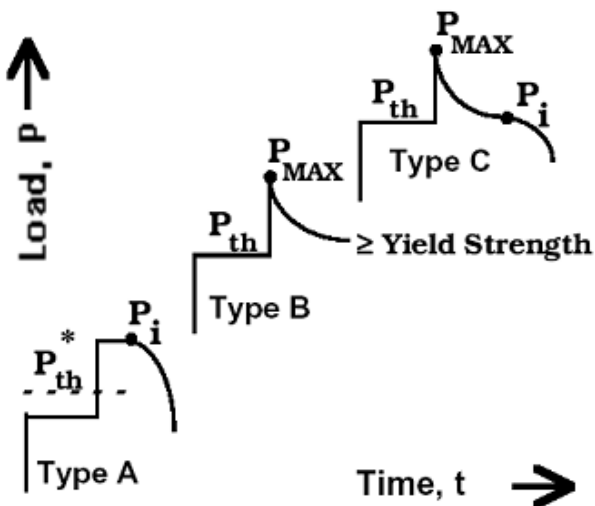
Figure 3.2-7: Definition of Crack Initiation Load, P_i Load and Threshold Load, P_{th}

Hydrogen embrittlement or Stress Corrosion Cracking will produce an accelerating curve that appears as a concave downward Type A load time curve as shown in Figure 3.2-7. On the other hand, yielding will produce a Type B load time curve that is concave upwards.

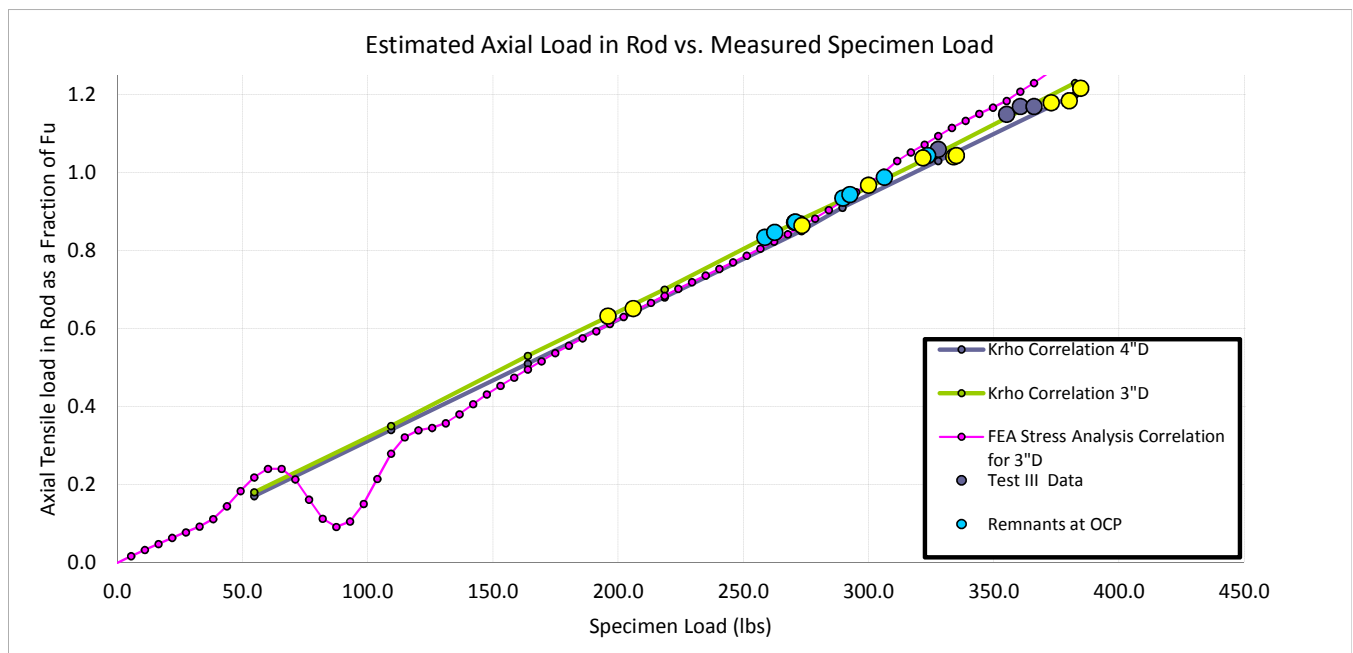
Figure 3.2-10: Estimated Rod F_u vs. Specimen Threshold Load

As can be seen in Figure 3.2-10, the stress-intensity correlation agrees well with the FEM correlation. Test IV Phase I testing found that, out of four rods tested, one had a threshold of $0.75 F_u$, two had a threshold of $0.80 F_u$, and one had a threshold greater than $0.85 F_u$. The data from remnants from Test IV, Phase I Rods and their sister rods identified as 3-V-xx rods (blue data points) match well to the Test IV and Test III results.

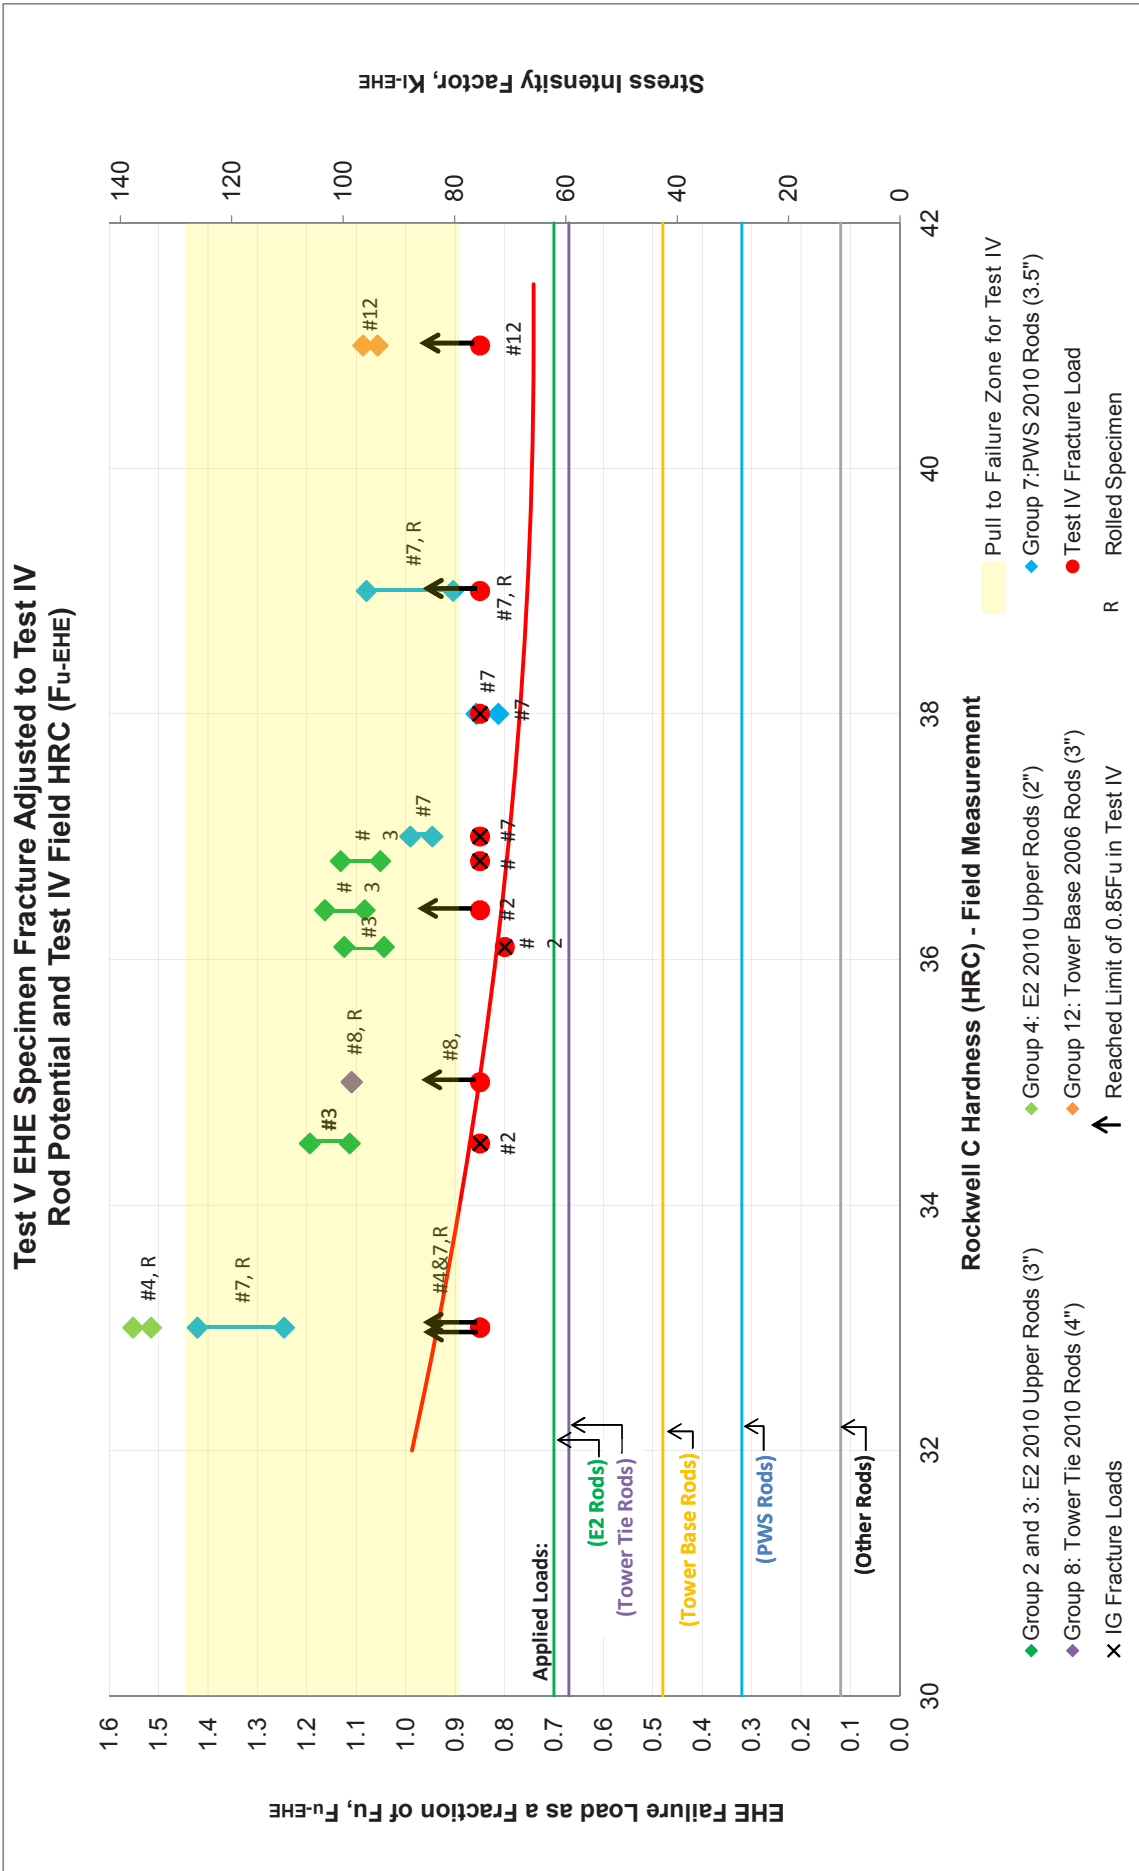
Figure 3.2-14: Test V 2010 and 2006 EHE Specimen Fracture Load in 3.5% Salt Water Adjusted to Test IV Rod Potential (Fu EHE) and Hardness (HRC)

Figure 3.2-14 shows a plot of minimum F_u -EHE against HRC with 2010 Test V data adjusted to the corresponding Test IV rod potential and hardness as described above. Again, the Test IV data was preserved and the Test V data was adjusted for potential and hardness. The figure shows the range of values for each test series. These results also show all rods are significantly above the applied load demand in the SAS. Tables of results can be seen in Appendix M.

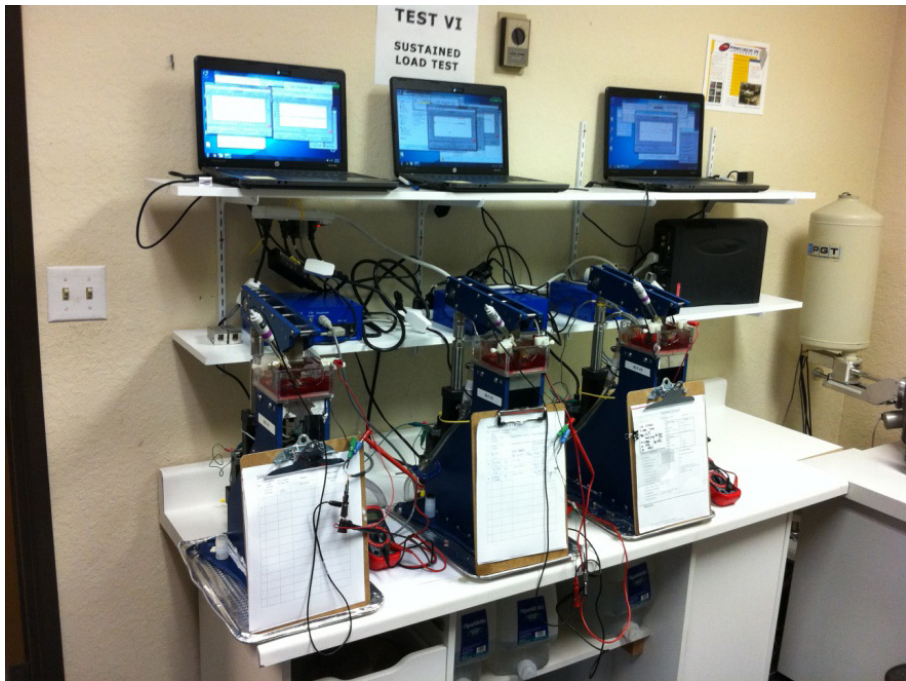
Three test rigs were designed, fabricated, and assembled for sustained load testing of small specimens. A schematic representation of the test rigs is shown in Figure 3.3-3 and a photograph of the three rigs is shown in Figure 3.3-4.

Figure 3.3-4: Three Sustained Load Test Rigs Undergoing Final Check-out Prior to Calibration

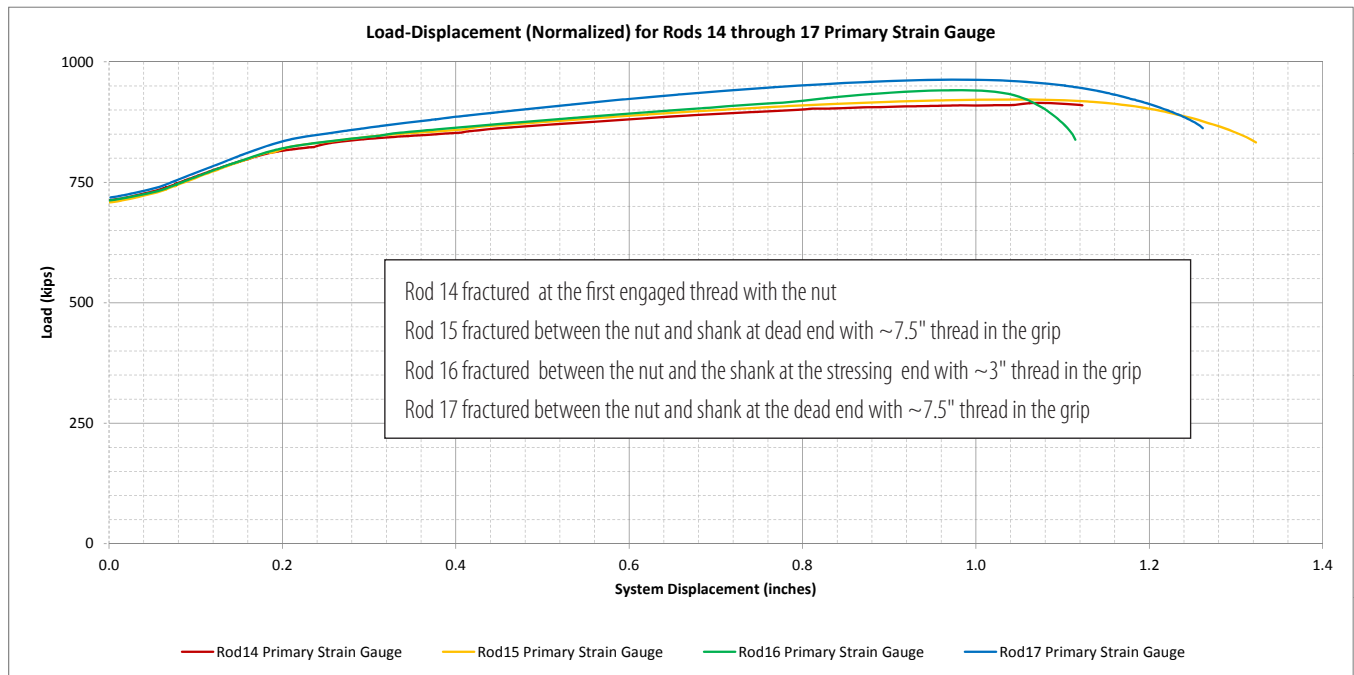
Figure 4.3-3: Load Displacement Graphs for Rods 14 -17 (2013 Galvanized and Ungalvanized)

Figure 4.3-3 shows the load-displacement of the galvanized and ungalvanized 2013 rods after being subjected to step load of Test IV and reaching 0.85 Fu without failure. There are no notable differences in their load-displacement characteristics.

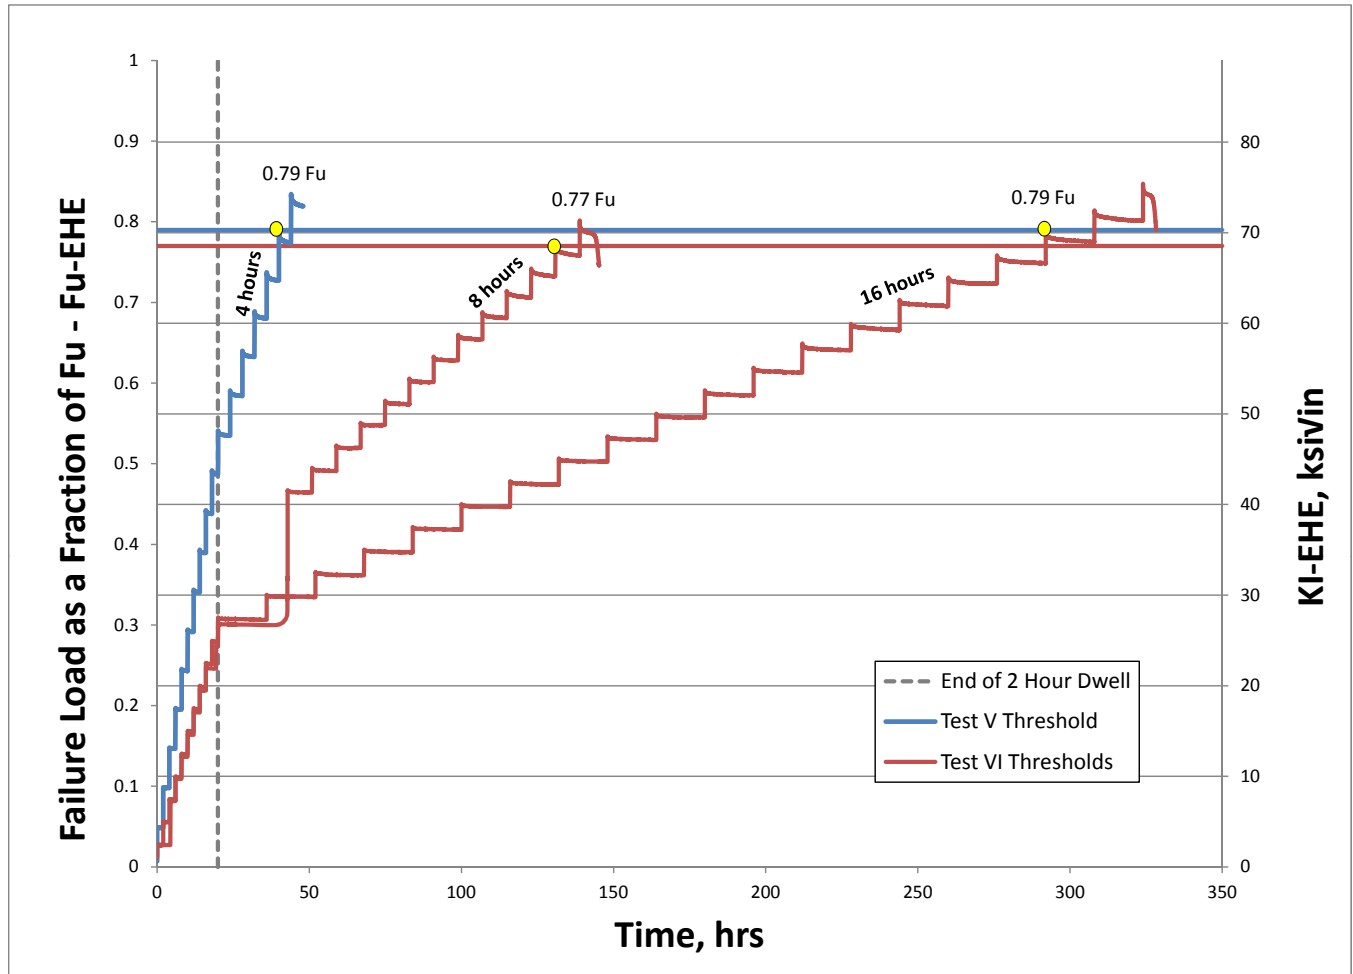
Figure 4.5-1: Test V and Test VI Load Rating

- Test VI validated that the Test IV and Test V strain rates were sufficient to reach a threshold.
- No additional crack initiation mechanisms were identified by decreasing the loading rate in Test VI, equivalent to extending the RSL-dwell time to eight hours or 16 hours.
