BATA OVERSIGHT COMMITTEE

Wednesday, April 10, 2013, 9:30 a.m.

THE SAN FRANCISCO-OAKLAND
BAY BRIDGE
SEISMIC SAFETY PROJECT

BATA Oversight Committee – April 10, 2013

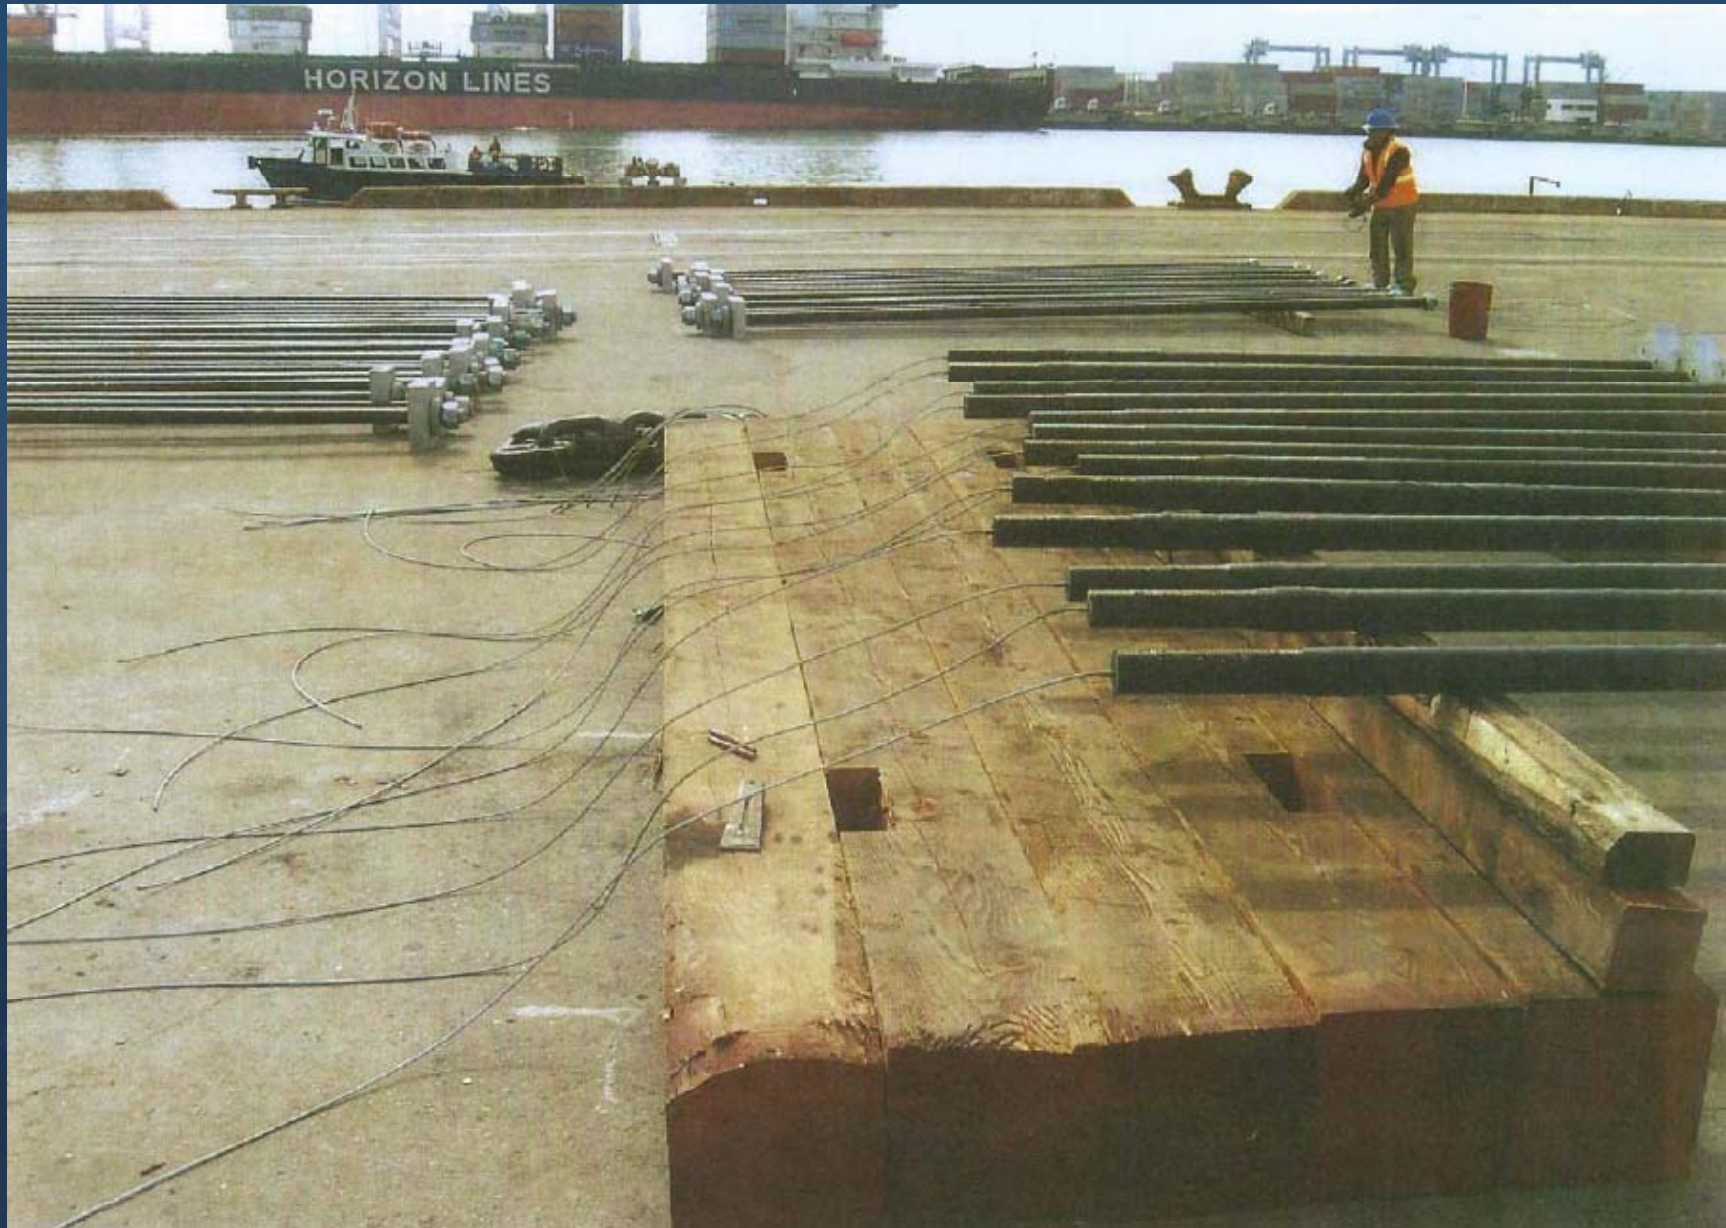
I've just got a couple of images here to... I think you've seen some of these in the past. But, again, you have an image of the rods at delivery. I've got one piece of one of the fractured rods sitting in front of me here just to give you some sense of the size of these. These things are really big. And, again, they range from about 9-1/2- to 24 feet in length, 3 inches in diameter. These are massive, steel components of the bridge. Next slide.

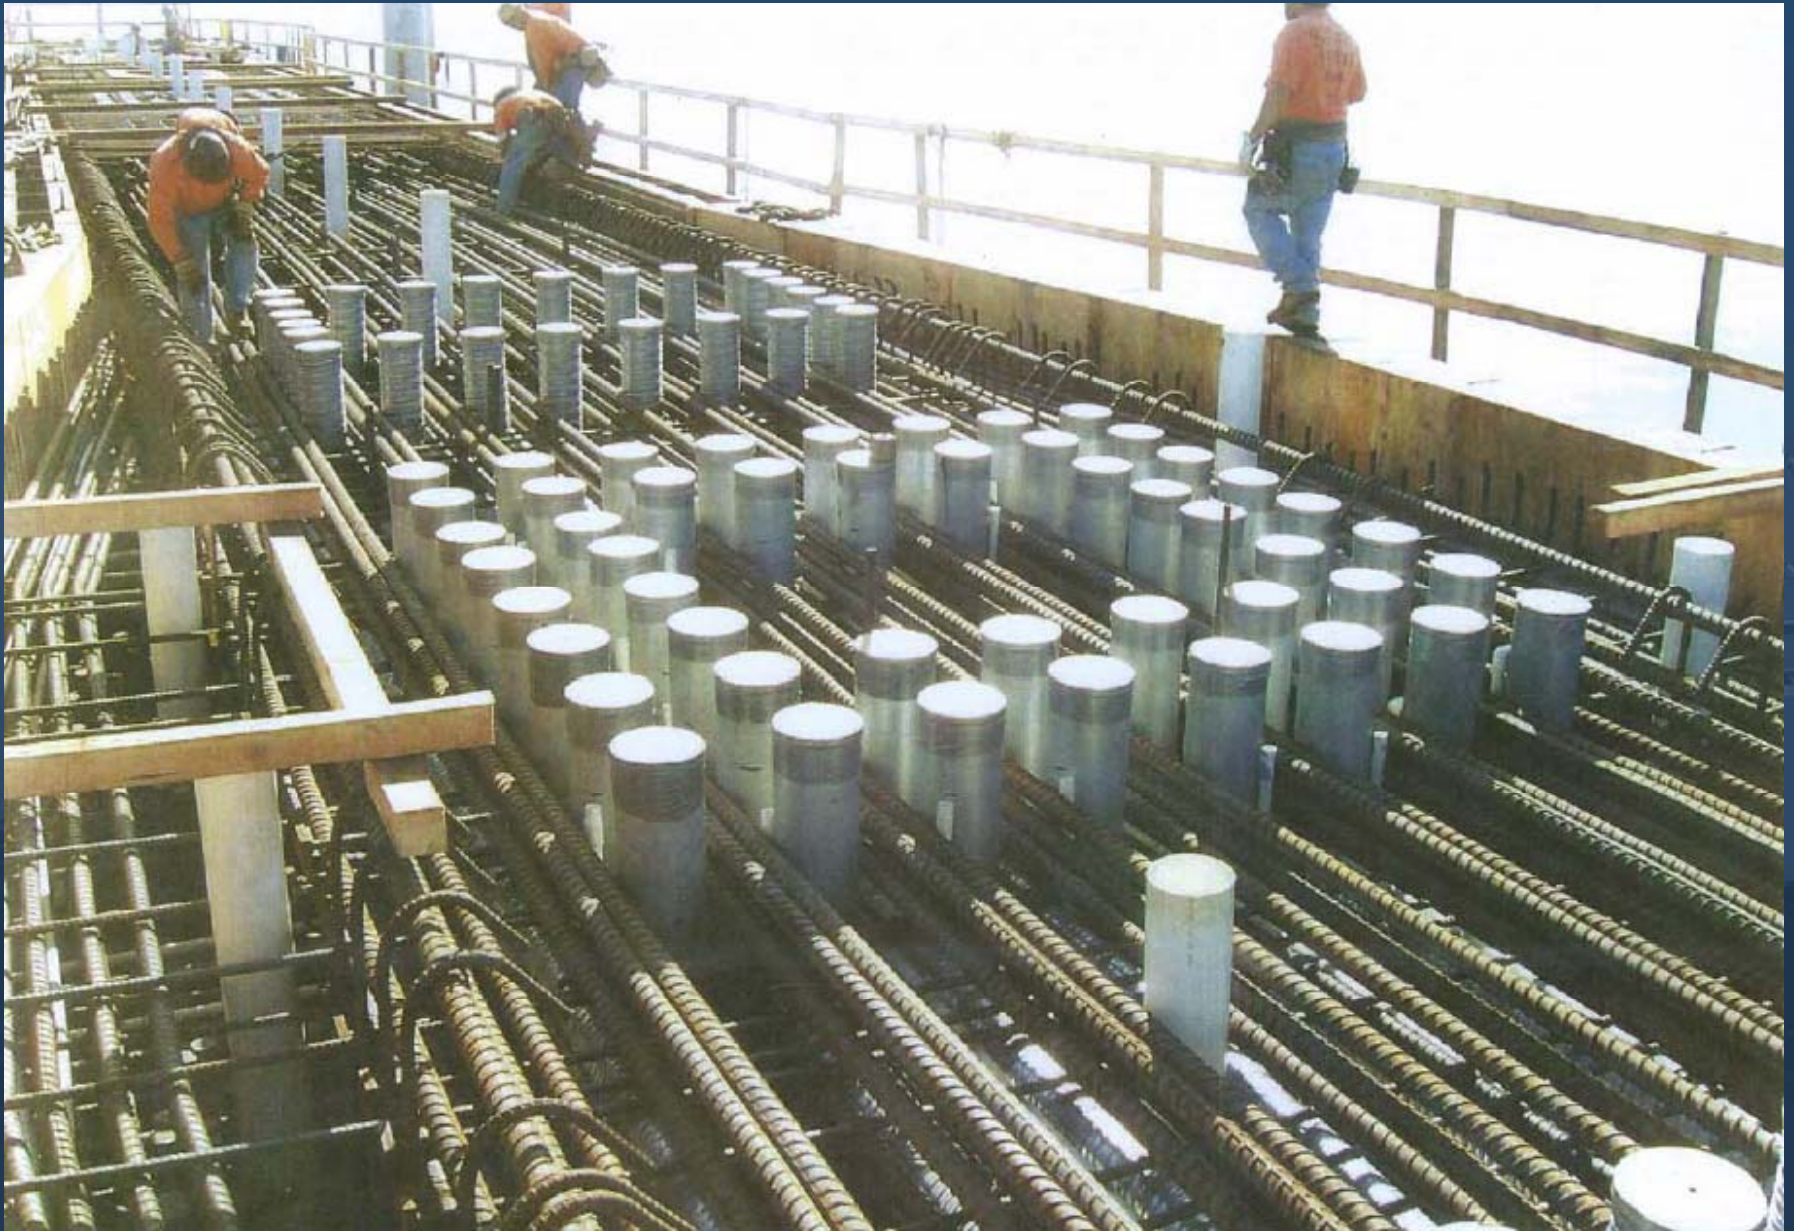
And here we, again, have a slide showing you sort of an x-ray image of the rods in place, again, showing you how those center rods are sitting right on top of the column, which does present some access challenges at this point in time. You also see on this diagram where we have observed the location of the fractures. This is an important forensic piece for us. Again, we've extracted four rods at this point from shear key S1 and S2. We will be extracting more in the future, but with respect to the four that we have extracted, all of the fracture locations are the same. They are all down at the

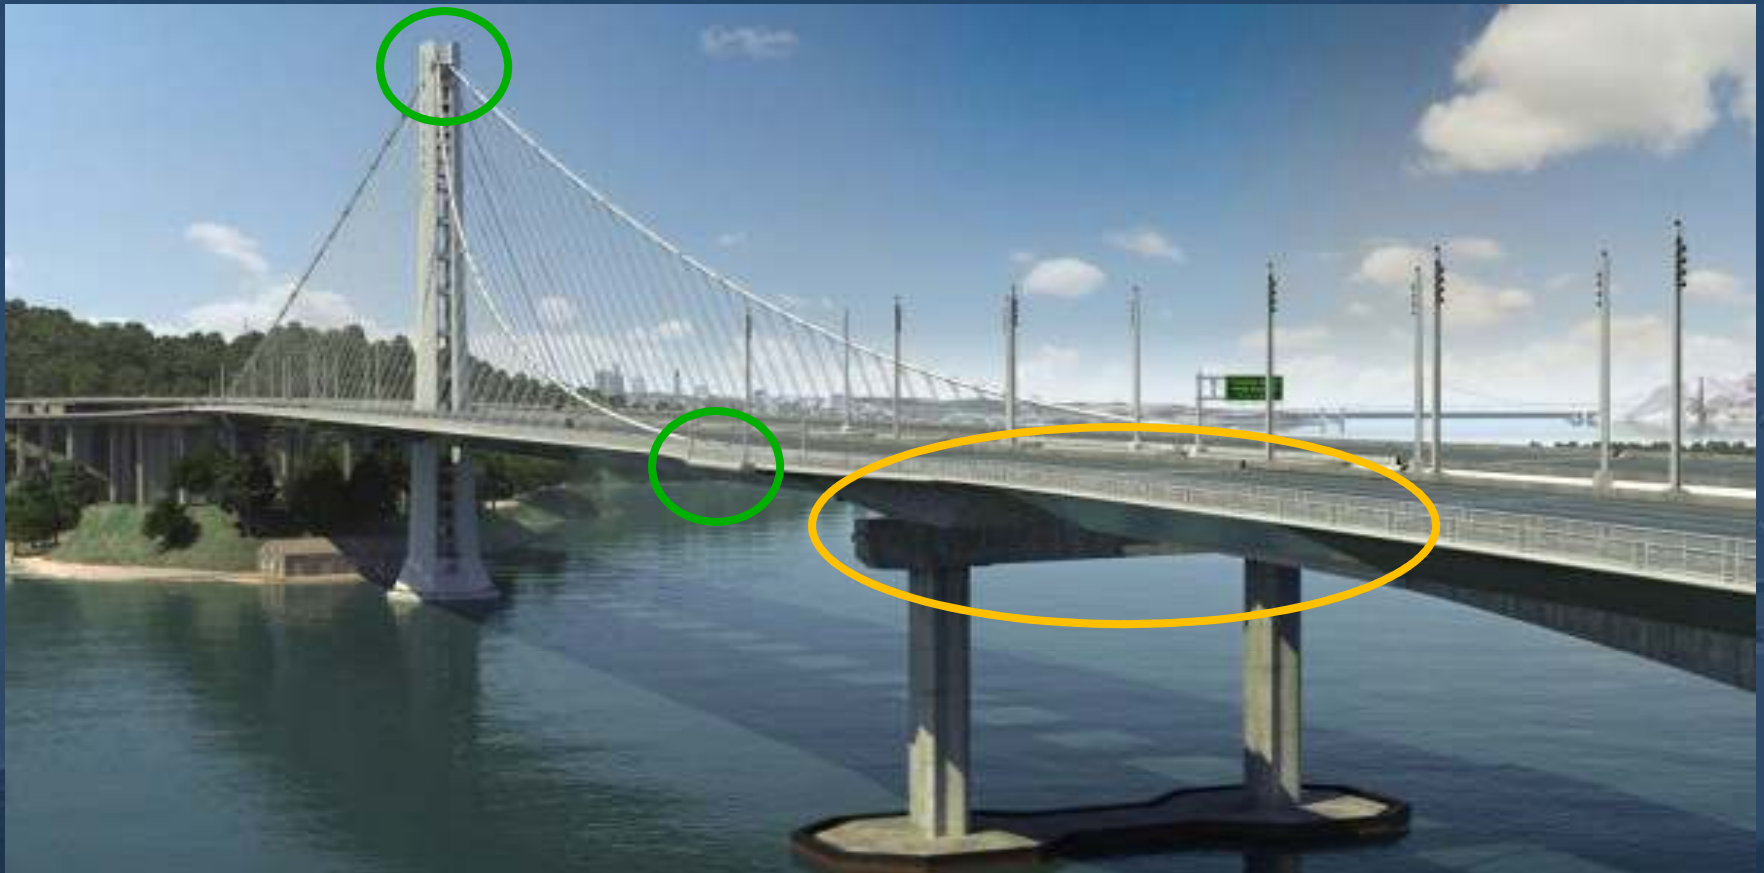
- **Visual inspections of similar rods by the same manufacturer have been completed with no abnormalities.**
- **A desk audit of QC/QA results still underway**
