**BAY AREA TOLL AUTHORITY (BATA) MEETING**

6. Bay Bridge Anchor Bolts Update (Peter Lee)

# Briefing on E2 Anchor Bolts – April 24, 2013

THE SAN FRANCISCO-OAKLAND  
**BAY BRIDGE**  
SEISMIC SAFETY PROJECT

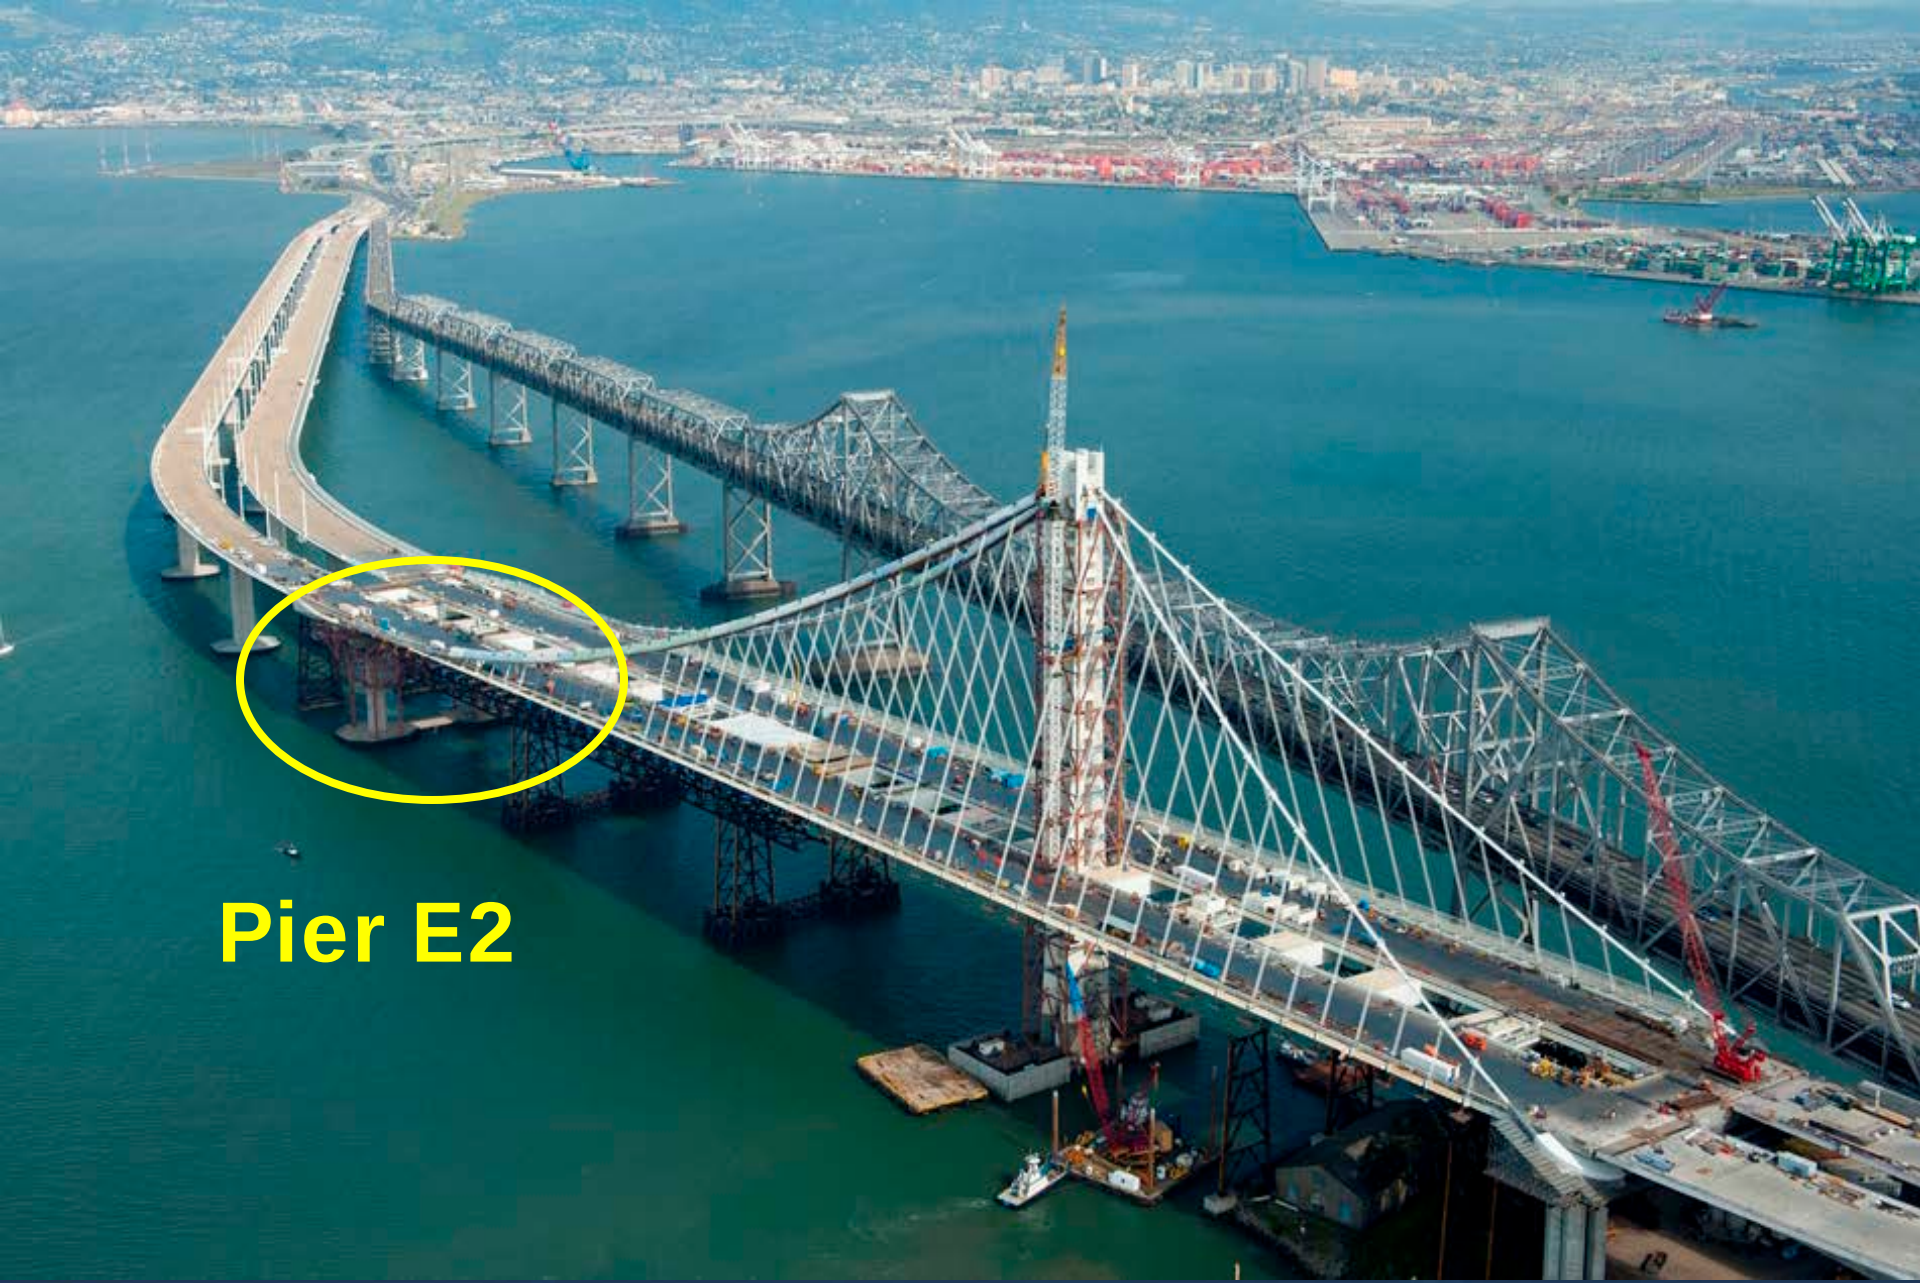
**Pier E2**

- 1. What caused the E2 anchor bolts manufactured in 2008 to fail?**
- 2. What retrofit strategy should be used to replace the 2008 anchor bolts?**
- 3. Should the anchor bolts manufactured in 2010 be replaced?**

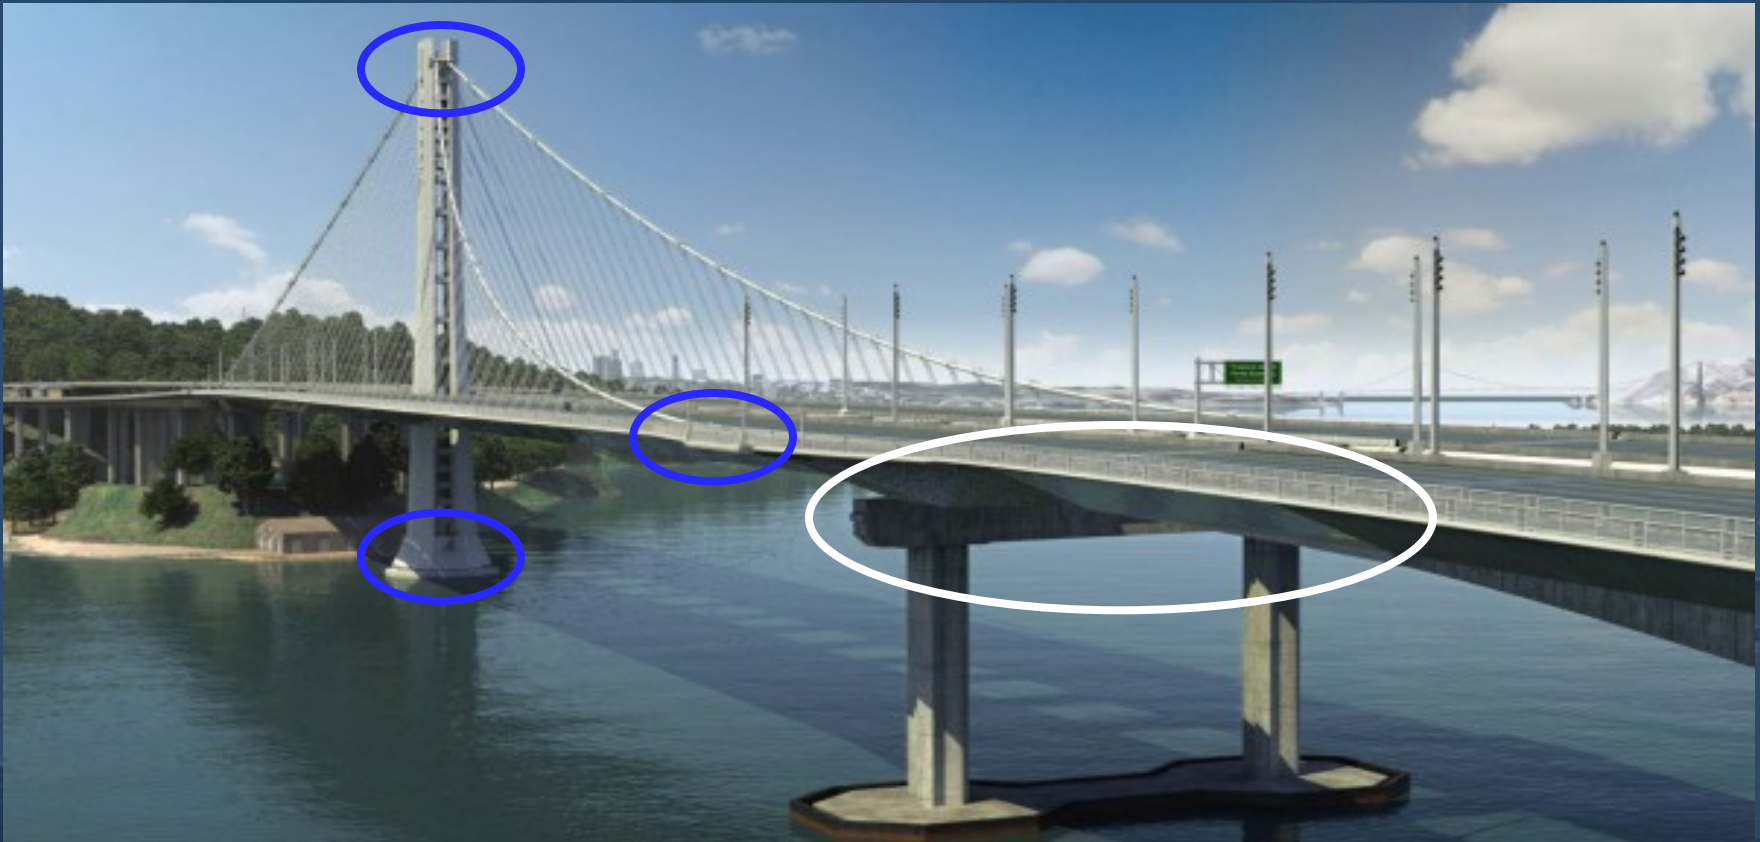
- Visual inspections of similar anchor bolts revealed no abnormalities.
- Some E2 Bearing assembly bolts are not accessible to inspection.
- Most anchor bolts at other locations are under lower tension levels.
- Prioritized Desk Audit of QC/QA results underway.
