## **BATA OVERSIGHT COMMITTEE**

# Briefing on E2 Anchor Bolts – May 8, 2013

THE SAN FRANCISCO-OAKLAND  
**BAY BRIDGE**  
SEISMIC SAFETY PROJECT

Metallurgical Analysis of Bay Bridge Broken Anchor Rods S1-G1 & S2-A6

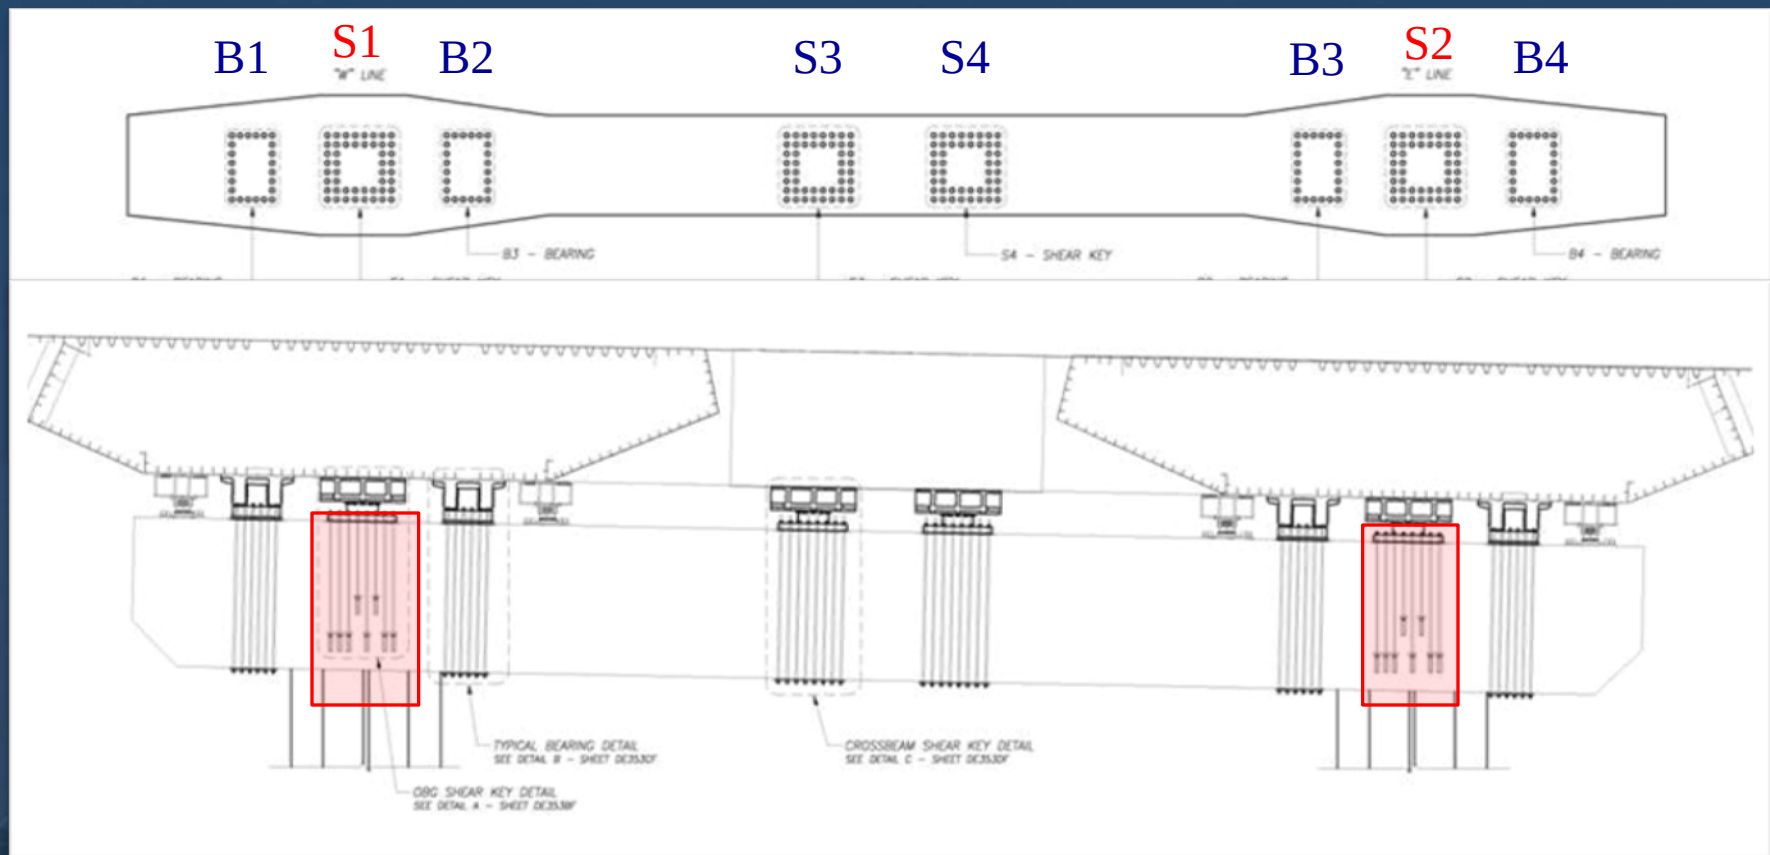
- Bearings and shear keys are secured to E2 by 3 inch diameter bolts, ranging from 9 feet to 24 feet in length and to the OBG by 2 to 3 inch diameter bolts ranging 2 to 5 feet in length.
- 96 bolts manufactured in 2008 shown in red are embedded in the pier.

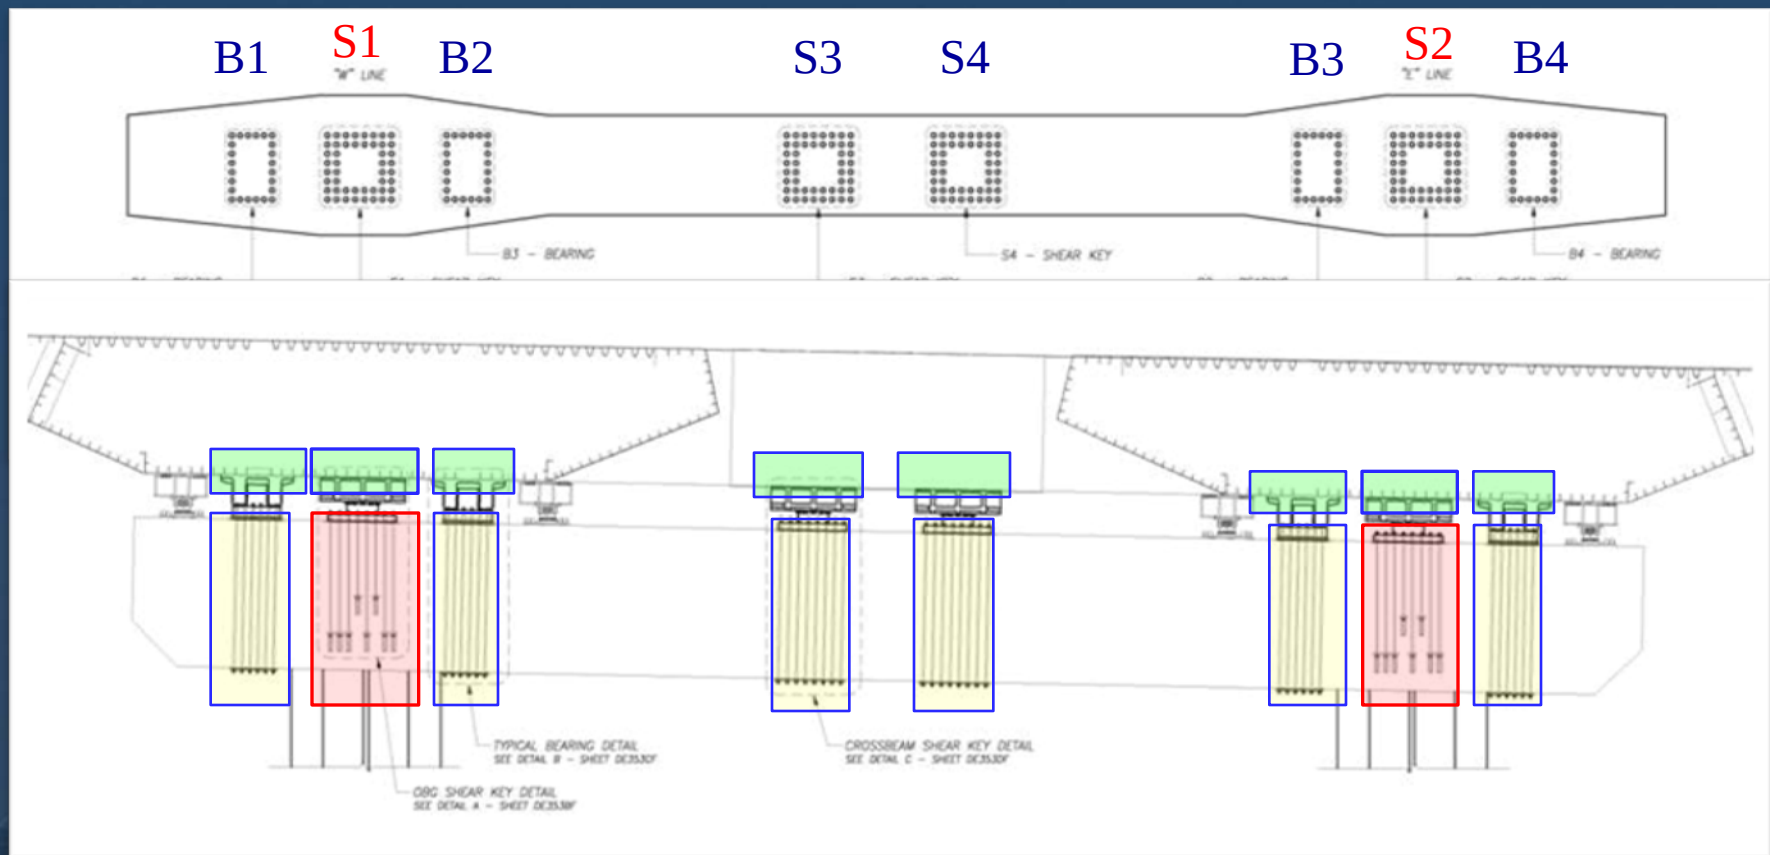
- 96 bolts manufactured in 2008 shown in red are embedded in the pier.
- 192 bolts manufactured in 2010 shown in yellow are not embedded in pier.
- 544 bolts manufactured in 2010 shown in green are connected to the OBG.
- There are an additional 432 bolts of 1 inch diameter, varying from 2 inches to 2 feet in length, that are internal to the E2 bearing assembly.

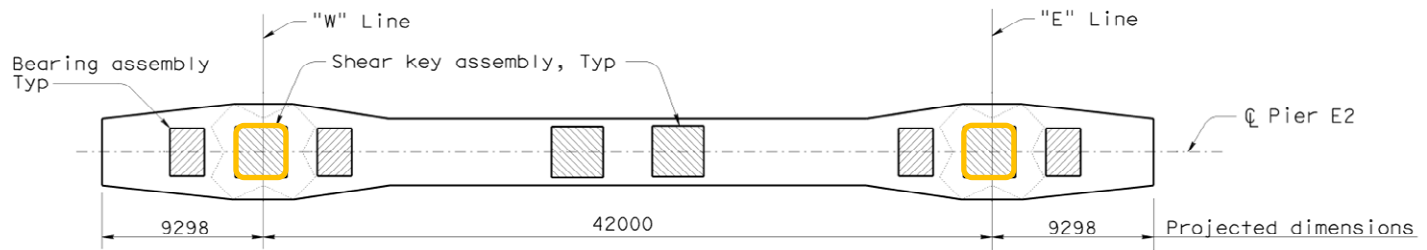
**Figure 1: Plan View of Pier E2 Layout**

A total of 288 ASTM A354 grade BD [1] bearing and shear key anchor rods (3 inch diameter) were installed at Pier E2 per the contract requirements (Figure 1). Ninety six (96) of these anchor rods are installed at shear keys S1 and S2 underneath the E-Line and W-Line OBG's, embedded into the concrete as shown in Figure 2. These rods were fabricated at Dyson between June 4, 2008 and September 6, 2008.

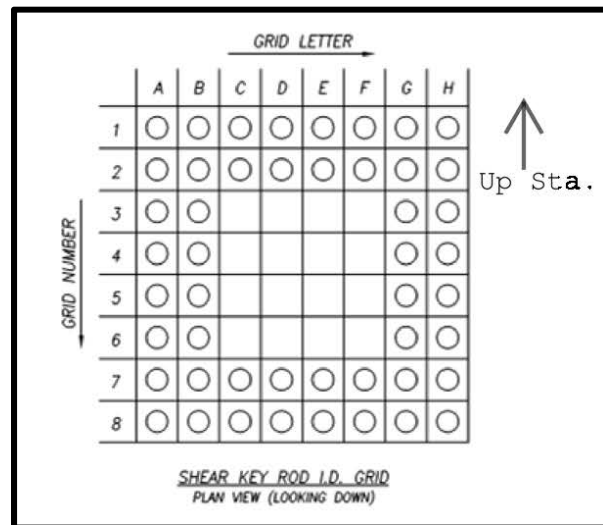
Figure 3: Shear Key Rod Identification Grid

The Contractor started tensioning S1 and S2 anchor rods between March 1, 2013 and March 5, 2013. In accordance with the Contract Documents and approved Submittal 2747, the rods were initially jacked to 0.75  $F_u$  (i.e., 75% of ultimate tensile strength). Due to seating losses as the load is transferred from the jack to the nut, the load is expected to reduce to the final design load of 0.68  $F_u$ . Between March 8, 2013, and March 15, 2013, 32 out of 96 rods fractured. The Contractor extracted three rods (Rod ID's S1-G1, S2-A6, and S2-H6) for further analysis. Figure 3 below shows a schematic of the shear key layout with the rod identification system. Due to small overhead clearance, the rods were extracted in multiple sections. The sections were numbered incrementally from top to the bottom. Therefore the first section pulled out from rod ID S2-A6 is identified as S2-A6 #1 and the bottom section (with the fractured surface) is

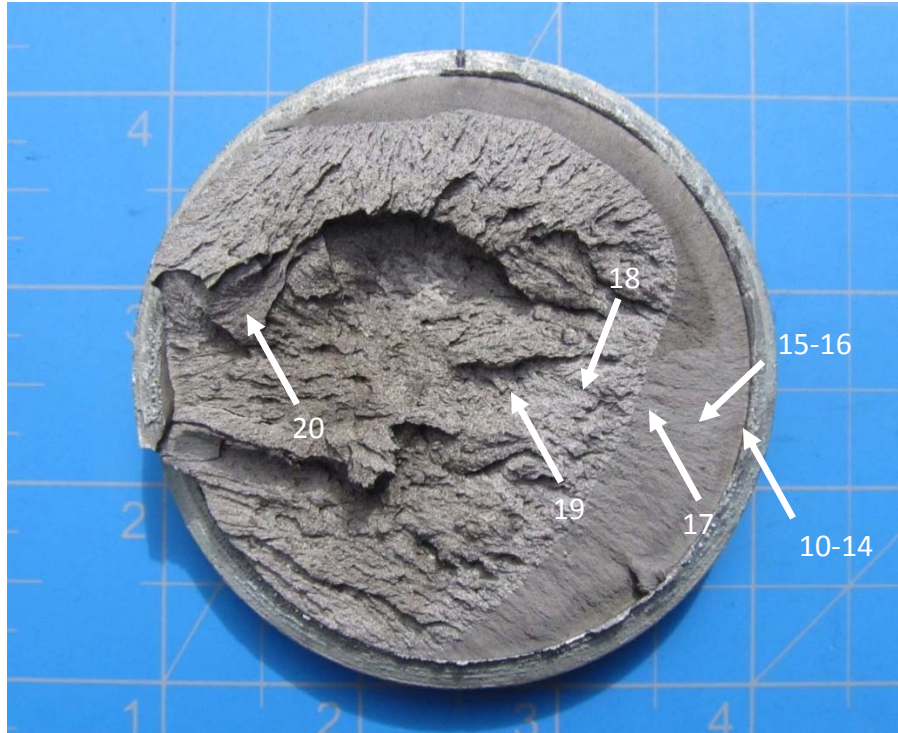
The fracture surfaces were examined at high magnification with a scanning electron microscope (SEM) to further characterize the failure mechanism. Intergranular fracture morphology was observed at, and near, the thread root (i.e., crack origin). See Photos 9-14. Intergranular cracking is a characteristic feature indicative of a number of brittle fracture mechanisms, including hydrogen assisted cracking. Intergranular features were predominant at the thread root (i.e., crack origin). Gradually increasing mixed morphology was observed as the crack progressively grew and extended inward from the thread root (i.e., more ductile tearing, and less intergranular features). See Photos 15-17. Sudden fast fracture occurred when the crack reached a critical size, wherein the reduced capacity of the rod could no longer sustain the applied load. The morphology across the final fast fracture zone was almost exclusively cleavage (brittle fracture mechanism). See Photos 18-20. This observation is considered unusual. Final rupture of bolts (in the strength range of A354 grade BD) caused by tensile overload following crack propagation typically occurs in ductile mode.

Photo 9) Fractured rod S1-G1 showing the locations of SEM photos 10-20.

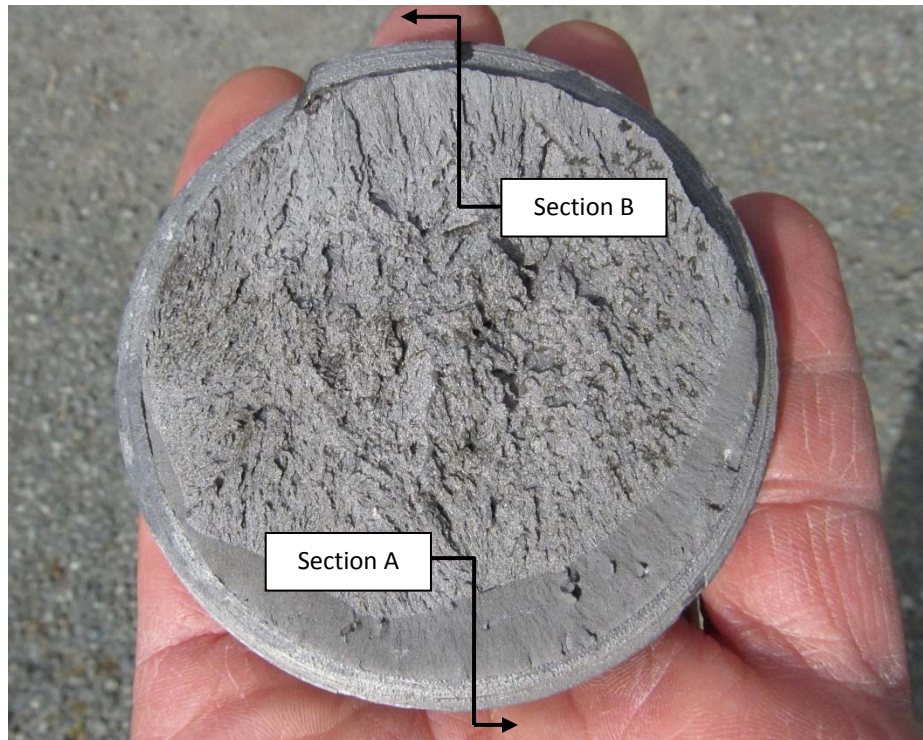
Cross-sections were cut from both rods and metallurgically prepared (i.e., mounted/potted, polished and etched). The location of the cross-sections is shown in Photos 21-22. The observed microstructure was generally tempered martensite, which is the normal structure associated with quenched and tempered AISI 4140 steel. However, many areas especially toward the center of the rod, showed evidence of incomplete martensitic transformation. The regions of incomplete transformation, as characterized by the observed presence of ferrite and pearlite, appeared to alternate in banded layers between regions of fully transformed martensitic structure. The banded nature of the microstructure is an indication that the material is not homogeneous. See Photos 23-26. Additionally, there was a relatively high amount of non-metallic stringer inclusions present in the microstructure. See Photos 27 and 28.

Photo 21) Fractured rod S2-A6 showing the location of cross-sections for microstructural examination and microhardness tests.

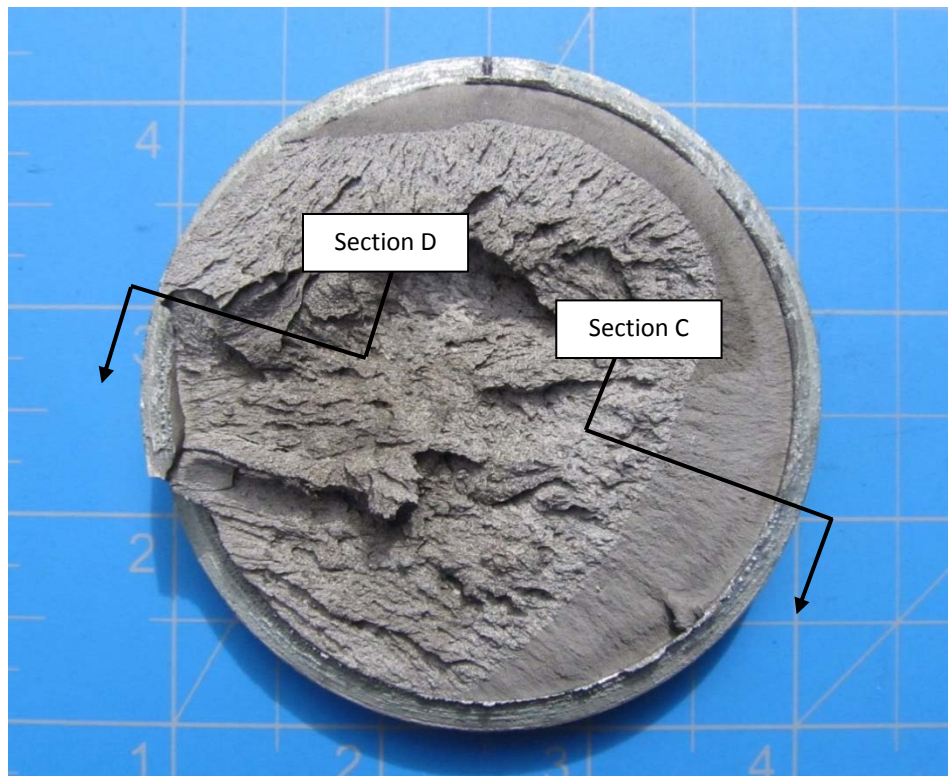
Photo 22) Fractured rod S1-G1 showing the location of cross-sections for microstructural examination and microhardness tests.

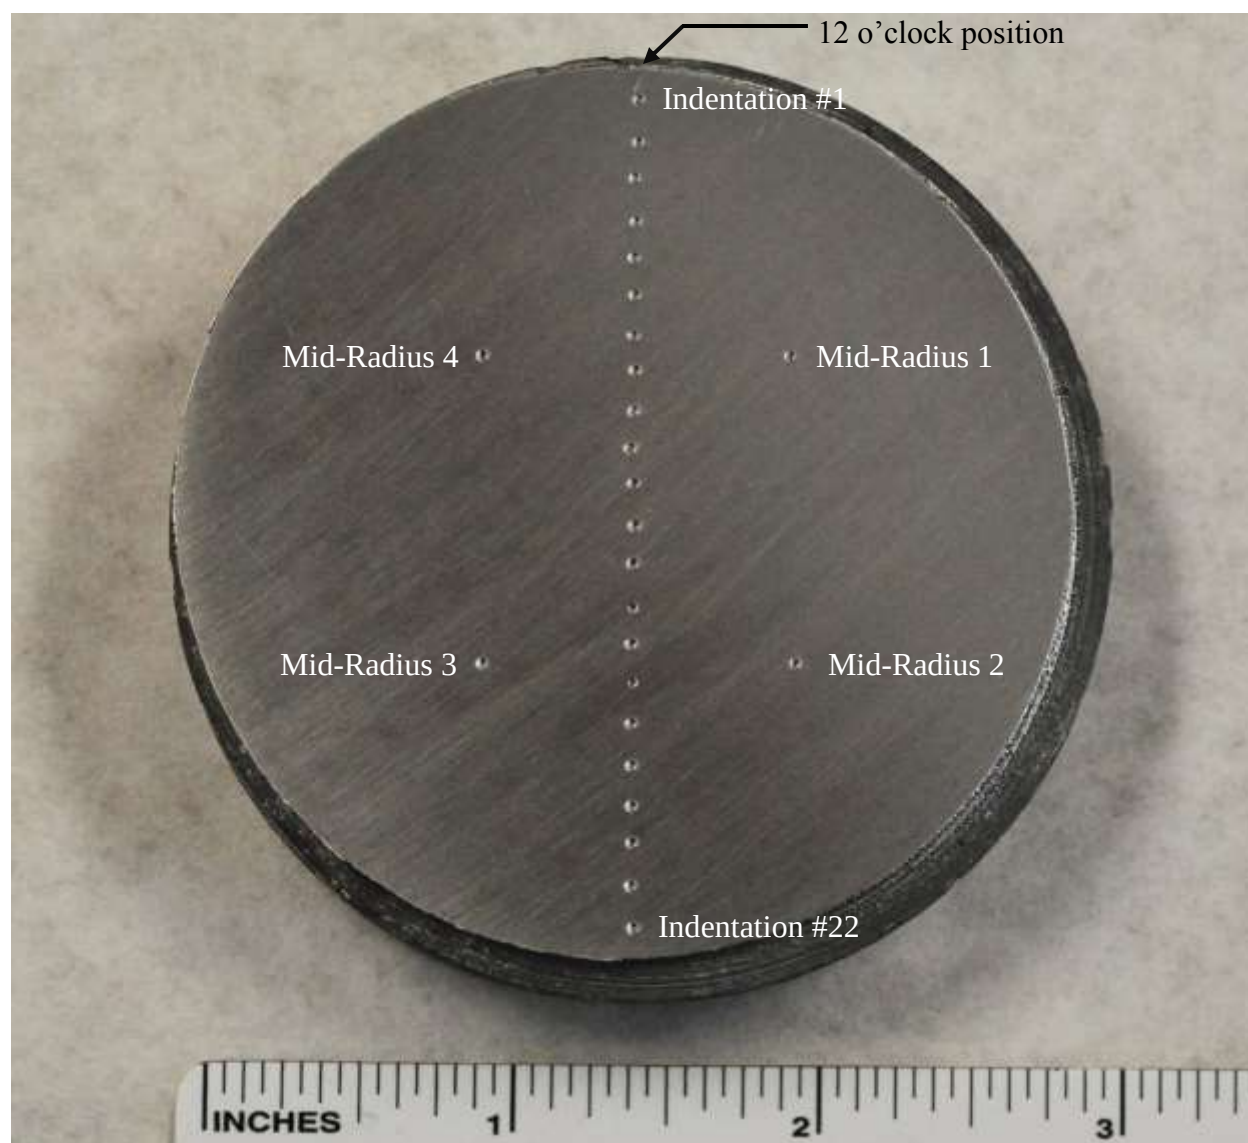
(a)

Figure 1 Photograph of the anchor rod with Rockwell hardness indentations at the four mid-radii and traverse through the cross section.

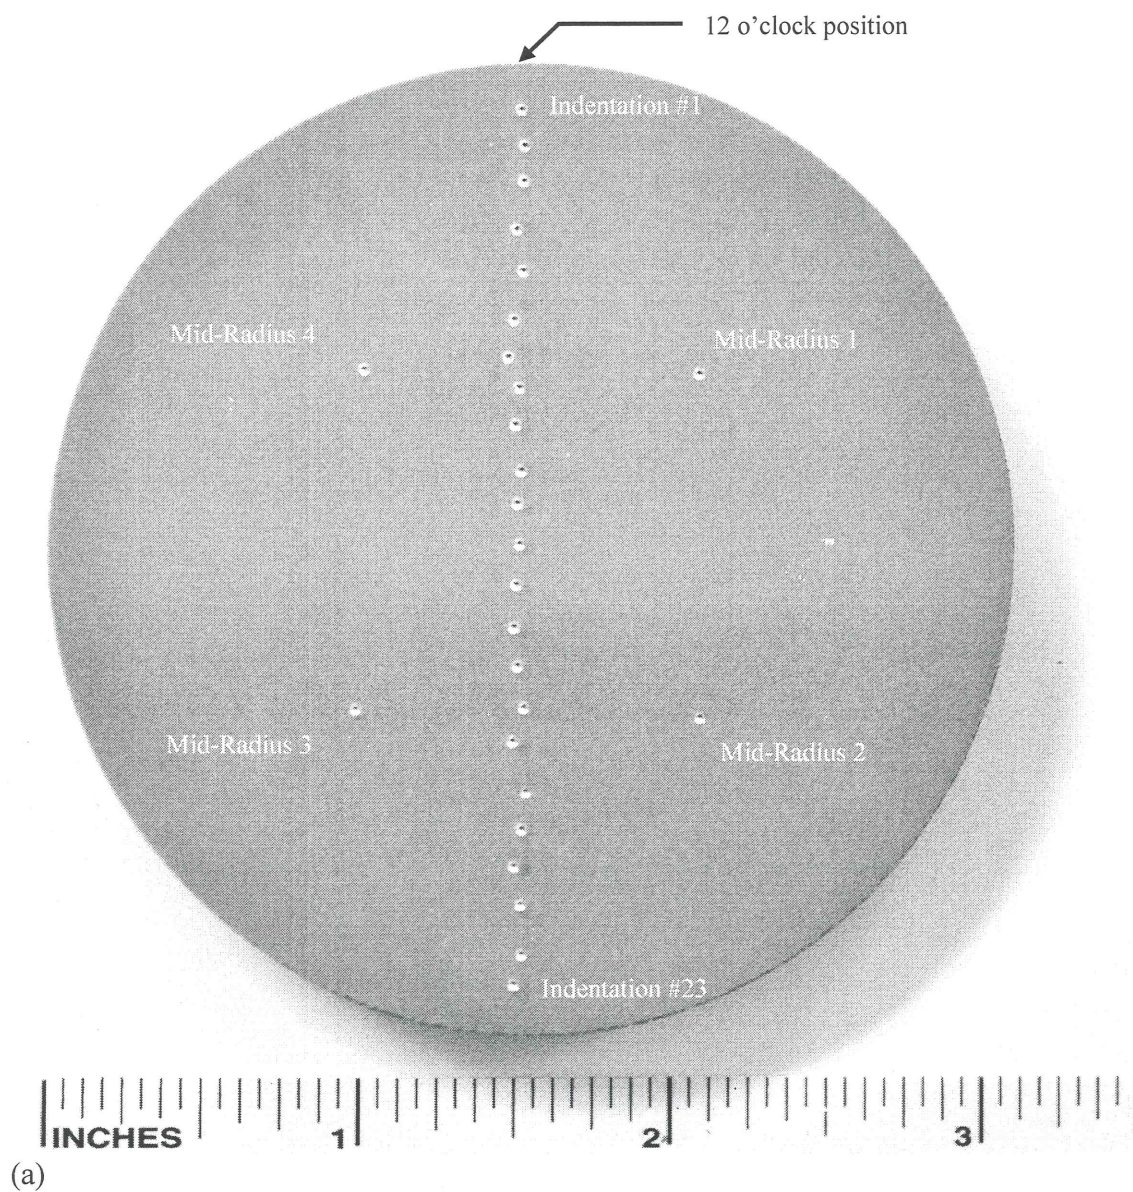
Lab. No. 5004.8677

Figure 1 Photograph of the anchor rod with Rockwell hardness indentations at the four mid-radii and traverse through the cross section.

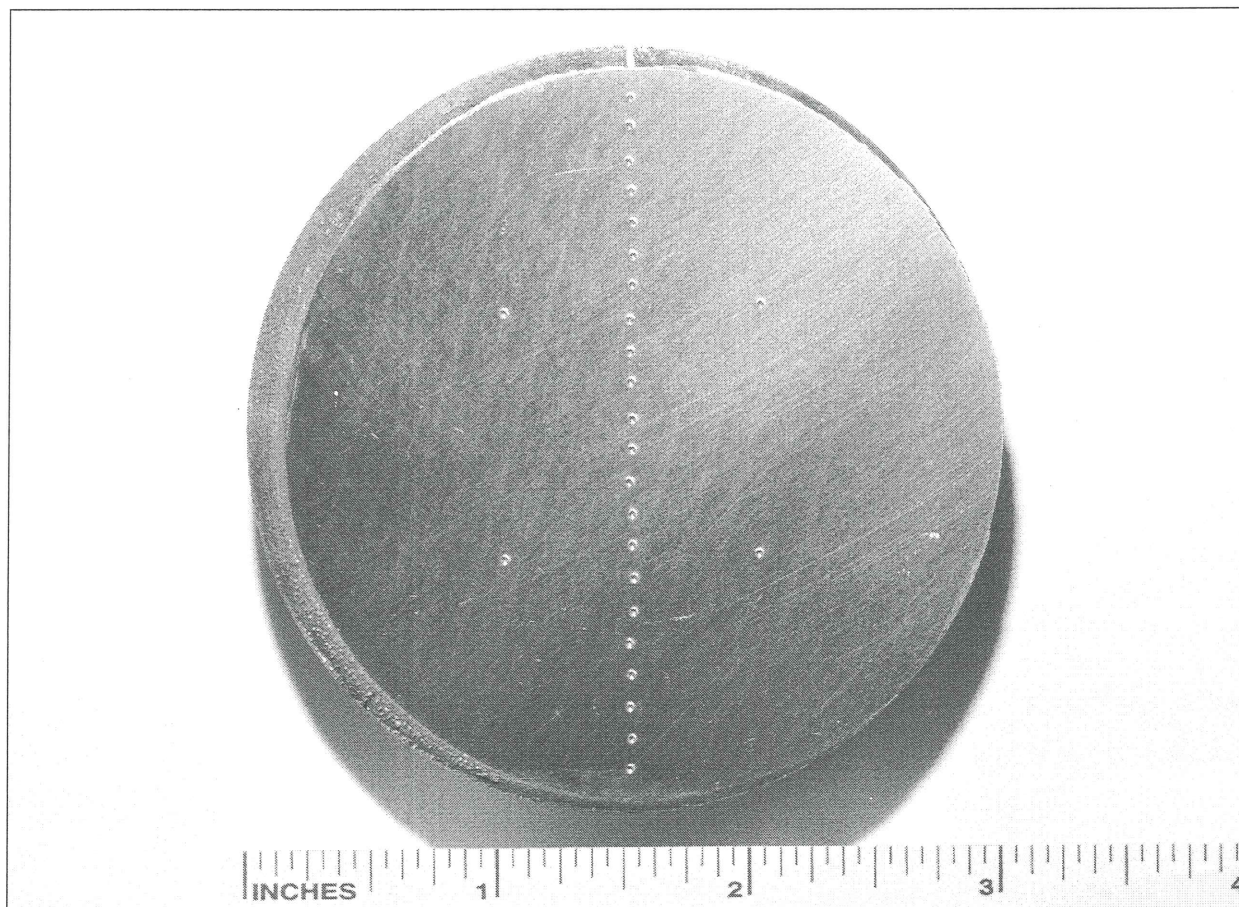
Lab. No. 5004.8710

Figure 1 Photograph of the anchor rod with Rockwell hardness indentations at the four mid-radii and traverse through the cross section.
