# **SAS PIER E2 HOT DIP GALVANIZED GRADE BD ANCHOR ROD FAILURES**

**AMY REIN WORTH  
Commissioner/Chair  
Metropolitan Transportation Commission  
Oakland, California**

**April 21, 2013**

**Prepared by Yun Chung  
Alameda, California**

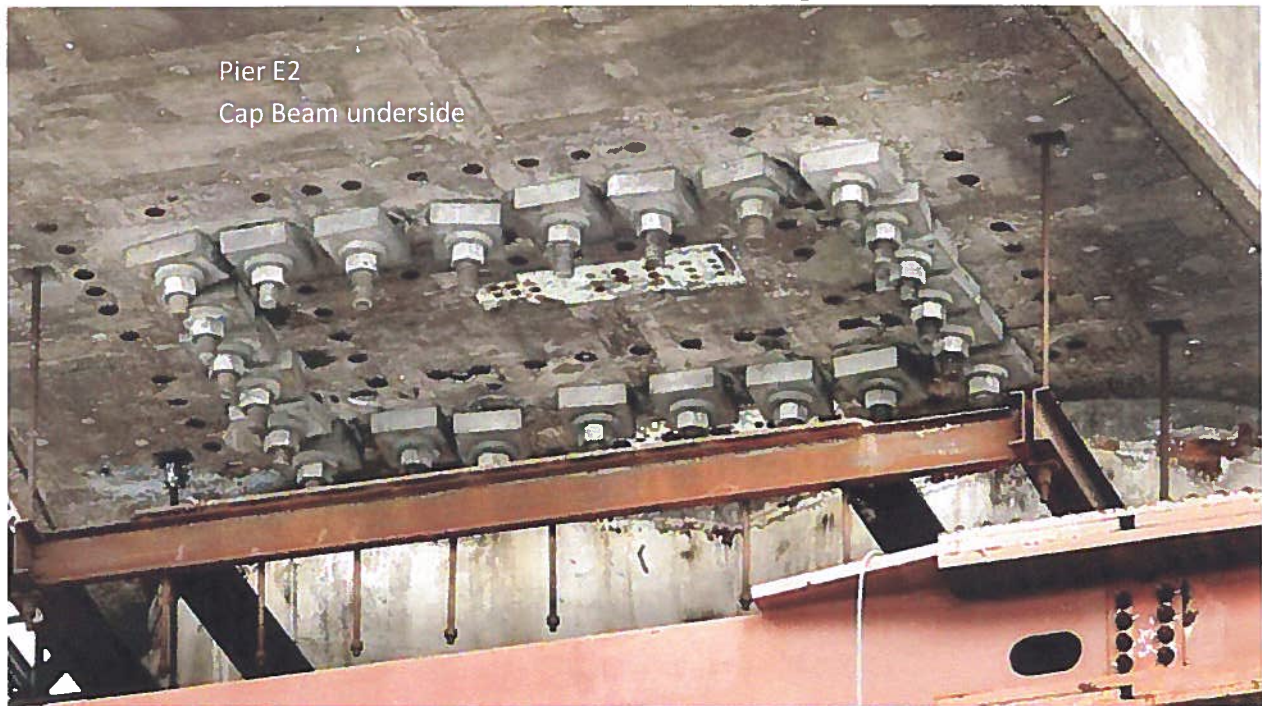
(b) Underside of the Pier E2 camp beam showing anchor rods for a bearing

Figure 5 (a) Top of Pier E2 Cap Beam showing the anchor rods for bearings and a shear key. Several anchor rods failed at the bottom ends. (b) Underside of the Pier E2 cap beam showing the anchor rods for a bearing.

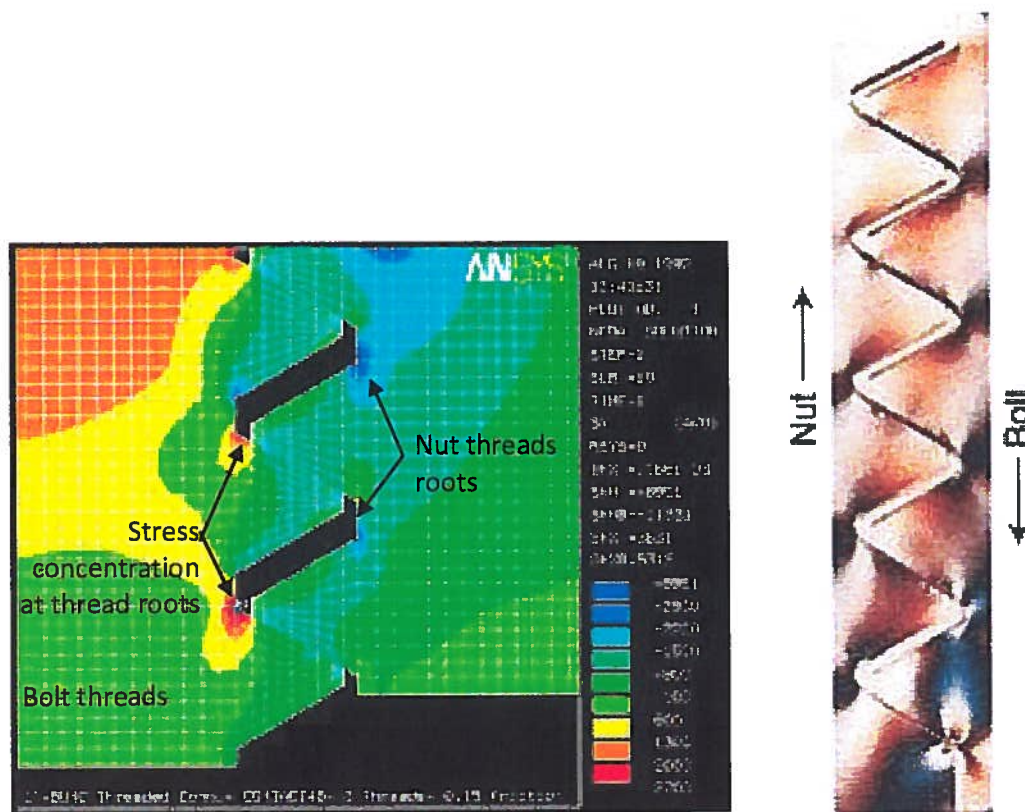
(a) Stress concentrations at bolt thread roots<sup>47,48</sup>

Figure 9 (a) Stress concentration effects at the roots of bolt threads under tension as a result of torquing down the nut. (b) The root of the first engaged thread in the bolt would experience the highest stress when tensioned by a nut.

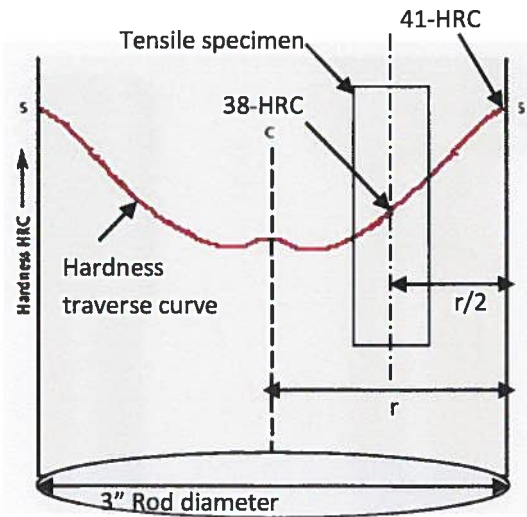
(a) Exemplar hardness traverse curve for oil quenched and tempered 4140 steel

The hardness and strength across the diameter would be not uniform because the cooling rate at the surface of a round steel bar is higher than that at the core during oil quenching for hardening. The hardness and strength will be always higher at the surface than those at the interior or core. The hardness curve across the diameter of a 3-inch 4140 steel anchor rod would look like that in Figure 10a when it was heat treated by oil quenching from 1600°F and tempering at 1025°F as was done by TC Industries and Gerdau MacSteel for Dyson.<sup>29,30</sup>

Referring to Figure 10a, a 3-inch diameter 4140 steel anchor rod can have 38-HRC at mid-radius (or  $r/2$ ), and 41-HRC at the surface. The latter would exceed the maximum hardness of 39-HRC for ASTM A354 Gr BD and should not be acceptable. This would be still acceptable, however, under the test methods of ASTM F606,<sup>31</sup> to which ASTM A354 refers for testing, and also according to ASTM A370.<sup>32</sup> Caltrans should have recognized this problem in ASTM specifications and should have made the anchor rod surface as the hardness test location specifically for the Pier E2 anchor rods and required a 100% hardness check at both ends of each anchor rod.

(a) Exemplar hardness traverse curve across a 3 inch diameter 4140 steel anchor rod, heat treated to meet the ASTM A354, Grade BD.

- (6) Alternatively, consider specifying ASTM F1554 Gr 105, hot dip galvanized, for replacement anchor rods. Specify 33-HRC as a maximum surface hardness, not at  $r/2$  or at the core.

- (7) If the same strength level (140-ksi min) as ASTM A354 Gr BD is required for replacement anchor rods, consider specifying 4340 as the material rather than 4140.

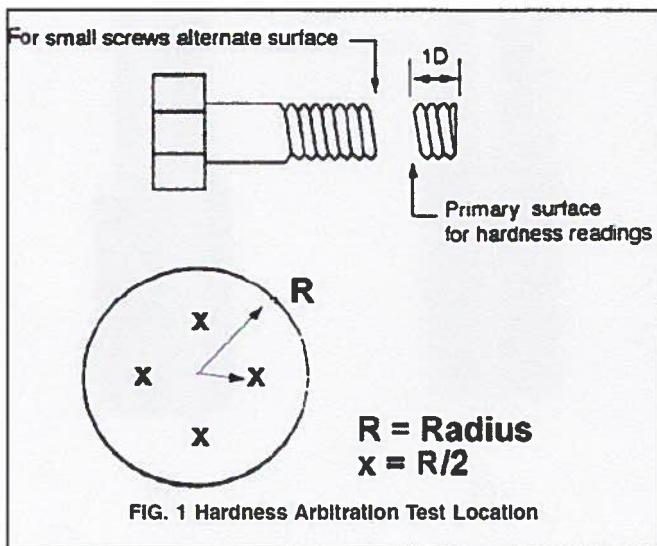
(b) Arbitration hardness test location per ASTM F606 and A370

For routine hardness tests [of finished products], ASTM F606 states, “tests shall be conducted on the unthreaded shank, end of the bolt or stud or at the arbitration location.”<sup>33</sup> These different hardness test locations would produce different hardness numbers because steel bolts and anchor rods are seldom uniform in hardness or strength across the diameter, particularly for large diameters, as discussed above. ASTM F606 states further, however, “For purposes of arbitration between the purchaser and the seller over reported tests, hardness tests shall be conducted at the mid-radius ( $r/2$ ) of a transverse section ...” as illustrated in Figure 10b.<sup>34</sup> Thus, a 3-inch ASTM A354 Gr BD anchor rod with 38-HRC at  $r/2$  (mid-radius) and 41-HRC at the surface would have to be acceptable to the buyer (Caltrans) based on the 38-HRC at  $r/2$ , completely ignoring the higher hardness, 41-HRC, at the surface. Caltrans should have recognized this problem and should have specified a maximum hardness at the surface of the 3-inch diameter anchor rods.

(b) & (c) Hardness and tensile test locations for steel fasteners including anchor rods in accordance with ASTM F606 and A370.

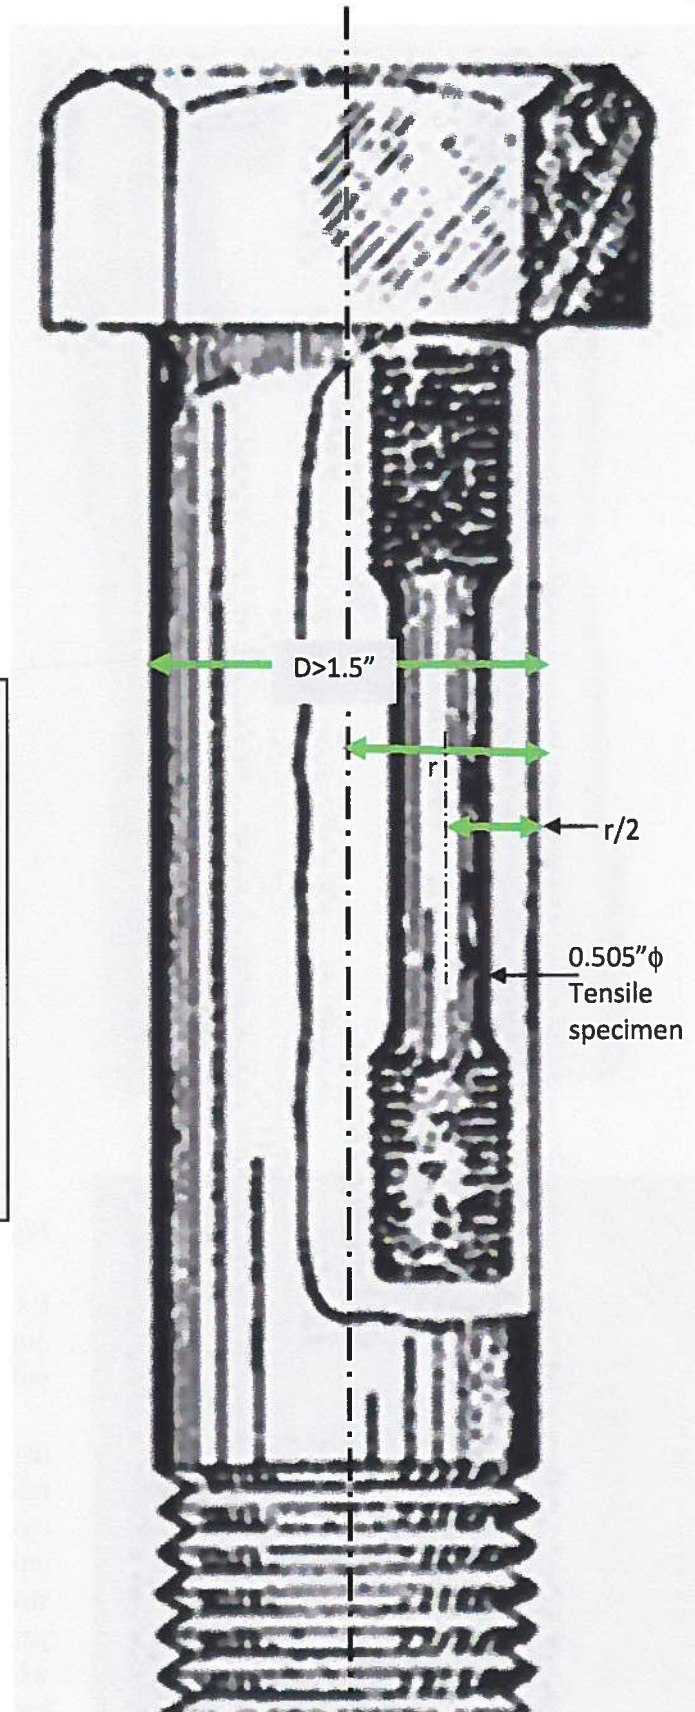
(c) Tensile specimen location at mid-radius per ASTM F606 and A370 for  $D > 1\frac{1}{2}$  inch

For tensile tests of ASTM A354 Grade BD anchor rods, Dyson chose the option of using machined tensile specimens rather than doing full size pull tests.<sup>40</sup> Figure 10c is a sketch that illustrates the location of a machined tensile test specimen from a large diameter bolt or anchor rod. The centerline of the tensile specimen is at  $r/2$  of a bolt or anchor rod cross section. This is consistent with the “arbitration hardness test location” at  $r/2$  as stipulated in ASTM F606.

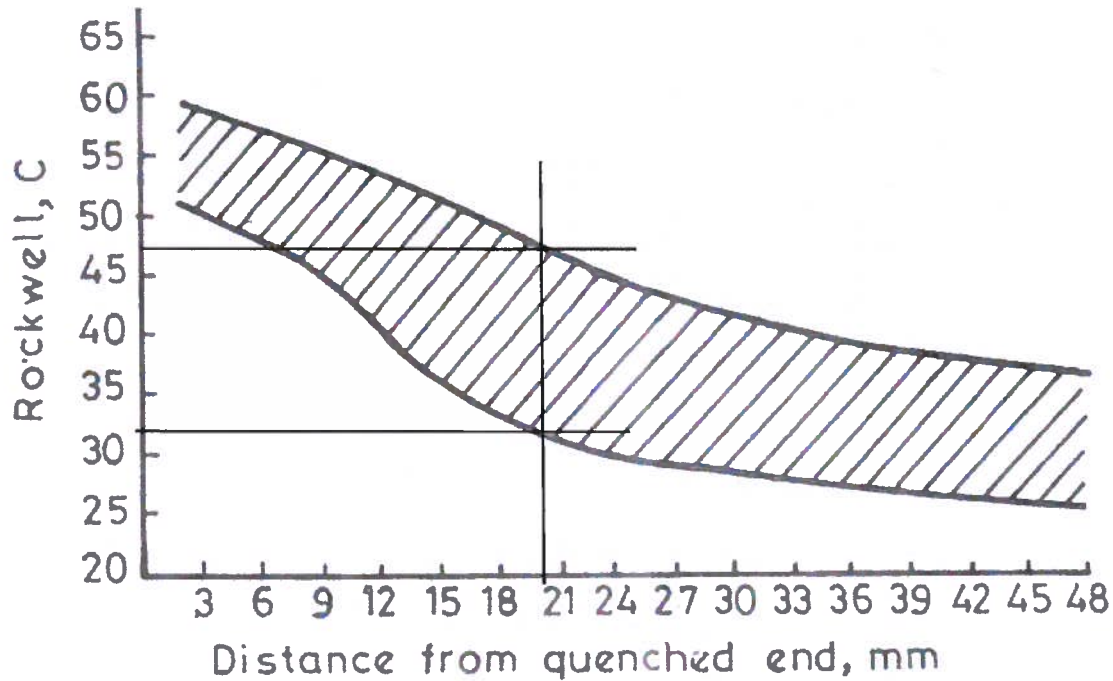
(a) Hardenability band for a low alloy steel similar to the 4140 steel

Figure 12 Variability of hardenability within the same steel grade such as 4140 in (a) and different hardenability for different grades of low alloy steels and a medium carbon steel in (b).

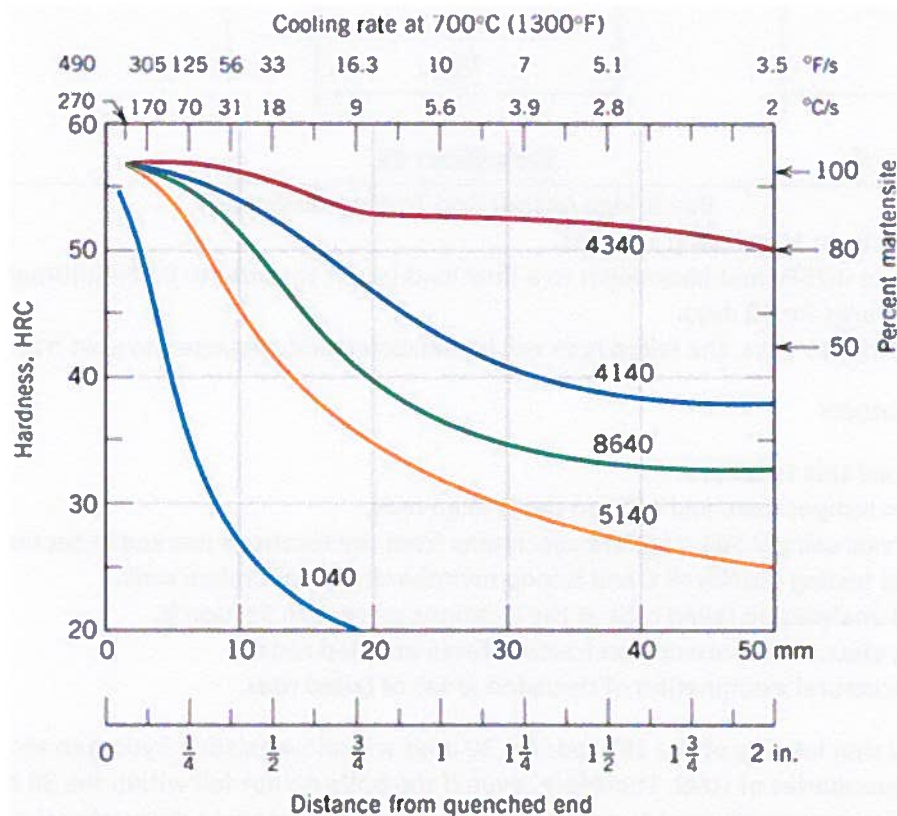
(b) Hardenability curves of different low alloy steels and a medium carbon steel.

flatter hardness traverse curve than that in Figure 10a. In other words, 4340 will have less problems with having surface hardness being too high for HE concerns and meeting the minimum tensile strength requirements of ASTM A354 Gr BD at the same time. Thus, anchor rods made of 4340 steel to the requirements of ASTM A354 Gr BD would tend to have surface hardness lower than those of 4140 steel and thus would be less prone to HE failures. The only problem is that 4340 is more expensive than 4140.

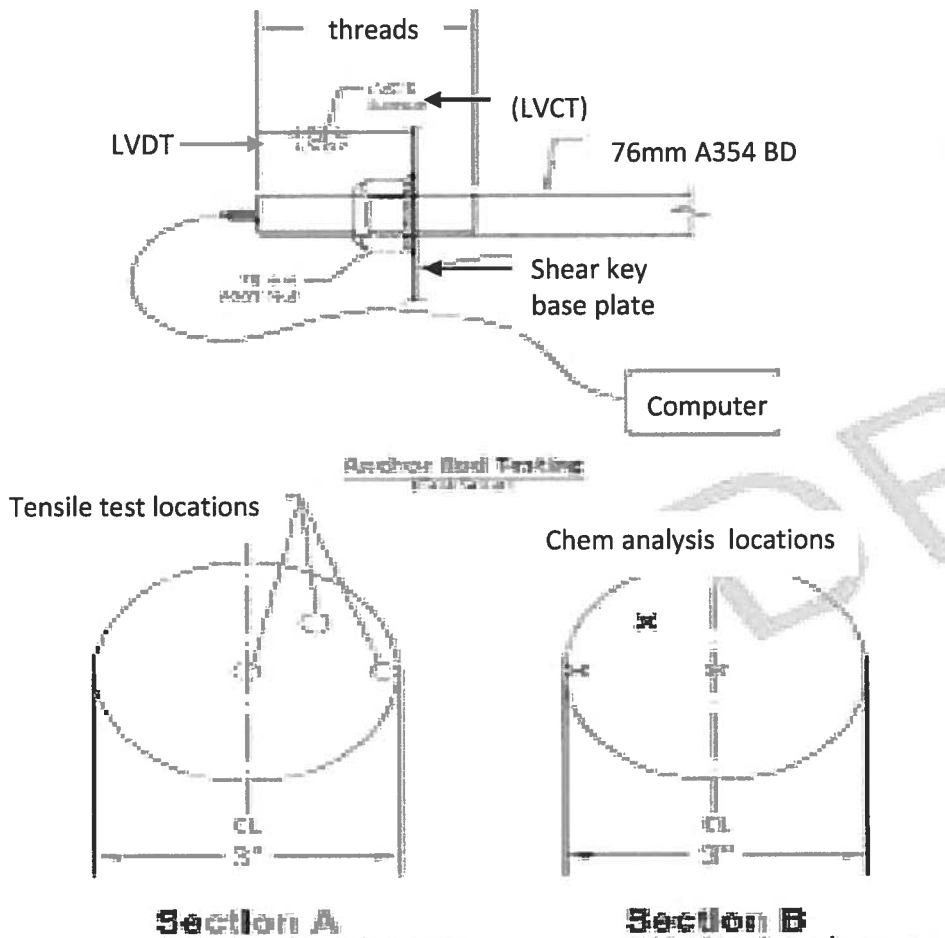
- (a) In-situ acoustic tests on 10 selected samples.
- (b) Load the 192 rod to  $0.75F_u$  and back down to a final load (static tension) to  $0.7F_u$  (ultimate tensile strength).
- (c) Check daily for failures for 30 days.
- (d) If any rod fails within 30 days, the failed rods will be extracted and subjected to post fracture analyses.

- (e) 10 samples full load test to failure
- (f) CVN tests at room temperature and  $40^\circ\text{F}$  on the broken rods.
- (g) Perform tensile tests using 0.505 standard specimens from the locations marked in Section A.
- (h) Perform hardness testing (Rockwell C and Knoop microhardness) of broken rods.
- (i) Perform chemical analyses on failed rods at the locations marked in Section B.
- (j) Perform scanning electron microscopy on fracture faces of failed rods.
- (k) Perform micro-structural examination of threaded areas of failed rods.

"Note: It is expected that loading of the 192 rods for 30 days will allow existing hydrogen atoms to propagate in between the grain boundaries of steel. Therefore, even if the bolts do not fail within the 30 day period, the scanning electron microscopy will provide sufficient information necessary to determine the presence of hydrogen."

Figure 13 Caltrans' testing protocols on failed anchor rods.<sup>50</sup>

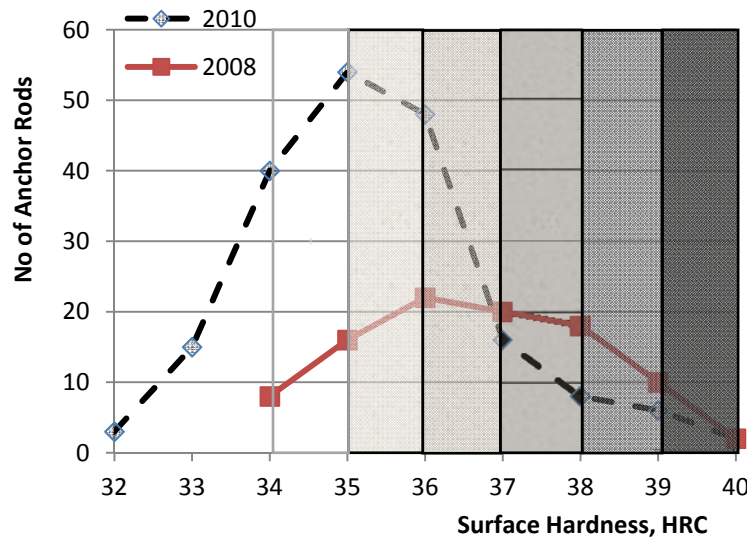
If the 96 of the 2008 anchor rods and the 192 of the 2010 anchor rods had been subjected to hardness tests individually at the shank surface next to the top threads, the results would look like the two curves in Figure 1, below.

Figure1 Hypothetical hardness distribution curves for the 2008 and 2010 anchor rods.

If Caltrans has actual hardness data for individual anchor rods in Pier E2, they have not released them to the public. Using the surface hardness as a criterion, Figure 1 shows hypothetical hardness distribution curves for the 2008 and 2010 anchor rods. Had Caltrans taken a complete inventory of surface hardness, using a portable hardness tester, the results will be similar to Figure 1.

Experiences with LAQTS have shown that it can fail due to HE when the hardness was high. To avoid HE failures, ASTM A354 limits the hardness to 39 HRC maximum and A490 to 38-HRC. A general consensus exists on the validity of the maximum hardness limit at 38 – 39 HRC for avoiding failures due to HE during atmospheric services. This is indicated by the darkest shade in Figure 1. Again, based on empirical data, the susceptibility of LAQTS to HE has been known to decrease with hardness below 39 to 40 HRC as depicted by progressively lighter shades in Figure 1.
