*Appendix F –  
Borescope Investigation of Pier E2 Rods  
Holes, SMR Reports (2011 and 2013)*

Self-Anchored Suspension Bridge

Borescope Observation of Pier E2 Rod Holes – 2011

Borescope Investigation of Pier E2 Rod Holes – 2013

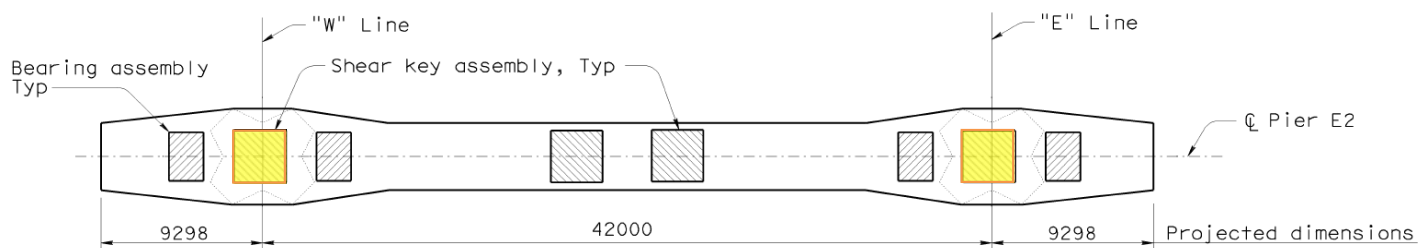
Figure 1: Locations of Shear Keys S1 (left) and S2 (right) on Pier E2

A total of 288 ASTM A354 Gr. BD bearing and shear key anchor rods have been installed in Pier E2, per the contract requirements; 96 of these 3-inch hot-dip galvanized rods are shear key anchor rods that were embedded in concrete at Pier E2. The shear key anchor rods were fabricated in 2008 and assembled inside pipe sleeves in Shear Keys S1 and S2 after release to the jobsite. The locations of the shear keys (S1 and S2) are highlighted in **Figure 1**.

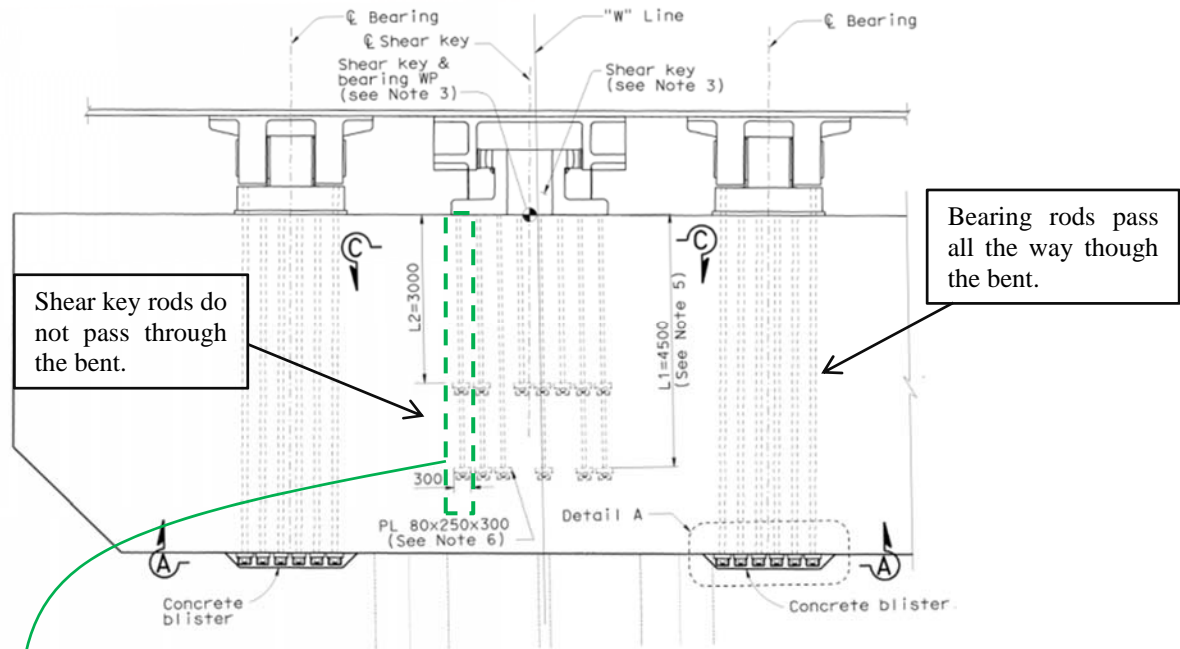
Figure 2: Cross-sectional view of shear key and shear key anchor rods setup

As shown in **Figure 2**, the details of the rods in S1 and S2 are different from the details for the bearing anchor rods. The embedment of the shear key E2 rods in concrete prevents access from below. Prior to installation of the shear keys, the rods had to be flush with the Pier E2 top surface; therefore, pipe sleeves were installed below the bearing plate to allow for the rods to be temporarily lowered (**Figures 3 and 4**). The area inside the temporary pipe sleeve was to be grouted after the rods were raised to their final position during installation of the shear key.

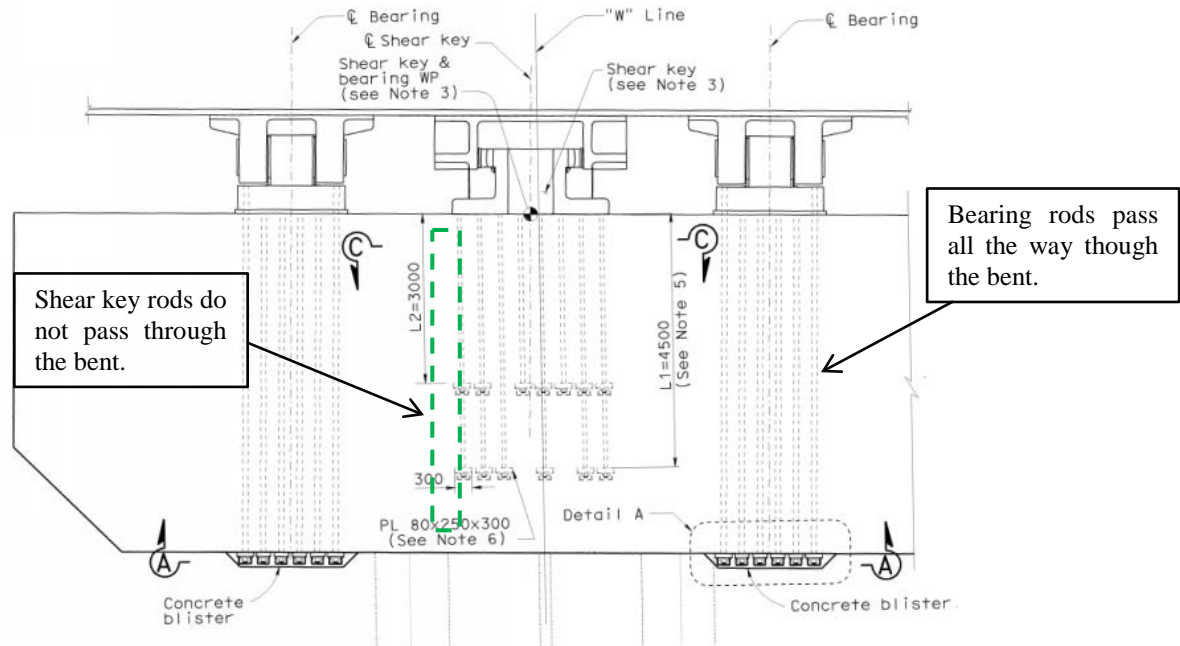
**Figure 2: Cross-Sectional View of Shear Key and Bearing Anchor Rods**

As shown in **Figure 2**, the details of the rods in S1 and S2 are different from the details for the bearing anchor rods. The embedment of the shear key rods in concrete prevents access from below. Prior to installation of the shear keys, the rods had to be flush with the pier E2 top surface. Temporary pipe sleeves were installed below the bearing plate to allow for the rods to be installed in a lowered position (**Figures 3 and 4**). After the shear keys were installed, the rods were raised to their final position where the bottom nut was against the bearing plate and the top of the rod was tensioned against the shear key base. The area inside the temporary pipe sleeve was grouted after the rods were raised to their final position.

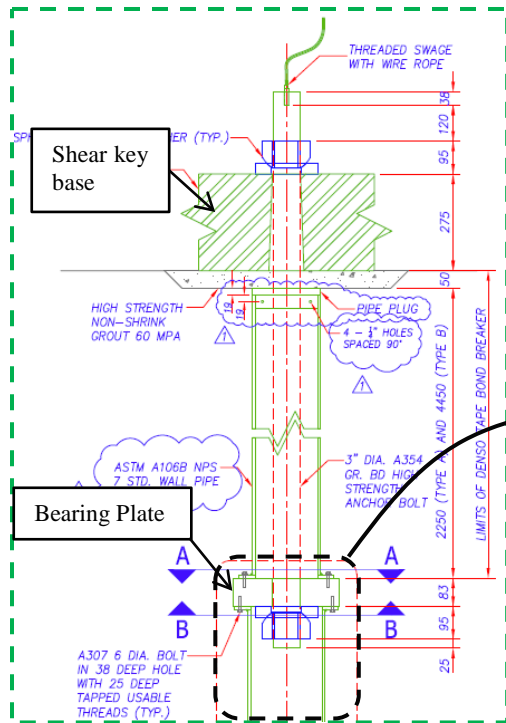
Figure 3: Anchor rod setup

Standing water was observed as shown in **Figure 7**. The water is right below the bearing plate as shown in **Figure 8**. A gap appeared to be between the fractured rod and the bearing plate as shown in **Figure 9** suggesting movement of the assembly away from the bearing plate. The views of the borescope images are at cross section A-A of **Figure 3**.

Contamination of the borescope lens reduced the range of visibility. The rod's fracture surface was identified and was dry (**Figures 10 and 11**). Corrosion products were visible on the rod fracture surface (**Figure 11**). The threads exhibited rusting as well (**Figure 12**). The views of the borescope images are at cross section A-A of **Figure 3**.

Standing water was observed during the inspection. No fracture surface was visible. It appears that the nut had rotated and only the flats of the nut were visible (**Figure 13**). There are gaps between the bearing plate and the spherical washer edge. The gaps vary in size, further suggesting the rotation of the nut as shown in **Figure 14** and **Figure 15**. The views of the borescope images are at cross section A-A of **Figure 3**.

The fractured rod was not submerged in water, but moisture was present (**Figure 16**). The camera lens was rotated to observe the threads on the rod and the nut and as shown in **Figure 17**; the threads exhibited rust deposits. The fracture surface was clearly visible. The nut appeared to be seated within the spherical washer (**Figure 17**). The views of the boreoscope images are at cross section A-A of **Figure 3**.

which is indicative of the nut moving away from the spherical washer. The flats of the nut are visible as shown in **Figures 18** and **19**. **Figure 19** also appears to show the fracture surface of the rod. **Figure 20** is a close up of the fracture surface visible in **Figure 19**. The views of the borescope images are at cross section A-A of **Figure 3**.

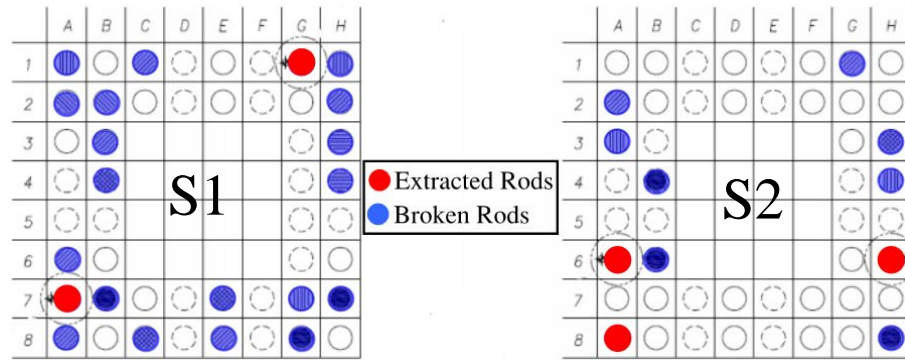
**Figure 6: Borescope Inspection Locations in Shear Keys S1 and S2**

Out of the thirty-two fractured rods, only five locations, as highlighted in **Figure 6**, were accessible for borescope inspection: S1A7, S1-G1, S2-H6, S2-A6, and S2-A8.

In all but one of the inspected locations, standing water was identified in the bottom of the anchor rod holes. In rod hole S2-A6, where water was not visible, corrosion was evident. In three locations, gaps were discovered between the washer and the spherical nut suggesting the nut had rotated.
