*Appendix F –
Borescope Investigation of Pier E2 Rods
Holes, SMR Reports (2011 and 2013)*

Self-Anchored Suspension Bridge

Borescope Investigation of Pier E2 Rod Holes – 2011

Borescope Investigation of Pier E2 Rod Holes – 2013

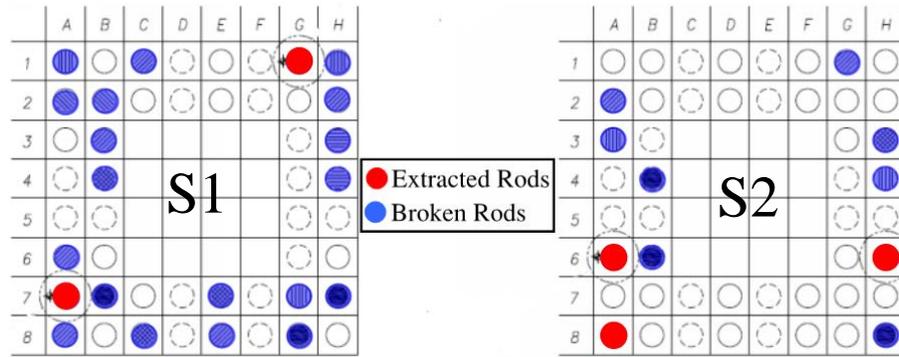
Figure 6: Borescope Inspection Locations in Shear Keys S1 and S2

Out of the thirty-two fractured rods, only five locations, as highlighted in Figure 6, were accessible for borescope inspection: S1A7, S1-G1, S2-H6, S2-A6, and S2-A8.
