Report on the A354 Grade BD High-Strength Steel Rods on the New East Span of the San Francisco-Oakland Bay Bridge With Findings and Decisions

July 8, 2013

**TOLL BRIDGE PROGRAM
OVERSIGHT COMMITTEE**

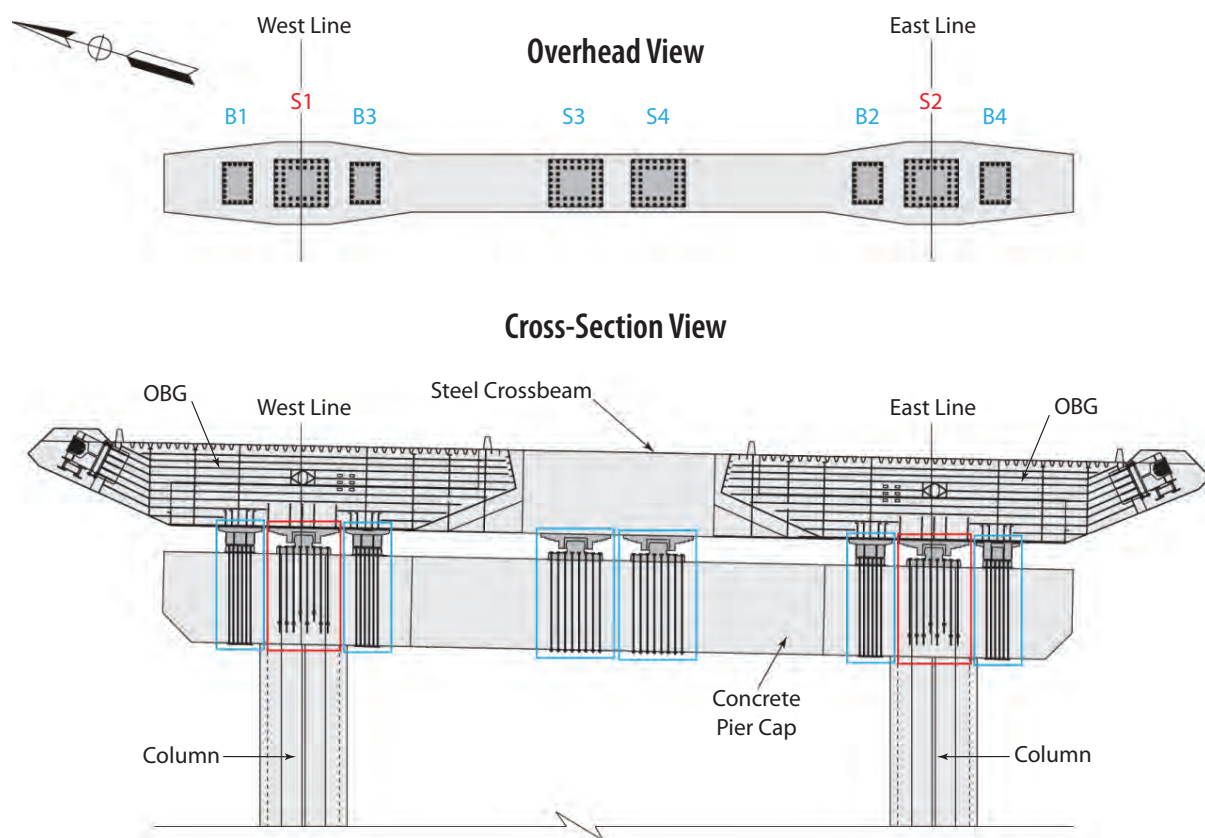
Figure ES-2 Bearings (B1-B4) and Shear Keys (S1-S4) in Pier E2

Ninety-six (96) high-strength steel rods are installed on the lower housing of shear keys S1 and S2 (Item #1 in Table ES-1) at Pier E2. These rods were fabricated by Dyson Corporation in Ohio between June 4, 2008 and September 6, 2008 and installed by American Bridge/Fluor Joint Venture, the bridge contractor for the SAS Bridge, in October 2008. Figure ES-2 illustrates Pier E2 and the location of the shear keys, bearings, and their high-strength steel rods. Figure ES-3 shows the location of the fractured rods.

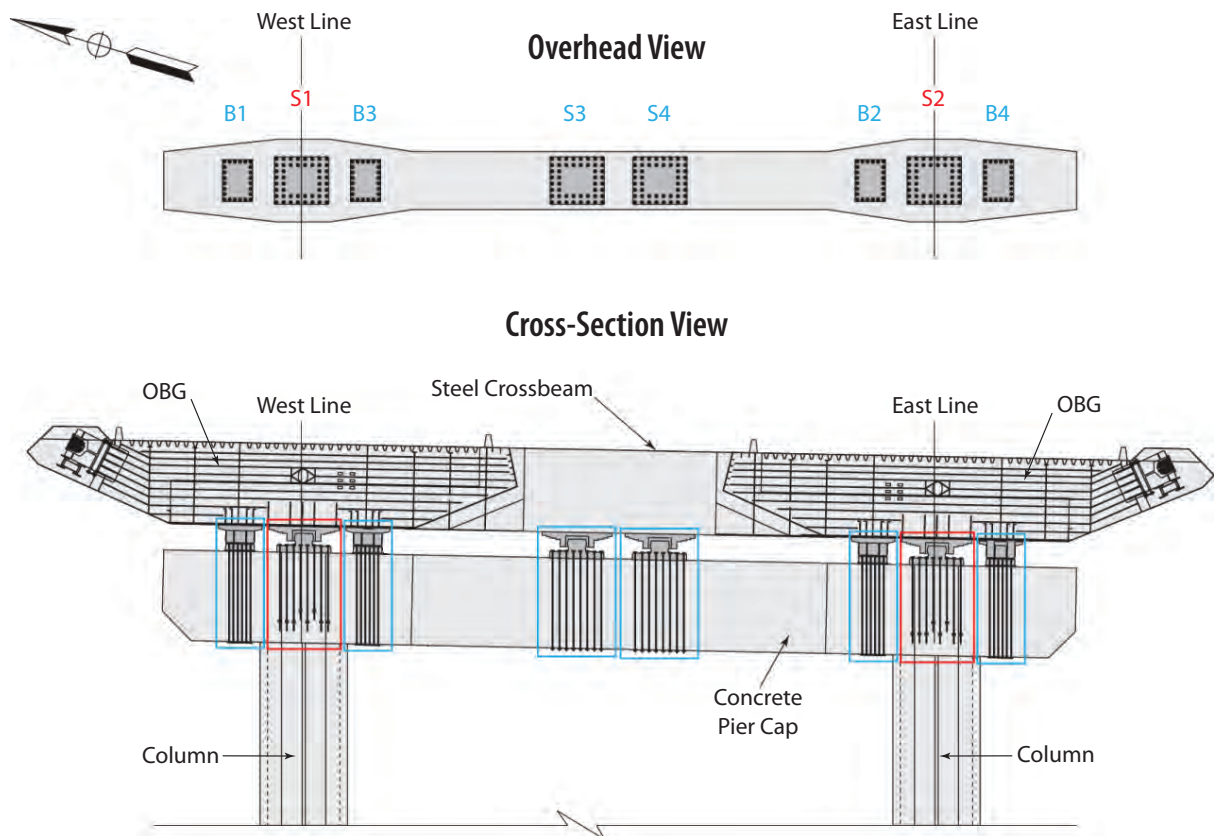
Figure 3 Bearings (B1-B4) and Shear Keys (S1-S4) in Pier E2

Because of the location of shear keys S1 and S2, directly over the Pier E2 support columns, the design developed by the T.Y. Lin International/Moffatt & Nichol Design Joint Venture called for the rods to be embedded as the concrete pier cap was constructed. This rendered the lower portion of the rods and nuts inaccessible after installation. Figure 3 illustrates Pier E2 and the location of the shear keys, bearings, and their high-strength steel rods. Figure 4 shows the location of the fractured rods.

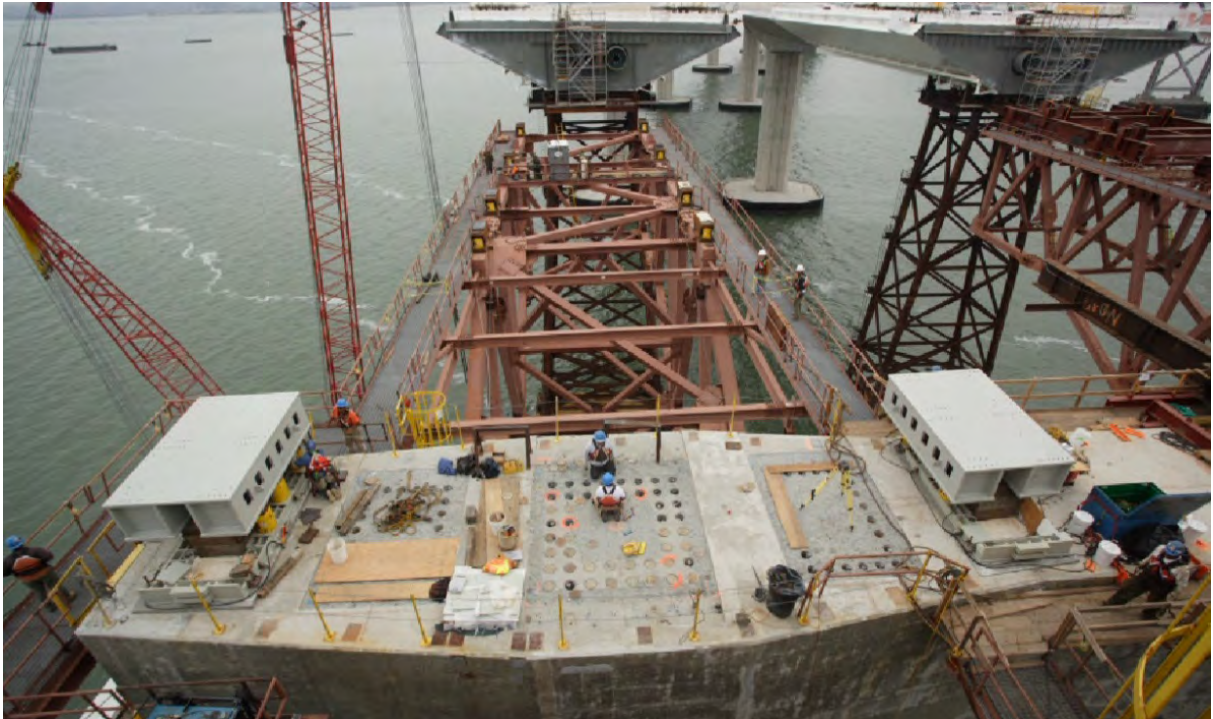
Figure 5 E2 Pier Cap Construction —
(Center of photograph is the location of future shear key S1)

The E2 pier cap, including the embedded 2008 shear key anchor rods, was completed by early 2009. Due to the extended construction schedule, Pier E2 was completed three years before the roadway boxes were erected in place over the pier. This resulted in the anchor rods being exposed to the environment for an extended period of time before the next construction stage, which would tension and grout them in place. This open environment is shown in a Pier E2 construction progress photograph (Figure 5) taken soon after completion of the pier cap. There were no provisions made in the design by the T.Y. Lin International/Moffatt & Nichol Design Joint Venture or the installation procedures prescribed by American Bridge/Fluor Joint Venture to include water drainage or sufficient rain protection to prevent the ingress and accumulation of rainwater or other moisture in the anchor rod housings during this extended period.

Between March 8, 2013 and March 14, 2013, 32 out of the 96 rods were discovered to have fractured. By March 14, 2013, Caltrans decided to lower the tension of the remaining unbroken rods from the 0.68 F_u to 0.45 F_u to avoid further fractures and to allow for investigation of the cause of the failures. The tension level was reduced on all unbroken rods. If the tension

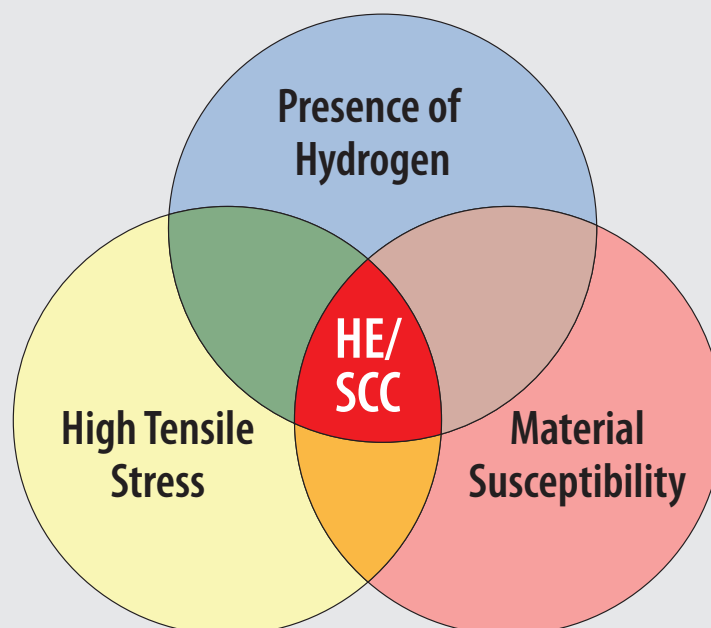
Causes of Hydrogen Embrittlement (HE) or Stress Corrosion Cracking (SCC)

The accompanying Venn diagram shows that when all three conditions apply (i.e., the presence of hydrogen, high tensile stress and a susceptible material), the metallurgical structure of the steel has a higher susceptibility to HE. The diagram also shows that these same conditions can cause a related phenomenon known as Stress Corrosion Cracking (SCC), which will be addressed later in this report.

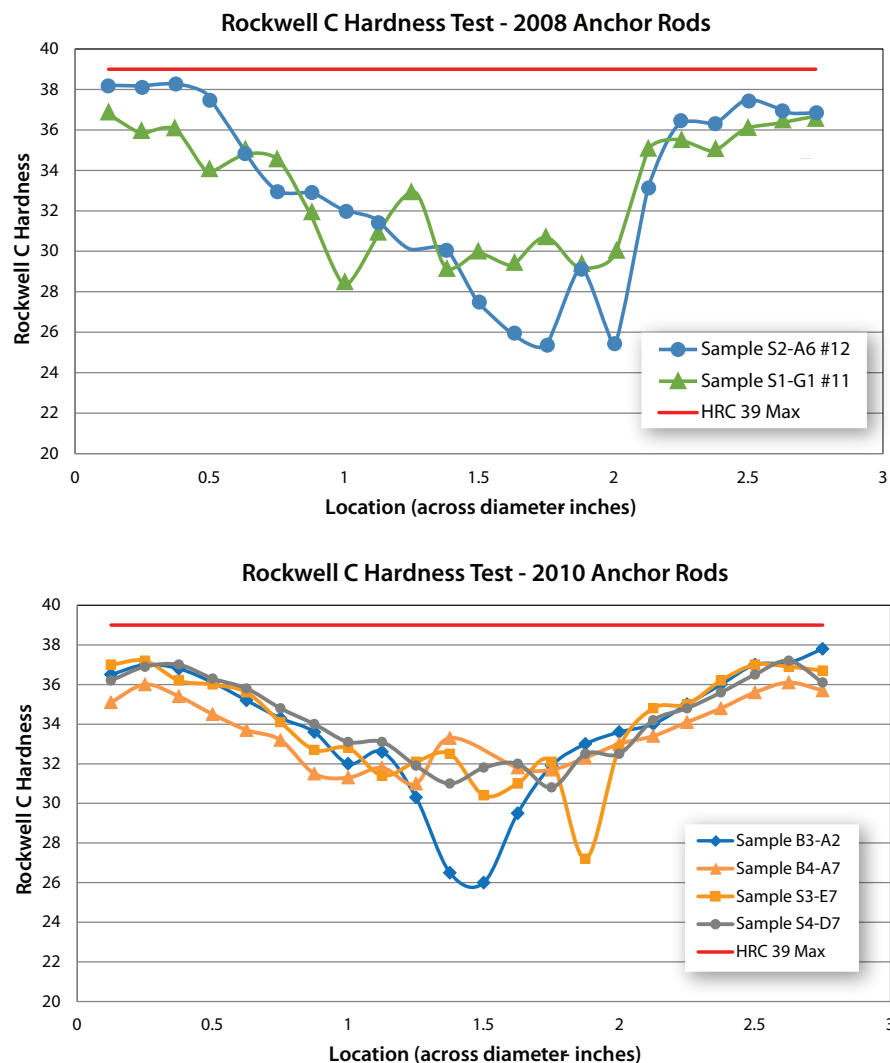
Figure 23 Mechanical Test Comparison 2008 vs. 2010 (Pier E2)

A number of rods were extracted and subjected to an extended test program to determine if hydrogen embrittlement had occurred. These extracted rods were examined extensively and no evidence of hydrogen embrittlement was found. Further the 2010 material properties were substantially better than the 2008 material with homogenous microstructure and improved toughness. The 2008 material failed at a tension level substantially lower than the actual yield strength of the rods, which is evidence of hydrogen embrittlement and lack of toughness. Laboratory testing results for both the 2008 and 2010 rod results are shown in Table 12 and Figure 23.

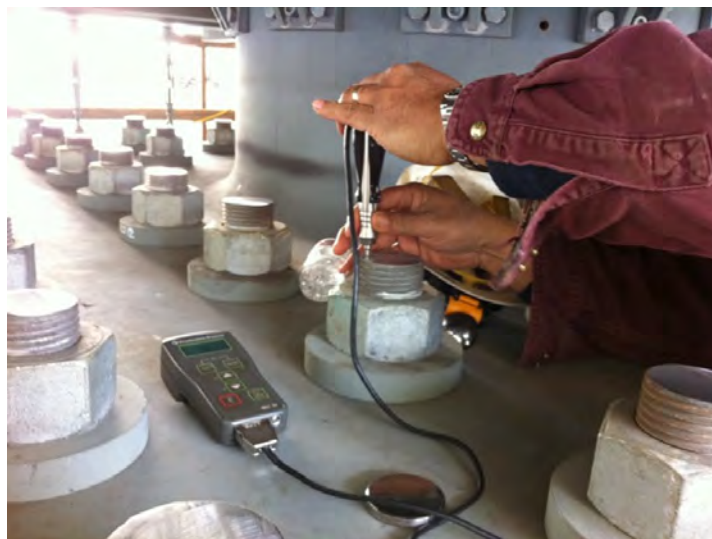
Figure 24 Photograph of Inspector Performing *In-situ* Hardness Test on Bearing Rod

Test I Test I is a test to conduct an *in-situ* hardness test on all accessible A354 grade BD rods and bolts on the SAS Bridge, thereby categorizing the susceptibility of each individual rod relative to hardness and applied stress intensity. The galvanized layer will be ground off the top surface of the rods using a grinder and sand paper. Once the surface is free from oil, grease, dust, rust, and surface coatings, measurements will be taken throughout the rod's diameter using a hardness tester that measures the depth of penetration of an indenter under a large load. A photo of such field testing on Pier E2 is shown below in Figure 24.

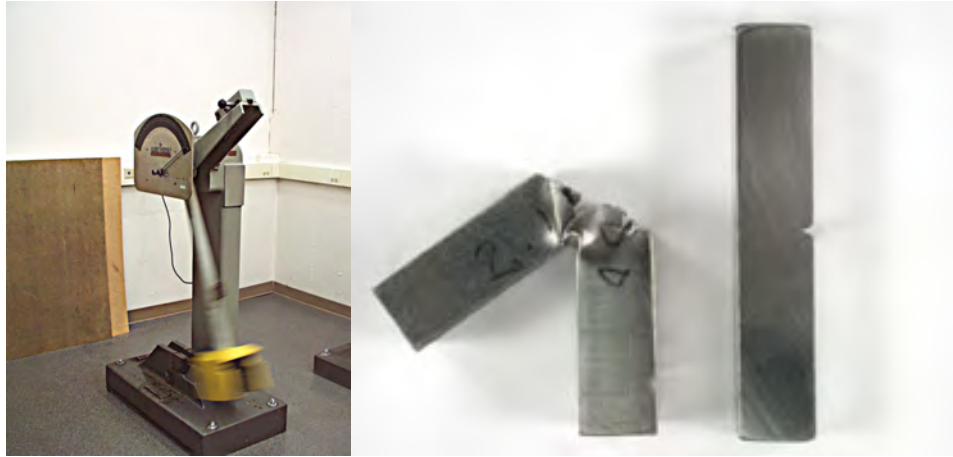
Figure 25 Charpy Toughness Test in Process (left); Tested and Untested Specimens (right)

Test II Test II is to conduct laboratory tests on a selected number of specimens or spares in order to determine a rod's hardness (Rockwell hardness test), toughness (Charpy V-Notch test) and chemical composition (Figure 25). In some locations there are rods installed in the bridge that have an excess or protruding length which, if cut off, could serve as a test specimen in a controlled laboratory environment. There are also some spare rods from the original manufactured lots that are available for laboratory testing.

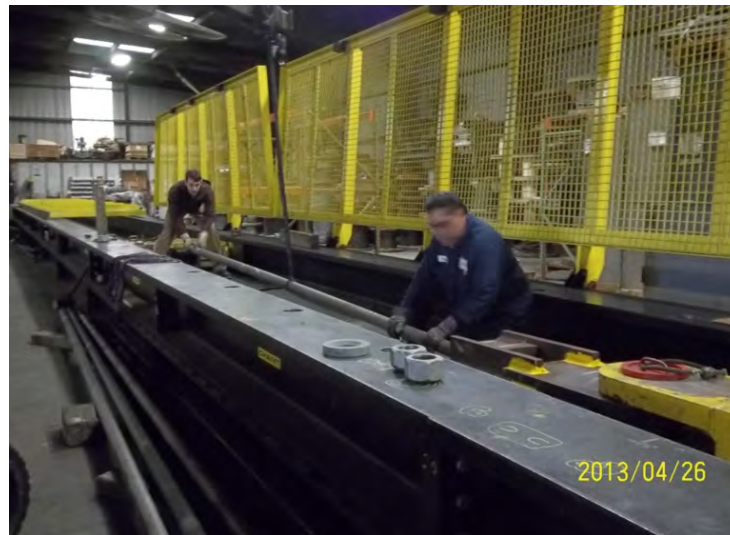
Figure 26 Photograph of Full-Sized Rod Being Placed into Test Rig

Test III Test III is to conduct laboratory testing (full size tension test, coupon tension test, Rockwell C hardness, Charpy, chemistry, fracture analysis) of full-sized rods extracted from the Pier E2 shear key and bearings (Items #2, 3, and 4 in Table 1) and the Tower Anchorage (Item #12 in Table 1). All the other full-sized tests can be performed on spare rods and bolts from the original manufactured lots. Under Test III, rods will be loaded to failure, and the failed rods will be examined and tested to determine their hardness, toughness, mechanical properties, and chemical composition. Figure 26 shows such a full-sized laboratory test underway.

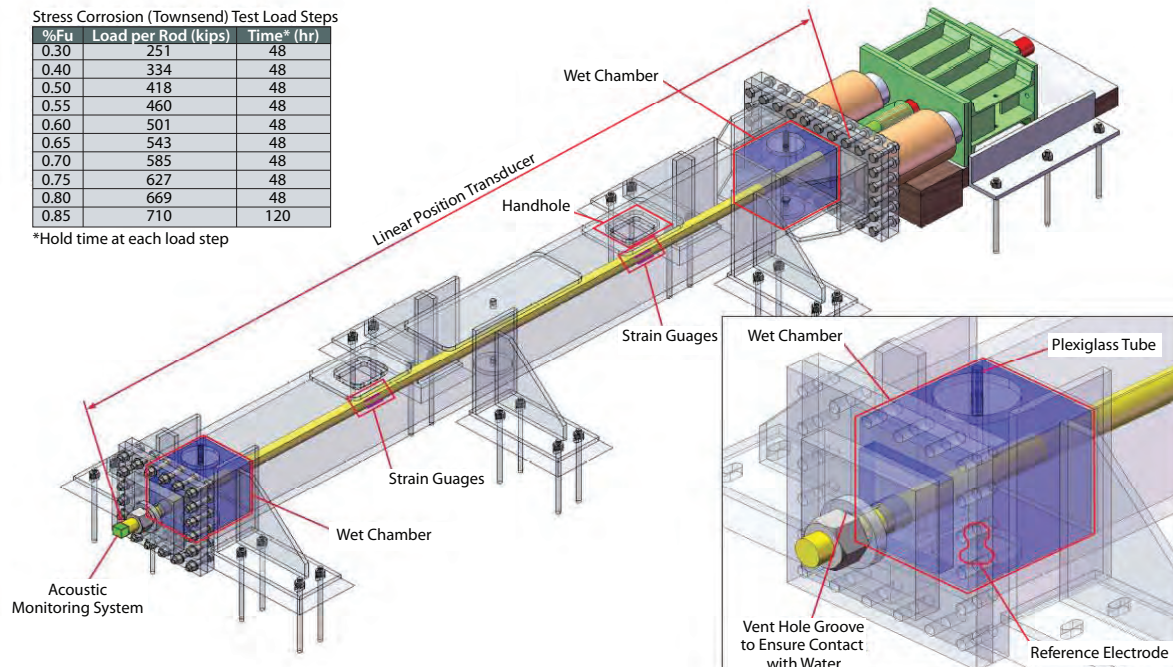
Figure 27 3D Rendering of Stress Corrosion Test Platform for Test IV

Test IV Test IV (Townsend Test) is to conduct an accelerated stress corrosion test which replicates the earlier Townsend research (Figure 27). The results of Test IV will provide the curve against which the results from Tests I, II and III will be plotted and assessed in an updated and completed in the figure in the following section. The sample selection focuses on the rods subjected to the higher stress intensities (i.e., 0.7 Fu) with one additional sample from each diameter size of 2, 3 and 4 inches. Also of interest is whether there is a difference in susceptibility between rolled threads

or cut threads and between galvanized and non-galvanized rods. Determining these differences will also require testing of rods with a diameter of 3½ inches under lower stress intensities.

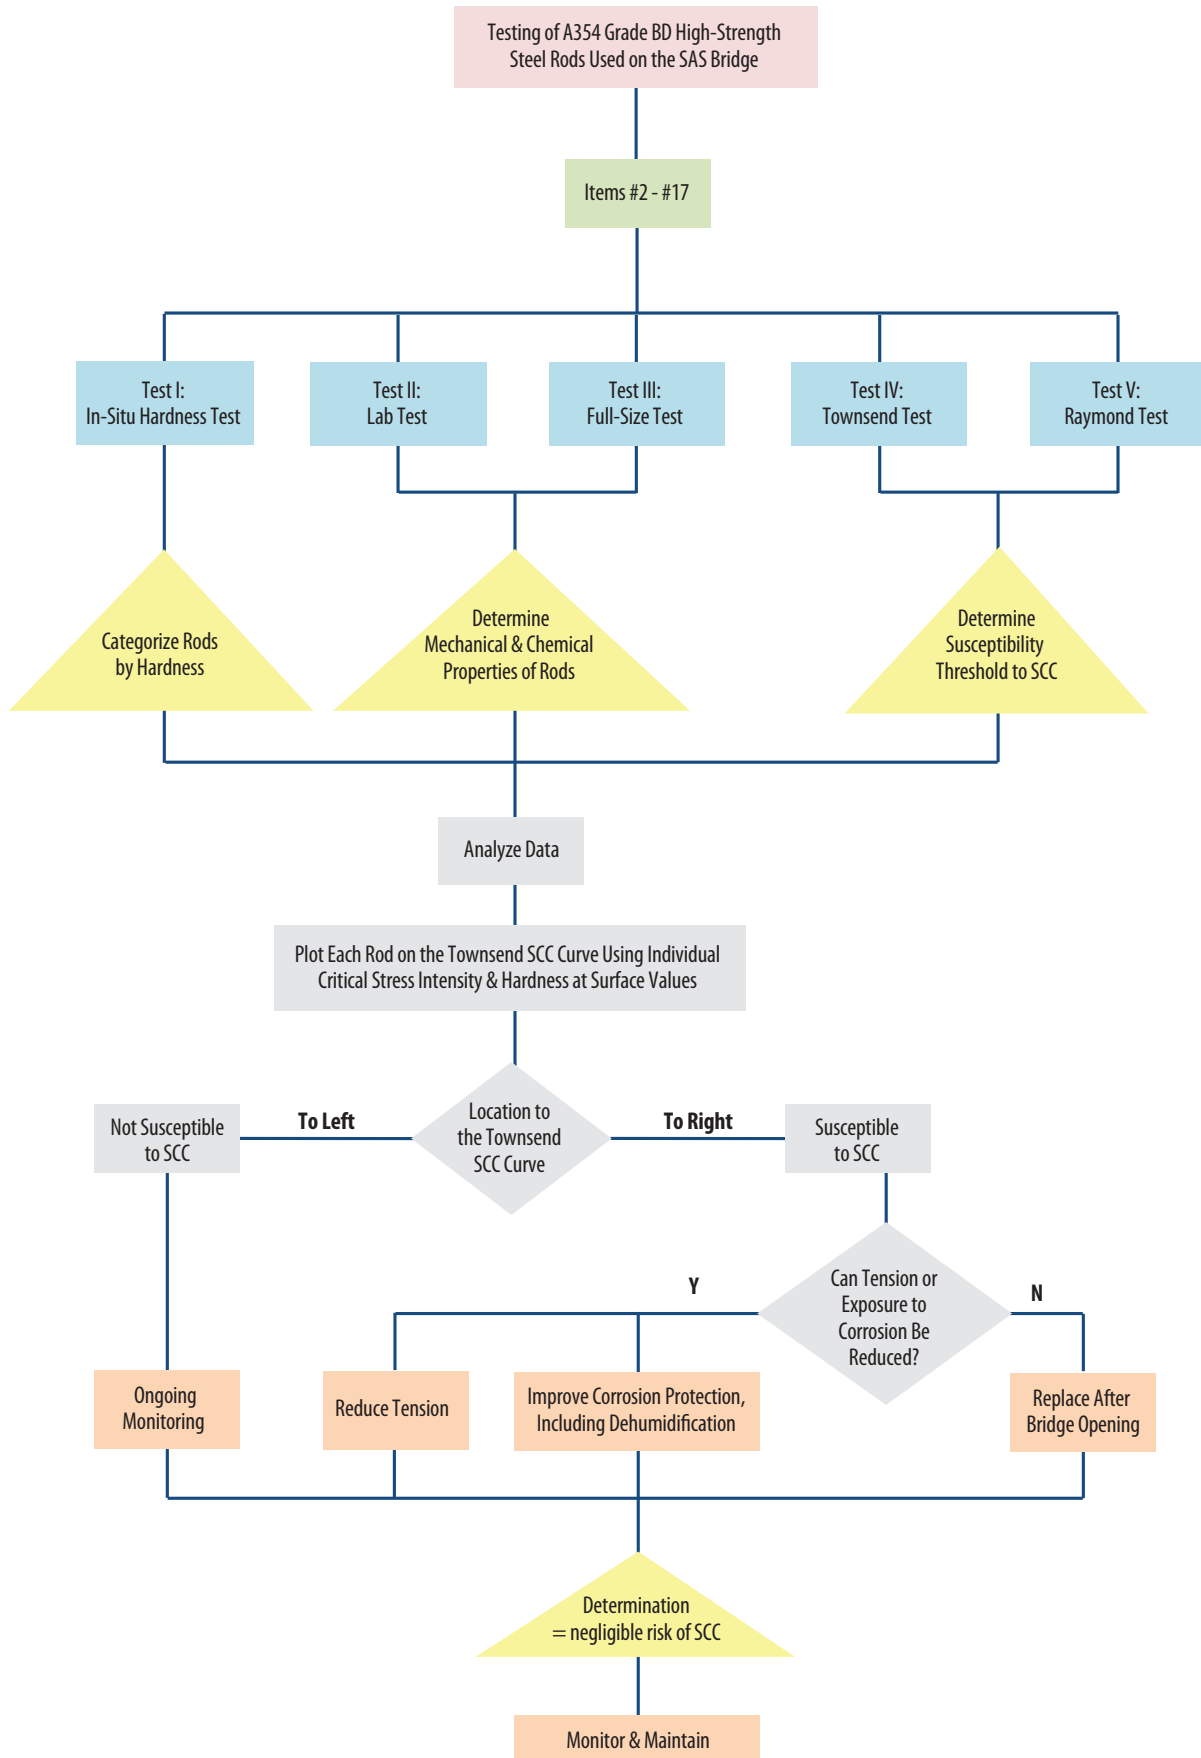
Figure 33 Determination for Susceptibility to Stress Corrosion Cracking

The flowchart displayed in Figure 33 shows the sequence of Tests I through V and at what point it can be determined that a group of rods has “passed the test” of longer-term stress corrosion cracking or, as deemed necessary, must be addressed by the implementation of mitigation measures. The tests are shown in the blue rectangular boxes; mitigating actions in the orange rectangular boxes; and the outcome/determination in the yellow triangle.

Tests I (*in-situ* hardness test), II (lab test) and III (full-sized test) were completed on June 21, 2013. The results from Tests I, II and III verified the mechanical properties of the rods and categorized each rod by hardness. The results from these tests are displayed in Table 13.

For Test IV (Townsend test), the construction of the test rig is underway and scheduled for completion in early July 2013 and used for the first group of Test IV samples. Additional test rigs are being constructed for Test IV to accommodate the range of ASTM A354 grade BD rod lengths and diameters. Results from Test IV will create the graphical curve per Townsend’s research based on the ASTM A354 grade BD rods in the SAS Bridge and superimposed onto Figure 34. Rods that are to the left of the Townsend curve would be deemed not susceptible to stress corrosion cracking, while rods that are to the right of the curve will be deemed susceptible to stress corrosion cracking.

Upon completion of all the testing and implementation of mitigating measures as depicted in Figure 33, the risk of hydrogen-associated damage to the metallurgical structure of the high-strength rods will have been addressed for the SAS Bridge. These test results also provide conclusive evidence that the cause of the high-strength rod failures observed in March 2013 from short-term hydrogen embrittlement is isolated to the shear key S1 and S2 anchor rods at the top of Pier E2 manufactured in 2008. This conclusion is further confirmed by the ongoing performance of the remaining rods under varying levels of tension as depicted earlier in Table 9.

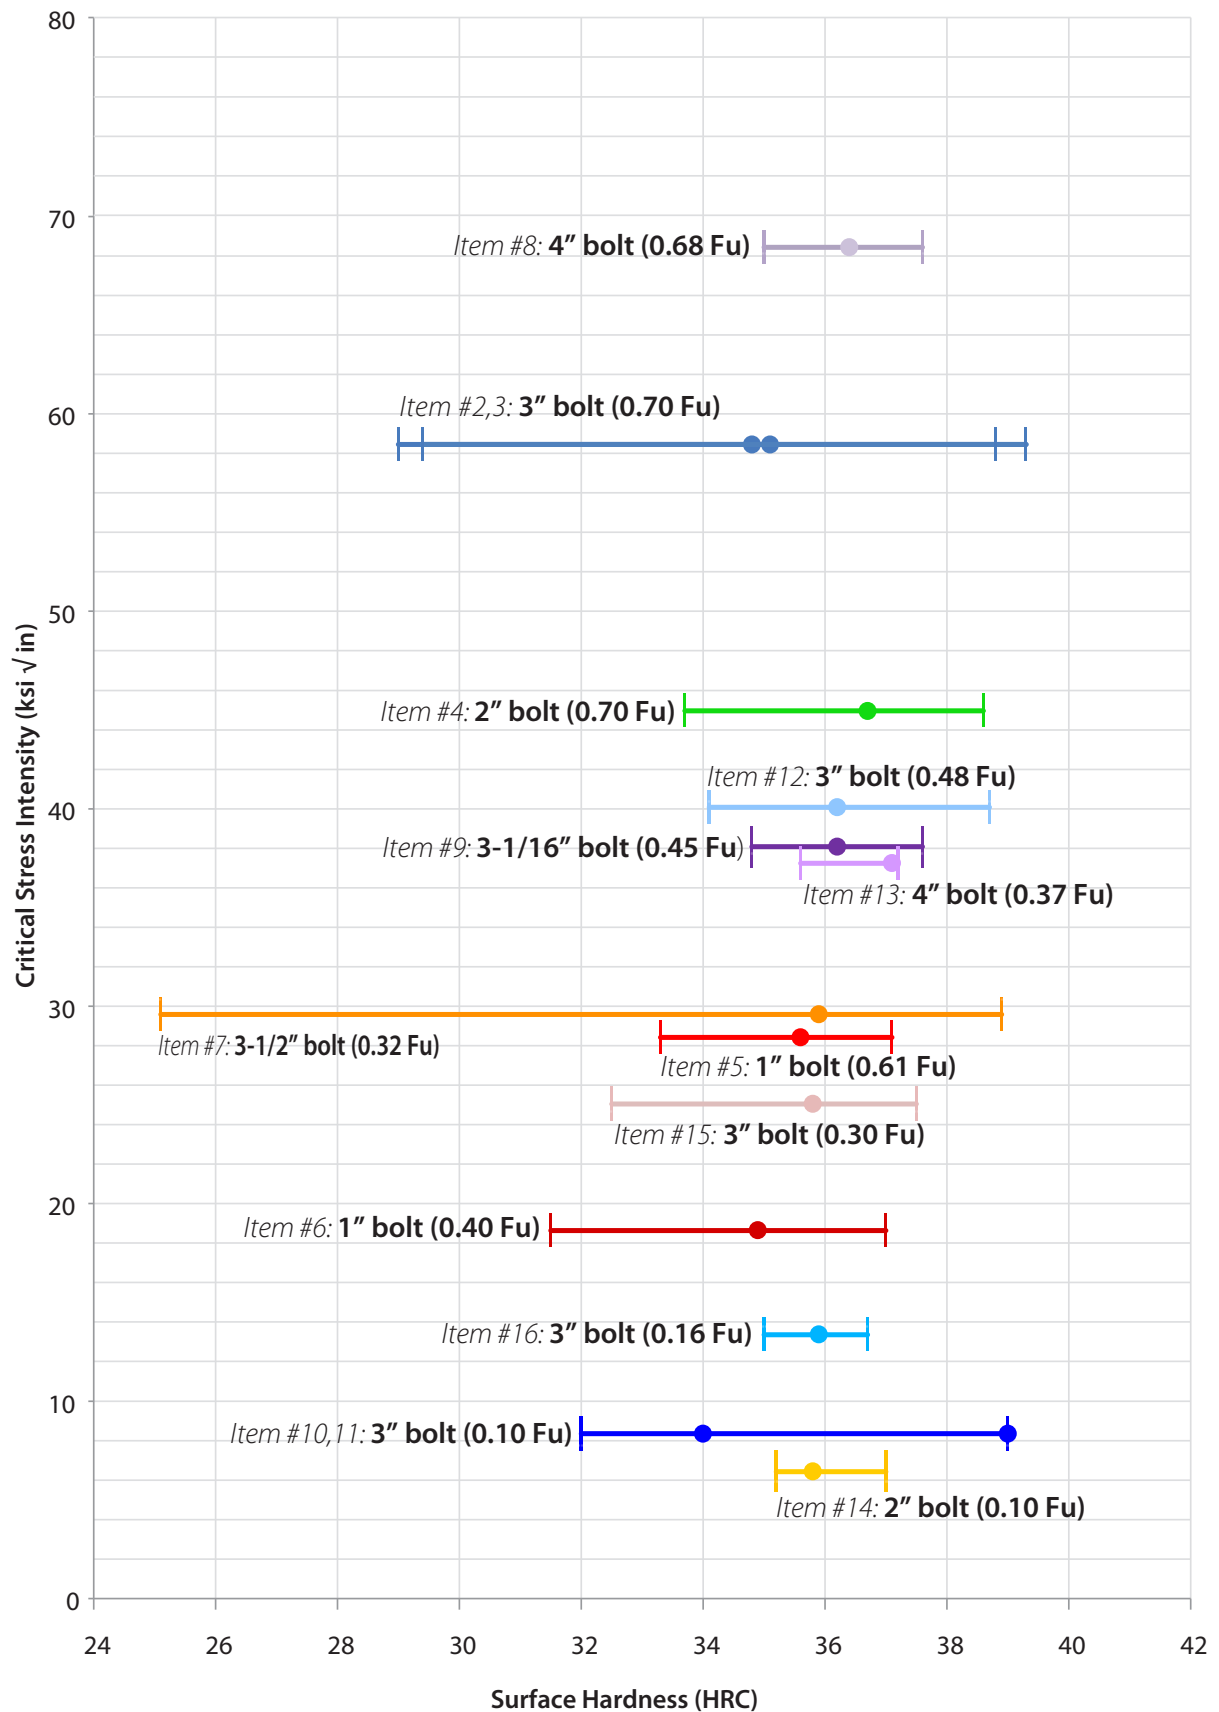
Figure 34 Critical Stress Intensity as Compared to Surface Hardness
With *In-situ* Surface Hardness Test Data

As noted earlier, critical to the development of stress corrosion cracking is the tension the rod is placed under, its diameter, threads and the hardness of the material. Individual rods with higher tension levels and hardness levels at, or above, 35 HRC should be further evaluated for risk for stress corrosion cracking, per guidance from Dr. Fisher. Test I results for *in-situ* surface hardness continue to show varying hardness levels across all tested rods. These results are plotted in Figure 34.

Upon completion of Test IV later this summer, a stress corrosion cracking susceptibility curve for the A354 Grade BD rods can be plotted on the critical stress intensity graph shown in Figure 34, displaying Critical Stress Intensity versus Surface Hardness. As described earlier, when the stress corrosion cracking susceptibility curve is included in Figure 34, in general, those rods plotted to the right of the curve will exhibit greater susceptibility to stress corrosion cracking over time. Conversely, rods plotted to the left of the curve are unlikely to be susceptible to stress corrosion cracking.

In regards to longer-term stress corrosion cracking, there are a number of rods that exhibit surface hardness that is in excess of 35 HRC, a point at which there is increased risk for stress corrosion cracking under sustained high tension. However, based on the tests, these rods also exhibit better metallurgical uniformity and improved toughness. Further, many of the remaining rods are not subject to high sustained tension levels or are located in dehumidified or sealed areas that provided additional corrosion protection. Further, stress corrosion testing is underway as part of Tests IV and V that will provide important data for further analysis and remediation of the rods. A summary of findings based on the material properties obtained from Tests I through III (unless otherwise noted) is contained in Table 13.
