HIGH STRENGTH STEEL ANCHOR ROD PROBLEMS ON THE NEW BAY BRIDGE

Revision 1

November 12, 2013

Senator Mark DeSaulnier

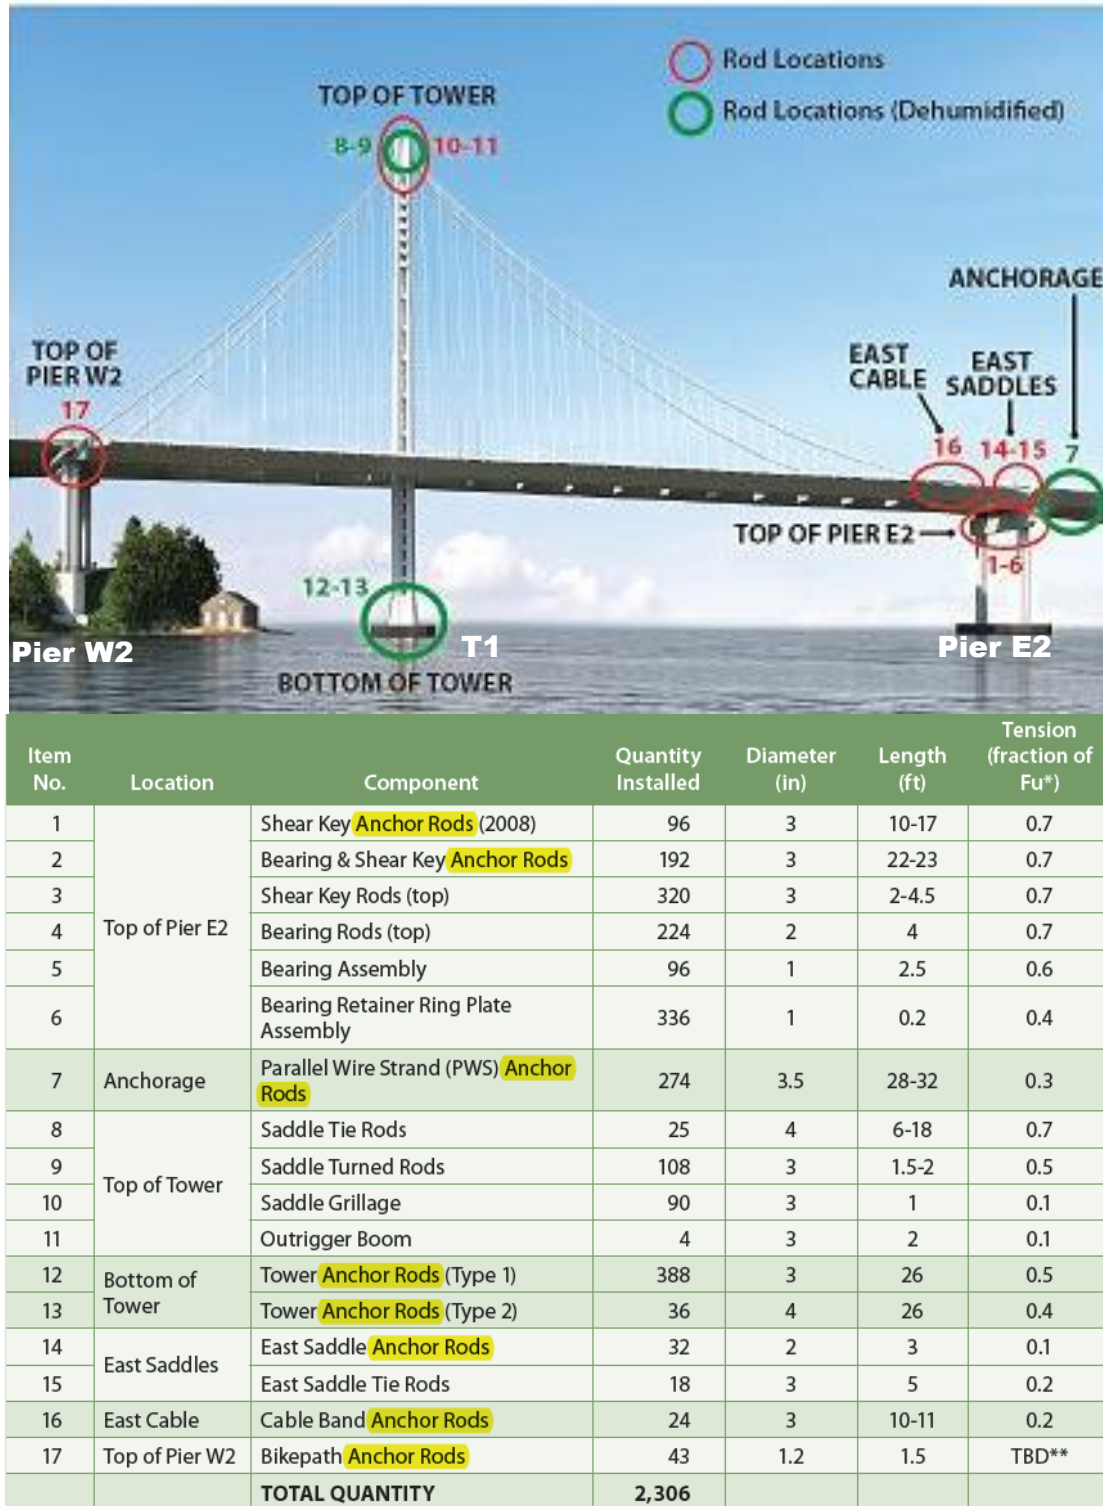
*Fu = Design-specified minimum ultimate tensile strength. Numbers rounded to the nearest tenth.

**Details for bike path support frame being redesigned to improve consistency with other design features of SAS.

Figure 2 Identification of ASTM A354 Grade BD rods on the SAS Bridge.

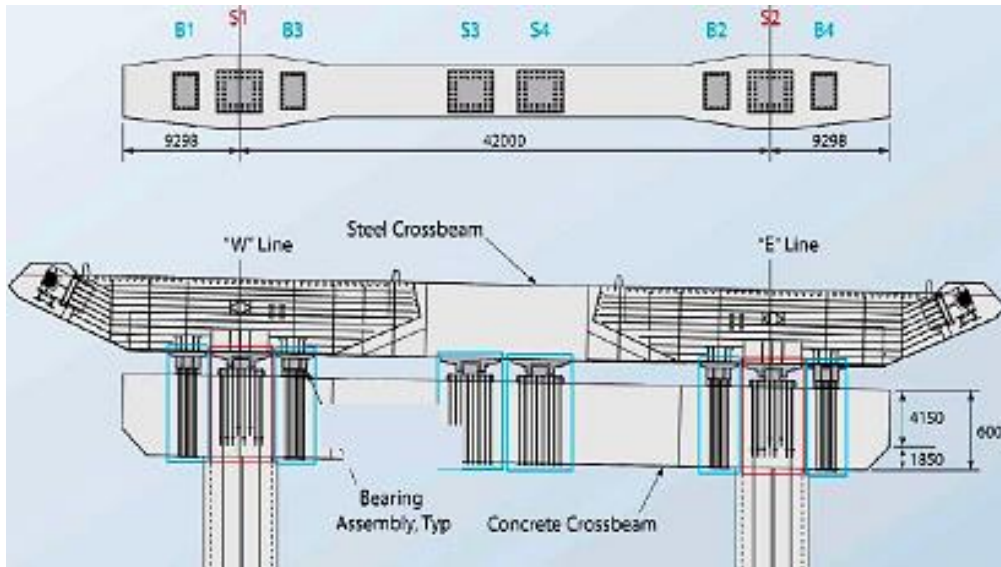
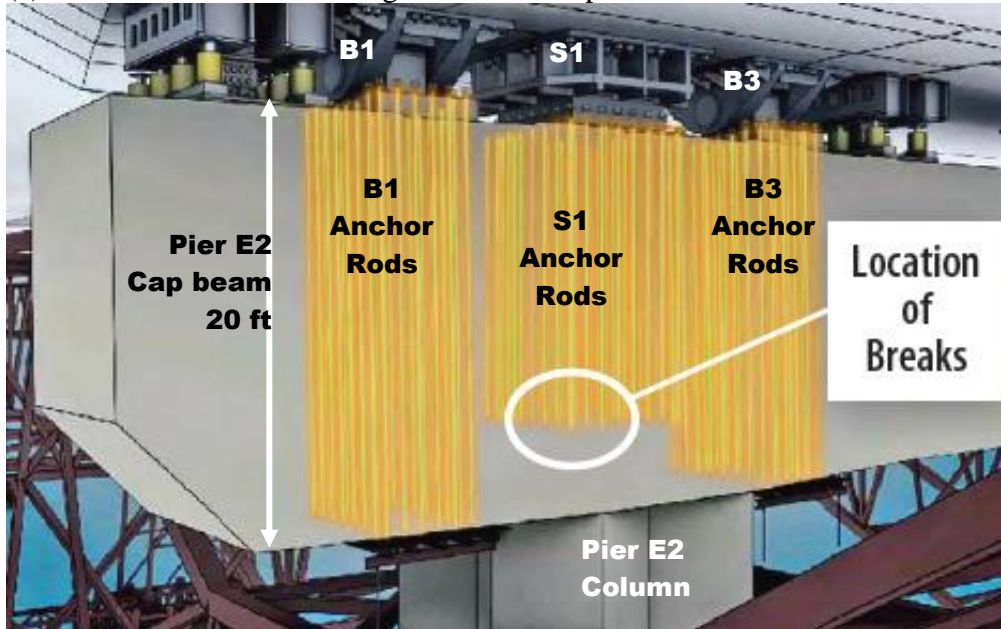
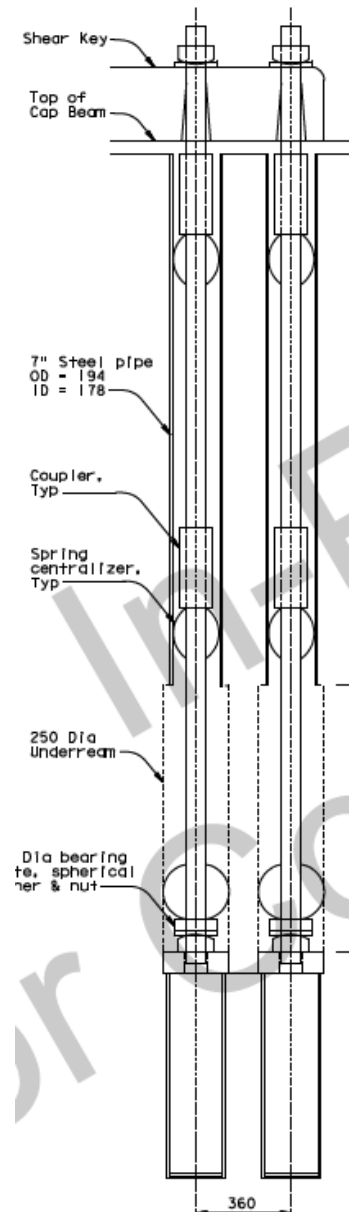
(a) Plan and elevation drawings of Pier E2 cap beam and OBG traffic deck

(b) Anchor rod locations for Shear Key S1 and Bearings B1 and B3

(c) Anchor rod detail

Figure 3 (a) Locations of Shear Keys S1 – S4 and Bearings B1 – B4 between the Pier E2 cap beam and the OBG (orthotropic box girder) traffic decks. (b) Anchor rod locations. Shear Keys S1 and S2 each had 48 anchor rods. 32 anchor rods failed all in the bottom threads within two weeks of pretensioning. (c) Anchor rod details for Shear Keys S1 and S2.

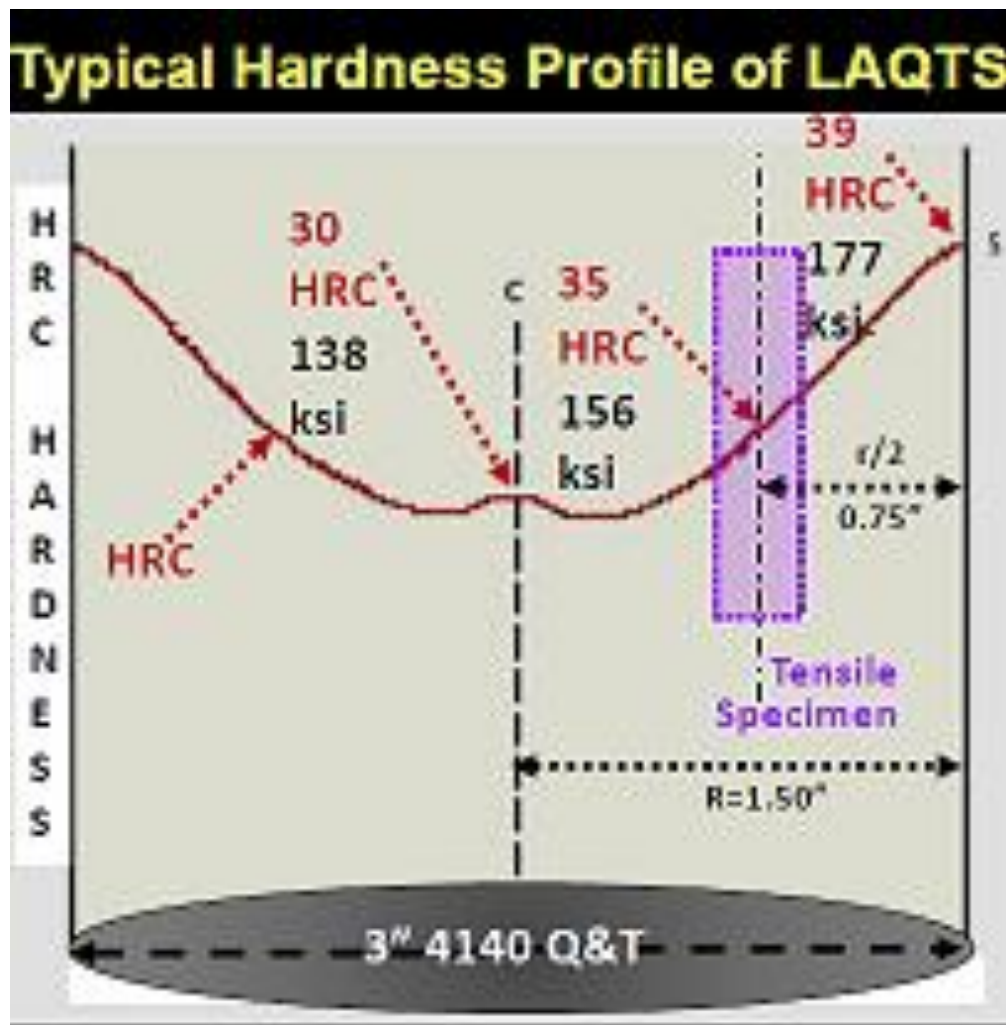
Likewise, Conclusion 3 is unacceptable. No consensus can be established as to what would constitute an ideal metallurgical condition. The microstructure of the anchor rod steel, 3-inch round 4140, quenched and tempered, will have a range of microstructures that will be inhomogeneous, “resulting in [a] large difference in hardness from center to edge.” This is illustrated in Figure 10, which shows a typical hardness traverse of a 3-inch round 4140 steel, quenched and tempered.

The HRC numbers cited in Figure 10 are actual lab test data from the ABC report. The hardness of a 3 inch anchor could vary from 39 HRC at the surface to 35 HRC at mid-radius (R/2) and to 30 HRC at the center (or core). The hardness decreases from the surface to the core as a result of different cooling rates that different locations would experience when the rod is hardened by quenching in an oil bath from around 1600°F. The larger the rod diameter, the slower the cooling rates, resulting in lower hardness.

A typical hardness traverse curve for 3 or 4 inch 4140 steel anchor rods, quenched and tempered to meet the requirements of ASTM A354 Grade BD, will typically be bowl shaped like that in Figure 10 or open-V shaped like those in Figure 23.

Figure 10 Typical hardness traverse profile for low alloy steel, quenched and tempered. The HRC data are actual lab test data from a 3 inch round 4140 steel, quenched and tempered at 1025°F.

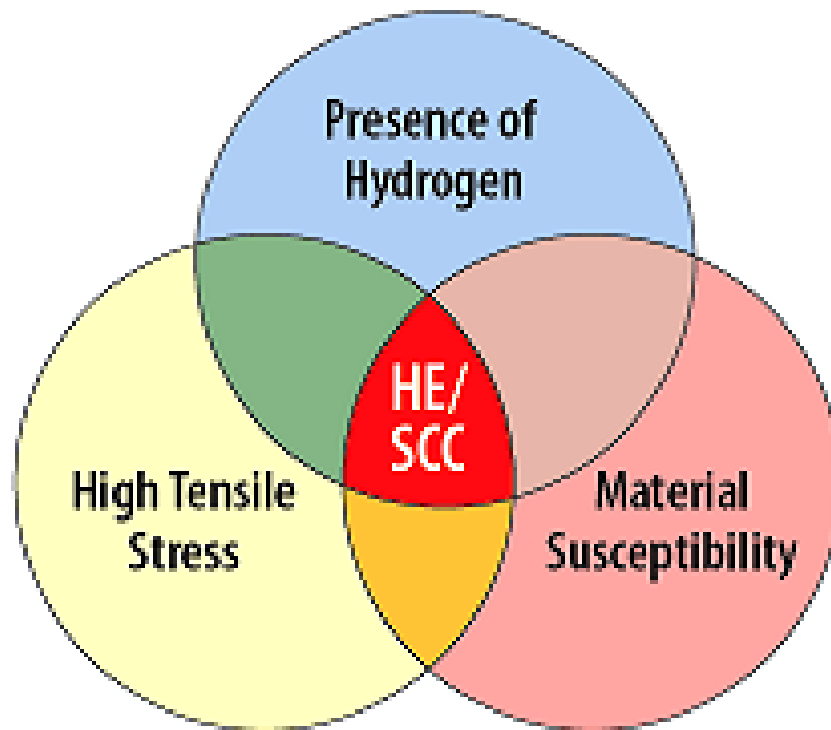
Figure 11 The three conditions for hydrogen embrittlement (HE) and stress corrosion cracking (SCC) (from the TBPOC report, p. 21).

The accompanying Venn diagram shows that when all three conditions apply (i.e., the presence of hydrogen, high tensile stress and a susceptible material), the metallurgical structure of the steel has a higher susceptibility to HE. The diagram also shows that these same conditions can cause a related phenomenon known as Stress Corrosion Cracking (SCC), which will be addressed later in this report.

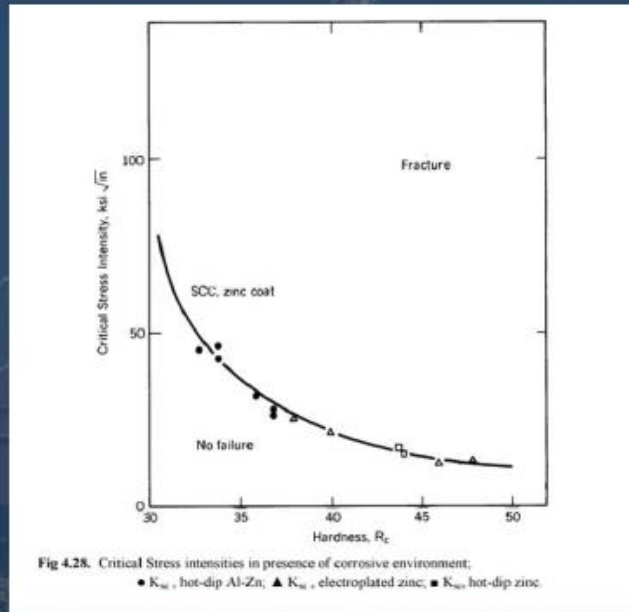
During the May 8, 2013 BATA Briefing, the TBPOC Chairman made the following statement in reference to the graph in Figure 17.⁷⁵

This was the beginning of misunderstanding of the SCC test designed by Townsend. From a description of his test and the reference that the TBPOC Chairman made to the graph in Figure 17, the objective of the Townsend test (or the wet test by the TBPOC Chairman) is to determine the critical stress intensity factors (or the critical stress) for stress corrosion cracking, $K_{I_{SCC}}$ (or σ_{SCC}), using full size sample rods as specimens, perhaps for different hardness levels. Ultimately, the $K_{I_{SCC}}$ data may be used to determine the threshold stress level below which HE would not occur for a given hardness/strength level irrespective of a hydrogen concentration in the steel.

Problems arise when the Townsend Test is misrepresented as a test to determine “long-term stress corrosion susceptibility” as in Figures 17 and 18. The $K_{I_{SCC}}$ test has no ability to predict a “longer-term” performance of a rod in a given environment such as the San Francisco-Oakland Bay. Therefore, the caption of the graph in Figure 17 or the definition given by the TBPOC, shown below, is incorrect.⁷⁶

Figure 17 Critical stress intensity for stress corrosion cracking vs. hardness, presented at the May 8, 2013 BATA Briefing. The above graph is part of a graph that was originally published by H. Townsend in 1975 in the Metallurgical Transactions. Fisher introduced errors in notations when he “borrowed” the graph from the Townsend paper. The open triangles and the open squares in the lower part of the curve are supposed to be solid triangles and solid squares as indicated by the notations of the graph.

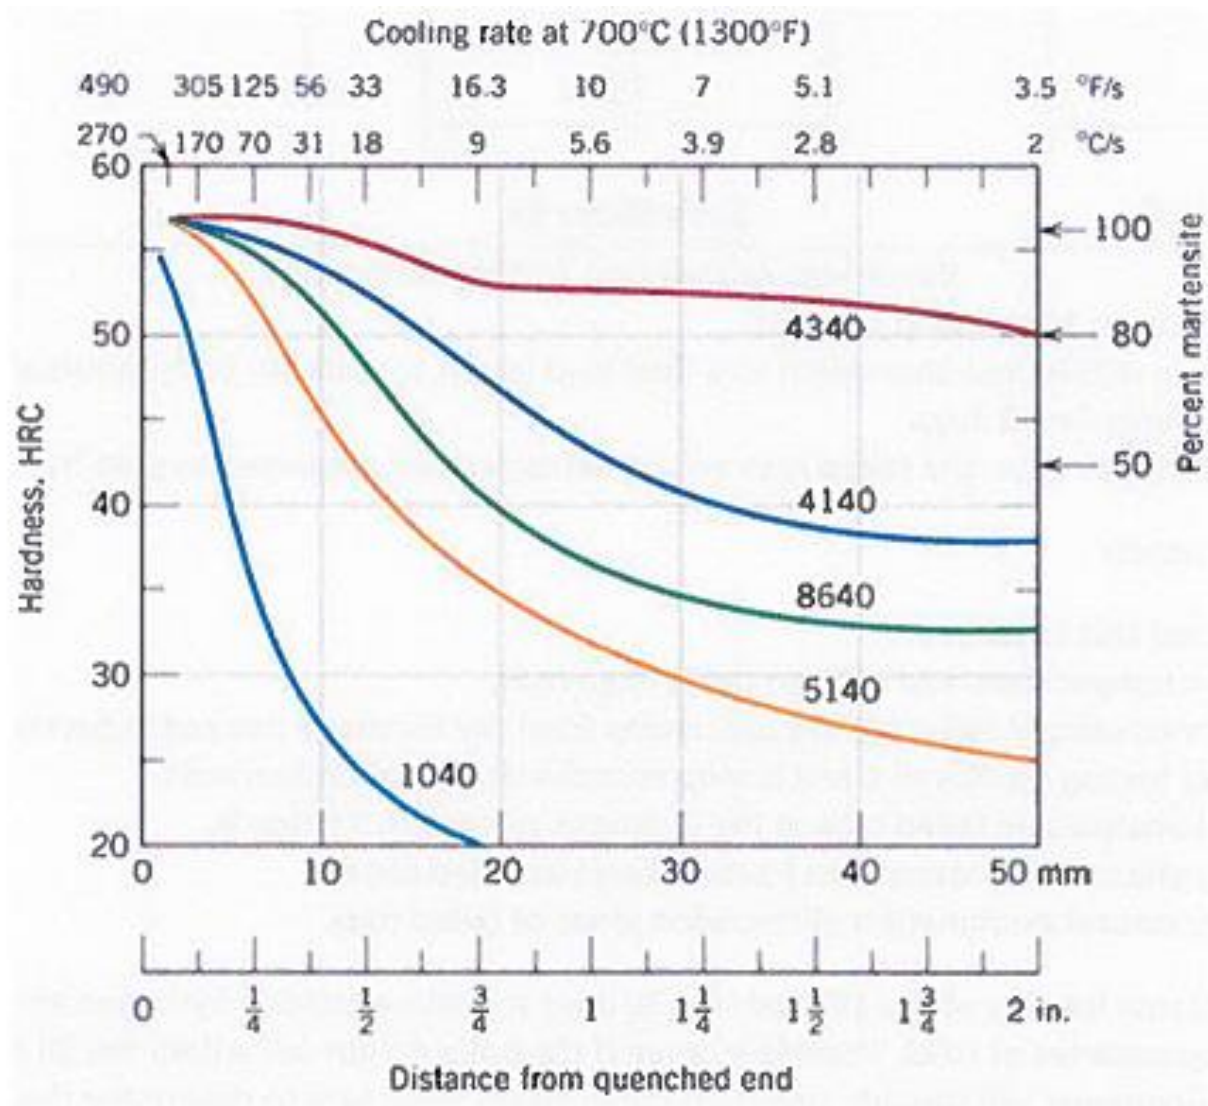
The stock material, 3 inch round 4140 steel, to make the S1 and S2 anchor rods does not have high hardenability as compared with, for example, 4340. This is well known (Figure 19), at least among materials engineers. Whether the rod was improperly heat treated or not could have been verified by conducting a heat treatment experiment, which was not done. Then, the ABC and the TBPOC reports cited 13.5 to 17.7 ft-lbs CVN (Charpy V notch) impact values as low toughness that was a significant factor in the HE failures of the S1 and S2 anchor rods, based more on the authors' opinion than technical justifications. They offered no technical references to back up their opinion on the effects of toughness on HE failures. Their interpretation of the low CVN values, however, had an important impact on the remedial decision by the TBPOC and has affected almost every decision TBPOC/Caltrans have made with regards to the disposition of the entire Grade BD rods on the SAS Bridge.

Figure 19 Hardenability curves for different low alloy steels and a medium carbon steel.

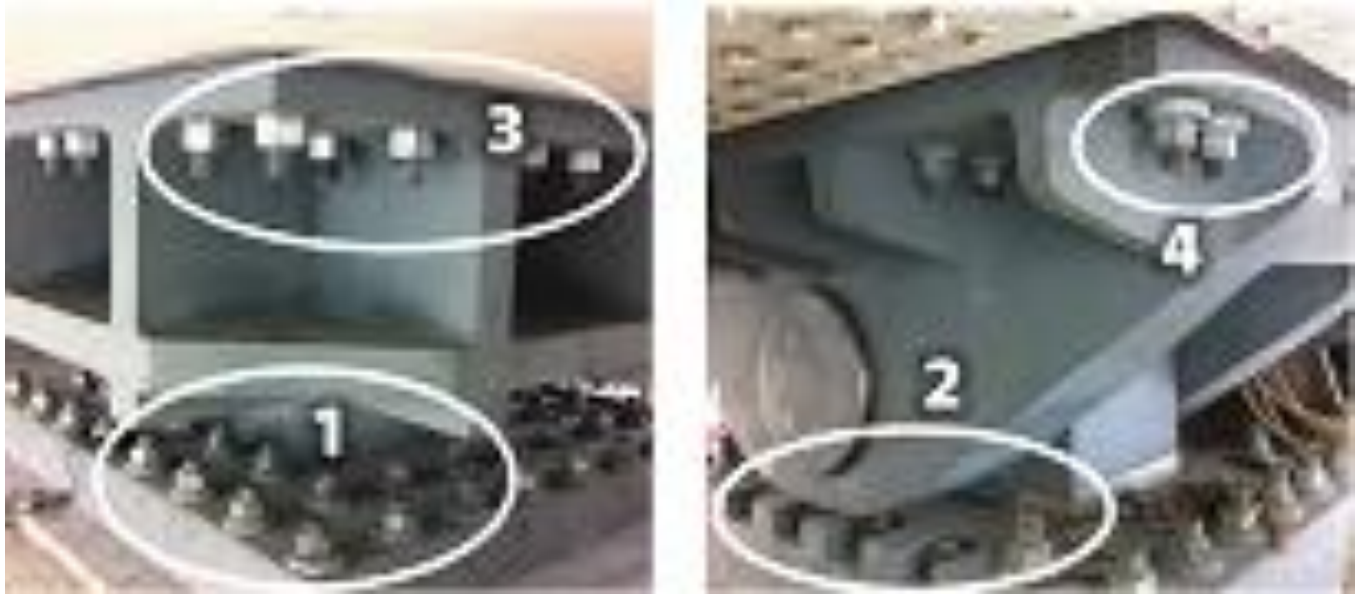
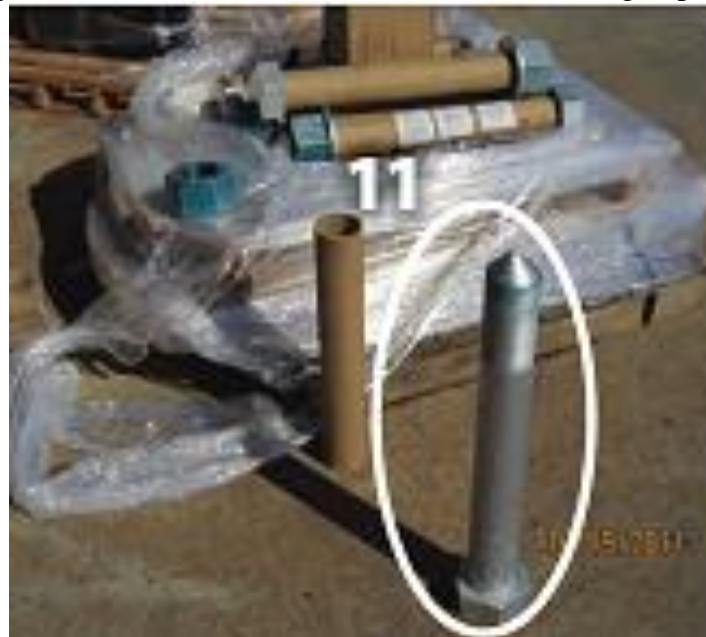
According to Table ES-2 and Table 14 of the TBPOC report, Items 2 - 4 and Item 11, shown below, will be replaced with new rods to be purchased with new supplementary requirements.⁸⁴ See Figure 20 for these items.

(a) 1 – Shear key, base plate anchor rods
3 – Shear key, top rods

(b) 2 – Bearing base, plate anchor rods
4 – Bearing, top rods

(c) 11 – Outrigger boom anchor rod at tower top¹⁰⁷

Figure 20 Item numbers 2, 3, 4, and 11 for locations of rods for replacement with rods to be purchased with new supplementary requirements.¹⁰⁸

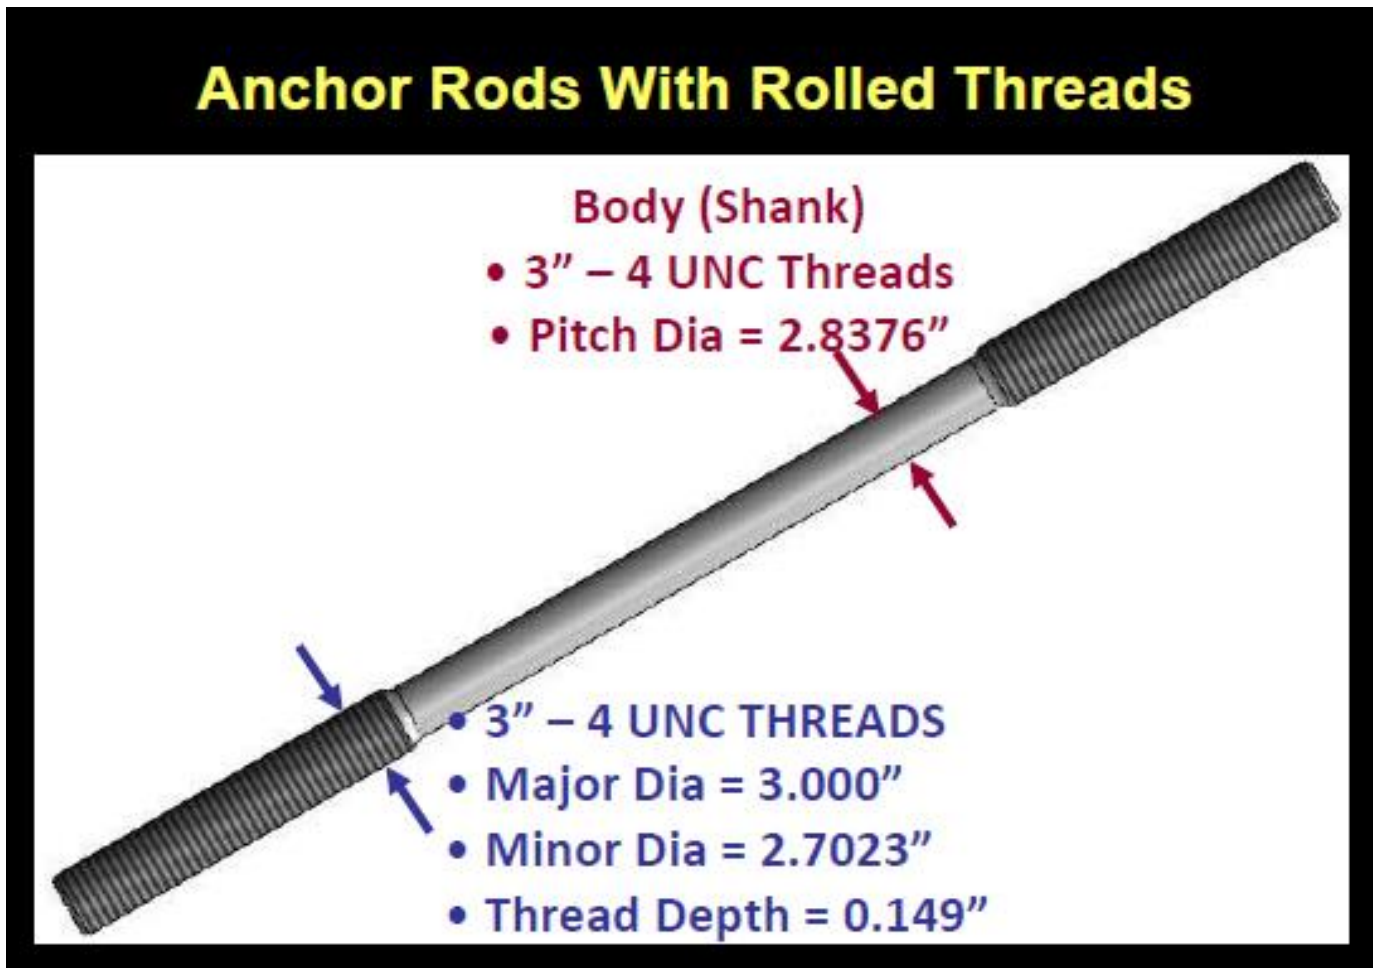
Figure 21 A 3 inch diameter rods with cold rolled 4UNC threads. The shank diameter is smaller than the thread major diameter.

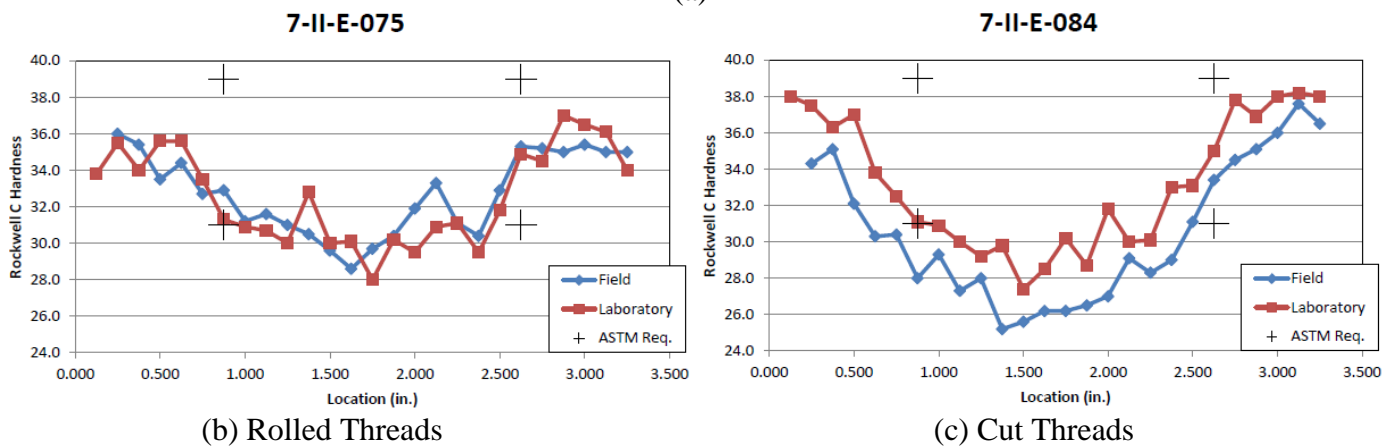
Figure 22 presents an example of these hardness test data and corresponding hardness traverse graphs for two cases of Item 7, 3½ inch PWS anchor rods. The shortcomings of these data, specific to the anchor rods with rolled threads, were already discussed.

Figure 22 (a) Part of hardness data for 3½ inch PWS anchor rods. (b) and (c) Hardness traverse plots for Rod E-075 and E-084 in the table in (a).

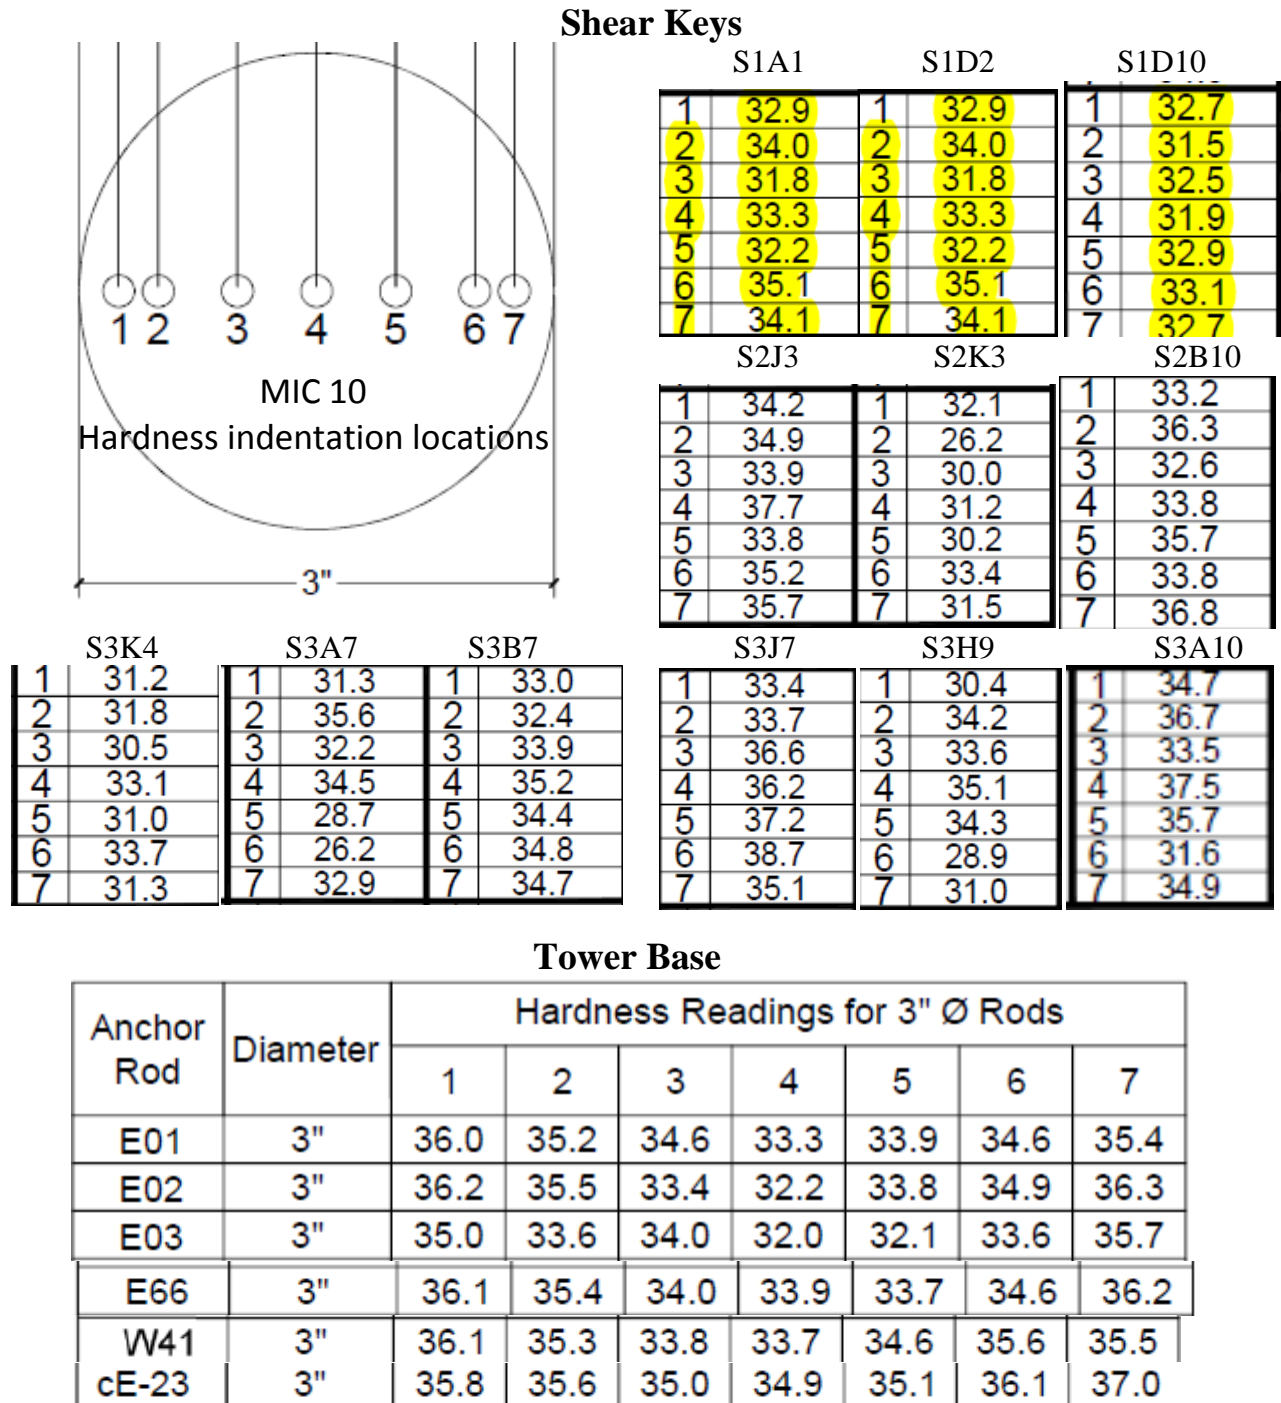
Many hardness data would look flat rather than bowl shaped if plotted as mentioned already. Some examples of flat hardness traverse data are shown in Figure 25.

Figure 25 Sketch showing the locations of potable hardness test indentations and examples of hardness traverse data that would look flat if plotted.¹⁰⁹
