*Appendix E –
Hood Canal Floating Bridge Report
(3/20/2014 Revision)*

HOOD CANAL FLOATING BRIDGE

High Strength Anchor Bolts
Example of Application of Greased and
Sheathed Double Corrosion Protection Systems

March 20, 2014

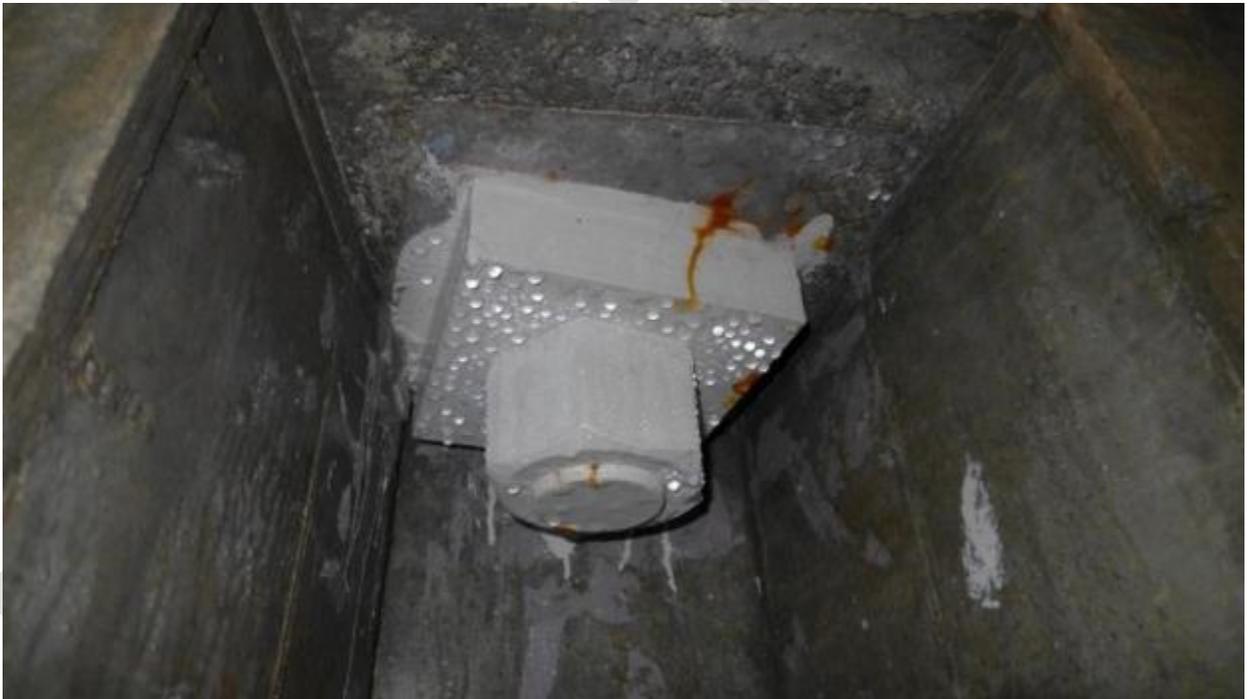
Bottom of 3 Inch Galvanized AISI 4140 Alloy A354 BD Bolt

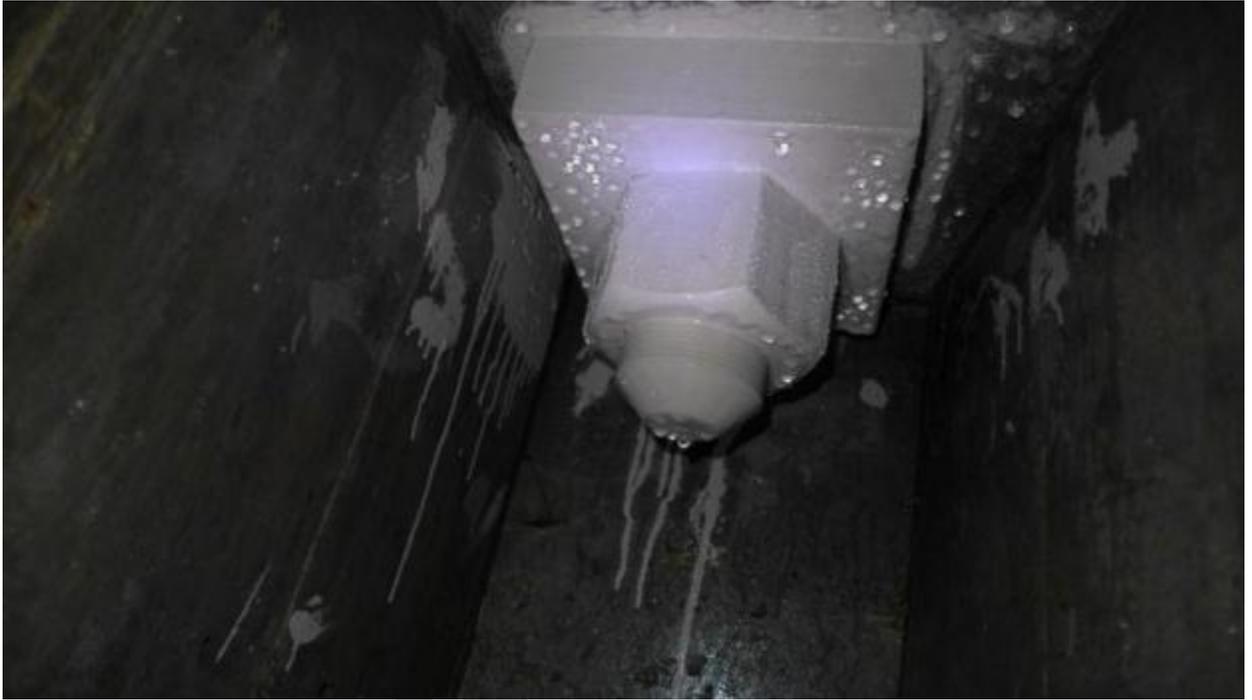
Bottom of 3 inch Galvanized AISI 4340 Alloy A354 BD Bolt

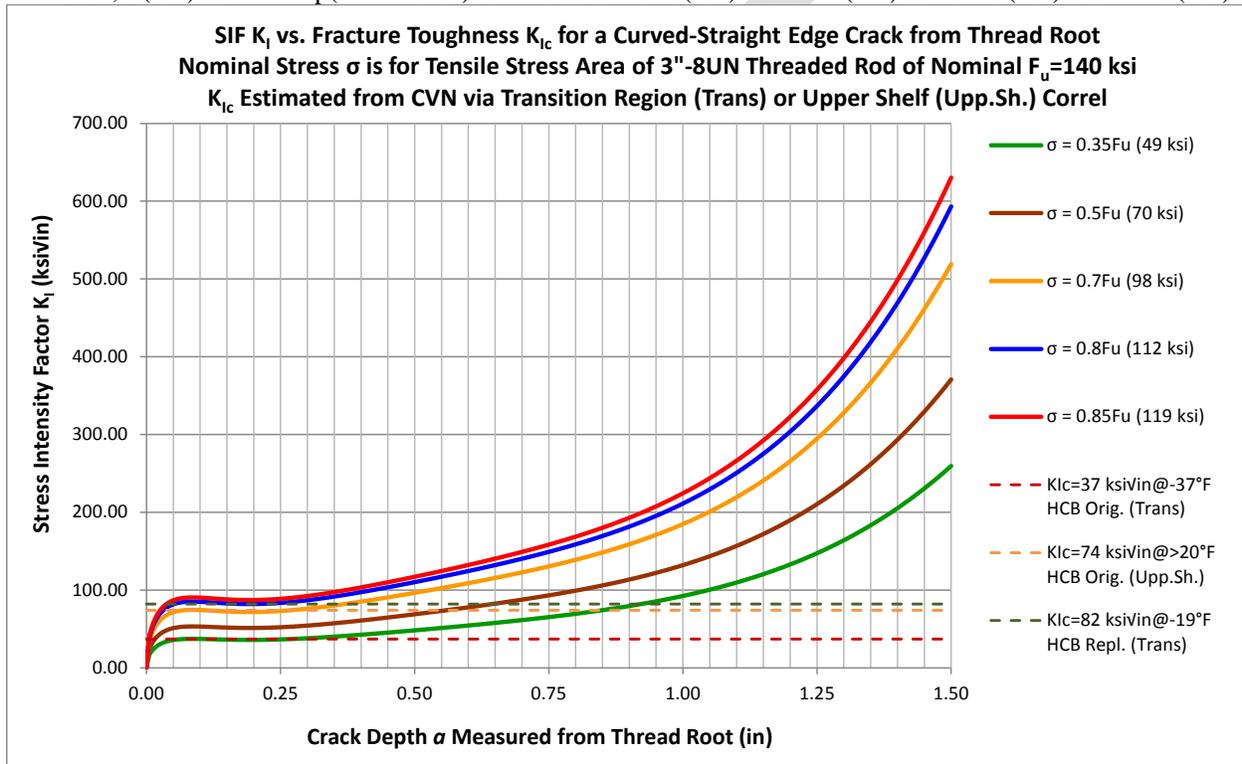
Calculated K_I vs. K_{Ic} at Fracture for a Curved-straight Edge Surface Crack from Thread Root
 (3"-8UN Rod, nominal $F_u=140$ ksi, a =crack depth, σ =nominal stress for tensile stress area)

- 1) Fracture toughness K_{Ic} is estimated from CVN and tensile test data (IMR KHA Report Nos. 201311742 and 201400457) per K_{Ic} -CVN correlations in “Barsom, J.M. and Rolfe, S.T., *Fracture and Fatigue Control in Structures*, 3rd Ed., ASTM, 1999”. For HCB original rods, K_{Ic} was estimated for transition region and upper-shelf based on CVN data at -20°F, 20°F, and 40°F. For HCB replacement rods, K_{Ic} was estimated for transition region only since CVN data was only available at -20°F.

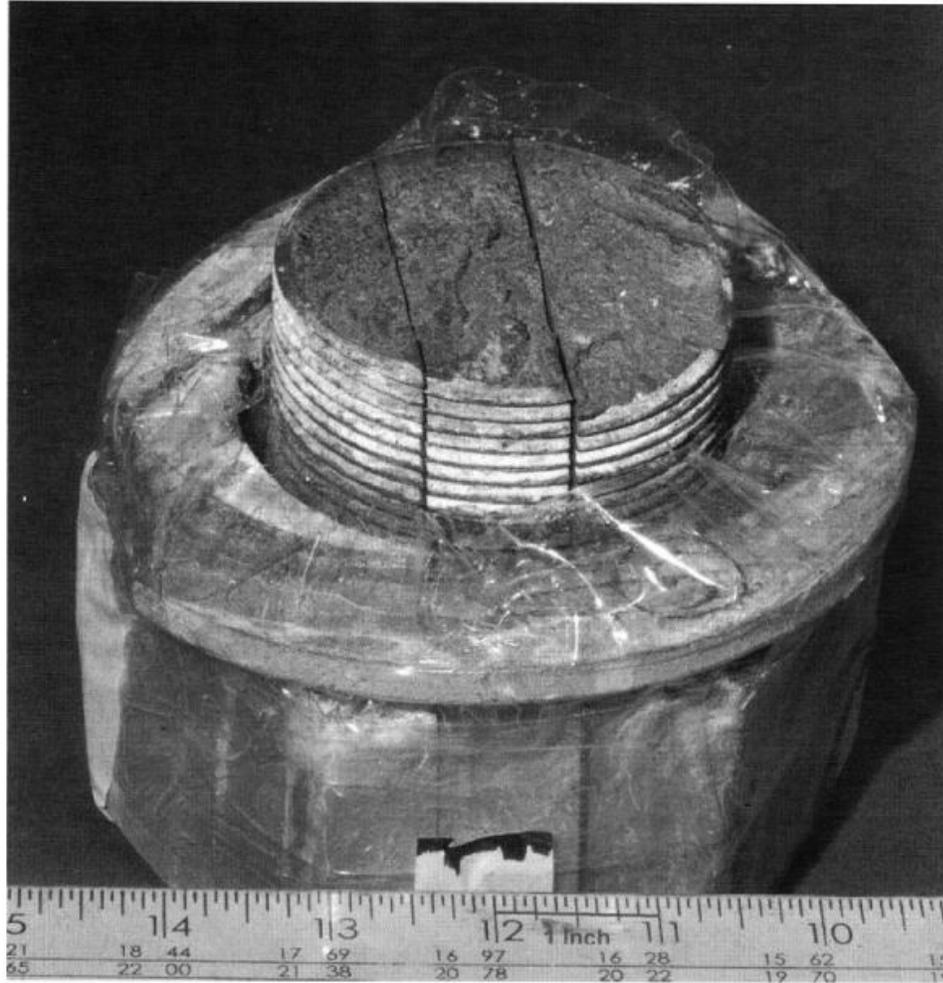
Figure 1

Sample 5 in the as-received condition. The sample consisted of a previously sectioned bolt, nut, and washer. The sample had been reassembled and wrapped in clear adhesive tape to retain the various remnants. The bolt was approximately 4 1/4 inches long by 3 inches in diameter. The fracture surface exhibited superficial rusting, and some non-uniform accumulation of white deposit suggests that some corrosion of the apparent galvanized surface had occurred. The washer was deformed well outside of the original plane and contained multiple fractures and cracks. The scale divisions at the bottom of the photograph are 1/16 inch.

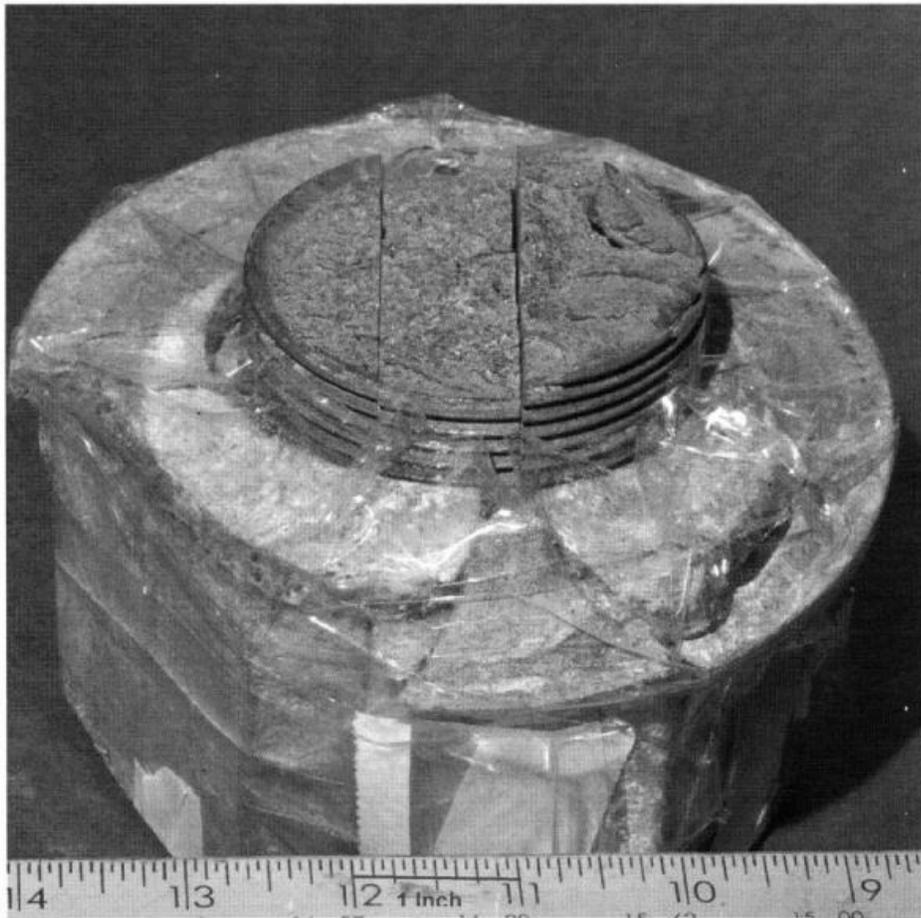
Figure 2

Sample 8 in the as-received condition. The sample consisted of a previously sectioned bolt, nut, and washer. The sample had been reassembled and wrapped in clear adhesive tape to retain the various remnants. The bolt was approximately 4 1/4 inches long by 3 inches in diameter. The fracture surface exhibited superficial rusting, and some non-uniform accumulation of white deposit suggests that some corrosion of the apparent galvanized surface had occurred. The washer was deformed well outside of the original plane and contained multiple fractures and cracks. The geometry, fracture location, and apparent failure mechanism of Bolts 5 and 8 appeared to be essentially identical based on visual examination. The scale divisions at the bottom of the photograph are 1/16 inch.

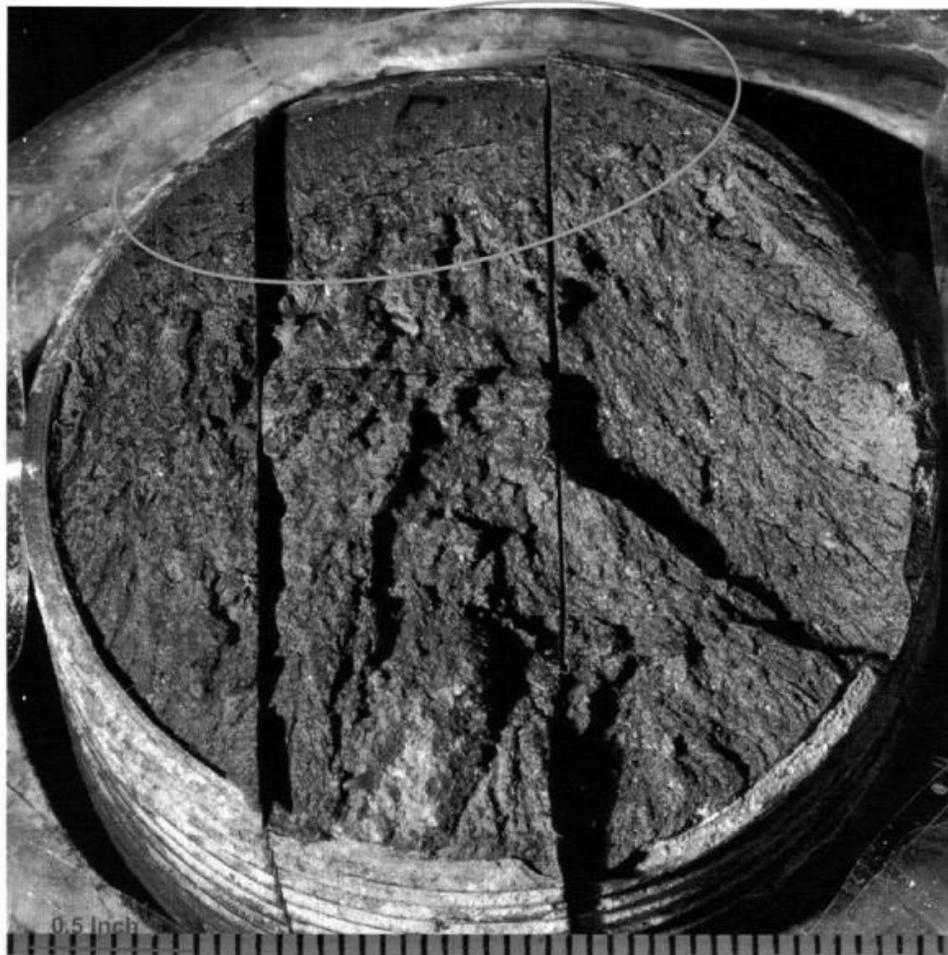
Figure 3

Sample 5 fracture surface. Ridges and grooves on the fracture point to an apparent fracture initiation area within the green oval. An abrupt boundary between smooth fracture at the initiation area and rough fracture over the majority remainder of the fracture indicates fracture in two stages or steps and likely due to two different fracture mechanisms. The rough fracture is characteristic of brittle final overload. The large area of final overload relative to the initiation fracture mode is indicative of a large stress magnitude. Fracture was oriented transverse to the axis of the bolt. Transverse brittle fracture is indicative of an axial tensile stress. Fracture was not the result of torsional overload. The scale divisions at the bottom of the photograph are 1/16 inch.

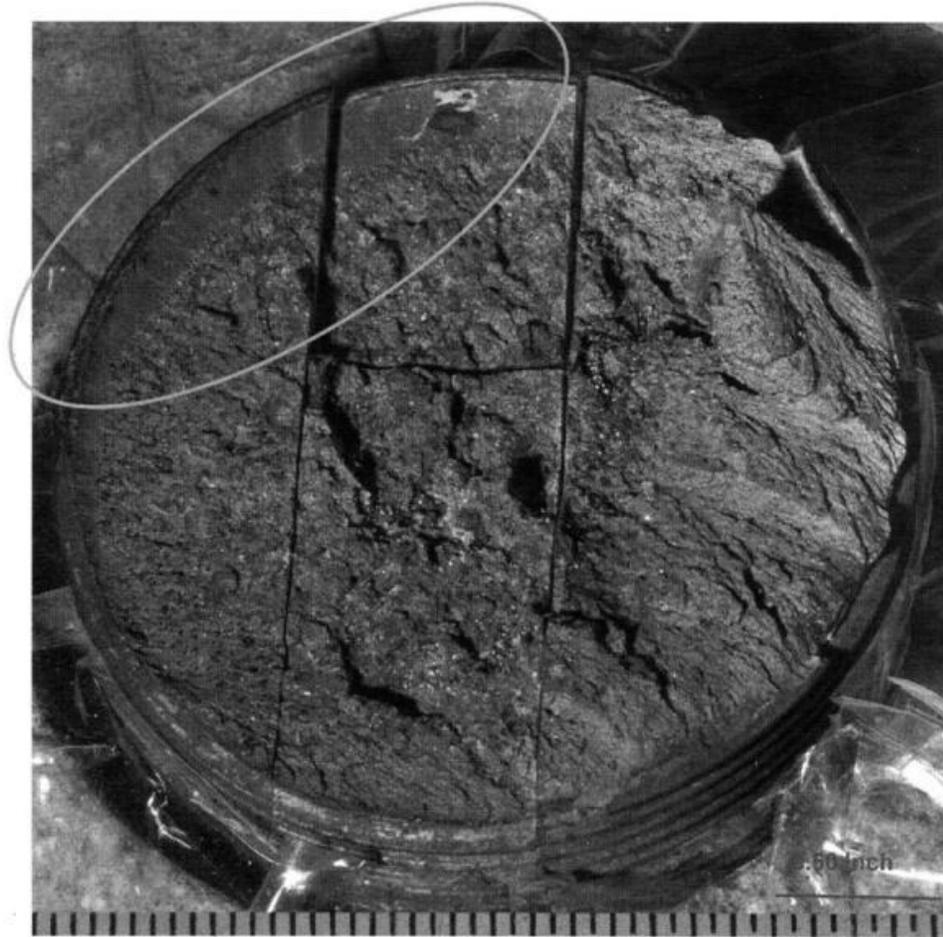
Figure 4

Sample 8 fracture surface. Ridges and grooves on the fracture point to an apparent fracture initiation area within the green oval. An abrupt boundary between smooth fracture at the initiation area and rough fracture over the majority remainder of the fracture indicates fracture in two stages or steps and likely due to two different fracture mechanisms. The rough fracture is characteristic of brittle final overload. The large area of final overload relative to the initiation fracture mode is indicative of a large stress magnitude. Fracture was oriented transverse to the axis of the bolt. Transverse brittle fracture is indicative of an axial tensile stress. Fracture was not the result of torsional overload. The initial fracture closely followed the thread root and the circumference of the bolt. Preferential fracture along the thread root indicates that the thread root acted as a substantial stress concentration. The scale divisions at the bottom of the photograph are 1/16 inch.

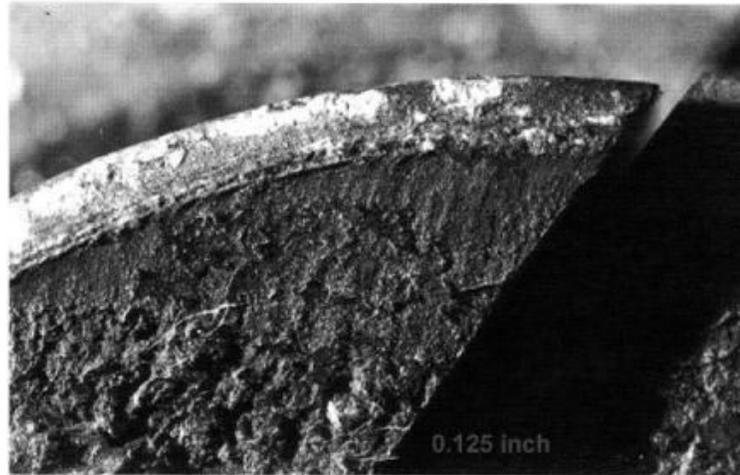
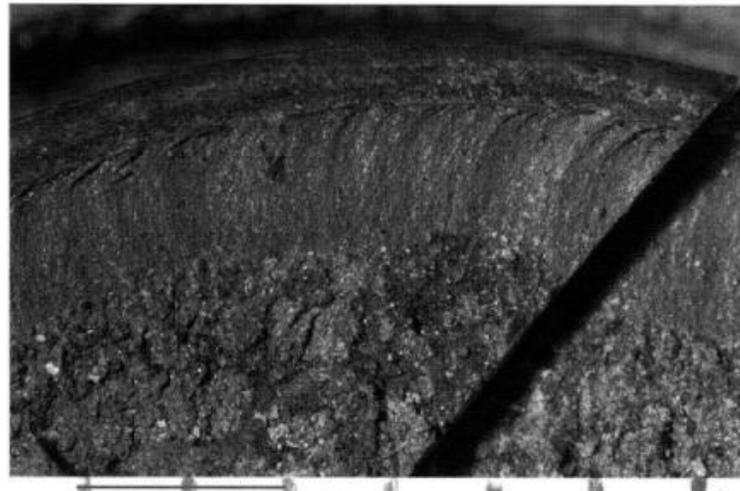
Figure 5

Apparent fracture initiation regions of Bolts 5 and 8. Faint ridges point to fracture initiation at the root of the thread of Bolt 5. Arc shaped features on the fracture surface just below the thread root may indicate deformation due to thread rolling. The scale divisions at the bottom of the photograph are 1/16 inch.

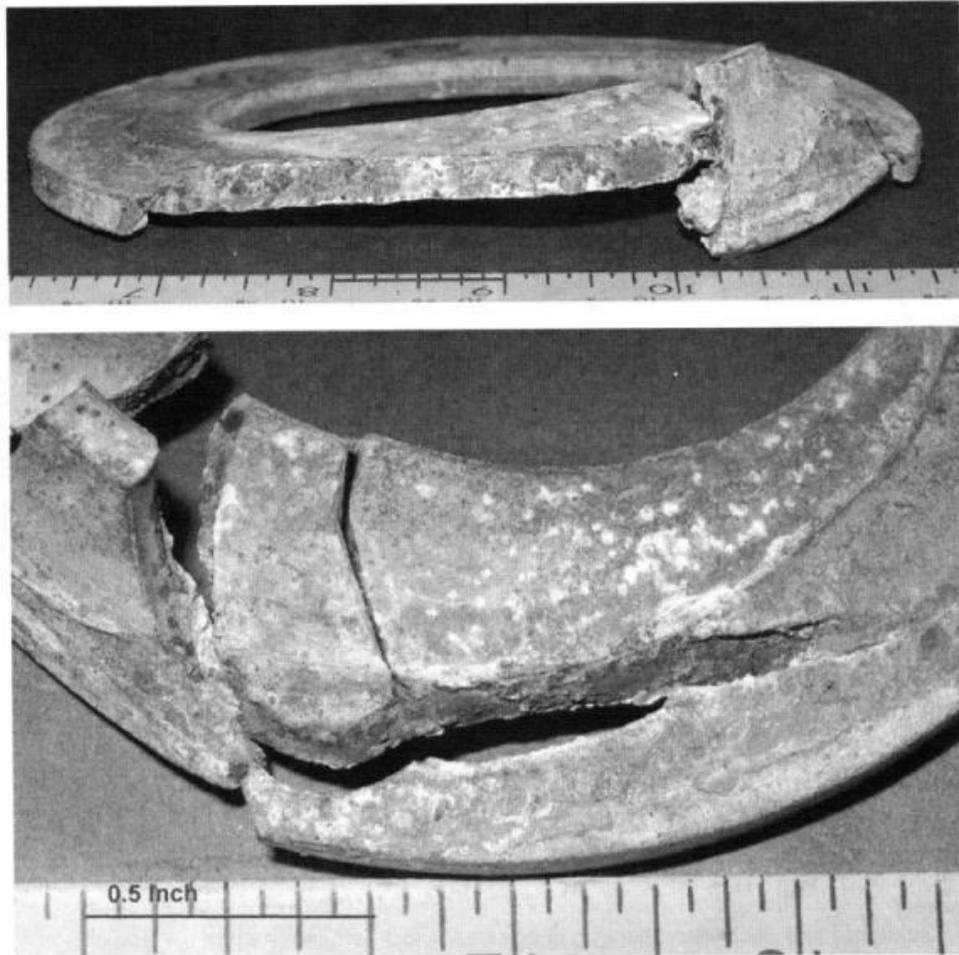
Figure 6

Washer from Bolt 8 in the as-received condition. Substantial axial deformation and fracture was apparent on both washers. We understand that the washers were too thin for the annular space between the bolt and the CIP 4 inch diameter pipe sleeves and that failure at the specified bolt loads would predictably cause washer failure. The observed deformation of the washer would predictably result in non-uniform bearing loads against the face of the mating nut. As a result, a bending load could exist in the bolt. The scale divisions at the bottom of the photographs are 1/16 inch.

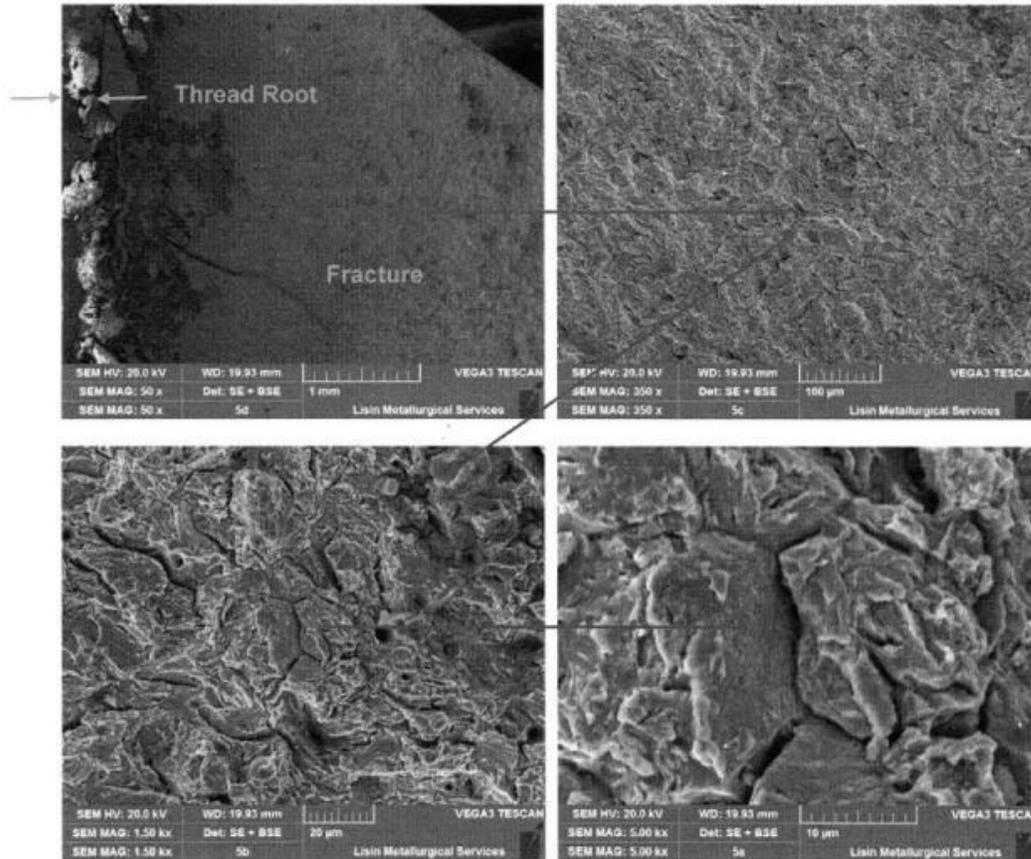
Figure 8

Mixed backscattered and secondary electron images acquired from the fracture surface of Bolt 5. The location shown is approximately 1 to 2 mm below the thread root, within the crescent shaped band of smoother fracture near the fracture initiation. This location is likely below the heavily deformed material created during thread rolling. Partially intergranular fracture along more equiaxed prior austenite grain boundaries is apparent. The fracture surface again appears to consist of a mix of brittle intergranular fracture and ductile or partially ductile transgranular fracture. Intergranular fracture is one characteristic of hydrogen embrittlement.

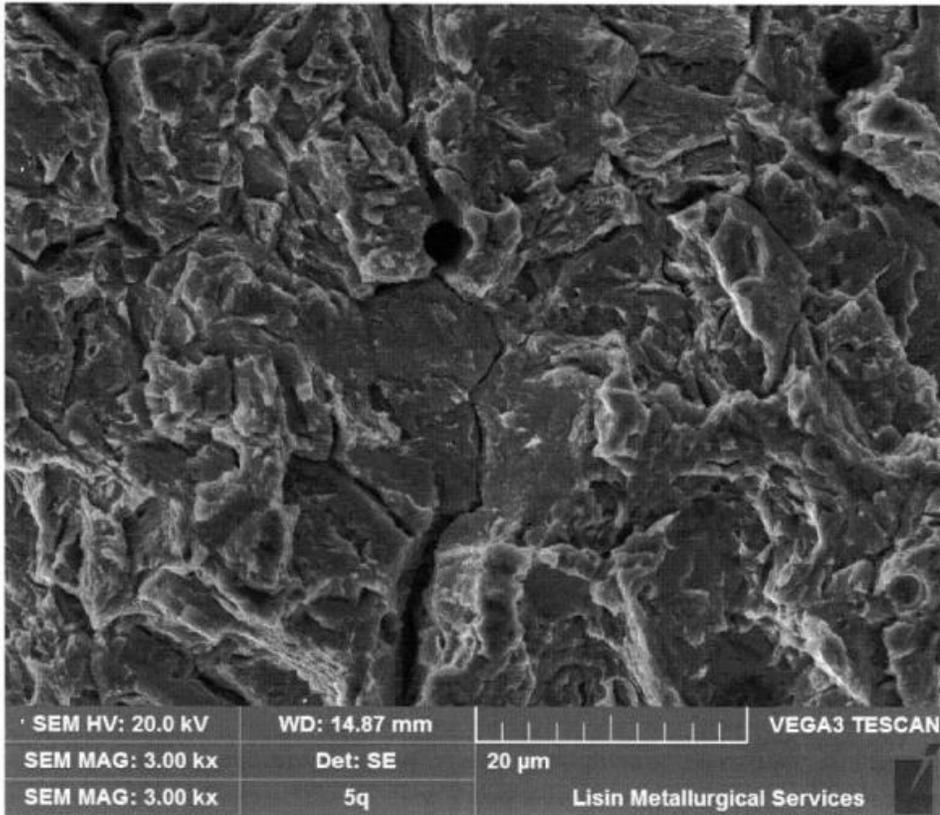
Figure 9

Secondary electron image acquired from the fracture surface of Bolt 5. The location shown is approximately 1 to 2 mm below the thread root, within the crescent shaped band of smoother fracture near the fracture initiation. The location shown is the most pronounced example of intergranular fracture revealed by an extensive search. The fracture surface at this location again consists of a mix of brittle intergranular fracture and more ductile transgranular fracture. Severe hydrogen embrittlement or hardened alloy steels, likely due to high hydrogen levels or high hardness levels typically exhibits pronounced intergranular facets and little or no ductile fracture. The mix of both ductile and brittle intergranular fracture suggests that fracture was due to embrittlement on the less severe side of a mild embrittlement to severe embrittlement continuum.

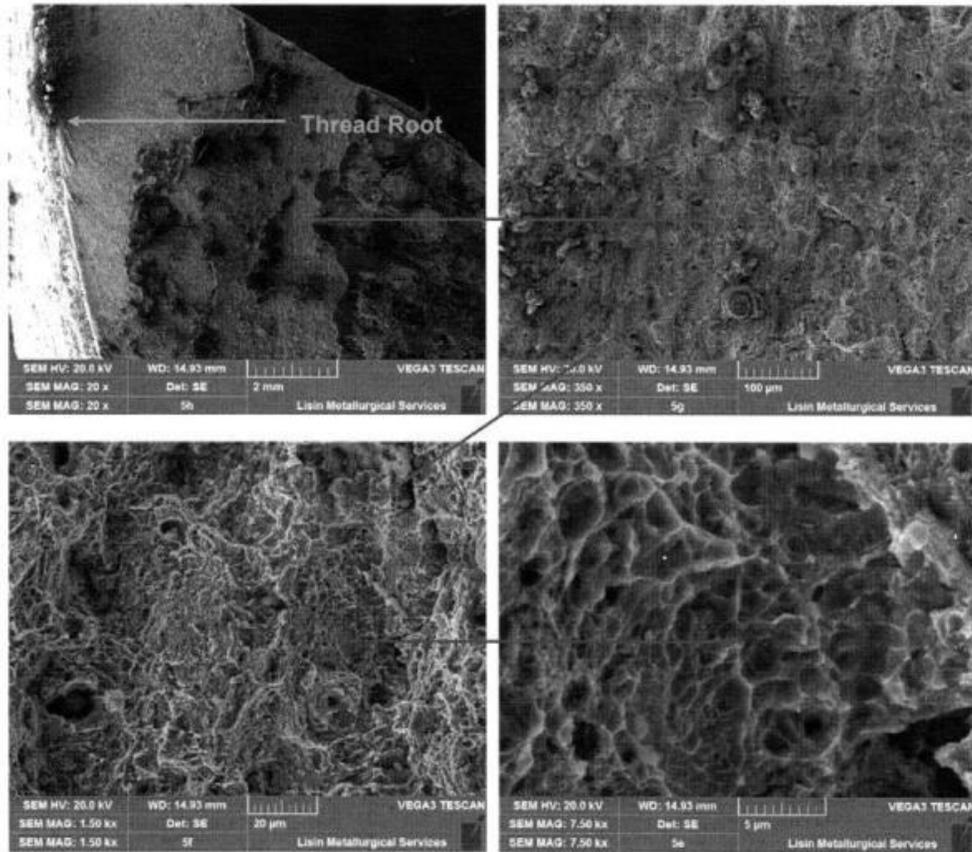
Figure 10

Secondary electron images acquired from the fracture surface of Bolt 5. The location shown is at the boundary between smooth fracture initiation and rougher overload fracture. The fracture surface features consist of micro-void coalescence (MVC). MVC is a ductile, transgranular fracture mode. Alternate bands of intergranular fracture and MVC can exist when hydrogen migrates to a crack tip and embrittles a local area at the tip of the crack. Crack extension due to this local embrittlement can result in crack propagation outside of the hydrogen rich zone and into ductile material. The presence of ductile overload argues against failure due to an inherently brittle material such as would occur with temper embrittlement. The ductile fracture suggests failure due to a localized or transitory mechanism such as hydrogen embrittlement.

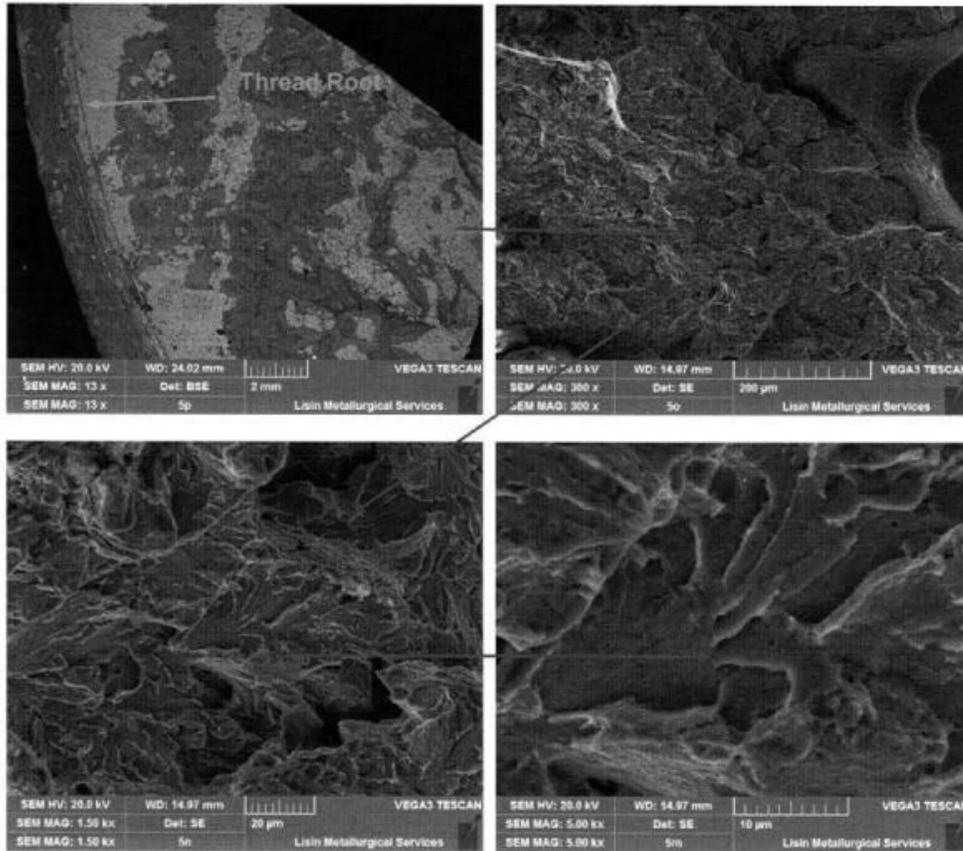
Figure 11

Secondary electron images acquired from the fracture surface of Bolt 5. The location shown is within the rougher overload fracture. Fracture was the result of brittle transgranular cleavage. Cleavage fracture can result from limited ductility, thick sections, and severe stress concentrations such as a crack tip. Cleavage is not characteristic of hydrogen embrittlement. The limited amount or small zone of intergranular fracture again suggests a "mild" case of embrittlement in the mild to severe embrittlement continuum.

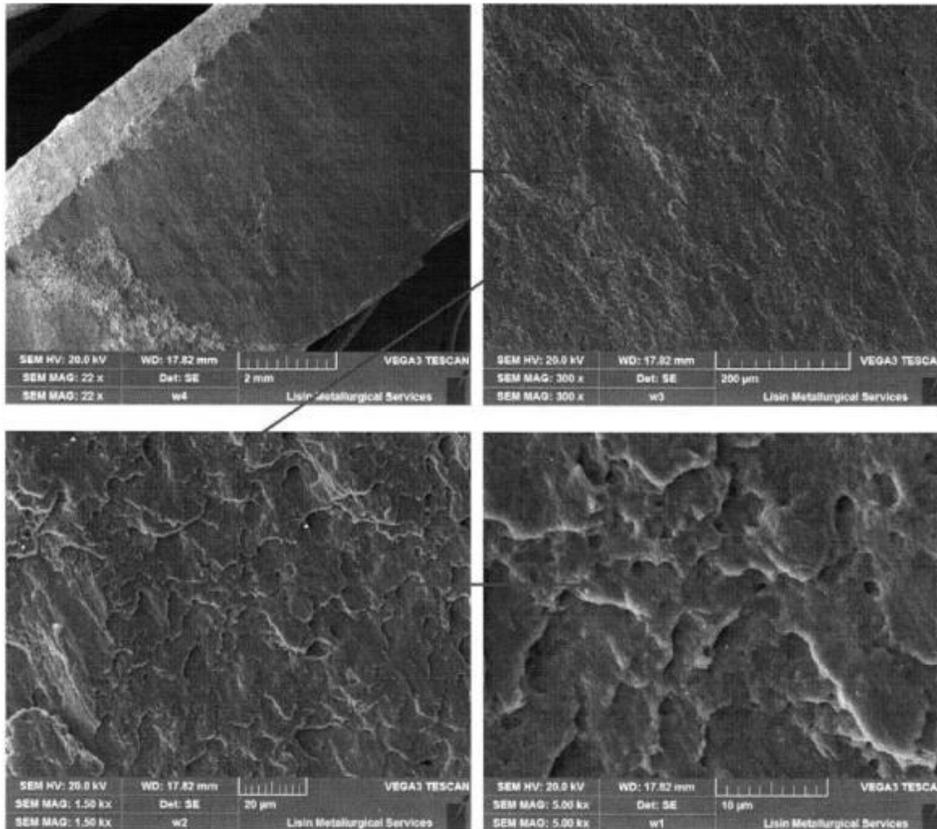
Figure 13

Secondary electron images acquired from a representative fracture surface on the Bolt 5 washer. The features are consistent with ductile shear fracture. The macroscopic deformation and shear fracture of the washer indicate that the washer thickness or strength was simply insufficient to support the clamp loads, and the fracture deformed into the hole and eventually fractured. Deformation and fracture of the washer could lead to non-uniform bearing on the nut and off axis loading on the bolt. We understand that the bolt was stressed to 70% of the minimum ultimate tensile strength during installation. A superimposed bending load due to washer damage and non-uniform bearing could increase local stresses within the bolt to near or at the yield strength. Susceptibility to hydrogen embrittlement increases with increasing tensile stress. Damage to the washer prior to bolt failure could therefore promote subsequent hydrogen embrittlement fracture of the bolt.

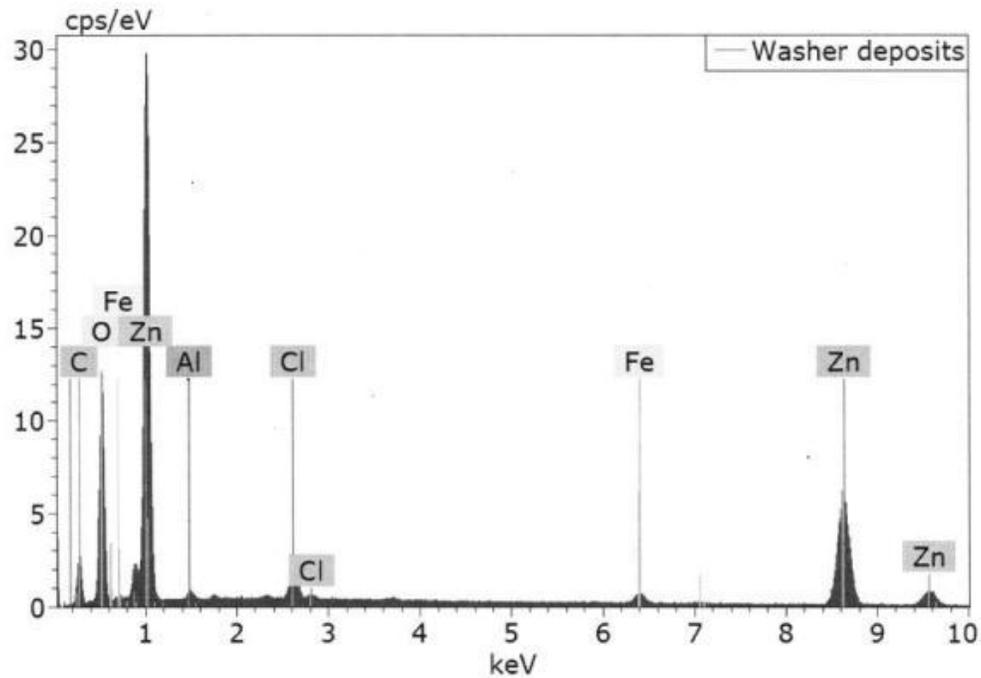
Figure 14

Energy dispersive x-ray spectra acquired from the deposited surface of the Bolt 5 washer. This sample presumably was not exposed to cutting fluids and was coated prior to our analysis, and the deposit composition should be representative of the as-fractured condition. Deposits consist primarily of zinc corrosion products. Substantial chlorine was also detected. It is not known if the chlorine exposure occurred prior to crack initiation or if exposure to chlorine was the result of fracture when the bolt dropped out of the joint and reportedly landed on the floor. Chlorine is a potent corrodant of alloy steels when present with moisture as the chloride ion, Cl^- . Corrosion of zinc coated steel can result in hydrogen generation and subsequent hydrogen embrittlement.

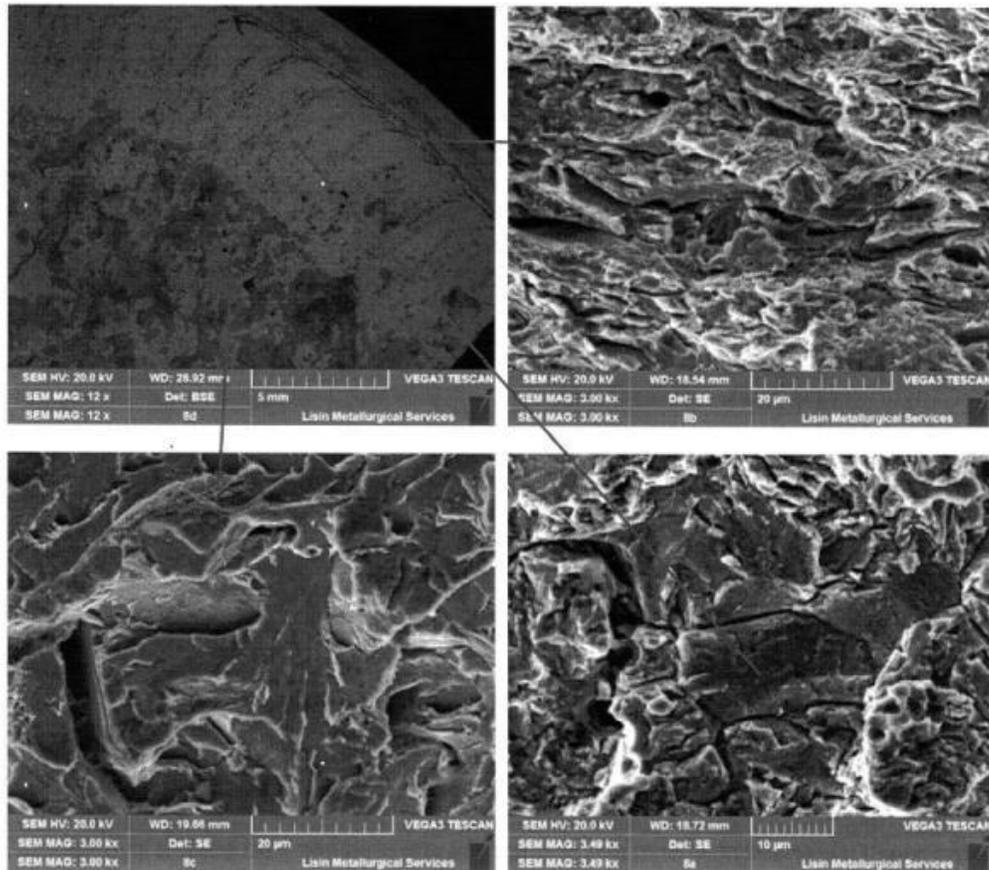
Figure 15

Backscattered electron and secondary electron images acquired from the fracture surface of Bolt 8. Fracture consisted of a mix of ductile overload and possible intergranular fracture along highly deformed grain boundaries at the thread root. A mix of ductile overload and less frequent intergranular fracture was apparent below the thread root deformation but still within the smoother crescent shaped zone of fracture initiation. The features are consistent with a mix of ductile overload and mild hydrogen embrittlement. Transgranular cleavage occurred within the large area of final overload. Cleavage fracture is consistent with high tensile stress, a limited ductility material, and a severe stress concentration at a crack tip. The fracture surface features shown above are essentially identical to those of Bolt 5, and indicate similar failure modes for the two bolts.

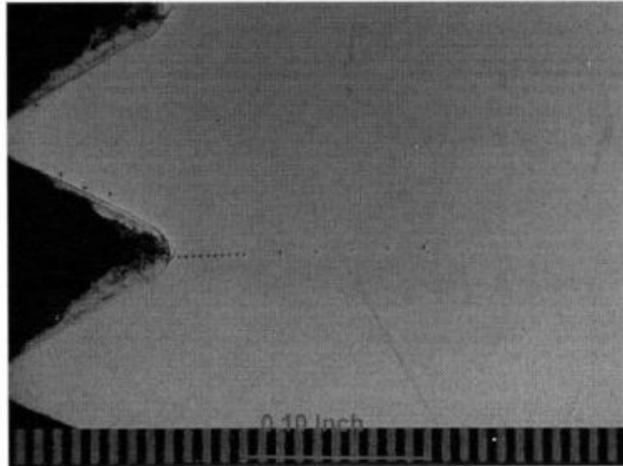
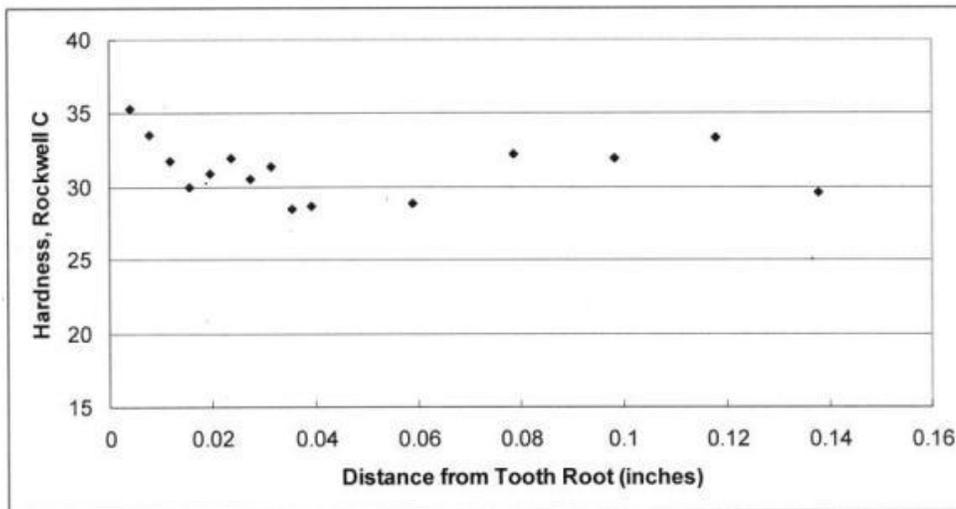
Figure 16

Bolt 5 microhardness results. Hardness values were converted from the 300 gram scale per Table 1 of ASTM E 140. For reference, a hardness of 31 to 39 Rockwell C (HRC) is specified for a 2 1/2 inch diameter or larger fastener per Grade BD of ASTM A 354. The measured core hardness is at or slightly below the specified range. The moderate increase in hardness at the thread root is consistent with work hardening due to thread rolling after completion of the harden and temper heat treatment. At mid height on the flank of the tooth from Bolt #5 the average hardness was 33 HRC.

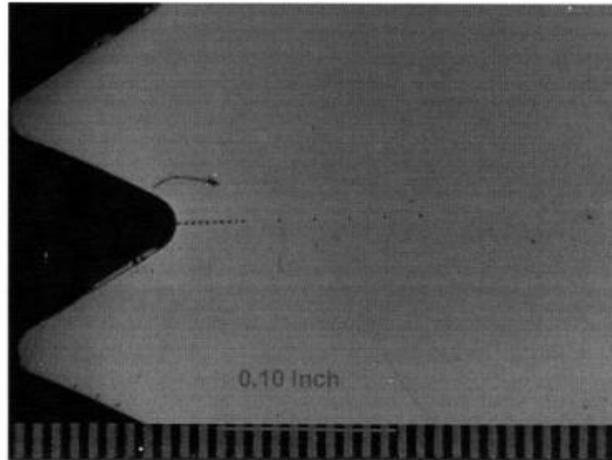
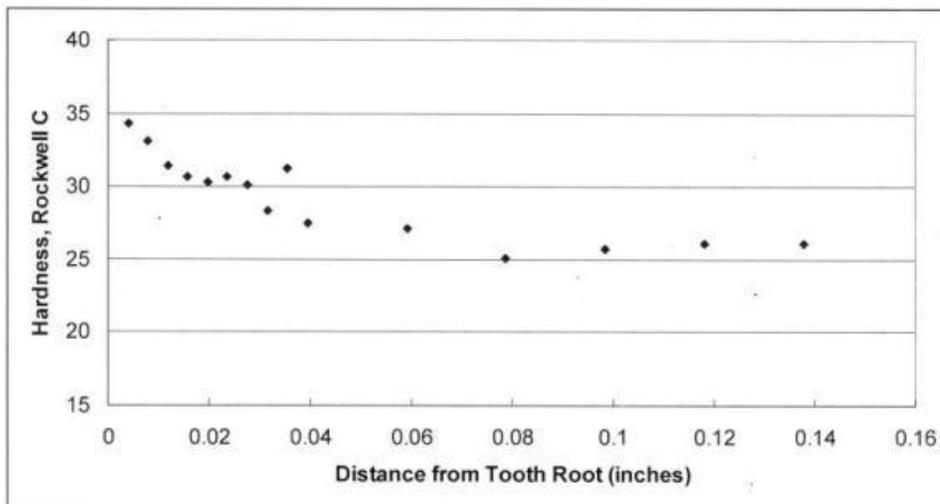
Figure 17

Bolt 8 microhardness results. Hardness values were converted from the 300 gram scale per Table 1 of ASTM E 140. For reference, a hardness of 31 to 39 Rockwell C (HRC) is specified for a 2 1/2 inch diameter or larger fastener per Grade BD of ASTM A 354. The measured core hardness is at or slightly below the specified range. The moderate increase in hardness at the thread root is consistent with work hardening due to thread rolling after completion of the harden and temper heat treatment. At mid height on the flank of the tooth from Bolt #8 the average hardness was 33 HRC.

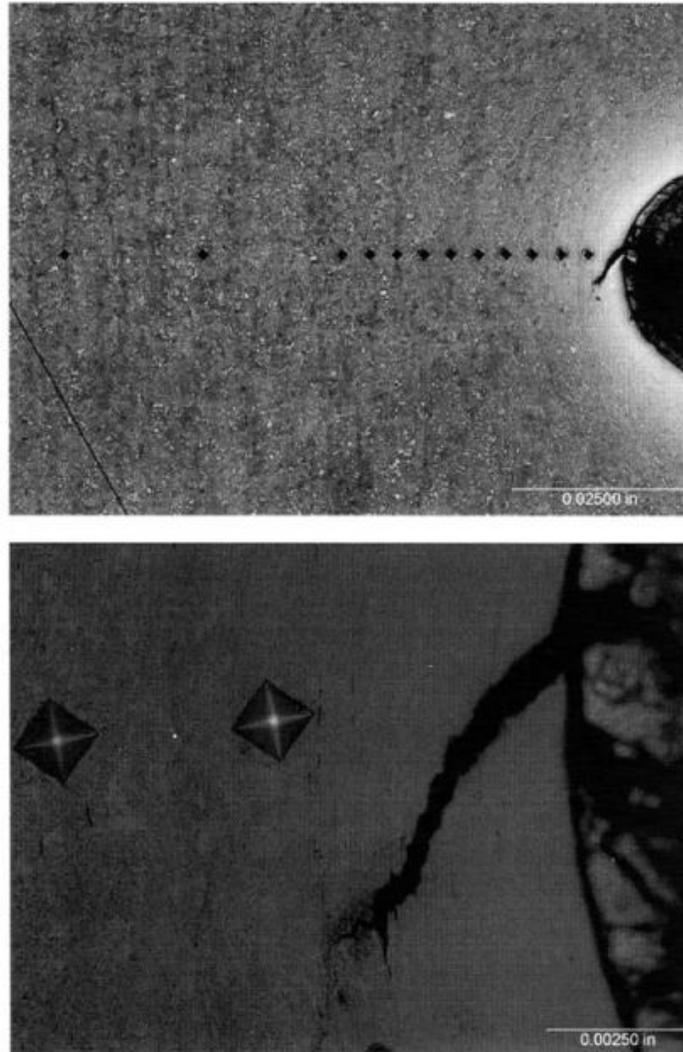
Figure 19

Longitudinal metallographic sections through the thread root adjacent to the fracture of Bolt 5. Cracking was apparent in the thread roots of the four threads adjacent to the fracture. The approximately 45° angle and wide crack is characteristic of a predominantly ductile fracture. Contour flow of inclusions along the thread root is indicative of a rolled rather than cut thread. The heavily deformed microstructure at the thread root indicates that the threads were rolled after completion of the heat treatment rather than before heat treatment. The diamond shaped features are Vickers microhardness indentations. 2% nital etch.

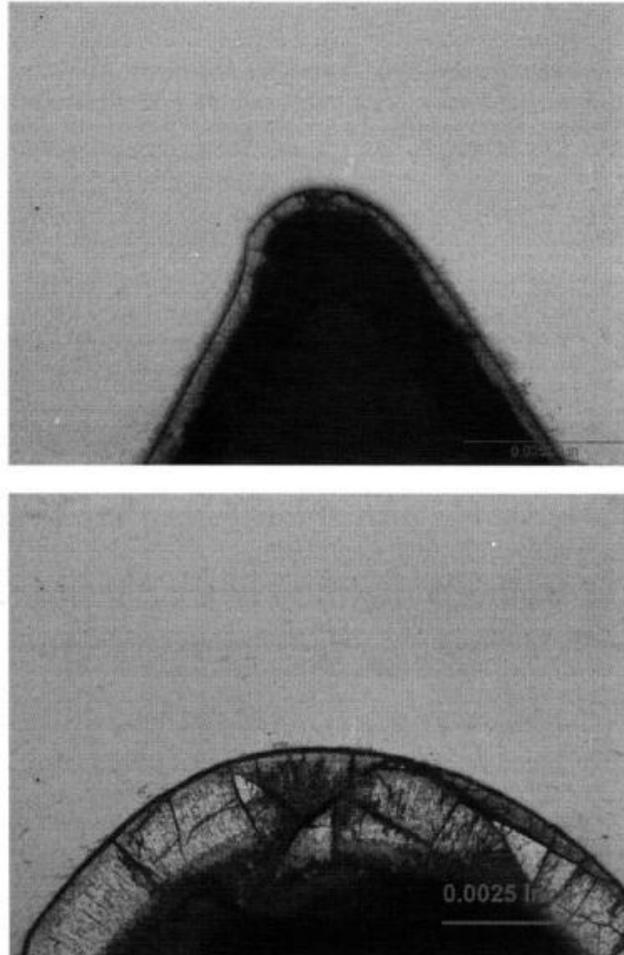
Figure 20

Longitudinal metallographic sections through the thread root adjacent to the fracture at a circumferential location roughly opposite (180°) to the apparent fracture initiation site, Bolt 5. No cracking was apparent in the four thread roots located adjacent to the fracture. Fracture initiation on one side and propagation to final failure on the opposite side suggests but does not confirm that a bending load existed in these bolts. The presence of cracks in the adjacent thread roots on the fracture initiation site and the absence of these cracks in the thread roots on the opposite side provides further evidence that a bending load existed. One likely cause of bending is the heavily deformed and cracked washers.

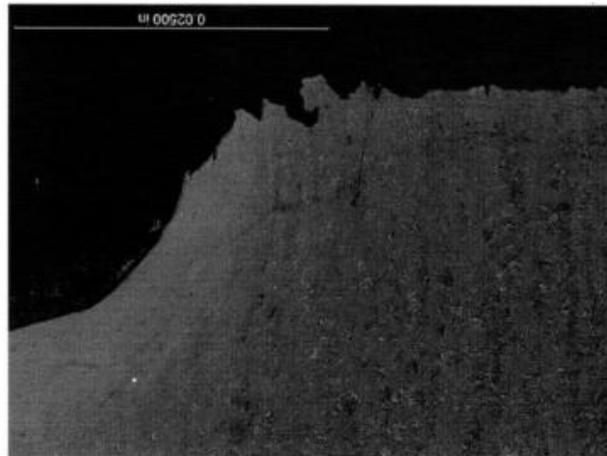
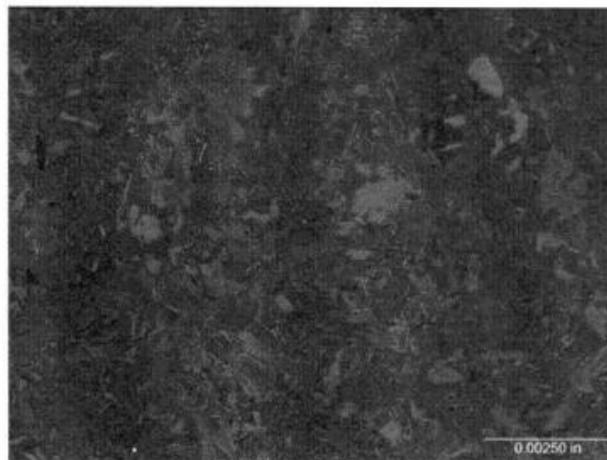
Figure 21

Longitudinal metallographic sections through the fracture initiation site of Bolt 5. Fracture adjacent to the thread root follows a 45° angle similar to that shown in Figure 19. The orientation of this portion of the fracture suggests crack initiation due to ductile overload. The remainder of the fracture is predominantly transverse to the axis and un-branched. Obvious intergranular fracture was not revealed by the metallographic examination. The microstructure below the thread root consisted of a mix of martensite and other transformation products, likely including fine pearlite, acicular, plate, or lath shaped ferrite, and possibly bainite. The mixed microstructure indicates incomplete transformation during hardening and is consistent with the use of a lean alloy for this large diameter. The mixed microstructure would predictably result in low hardness and low impact toughness relative to a fully tempered martensite microstructure. 2% nital etch.

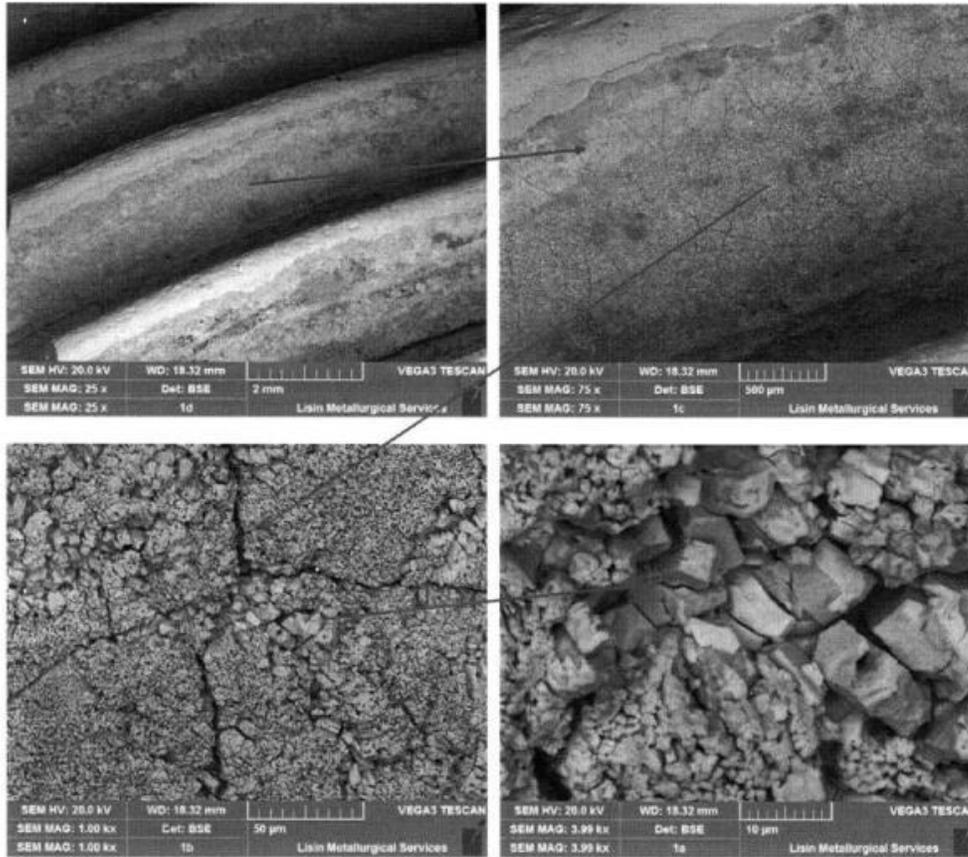
Figure 23

Backscattered electron images acquired from the threads of Bolt 5 after ultrasonic cleaning in an alkaline cleaner and an inhibited acid. The typical columnar crystal structure of a galvanized coating is readily apparent. The clear crystal structure suggests that the galvanized surface was etched due to exposure to a corrodant. Some of this corrosion may have occurred during cleaning to remove corrosion products, as both the alkaline and acid cleaning solutions are corrosive to zinc. However, substantial zinc appears to remain, indicating that the galvanized surface was not substantially degraded by mechanical damage during threading or by corrosion.

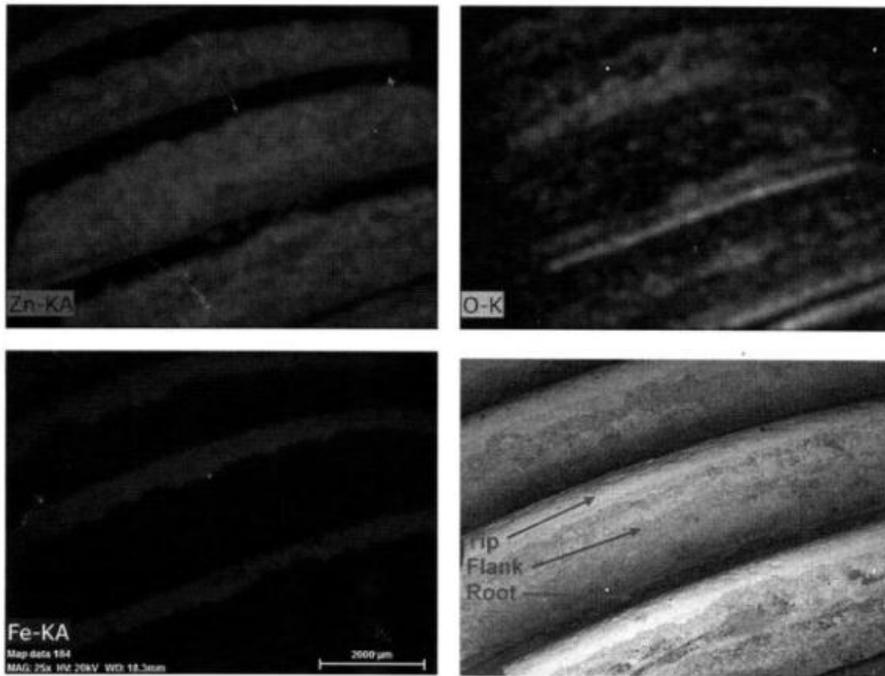
Figure 24

Backscattered electron image and x-ray maps for zinc, oxygen, and iron from threads on Bolt 5. Zinc was present on the thread flanks but not the thread tips. Iron was present at the thread tips. Oxygen appeared to be largely confined to corrosion product accumulation in the thread roots. The results suggest that the galvanized coating was removed from the thread tips, possibly due to contact with the thread roots of the nut. The zinc distribution on the thread flanks appeared to be fairly uniform, suggesting minimal mechanical damage to or corrosion of the galvanized layer on the thread flanks.
