*Appendix E –
Hood Canal Floating Bridge Report
(3/20/2014 Revision)*

HOOD CANAL FLOATING BRIDGE

High Strength Anchor Bolts
Example of Application of Greased and
Sheathed Double Corrosion Protection Systems

March 20, 2014

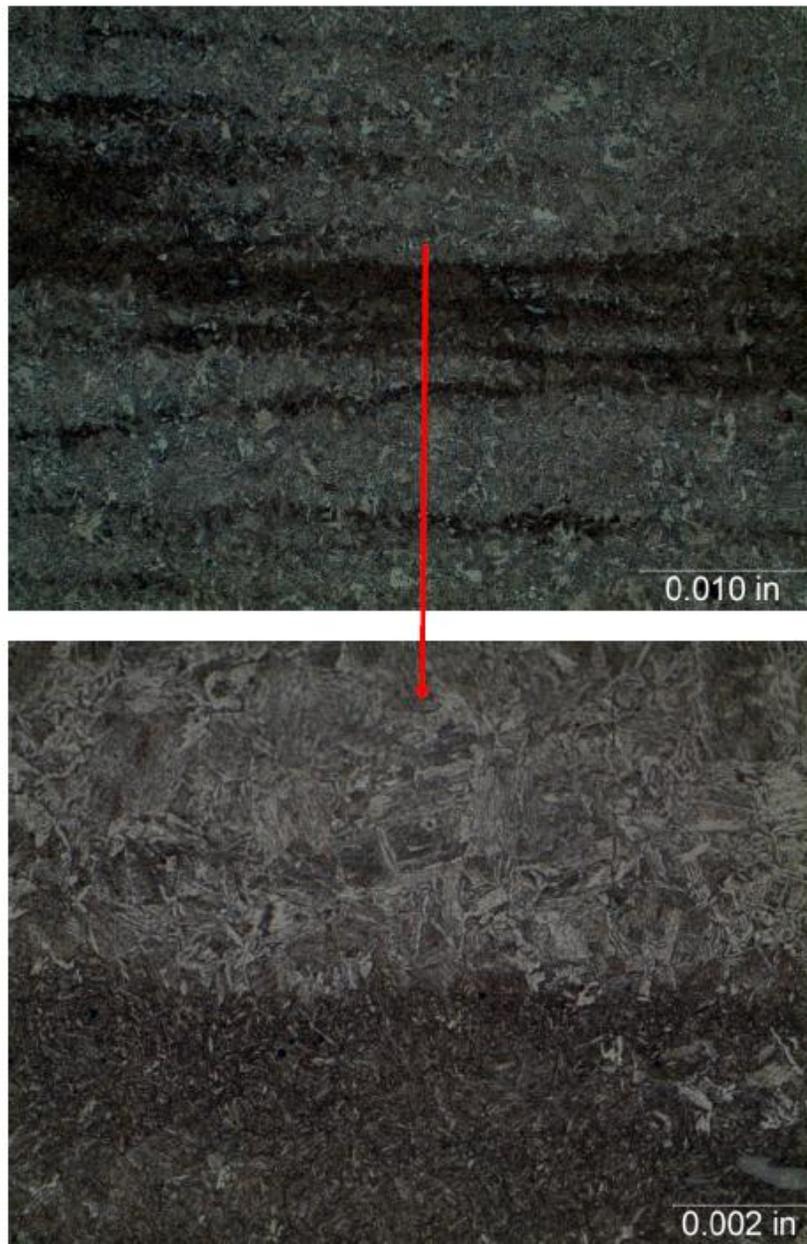
Figure 1

Longitudinal metallographic section through a Bolt 5 near surface Charpy sample. The microstructure consists of alternate longitudinal bands of martensite (darker etching) and other transformation products (ferrite, bainite, lighter etching). The microstructure is characteristic of a hardened and tempered limited hardenability alloy steel such as Grade 4140 in a thick section. The microstructure would predictably exhibit lower impact and fracture toughness relative to a fully martensitic structure at the same hardness. A higher hardenability alloy such as 4340 would likely provide a more uniform tempered martensite structure in this section thickness. The +20 °F sample is shown. Each of the three Bolt 5 surface samples exhibited a similar microstructure. 2% nital etch.

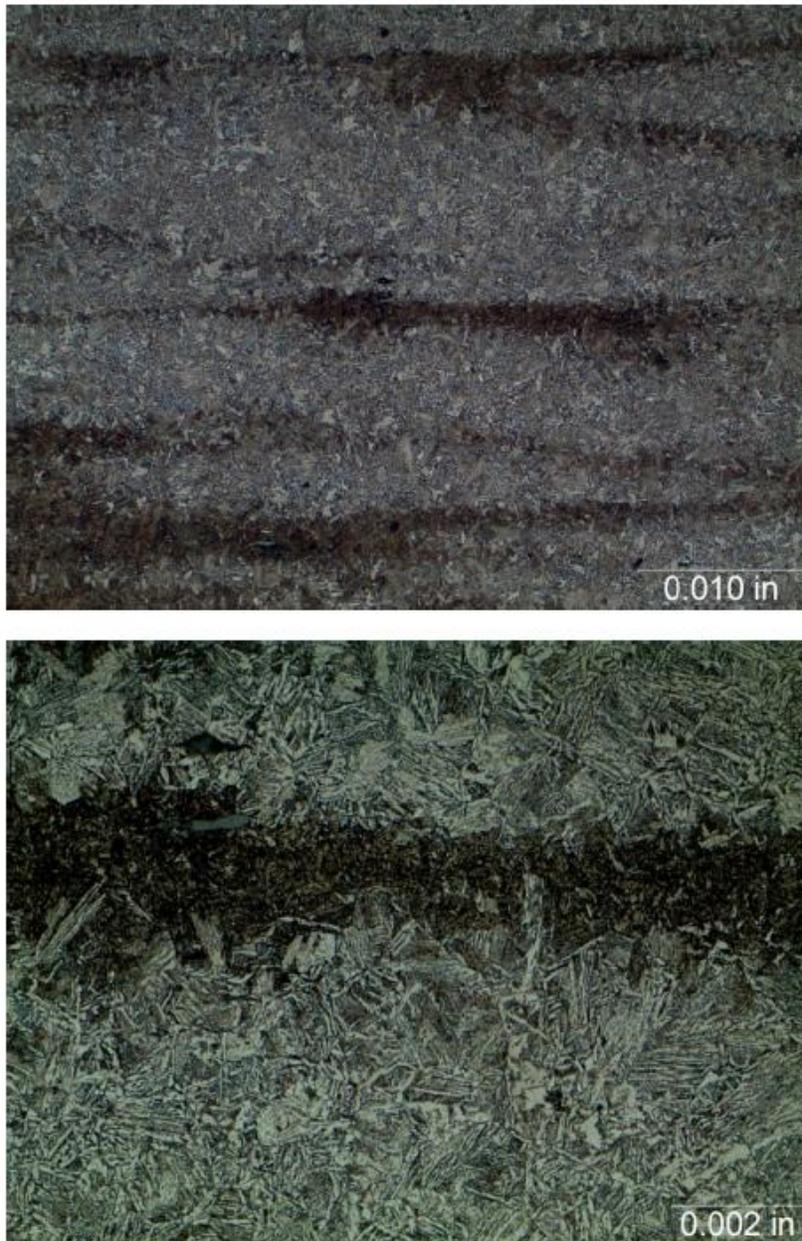
Figure 2

Longitudinal metallographic section through a Bolt 8 near surface Charpy sample. The microstructure consists of alternate longitudinal bands of martensite (darker etching) and other transformation products (ferrite, bainite, lighter etching). The microstructure is characteristic of a hardened and tempered limited hardenability alloy steel such as Grade 4140 in a thick section. The microstructure would predictably exhibit lower impact and fracture toughness relative to a fully martensitic structure at the same hardness. A higher hardenability alloy such as 4340 would likely provide a more uniform tempered martensite structure in this section thickness. The 14 ft/lb, +20 °F sample is shown. Each of the six Bolt 8 surface samples exhibited a similar microstructure. 2% nital etch.

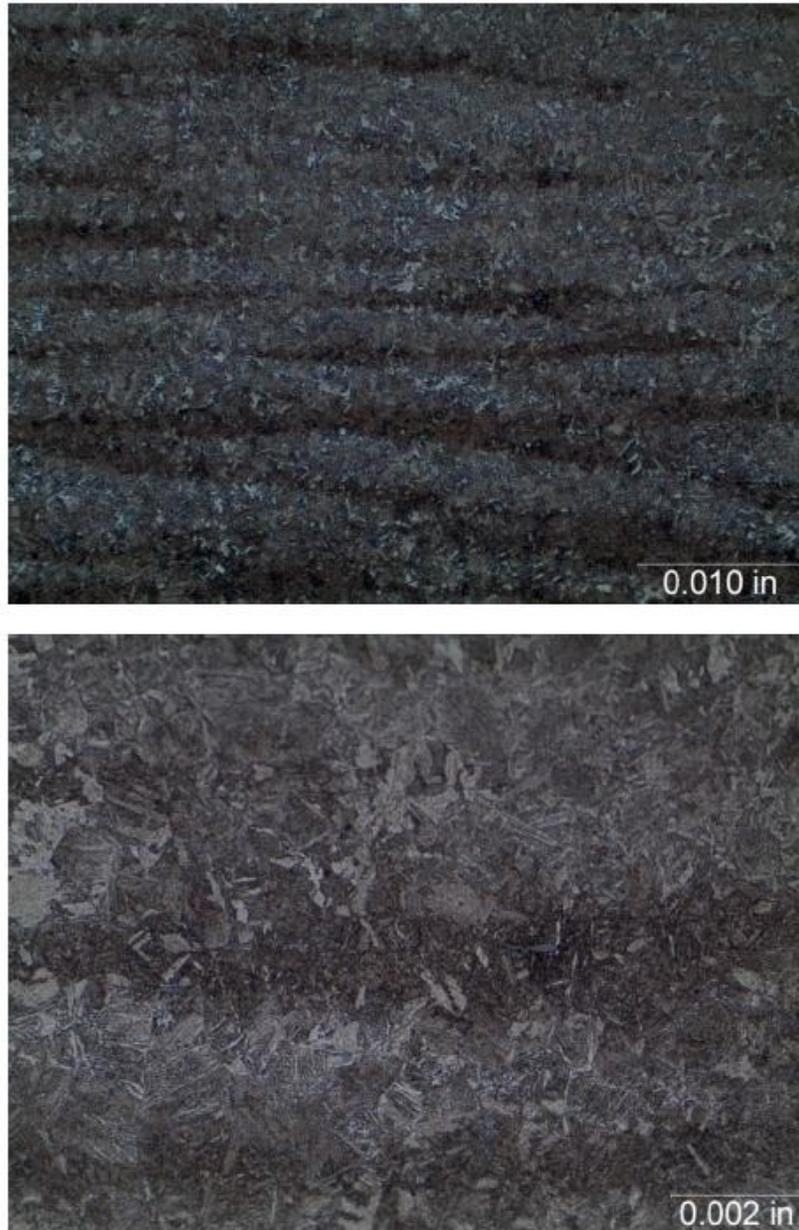
Figure 3

Longitudinal metallographic section through a Bolt 8 mid-radius Charpy sample. The microstructure consists of alternate longitudinal bands of martensite (darker etching) and other transformation products (ferrite, bainite, lighter etching). The microstructure is characteristic of a hardened and tempered limited hardenability alloy steel such as Grade 4140 in a thick section. Significant differences in the near surface and mid-radius microstructures were not revealed by the examination. The 17 ft/lb, +20 °F sample is shown. Both of the Bolt 8 surface samples exhibited a similar microstructure. 2% nital etch.

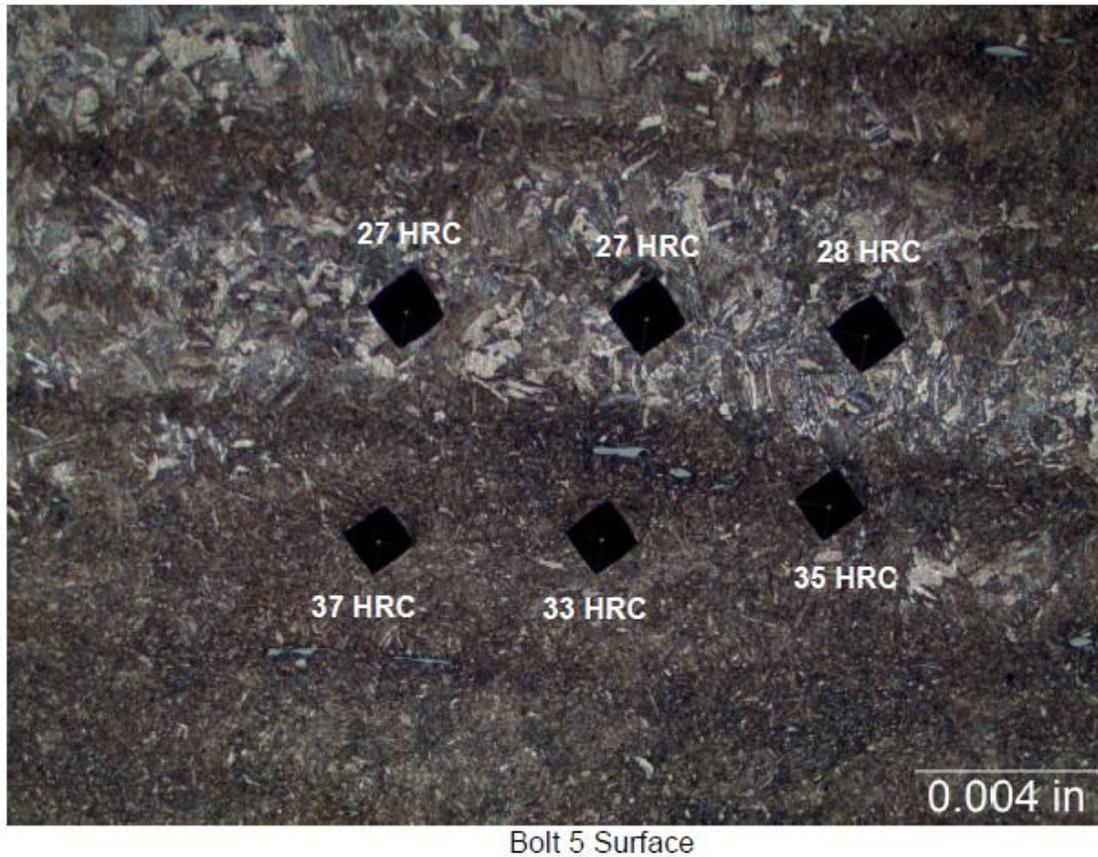
Figure 4

Vickers 300 gram microhardness indentations placed in a longitudinal metallographic section through a Bolt 5 near surface Charpy sample. The measured hardness ranged from 33 to 37 HRC within the martensitic band to 27 to 28 HRC within the lighter etching band of non-martensitic transformation products. Longitudinal banding is the result of alloy segregation during solidification. Alloy rich and alloy lean regions become elongated during rolling and result in alternating layers of high and low hardenability. Such banding is normal in commercial quality product. Non-martensitic transformation products are in general less tough than martensite at the same hardness, and the mixed microstructure likely degrades impact toughness relative to a more uniform martensitic microstructure. A higher hardenability alloy such as Grade 4340 alloy steel would likely also exhibit longitudinal banding. However, even the alloy lean areas would be more hardenable, and a more uniform martensitic structure would likely result. 2% nital etch.
