# TOLL BRIDGE PROGRAM OVERSIGHT COMMITTEE

## TBPOC MEETING MINUTES

April 17, 2013, 9:00 AM – 1200 PM

Items	Action
<b>E-2 BOLTS WORKSHOP</b> 1. What fix should be installed? – BATA Commission Meetings: 4/28 & 5/8/13  2. Should 2010 bolts be replaced? BATA Commission Meetings: 4/28 & 5/8/13  3. What caused 2008 bolts to fail? BATA Commission Meeting: 4/28/13  1. What fix should be installed? Currently there are 3 design alternatives underway (please refer to attached handouts provided in the meeting): A. <u>Option A</u> - Replace bolts, same as original design - <u>Status: Design at 65%</u> . This option would replace anchor rods and would require removal of shear keys; cut and removal of anchor rods in stages. Then re-installing shear keys, install rod extensions in stages, and grouting. Because of constructability	<ul style="list-style-type: none"><li>• TBPOC instructed the team to eliminate Option A, and continue developing Options BD1, BD2, and C to 65% design, continue providing design status update to TBPOC on a weekly basis. Design JV targeted that 65% design on Option BD and C to be completed by end of April.</li><li>• Team advised TBPOC of implementation cost of either of

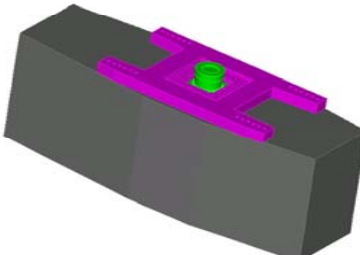
<ol style="list-style-type: none"><li>1) Procure material (PT strands/ steel plate/ bolts)</li><li>2) Fabricate steel frame</li><li>3) Tap holes in existing lower housing and prepare surface</li><li>4) Core existing concrete and cast supplemental concrete</li><li>5) Install steel frame</li><li>6) Grout</li><li>7) Tension</li></ol>	<ul style="list-style-type: none"><li>- More developed</li><li>- Potentially simplest but a lot of work</li><li>- Potentially fastest</li><li>- Shear keys do not need to be removed</li></ul>	<ul style="list-style-type: none"><li>- Potentially most costly</li><li>- More coring and PT placement required</li><li>- Most steel fabrication</li></ul>

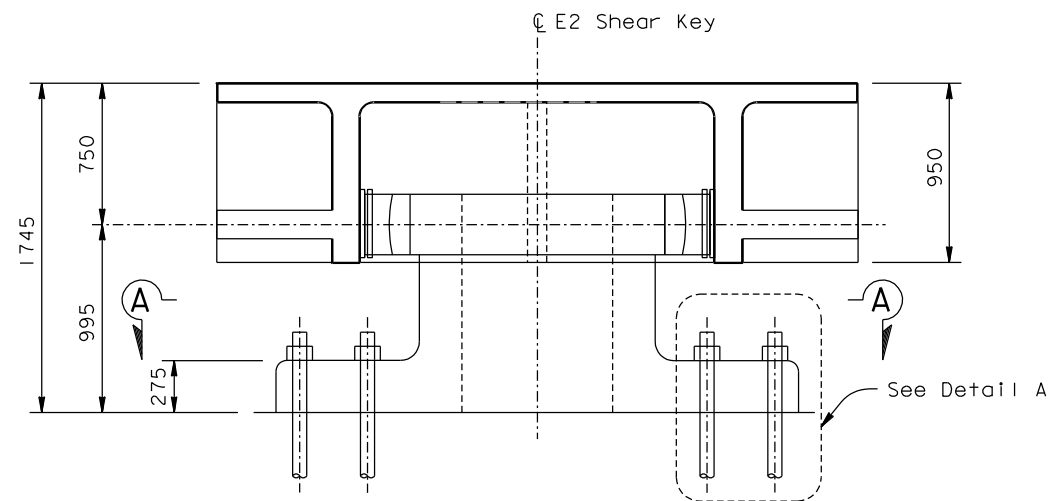
**E2 SHEAR KEY**

Alternative A

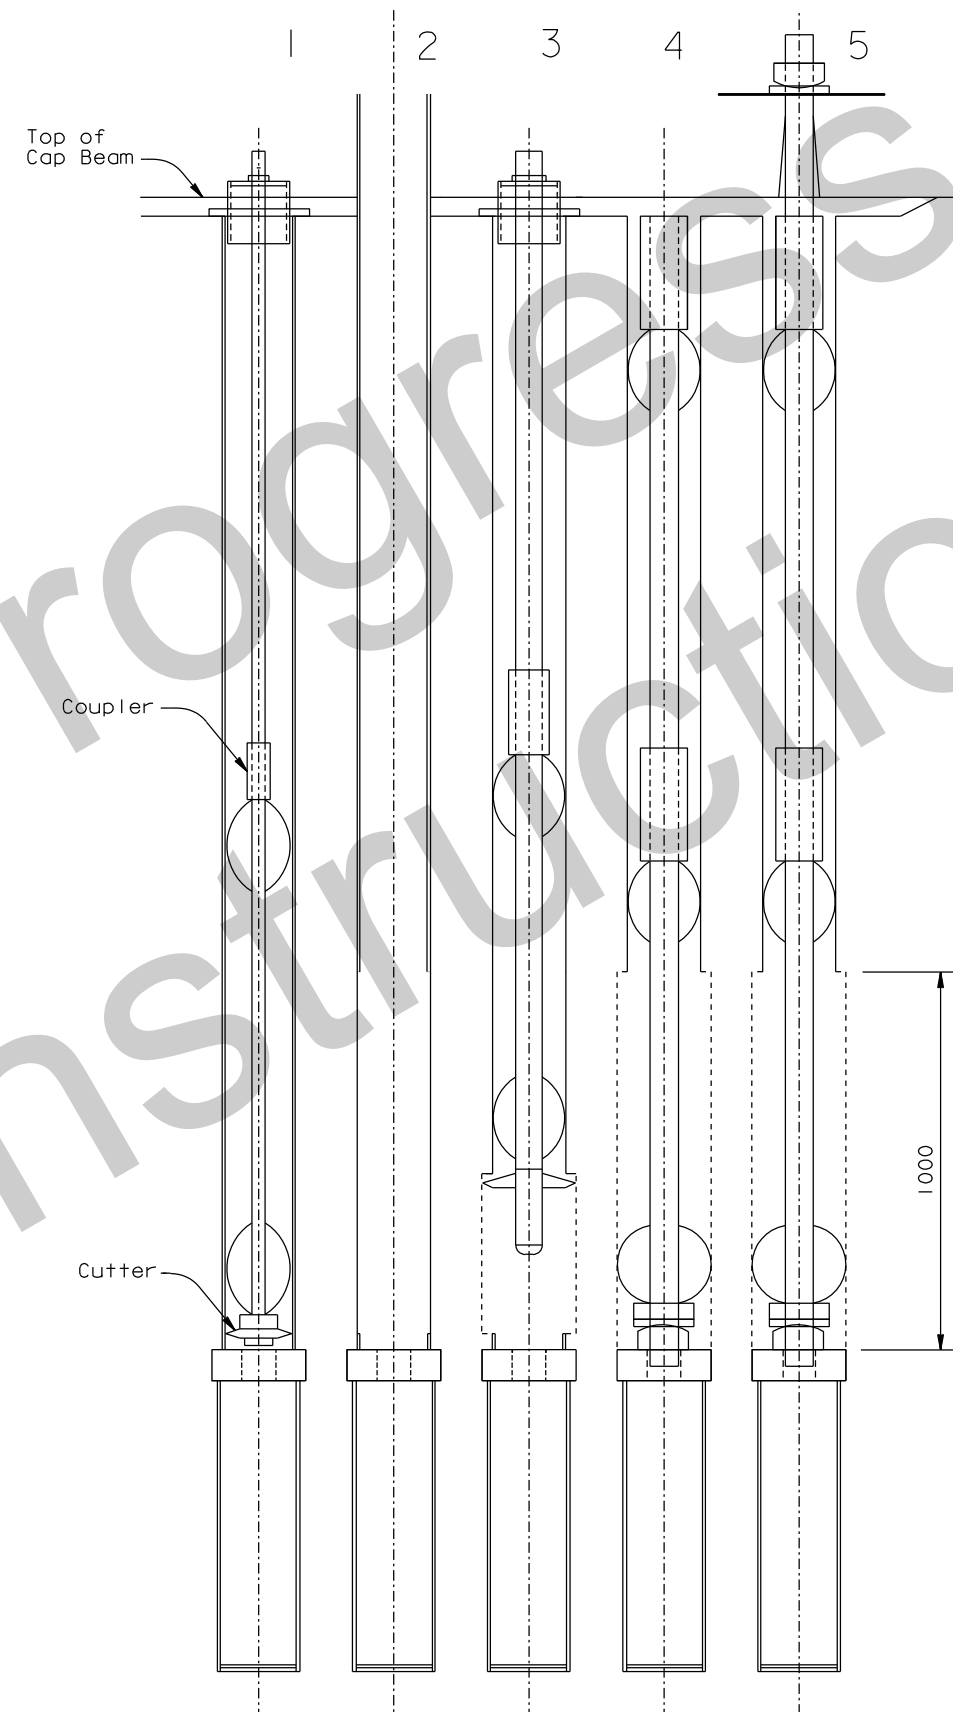
**ANCHOR ROD REPLACEMENT SEQUENCE**

**(SCHEMATIC)****ALTERNATIVE A**

<ol style="list-style-type: none"><li>1) Procure Material (Bolts)</li><li>2) Develop and construct mockups</li><li>3) Remove bolts and slide out shear keys</li><li>4) Remove grout and cut anchor bolts at bottom</li><li>5) Prepare holes and install new bolts</li><li>6) Install shear keys</li><li>7) Grout</li><li>8) Tension</li></ol>	<ul style="list-style-type: none"><li>- No formal design required</li><li>- If all went well, potentially the fastest and cheapest</li></ul>	<ul style="list-style-type: none"><li>- High degree of construction uncertainty, requiring construction related R&amp;D</li><li>- Requires shear keys to be removed and reinstalled</li><li>- Requires significant mock-ups (expect design iterations)</li></ul>
BD	Steel Collars

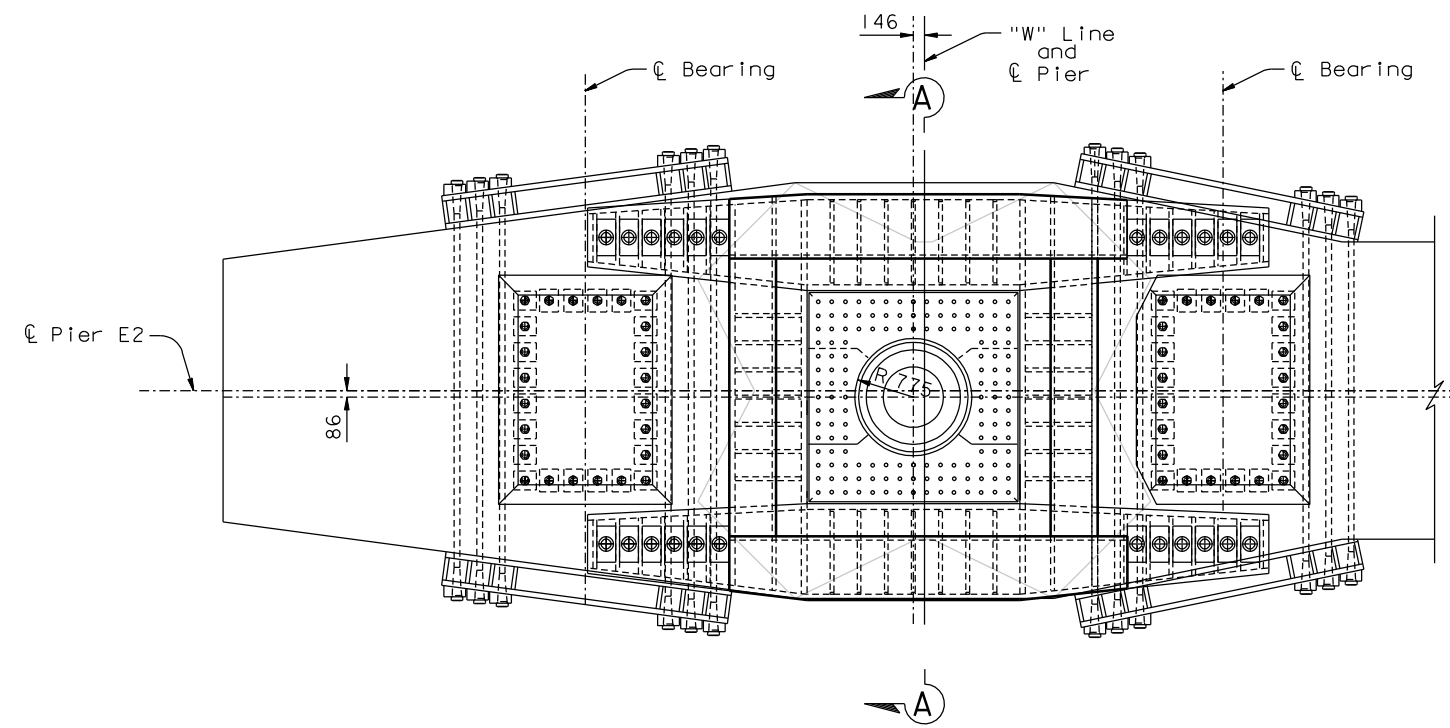
PLAN VIEW  
1:50

Alternative BD

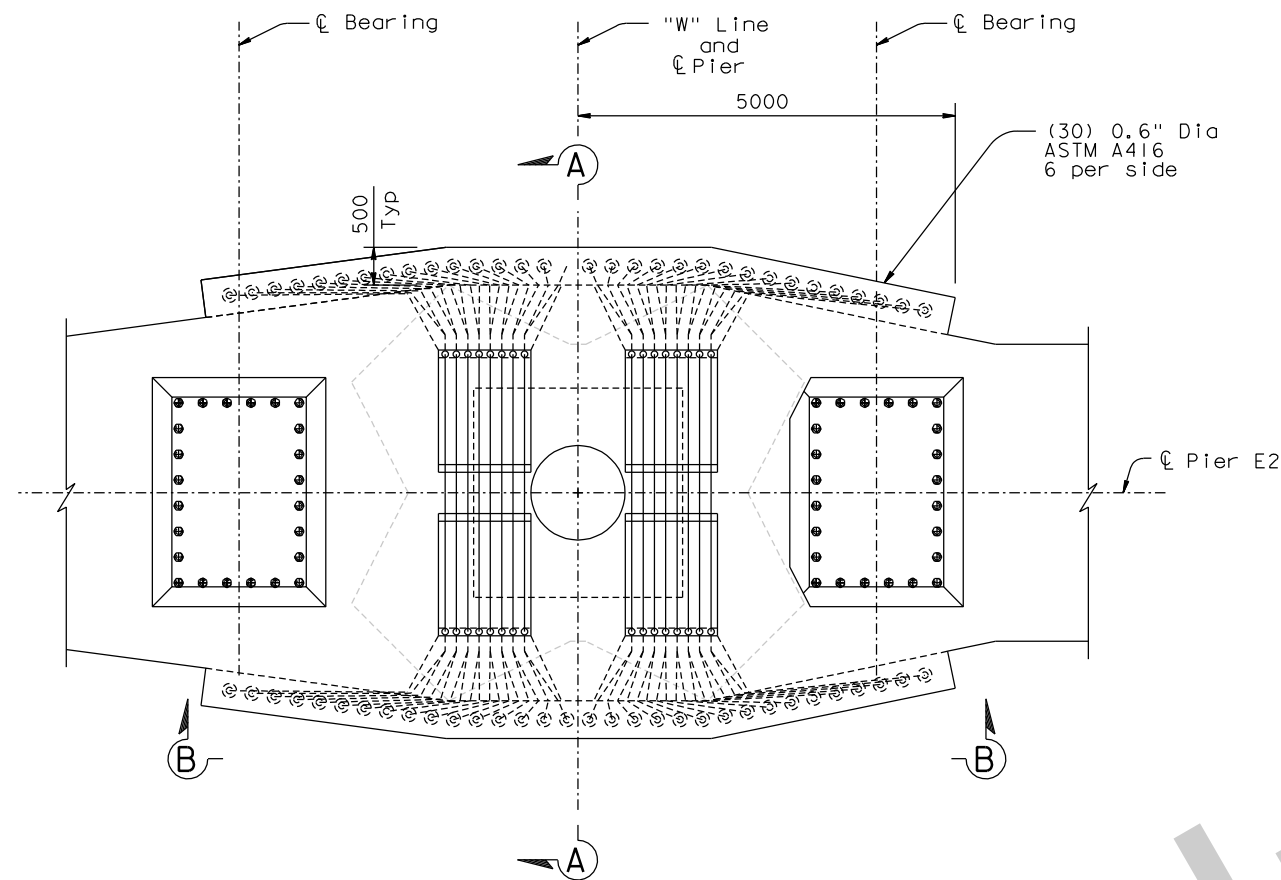
E2 SHEAR KEY - PT OPTION  
1:50

Alternative C

<ol style="list-style-type: none"><li>1) Procure material (PT strands/ steel plate)</li><li>2) Fabricate steel frame/ saddle</li><li>3) Core existing concrete and cast supplemental concrete</li><li>4) Install steel frame/ saddle</li><li>5) Grout</li><li>6) Tension</li></ol>	<ul style="list-style-type: none"><li>- Potentially cheapest</li><li>- Potentially fastest</li><li>- Shear keys do not need to be removed</li></ul>	<ul style="list-style-type: none"><li>- Not as developed as BD</li><li>- Requires unique saddle system</li></ul>
