# Theory of Hydrogen Embrittlement and Stress Corrosion Cracking

H.E. Townsend

H. E. Townsend Revision 4 3/11/15

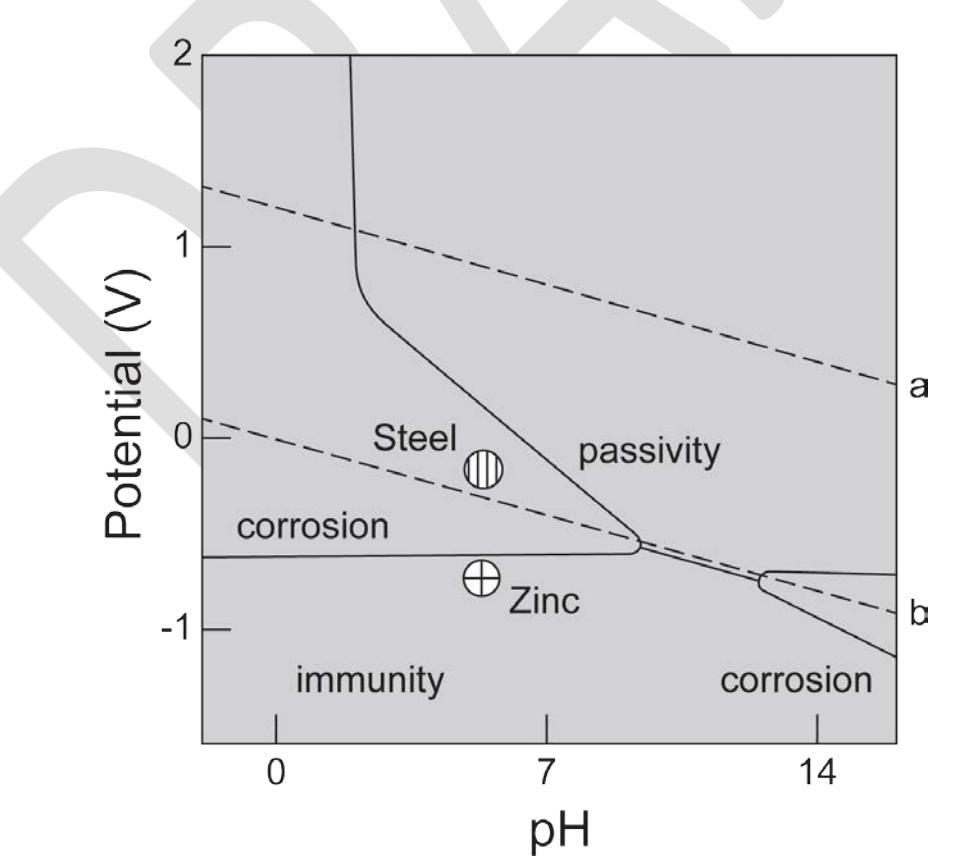
Figure 1 is a potential-pH, or Pourbaix, diagram [12], which provides a succinct compilation of thermodynamic data for iron, its oxides, and water. As such, it is a convenient framework to show what is possible when steel and zinc are exposed to water.

Figure 1. Potential-pH Diagram for the Iron-Water System, Showing the Corrosion Potentials of Steel and Zinc in Water, and the Region of Water Stability Between Dotted Lines a and b.

Stability limits for water are also shown as dotted lines. Above the upper dotted line, water can decompose to form oxygen. Below the lower dotted line, water can decompose to form hydrogen. Between the dotted lines, water is thermodynamically stable.

When steel is exposed to air-saturated water, its potential and the pH of the water are typically located at the point plotted in the corrosion region at a pH of about 6, and an electrode potential of -0.70 volts, measured against a saturated calomel electrode (SCE). The electrode potential of a zinc coating corroding at this pH is -1.06 volts (SCE), and it is located in the immunity region of iron. When the two metals are coupled together, and the area of zinc is large compared to that of the steel, as is the case when steel is exposed at a void in a galvanized coating, the potential of the steel is pulled to that of zinc, and into the domain where it is immune to corrosion.

When the electrode potential of the steel surface is pulled below the lower stability limit of water, hydrogen can be deposited as the water is decomposed. Thus, the thermodynamics are favorable for production of hydrogen on steel exposed at breaks in a zinc coating in an aqueous environment.

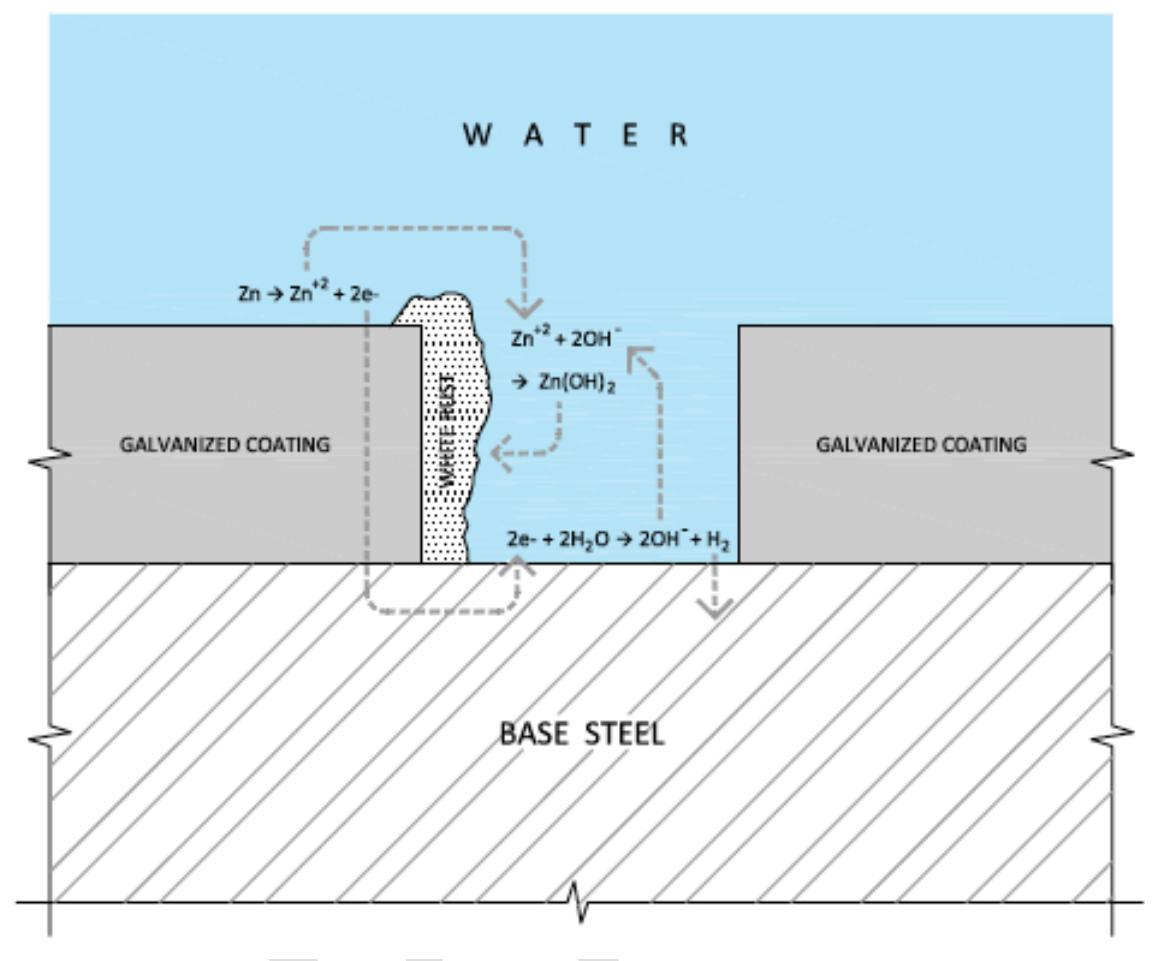
The electrochemical reactions involved in the generation of hydrogen during the sacrificial protection of steel by a zinc coating are shown below in simplified form, and shown on Figure 2.

Zinc in the galvanized coating acts as the anode of a galvanic cell, with the dissolution of zinc to form zinc ions in solution and release of electrons to the metal,

Steel exposed at breaks in the galvanized coating acts as the cathode, with the reaction of water and electrons to form hydroxyl ions in solution, and hydrogen, some of which is absorbed by the steel.

Dissolved zinc from the anode and hydroxyl ions from the cathode react to form zinc hydroxide precipitate, generally known as white rust.

Figure 2 – Reactions That Occur During Sacrificial Corrosion of Galvanized to Protect Steel Exposed at Bare Spots with the Deposition of Hydrogen.

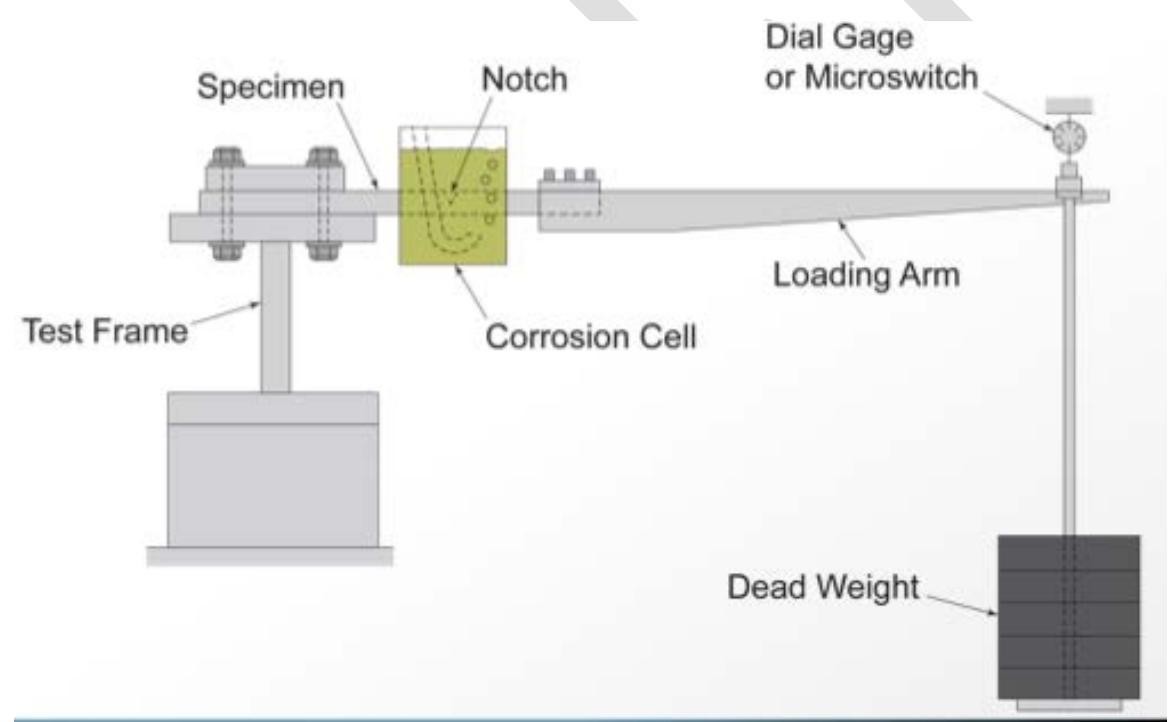
To further explore the effects of galvanizing and hardness on hydrogen embrittlement of A490 bolt material, Townsend [10] conducted fracture mechanics tests of black and galvanized bars according to ASTM E1681, see Figure 3.

Figure 3 - Cantilever Bend Testing of Pre-Cracked Cantilever Beams According to ASTM 1681.

Precracked, quenched-and-tempered 4140 steel bars with hardness in the range 33 to 49 were subjected to rising step load in cantilever bending in three different ways as follows:

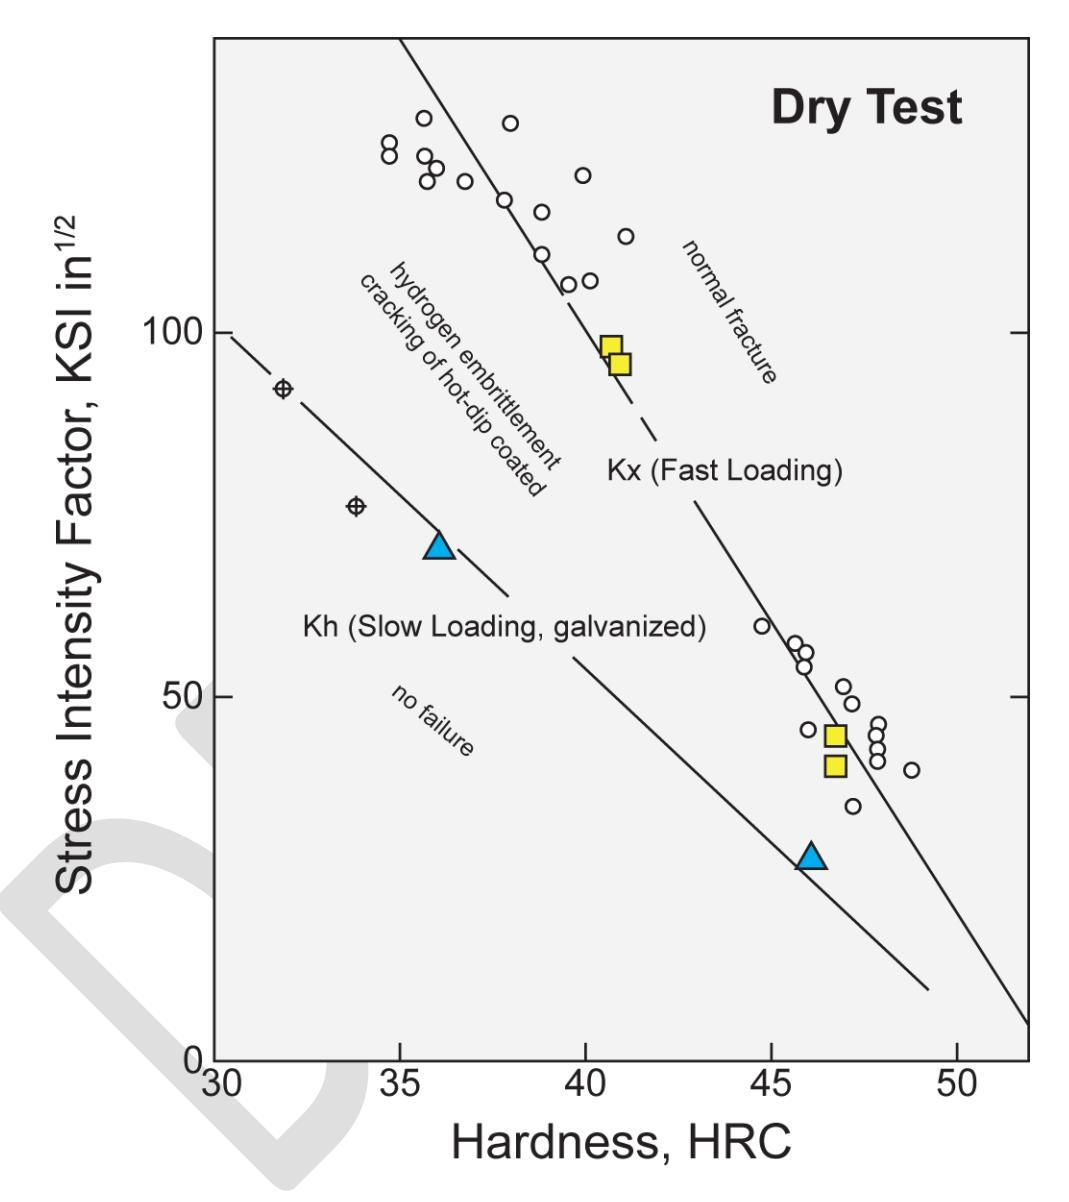
- Slow loading (0.2 KSI-in<sup>1/2</sup>) in air to determine the IHE threshold, labeled Kh on Figure 4 (Dry Test)
- Slow loading in 3.5% NaCl solution to determine the EHE threshold, labeled as Ksc in Figure 5 (Wet Test)

Figure 4. IHE tests - Dry-test threshold stress intensity factors, Kh, for slow loading of galvanized bars in air compared to Kx for fast loading in air [10]. Open circles – Fast fracture Kx for all surfaces; Crossed circles – hot-dip 55% Al-Zn; Blue triangles – hot-dip zinc; Yellow squares – electroplated and baked zinc.

• Loading at normal test speeds in air to determine a baseline value of fracture toughness, labeled as Kx on Figures 4 and 5.

- Threshold loads for IHE of zinc and zinc alloy-coated 4140 steel decrease with increasing hardness
- Threshold loads for EHE of zinc and zinc alloy-coated 4140 also decrease with increasing hardness

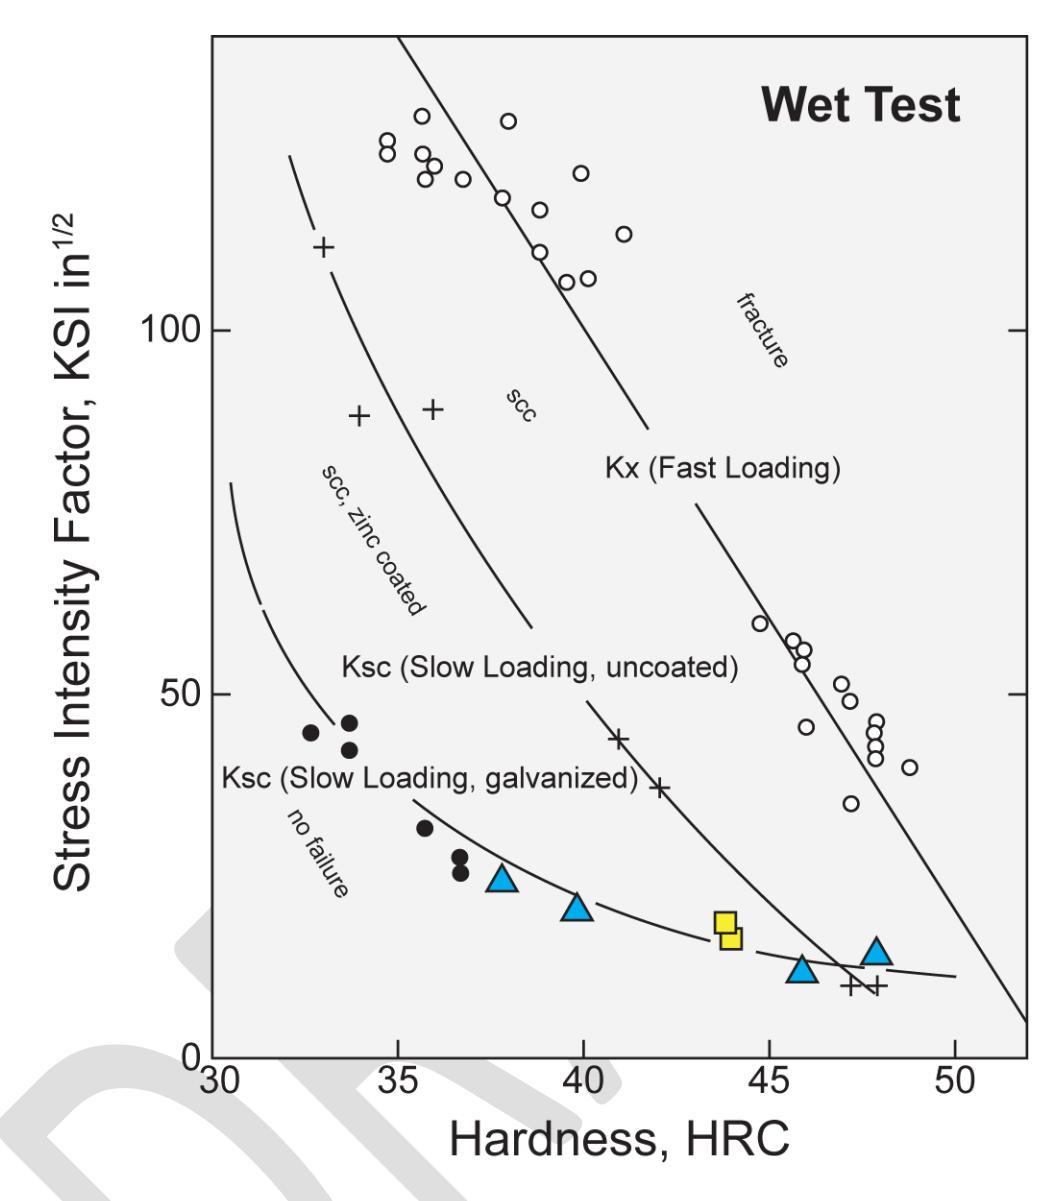
Figure 5. EHE Tests - Wet-Test threshold stress intensity factors, Ksc, for slow loading in water compared to Kx for fast loading in air [10]. Open circles – Fast fracture for all surfaces; Crosses – no coating; Black circles – hot-dip 55% Al-Zn; Blue triangles – hot-dip zinc; Yellow squares – electroplated and baked zinc.

- Threshold loads for EHE of zinc and zinc alloy-coated 4140 are significantly less than that of bare steel, owing to the increased hydrogen activity resulting from galvanic corrosion of the coating
- Threshold loads for EHE of zinc and zinc alloy-coated 4140 are also significantly less than the IHE thresholds, showing that EHE is a significantly greater potential threat than IHE.

As shown on Figure 5, the EHE thresholds of galvanized steel decrease from 58 to 20 KSI-in<sup>1/2</sup> as the hardness increases from 30 to 40 HRC. This is equivalent to an average 6.6% reduction in threshold load for each HRC unit increase in hardness.

This work also showed that the electrode potential of bare steel in 3.5% NaCl solution is -0.70 Vsce, and that of galvanized steel is -1.06 Vsce. As shown in Figure 5, this is accompanied by a decrease in EHE threshold from 87 to 38 KSI-in<sup>1/2</sup>. This is equivalent to an average decrease of 0.16% in threshold load for each mv change in electrode potential.

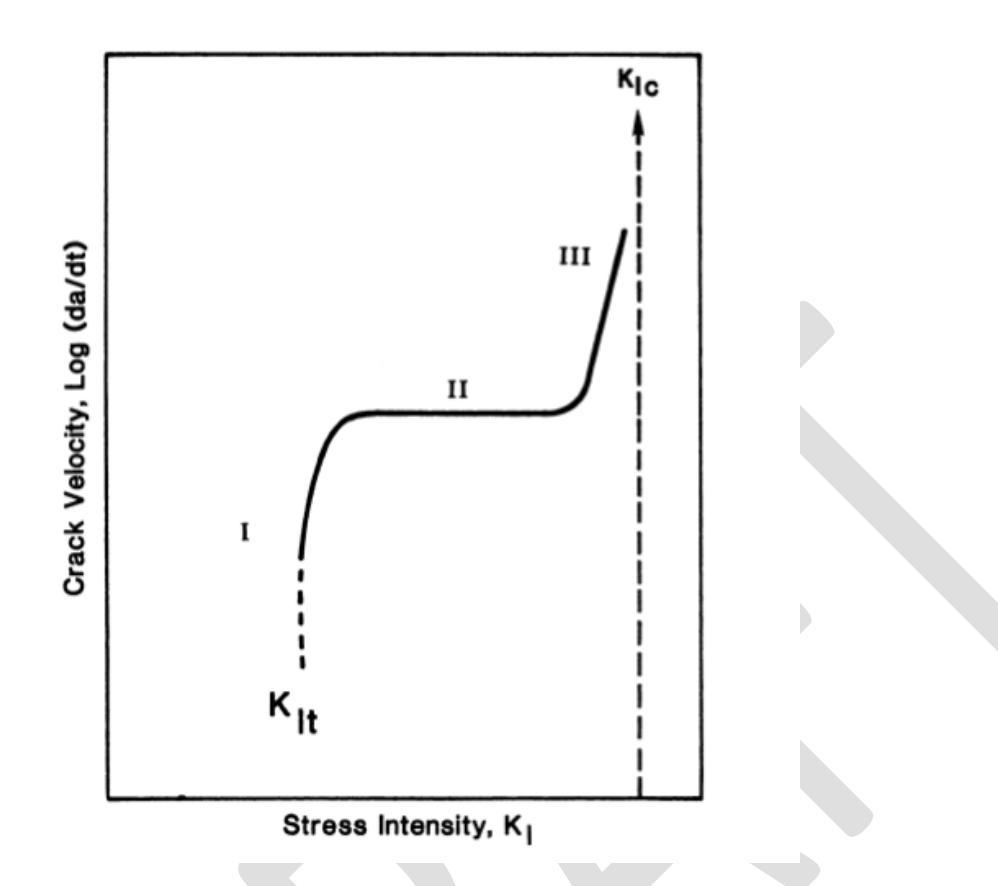
As discussed, for example by Brown (8), EHE crack-growth rates in pre-cracked, high-strength steel depends on stress intensity factor ( $K_1$ ) as shown in Figure 6. Below the threshold stress intensity factor, KIt, cracks do not grow. Above KIt, there are three regions of crack growth:

- Stage I crack growth begins just above the EHE threshold, Kit, and increases rapidly with increasing  $K_{\rm I}$
- Stage I is followed by Stage II in which the rate of crack growth is independent of K<sub>I</sub>. It is believed that Stage II crack growth is limited by the diffusion rate of hydrogen to planes of weakness within the plastic zone just ahead of the crack tip
- Stage III occurs when K<sub>1</sub> approaches K<sub>Ic</sub>, and crack growth changes from slow EHE crack growth to rapid ductile tearing.

Figure 6. Three Stages of EHE Crack Growth
