San Francisco Bay Area Toll Bridge Seismic Retrofit and Regional Measure 1 Programs

2014 Third Quarter
Project Progress
and Financial Update

TOLL BRIDGE PROGRAM
OVERSIGHT COMMITTEE

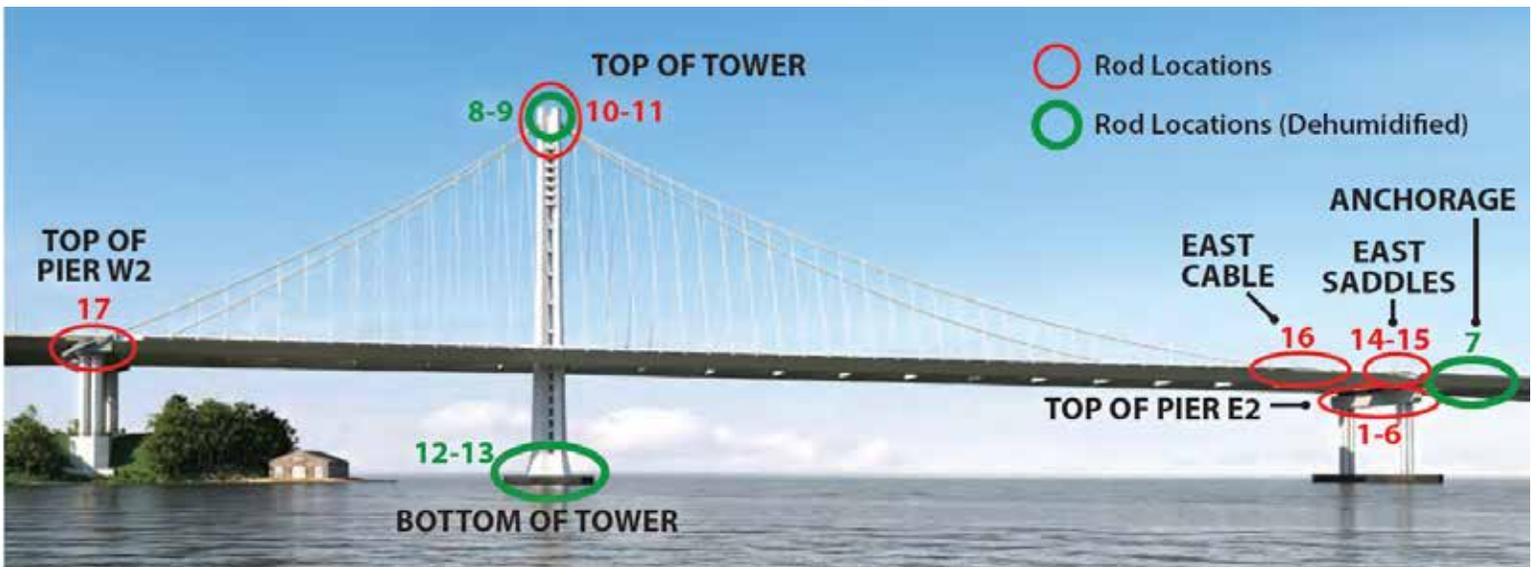
A354 Grade BD Rod Locations on the SAS Bridge

As far as the remaining A354 Grade BD high strength steel rods used on the bridge, the TBPOC is in the process of completing a comprehensive testing program. On September 30, 2014, a bolt review committee of nine experts in the areas of fasteners, corrosion, and metallurgy presented the TBPOC with the findings of the test results. Those results found that the 2008 bolts broke from hydrogen embrittlement due to specific combination of susceptible material properties and challenges during fabrication and installation. The remaining A354 grade BD high strength steel bolts used on the bridge were fabricated and installed in a definitively different manner than the broken 2008 bolts. The bolt review committee has determined that the remaining bolts are safe, meet the design requirements of the bridge, and will not be a long term problem as long as the corrosion protection of the bolts is maintained in accordance with maintenance requirements. Their report and test results can be found at www.baybridgeinfo.org.

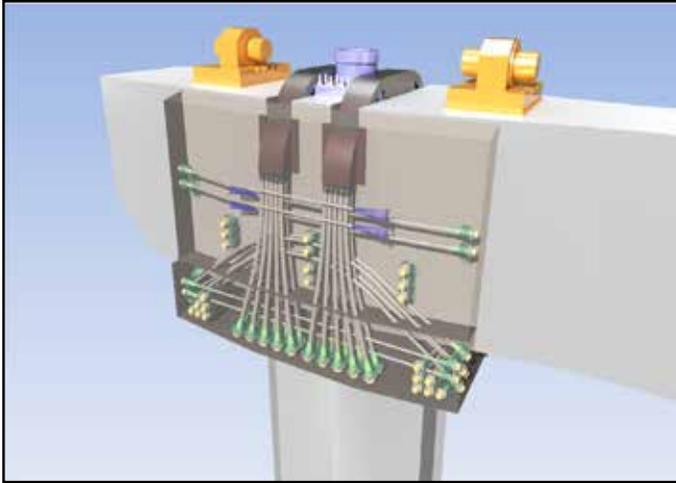
Rendering of E2 Saddle Retrofit Strategy

In early 2013, within days after tensioning was performed, the anchor bolts in the shear keys directly below the eastbound and westbound orthotropic box girder (OBG) structures (known as shear keys S1 and S2) began to fail. The function of the broken rods were replaced by the steel saddle retrofit that was completed in December 2013.

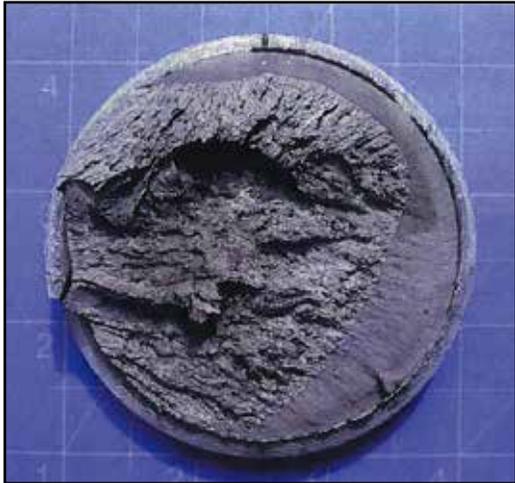
Cross Section of an E2 Shear Key Broken Bolt

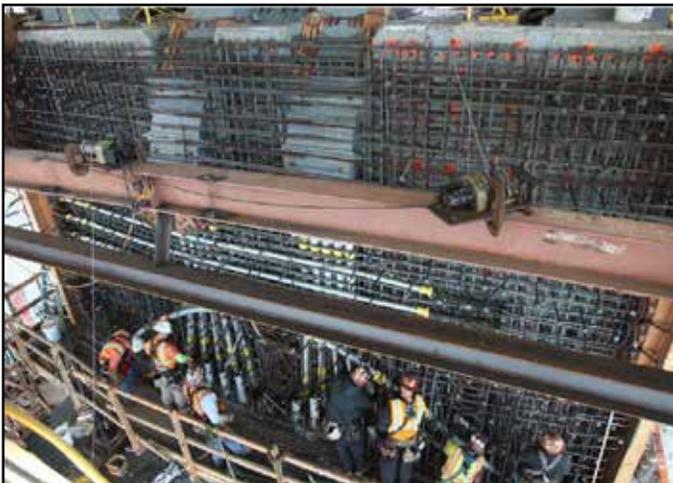
Rebar Installation at the west Face of E2E Cap Beam

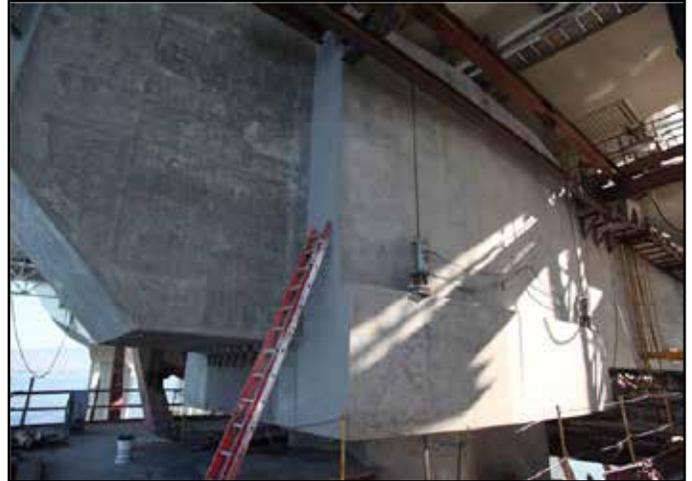
A View of the west Face of Pier E2W with S1 Shear Key Hold-Down Retrofit Complete

All retrofit work at pier E2 has been completed and the work platform has been removed. The team presented recommendations and test results related to the ASTM A354 Grade BD rods. Rods that have not been painted and are not in dehumidification zones will need to be painted. No other remedial action is recommended.

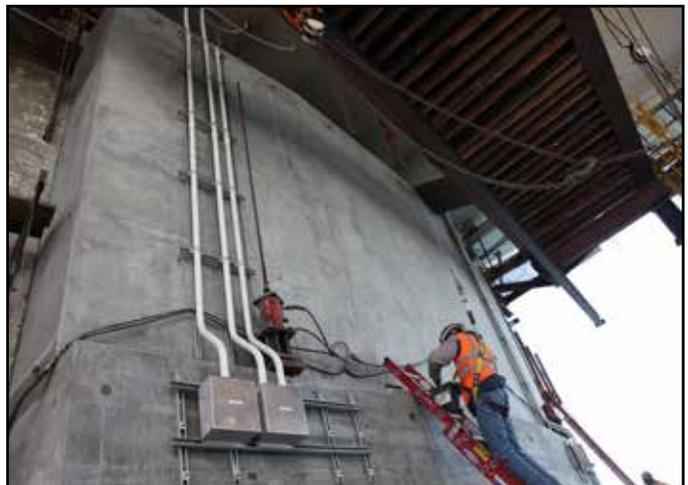
Patching E2W Cap Beam Concrete Face - Conduits and Enclosures in Place

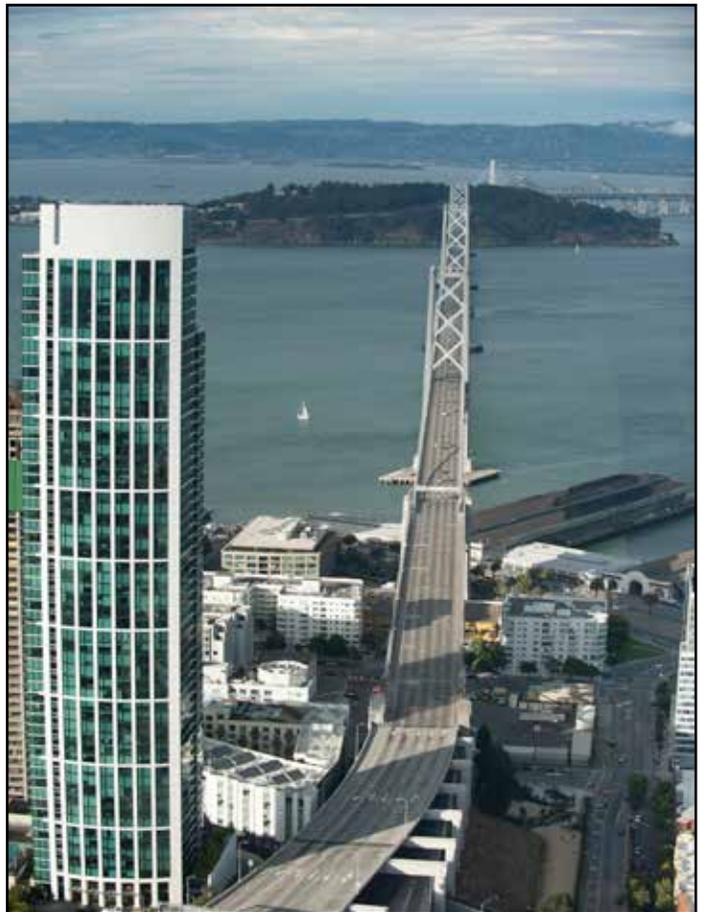
San Francisco-Oakland Bay Bridge West Span

The West Span lies between Yerba Buena Island and San Francisco and is made up of two complete suspension spans connected at a center anchorage. Retrofit work included adding massive amounts of steel and concrete to strengthen the entire West Span, along with new seismic shock absorbers and bracing.

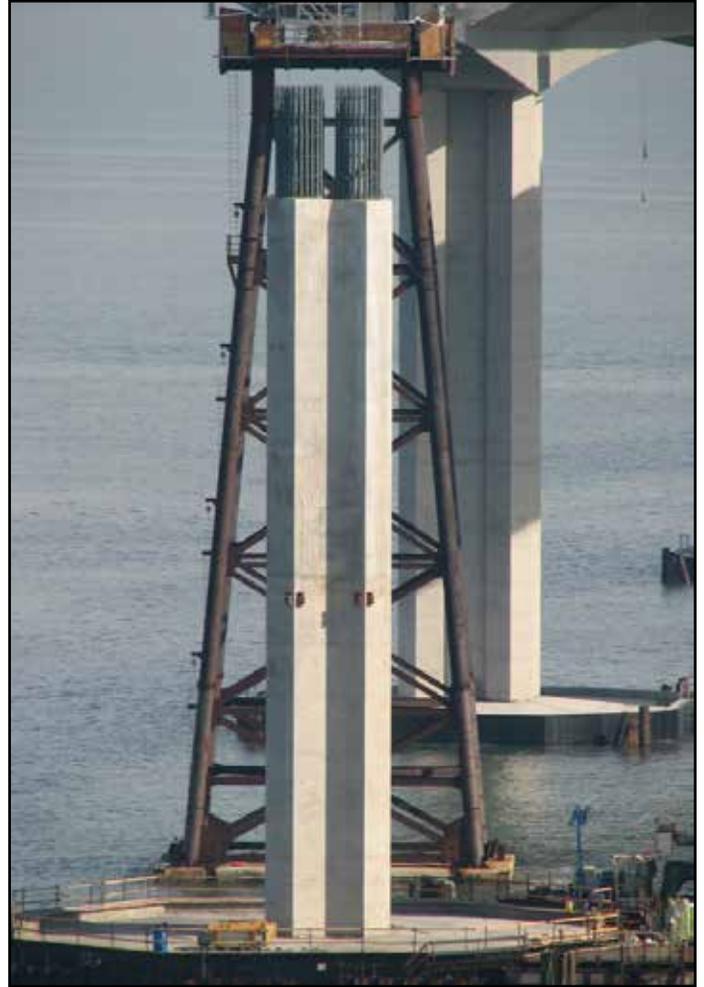
SAS Marine E2 and the Skyway Westbound Foundation and Columns

The T1 foundation piles extend 196 feet below the waterline and are anchored into bedrock with heavily reinforced concrete rock sockets that are drilled into the rock. Driven nearly 340 feet deep, the steel and concrete E2 foundation piles were driven 100 feet deeper than the deepest timber piles of the existing east span in order to get through the bay mud and reach solid bedrock.

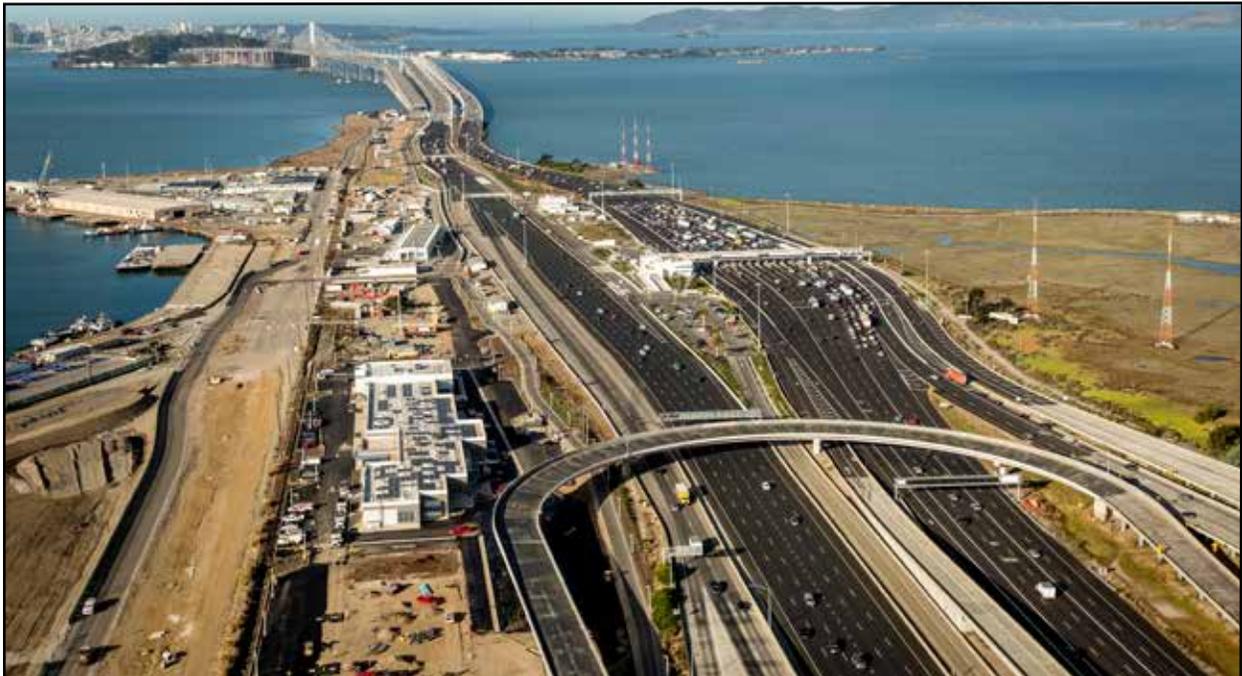
The New San Francisco-Oakland Bridge Skyway and Self-Anchored Suspension Bridge Looking West toward Yerba Buena Island

The Skyway marine foundation consists of 160 hollow steel pipe piles measuring eight feet in diameter and dispersed among 14 sets of piers. The 365-ton piles were driven more than 300 feet into the deep bay mud. The new East Span piles were battered or driven in at an angle, rather than vertically, to obtain maximum strength and resistance.

Designed specifically to move during a major earthquake, the Skyway features several state-of-the-art seismic safety innovations, including 60-foot-long hinge pipe beams. These beams allow deck segments on the Skyway to move, enabling the deck to withstand greater motion and to absorb more earthquake energy.

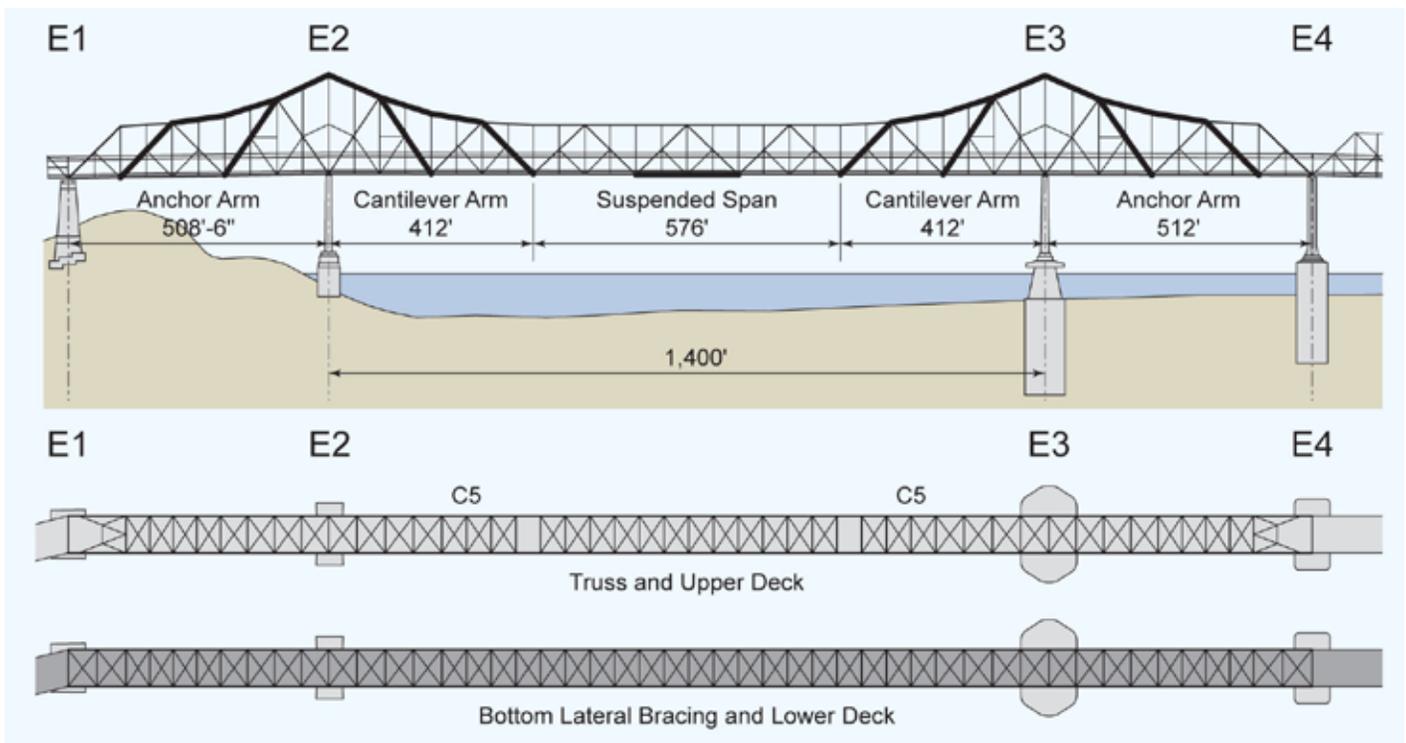
Demolition Diagrams

GENERAL LAYOUT

To expedite the opening of a new eastbound on ramp and the bike/pedestrian pathway from Yerba Buena Island to the SAS and to maximize contractor efficiencies, the TBPOC split the dismantling of the existing bridge into multiple contracts. The dismantling of the superstructure of the main cantilever section of the existing bridge has been incorporated into the YBITS #2 contract. The dismantling of the remaining portions of the bridge will likely be performed under separate superstructure (above water) removal and marine foundation (below water) contracts. These contracts are still in design and may change in scope over time.

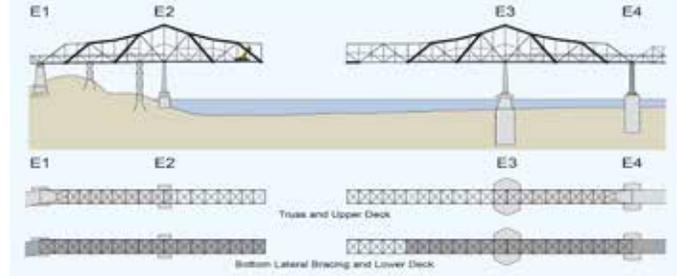
5. Install West Falsework Supports

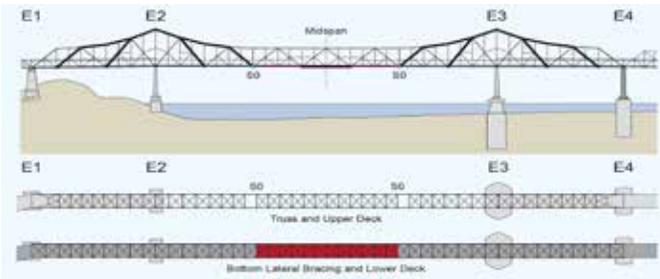
2. Remove Lower Deck from Suspended Span Replace with Timber Mat

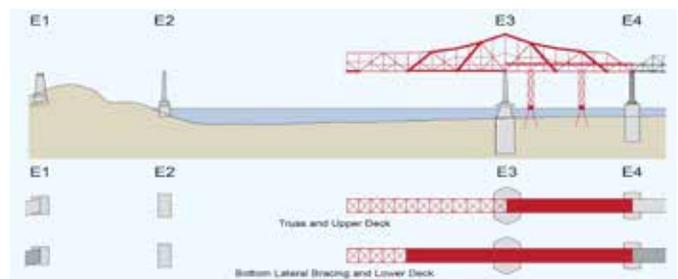
8. Remove East Spans Similarly

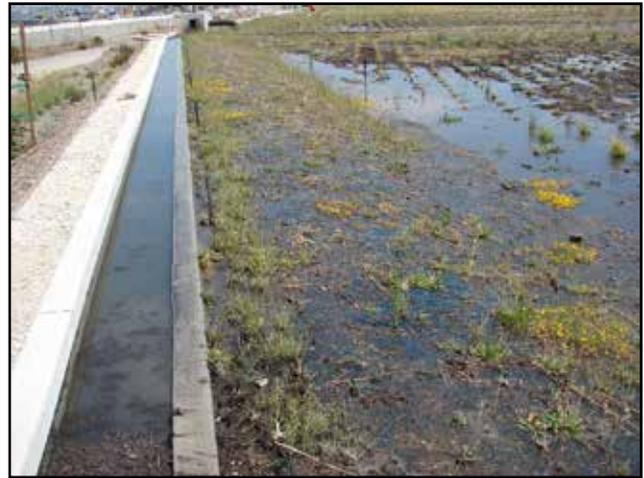
The Stormwater Treatment Measures contract implemented a number of best practices for the management and treatment of stormwater runoff. Focused on the areas around and approaching the toll plaza, the contract added new drainage and built new bio-retention swales and other related constructs.

Stormwater Retention Basin

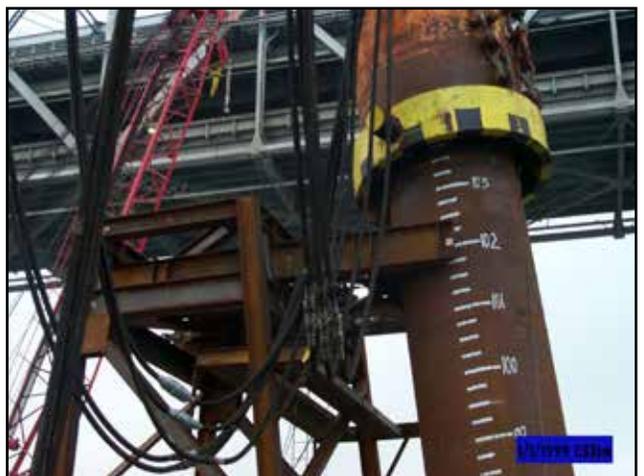
While large-diameter battered piles are common in offshore drilling, the new East Span is one of the first bridges to use them in its foundations. To minimize project risks and build industry knowledge, a pile installation demonstration project was initiated to prove the efficacy of the proposed technology and methodology. The demonstration was highly successful and helped result in zero contract change orders or claims for pile driving on the project.

Battered Pile Installation Demonstration

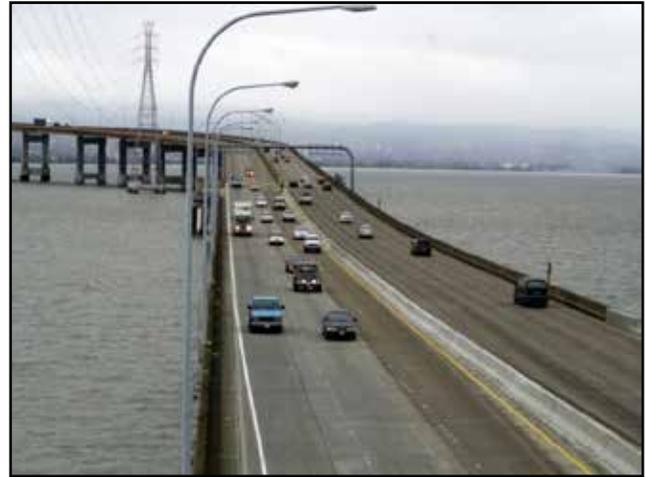
High-Rise Section of San Mateo-Hayward Bridge

The San Mateo-Hayward Bridge seismic retrofit project focused on strengthening the high-rise portion of the span. The foundations of the bridge were significantly upgraded with additional piles.

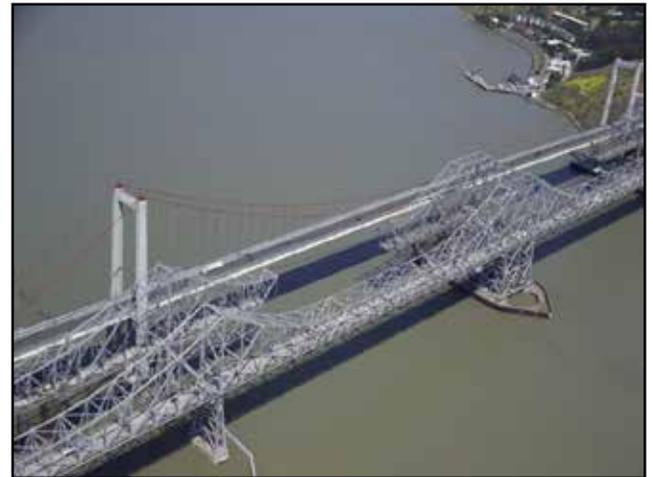
1958 Carquinez Bridge (foreground) with the 1927 Span (middle) under Demolition and the New Alfred Zampa Memorial Bridge (background)

The eastbound 1958 Carquinez Bridge was retrofitted in 2002 with additional reinforcement of the cantilever thru-truss structure.

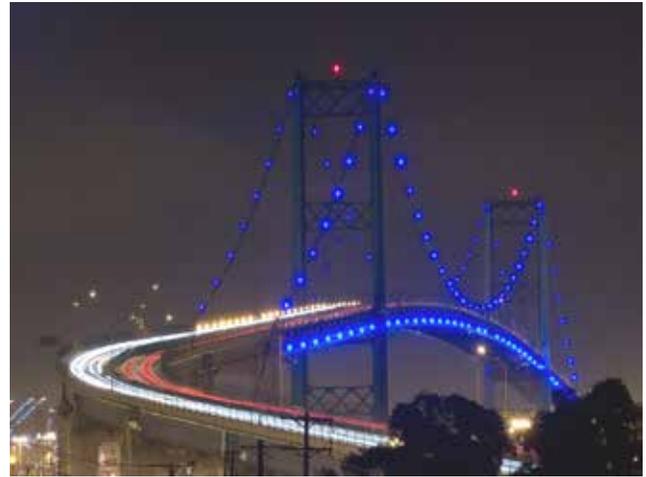
Los Angeles-Vincent Thomas Bridge

The Vincent Thomas Bridge is a 1,500-foot long suspension bridge crossing the Los Angeles Harbor in Los Angeles that links San Pedro with Terminal Island. The bridge was one of two state-owned toll bridges in Southern California (the other being the San Diego-Coronado Bridge). Opened in 1963, the bridge was seismically retrofitted as part of the TBSRP in 2000.

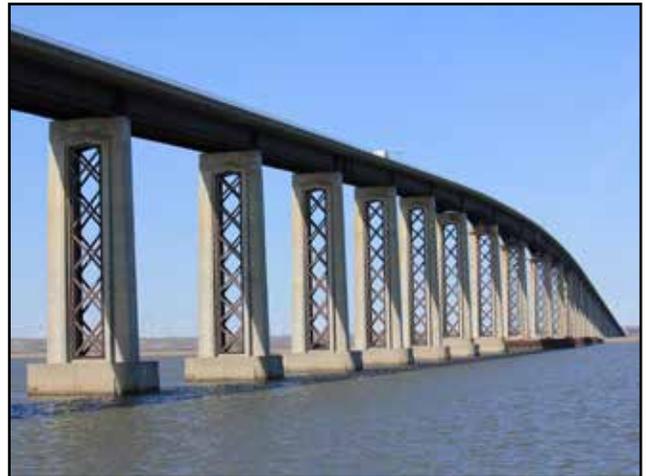
Serving the Delta region of the Bay Area, the Antioch Bridge takes State Route 160 traffic over the San Joaquin River, linking eastern Contra Costa County with Sacramento County. The current 1.8-mile-long steel plate girder bridge was opened in 1978 with one lane in each direction. The major retrofit measure for the bridge includes installing seismic isolation bearings at each of the 41 piers, strengthening piers 12 through 31 with steel cross-bracing between column bents, and installing steel casings at all columns located at the Sherman Island approach slab bridge.

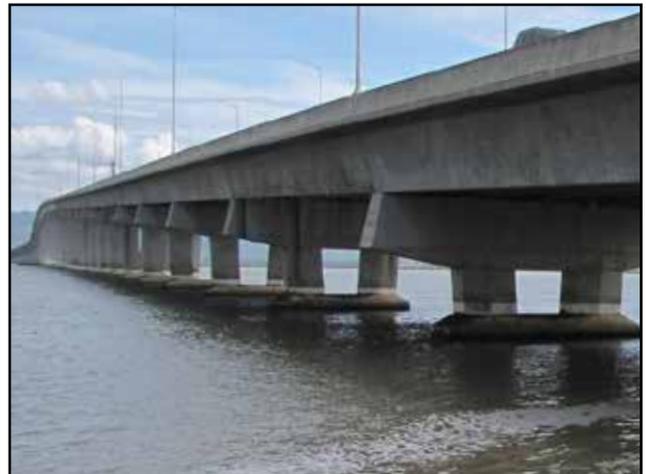
The current Dumbarton Bridge was opened to traffic in 1982 linking the cities of Newark in Alameda County and East Palo Alto in San Mateo County. The 1.6-mile long bridge has six lanes (three in each direction) and an eight-foot-wide bike/pedestrian pathway. The bridge is a combination of three bridge types; reinforced concrete slab approaches supported on multiple pile extension columns, precast-prestressed concrete delta girders and steel box girders supported on reinforced concrete piers. The current retrofit strategy for the bridge included superstructure and deck modifications and installation of isolation bearings.

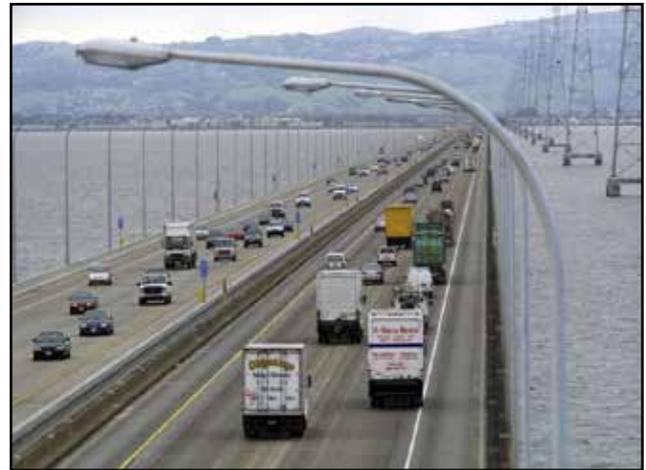
Widening of the San Mateo-Hayward Bridge Trestle on left

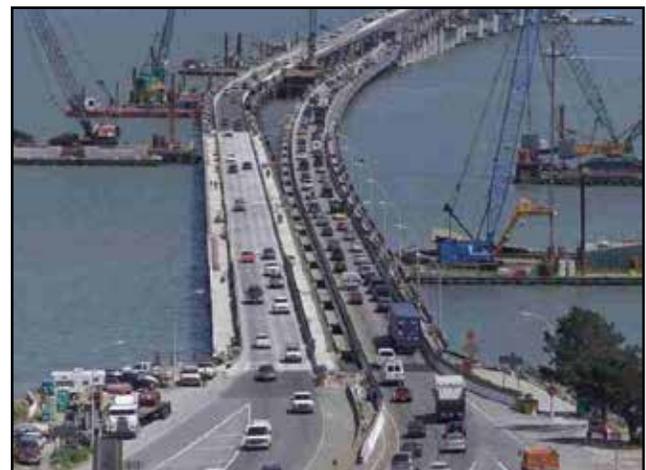
New Richmond-San Rafael Bridge West Approach Trestle under Construction

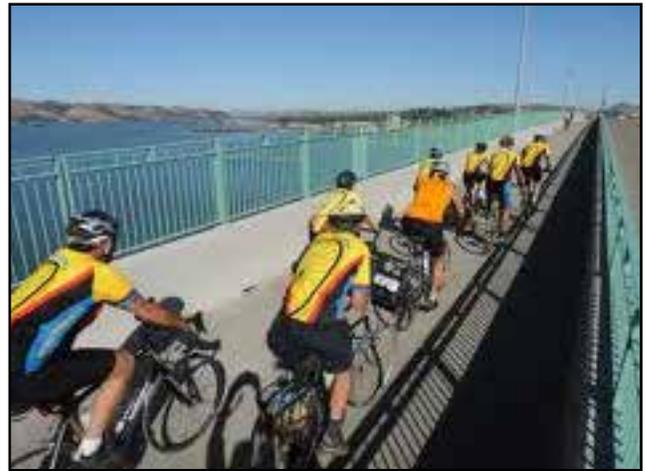
Benicia-Martinez Bridge Bicycle/Pedestrian Path

A two-year project to rehabilitate and reconfigure the original Benicia-Martinez Bridge began shortly after the opening of the new Congressman George Miller Bridge. The existing 1.2-mile roadway surface on the steel deck truss bridge was modified to carry four lanes of southbound traffic (one more than before) - with shoulders on both sides - plus a bicycle/pedestrian path on the west side of the span that connects to Park Road in Benicia and to Marina Vista Boulevard in Martinez. Reconstruction of the east side of the bridge and approaches was completed in August 2008. Reconstruction of the west side of the bridge and its approaches and construction of the bicycle/pedestrian pathway were completed in August 2009.

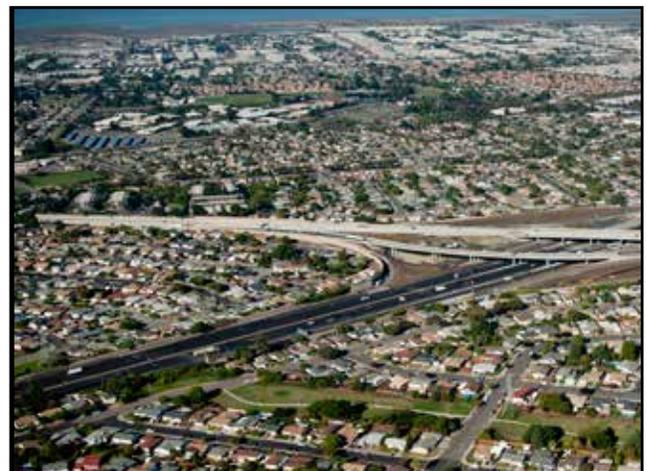
Aerial View of Completed 880/92 Interchange Project

This corridor was consistently one of the Bay Area's most congested during the evening commute. This was due in part to the lane merging and weaving that was required by the then-existing cloverleaf interchange. The new interchange features direct freeway-to-freeway connector ramps that now increase traffic capacity and improve overall safety and traffic operations in the area. With the new direct-connector ramps, drivers coming off of the San Mateo-Hayward Bridge can access Interstate 880 without having to compete with traffic headed onto east Route 92 from south Interstate 880.

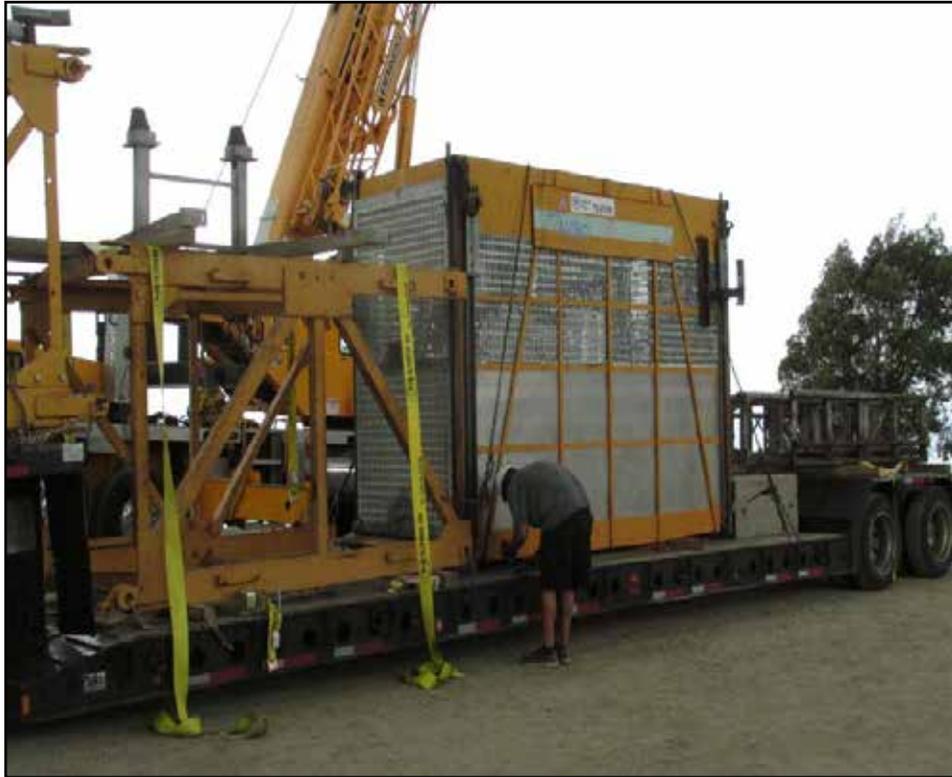
Construction Elevator Cab Loaded onto Truck

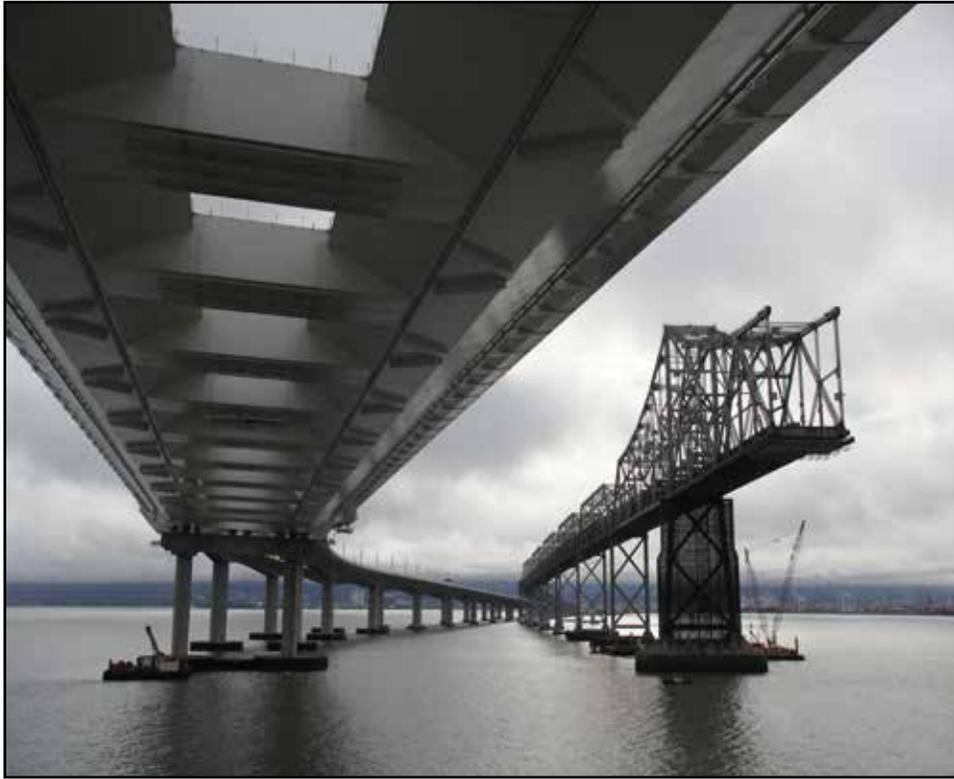
Underneath Cantilever Deck Removal in Progress Looking toward Oakland

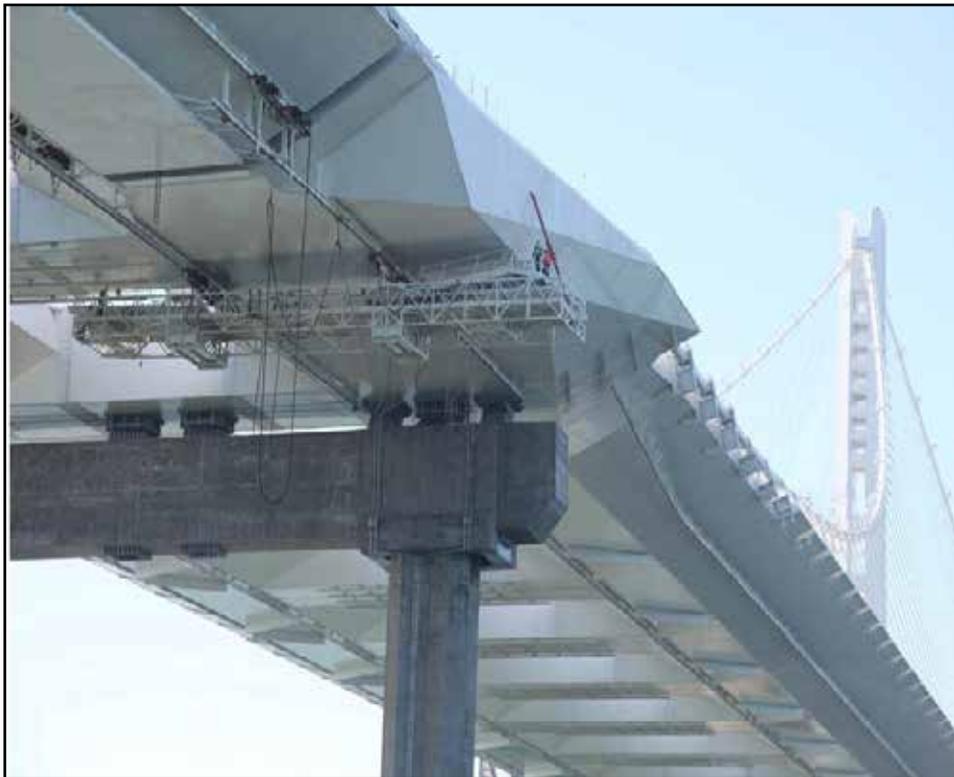
Paint Touchup at Roadway Box East End

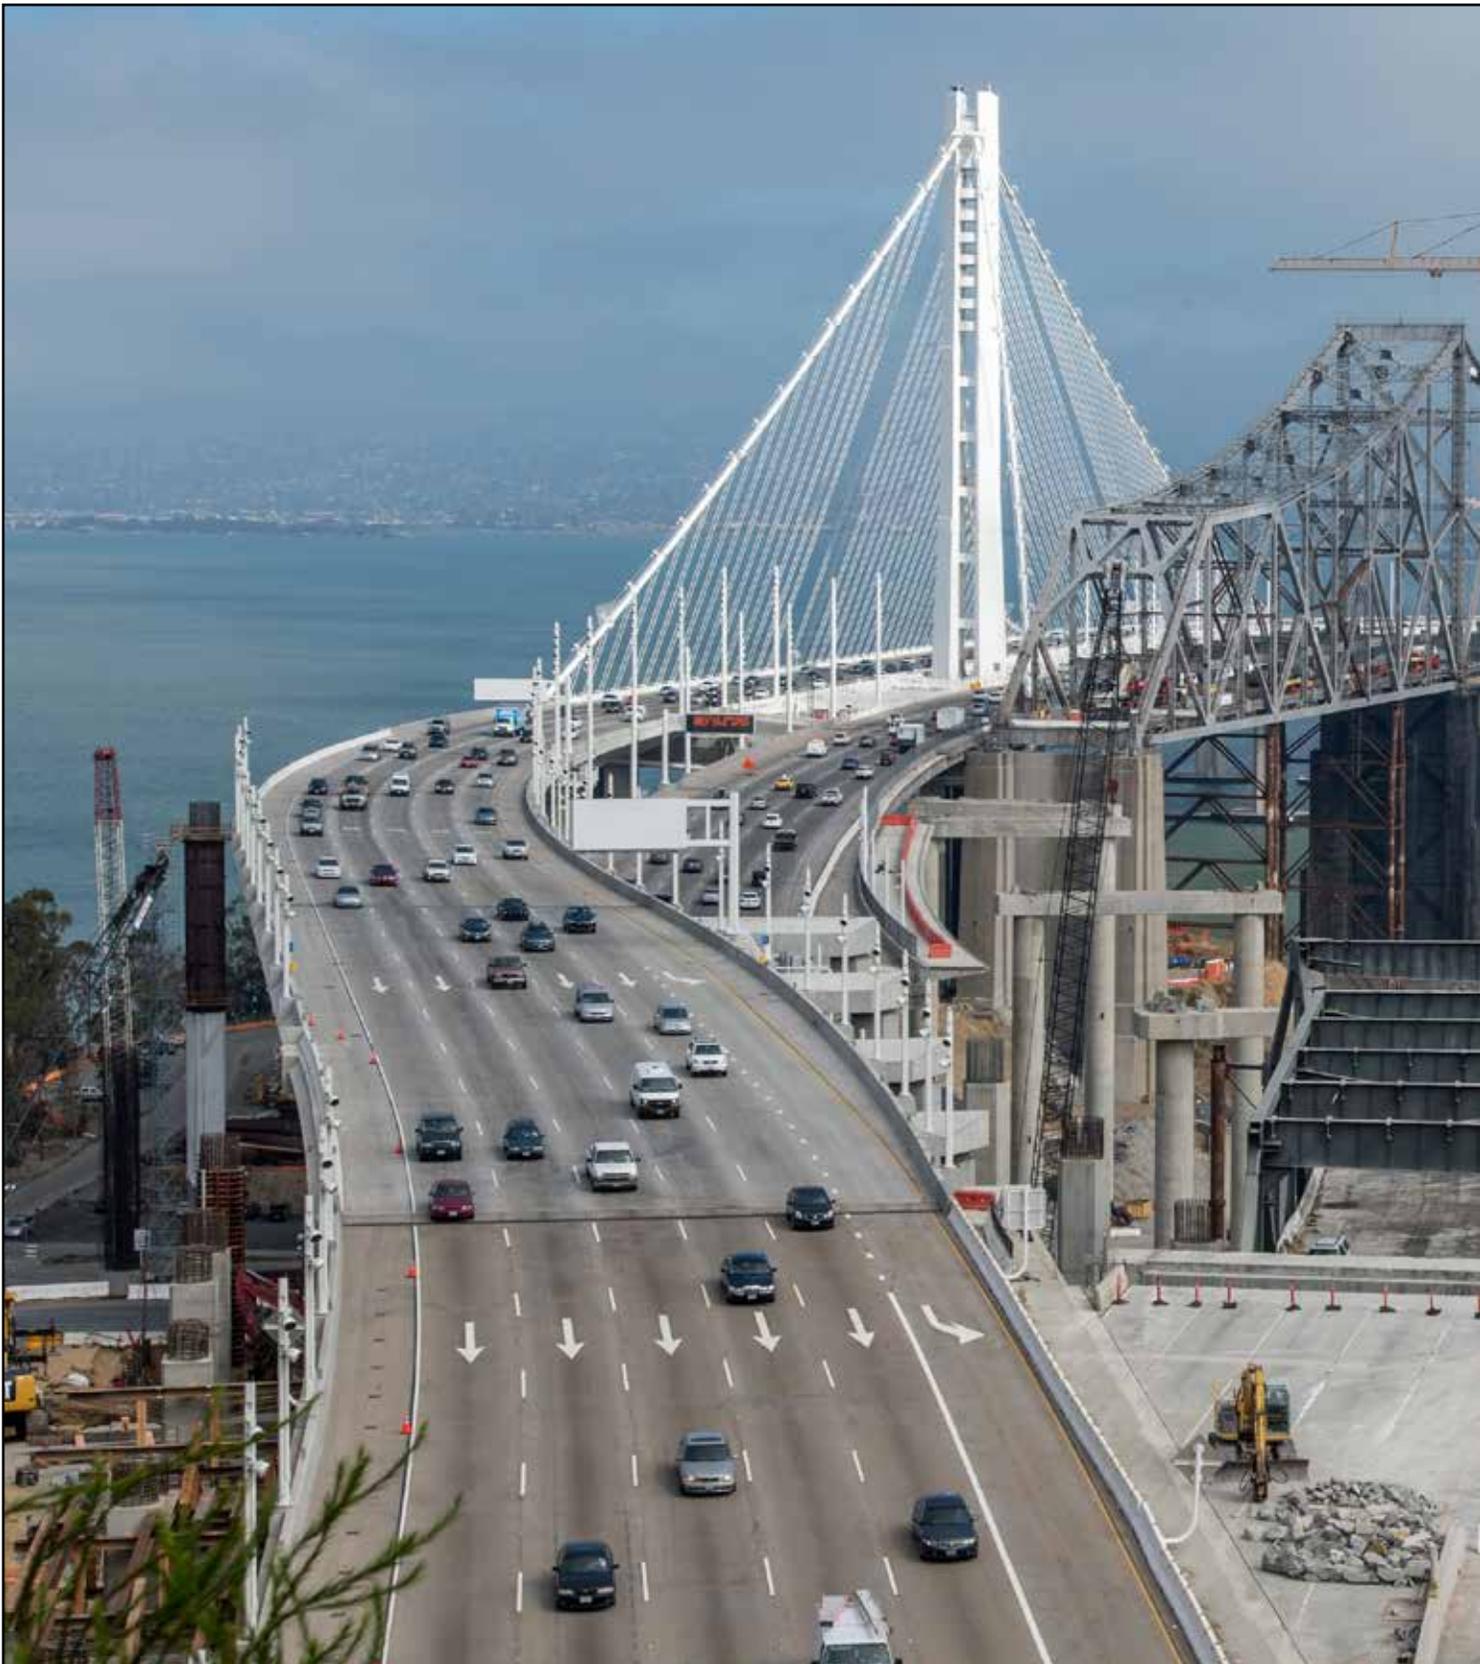
Aerial View of Yerba Buena Island Transition Structures Demolition Progress
